Evaluation of HDPE Pipelines Structural Performance

UT Arlington Center for Structural Engineering Research

November 2010

**As a Part of the Initiative on the Underground Structural Health
Monitoring and Equipment Development**

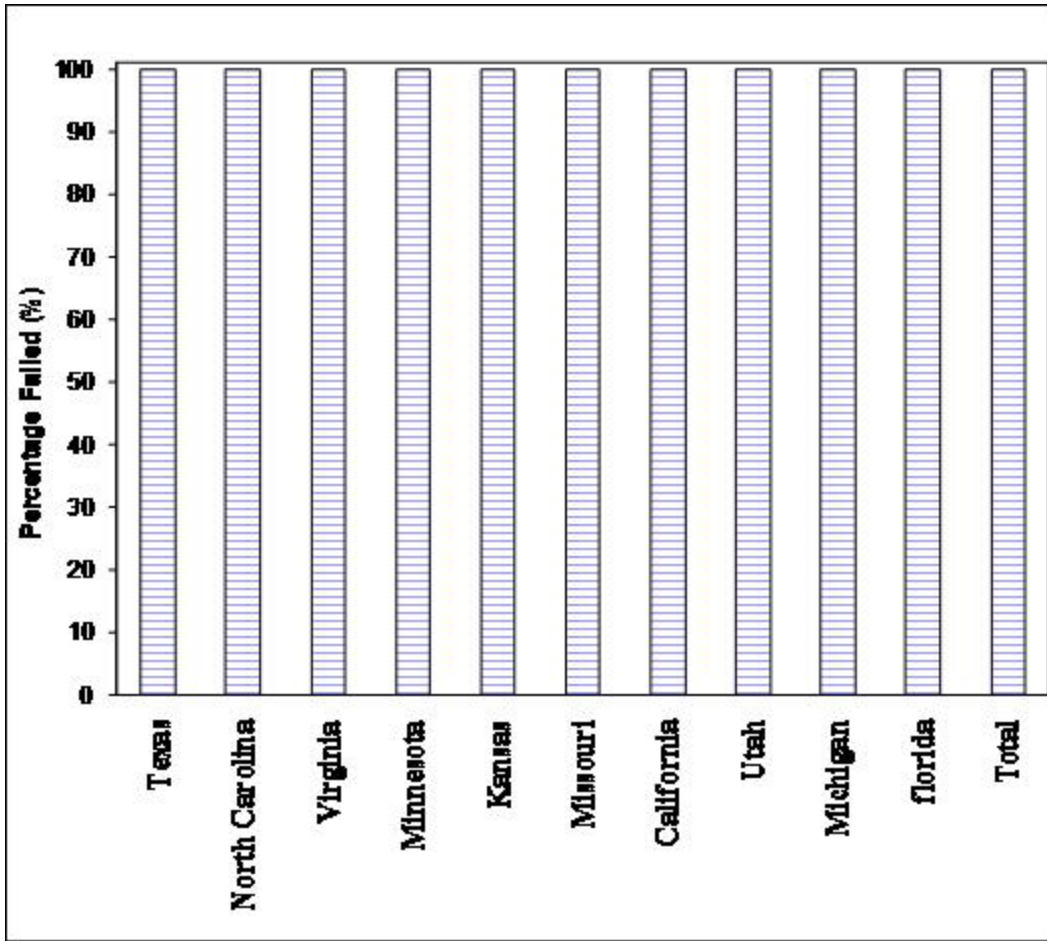
2. Since 100% of the pipes experienced corrugation growth, it is recommended that a comprehensive study to be conducted to establish a post installation Mannings, n, due to the corrugation growth.

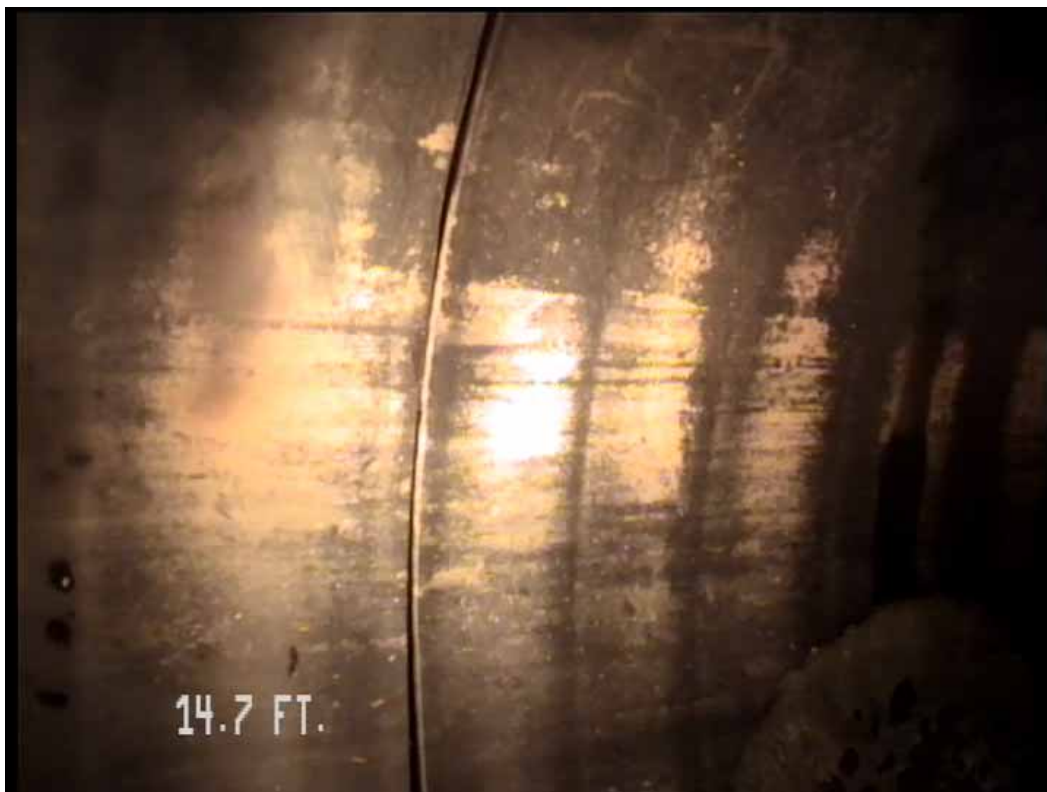
Figure 483 View of the minor joint displacement failure for pipeline No. 2 (Site No. 1: Orlando)

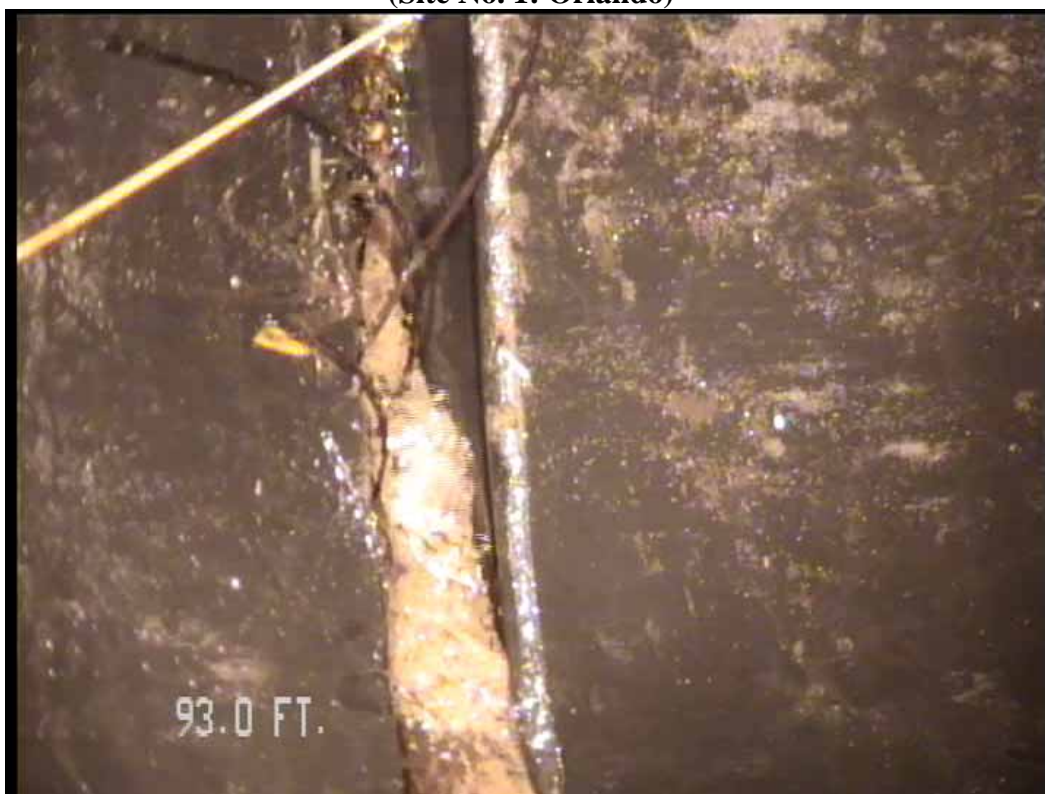
**Figure 487 View of the major joint displacement failure for pipeline No. 2
(Site No. 1: Orlando)**

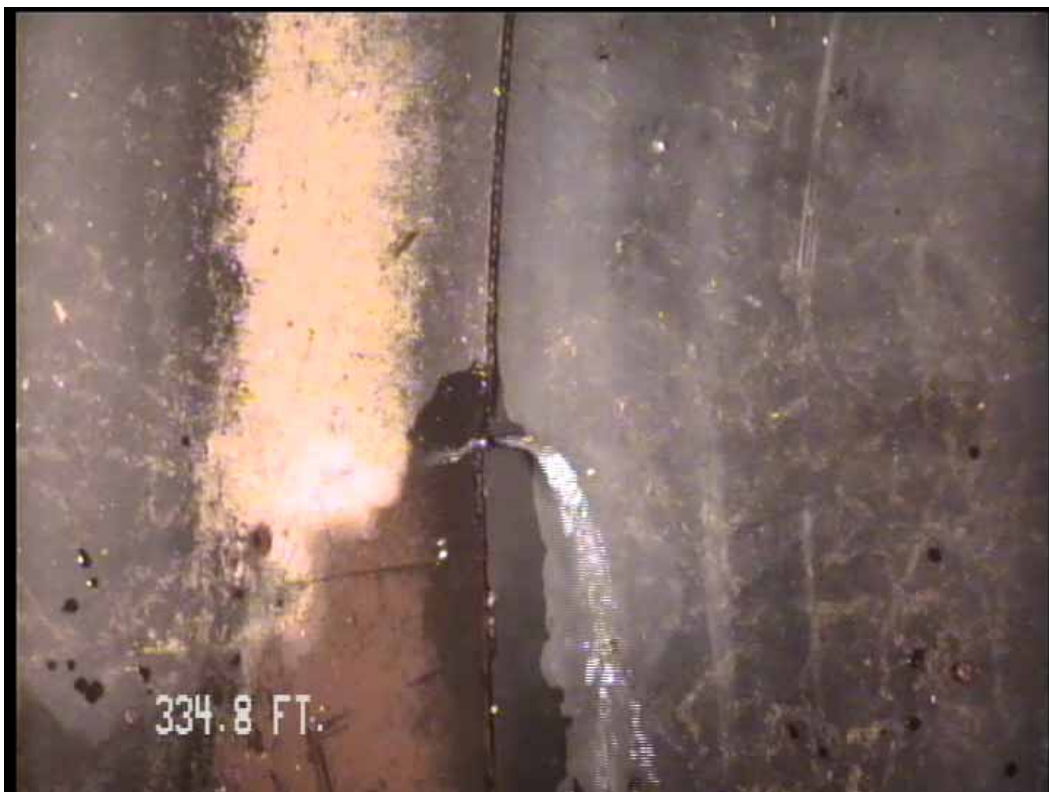
Figure 500 View of the leaking at the joint for pipeline No. 3 (Site No. 1: Orlando)

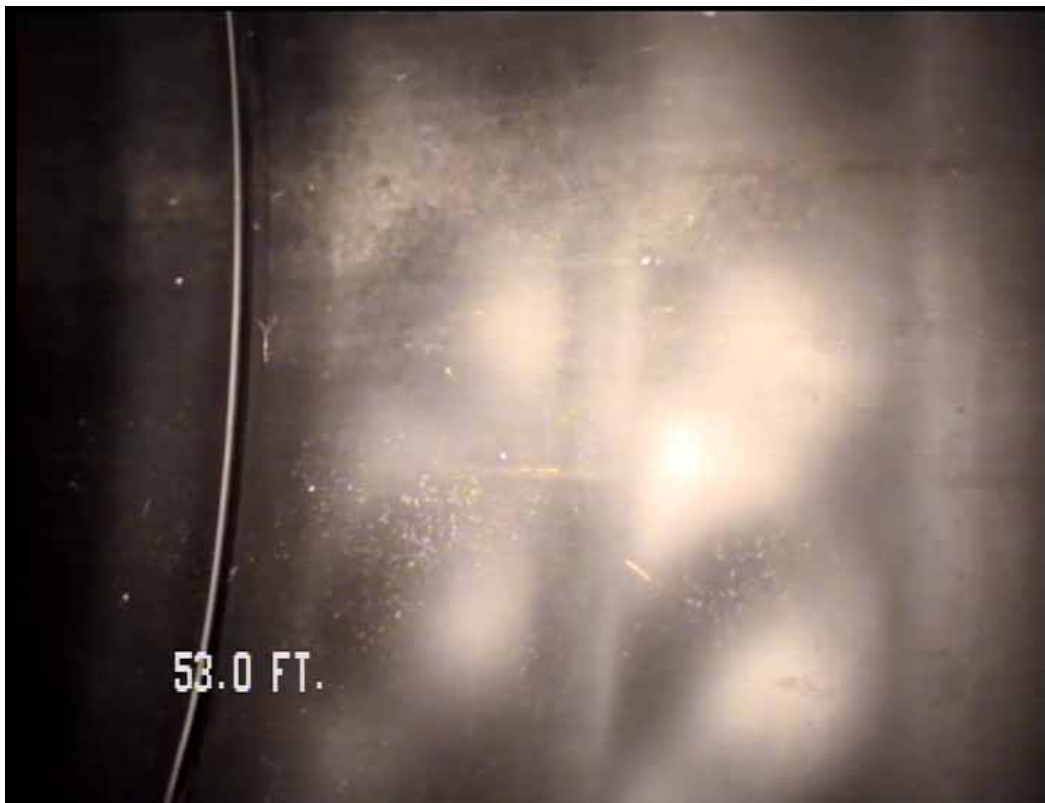
Figure 517 View of the minor joint displacement and buckling failure for pipeline No. 7 (Site No. 1: Orlando)

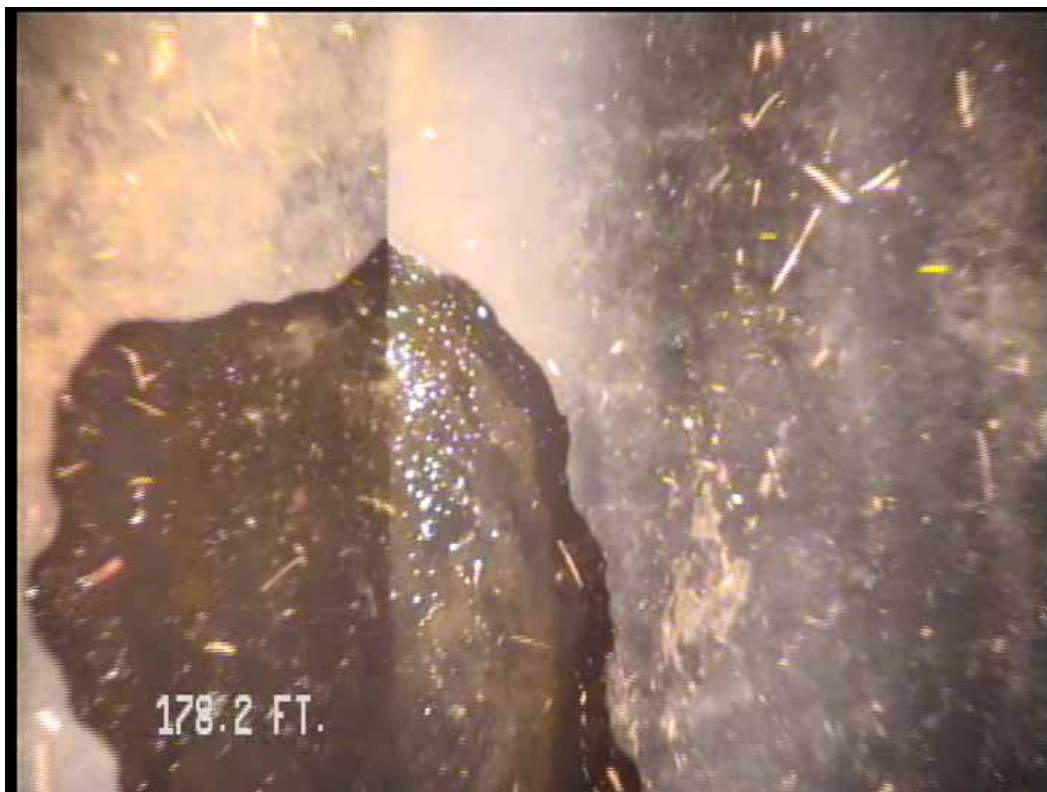
Figure 529 View of cracking/leaking failure for pipeline No. 8 (Site No. 1: Orlando)

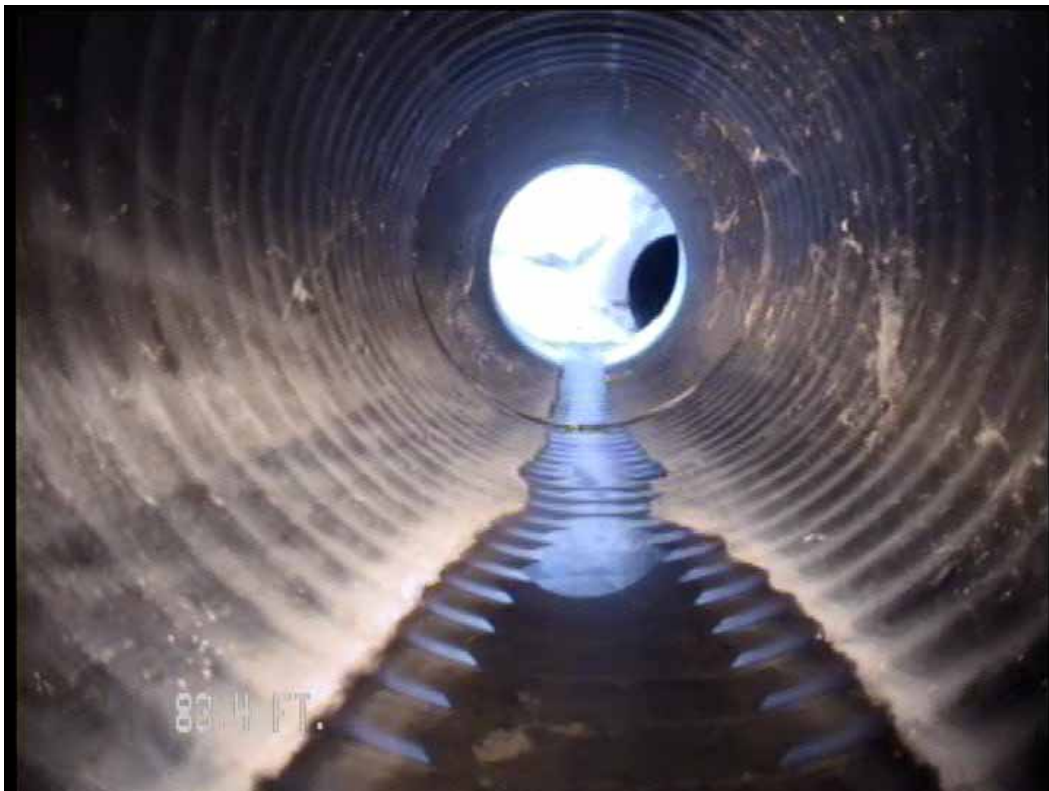
Figure 578 View of the corrugation growth failure at the end for pipeline No. 14 (Site No. 2: Apopka)

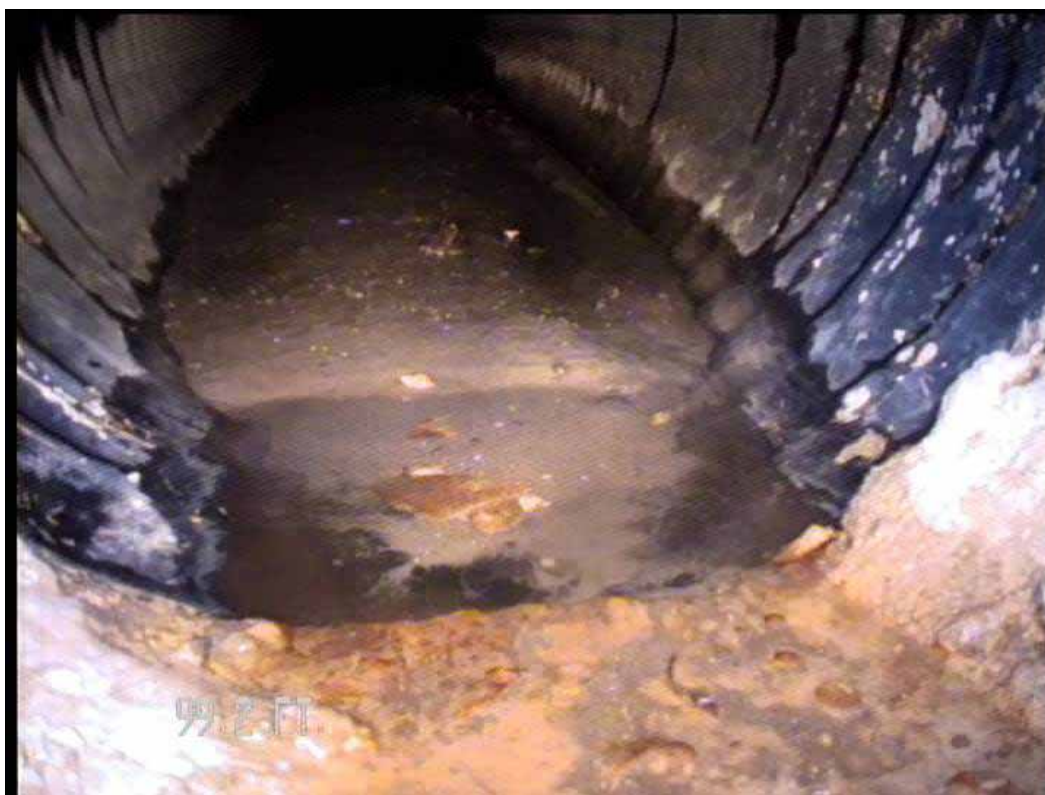
Figure 580 View of the corrugation growth failure at the opening for pipeline No. 15 (Site No. 2: Apopka)

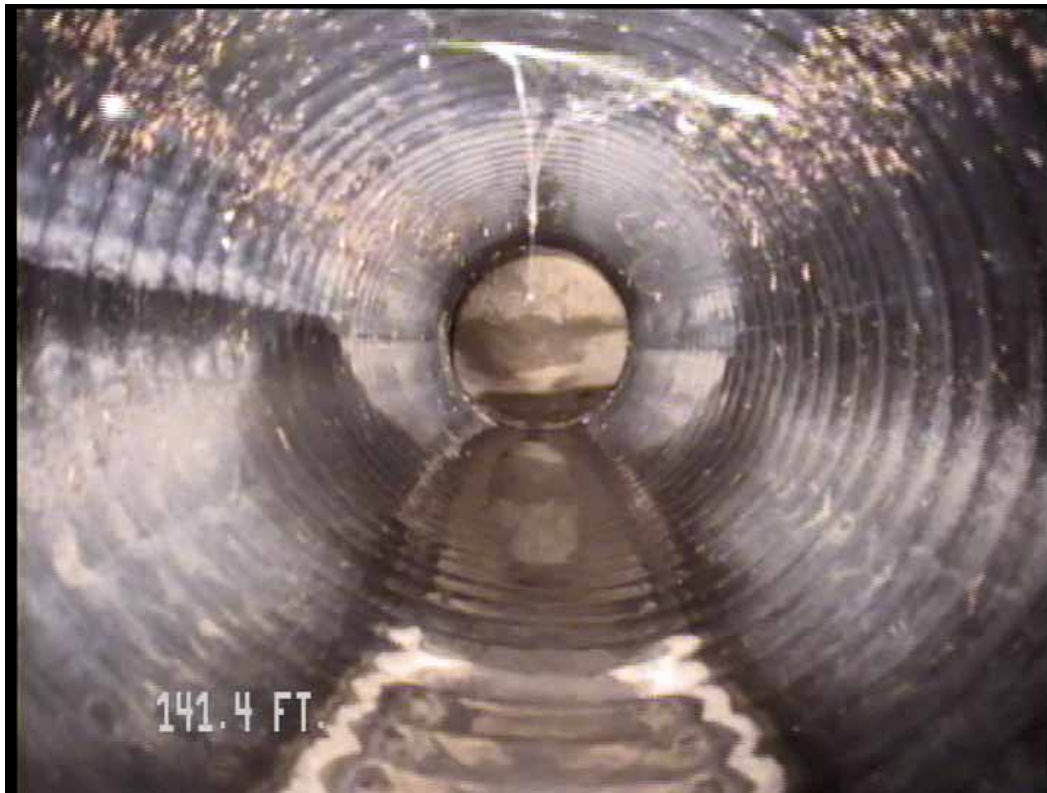
**Figure 584 View of corrugation growth failure at the end for pipeline No. 15
(Site No. 2: Apopka)**
