An educational document from the American Concrete Pipe Association for users and specifiers

Heavy rains in May 2011 overwhelmed a 72” four-barrel Corrugated Metal Pipe (CMP) culvert on Texas Farm to Market Road (FM) 2539 near the town of Buffalo in Leon County, Texas. Area management from the Texas Department of Transportation (TxDOT) and local maintenance crews were forced to shut down the road for more than a week while they replaced the metal culvert with reinforced concrete pipe (RCP). Estimated cost of the replacement process: \$350,000.

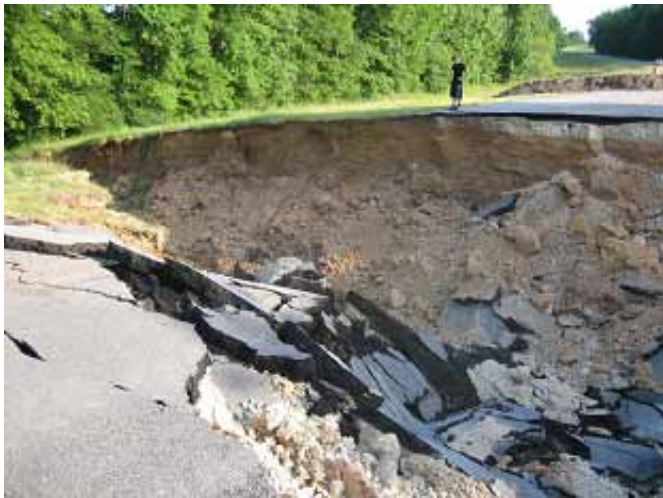
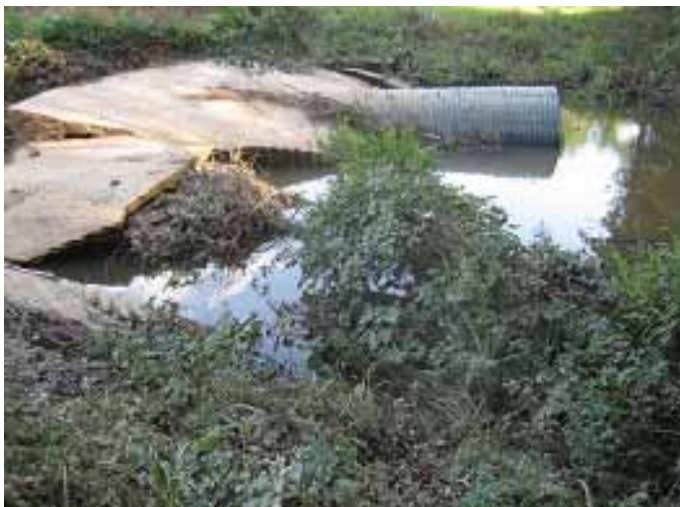
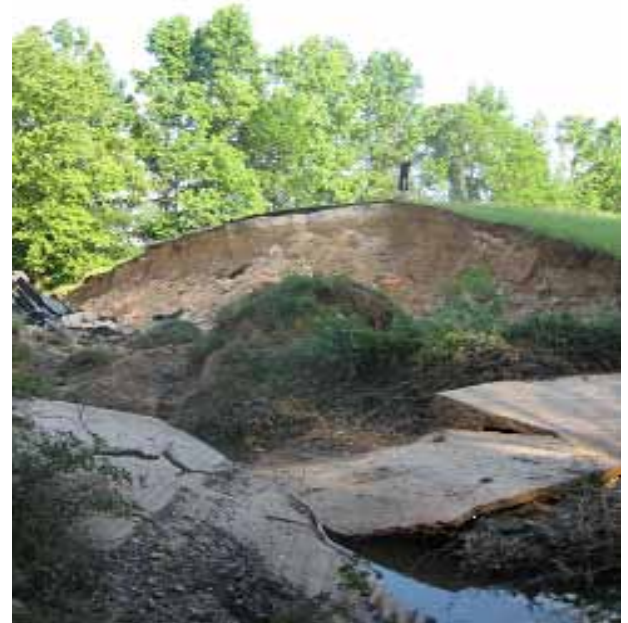
The failure occurred about five miles south of Buffalo on FM 2539, a road that serves a number of rural homes. Given the extensive damage, TxDOT was unable to conduct a full analysis of the root cause of the failure. However, TxDOT employees found sufficient evidence to indicate that the inverts failed, leading to partial collapse of the structure. The resulting restriction of the lines backed up enough water to cause the failure seen in these photographs.

According to the U.S. Corps of Engineers, corrugated metal pipe has a design life of up to 50 years, though the metal pipe industry recommends that a soil analysis be conducted prior to estimating the life cycle. The CMP pipe that failed here was installed in 1986; which means it survived for roughly 25 years, or half its “advertised” lifespan. Unfortunately, agencies like TxDOT across the country are routinely replacing failed CMP systems after only 25 to 40 years of service. CMP culverts often fail catastrophically, resulting in significant property damage and risk to public welfare.

Ironically, nearby landowners and TxDOT personnel confirmed that the recently failed metal culvert was installed in 1986 as a replacement for a previous CMP culvert that had also failed. Fortunately, for the third culvert installation at this location since the 1980s, TxDOT has opted to replace the failed CMP with reinforced concrete pipe, which has a design life of up to 100 years, according to the U.S. Corps of Engineers. Furthermore, unlike CMP, concrete pipe has a successful history of durability, performance over its service life and minimal risk of structural failure.

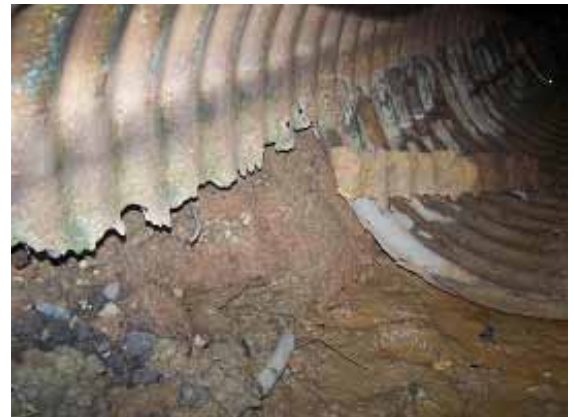
The photograph to the right shows a 30" CMP culvert on FM 2539, less than a half mile from the catastrophic failure described above.

While the age of this culvert is unknown, its apparent deteriorated condition suggests that structural failure may be imminent without mitigation.

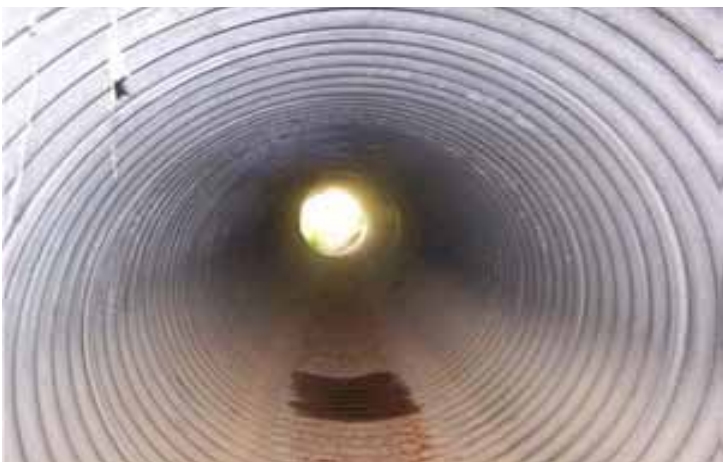
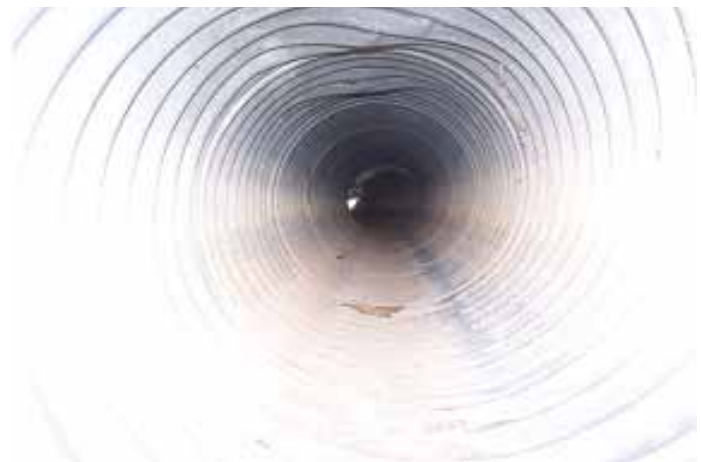
Now look at the 42" CMP culvert (*below*), which lies underneath the entrance to the Buffalo Ridley Block Operation, a local manufacturer of livestock feed blocks.

It is not only buckling, but it is significantly corroding as well. According to an official at Ridley Block, this visibly compromised culvert was installed in late 1999. After just 12 years, is this culvert already in need of replacement?
