A Message from the American Concrete Pipe Association

Bulletin No. 121

Installation Anomalies? You Be The Judge

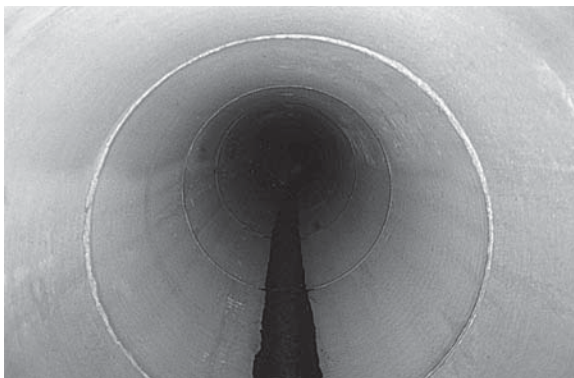
RCP Pipe Installed in 1987

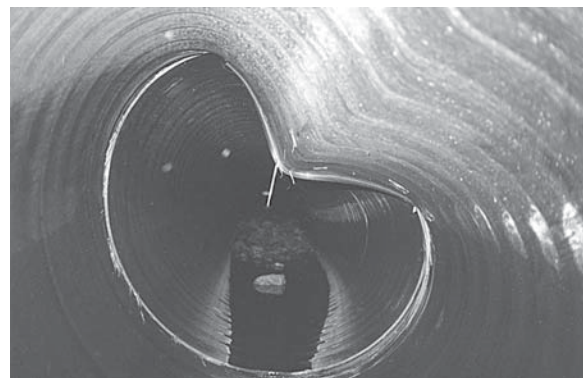
- 30" and 36" diameter lines have deflection of 13% (4" and 4 1/2" respectively).
- 30" line failed allowing debris into the line.
- Inconsistent grade.
- Deep corrugation growth.
- Cracked liner.
- The 60" concrete outfall line (1987) which this project empties into is in excellent condition.

HDPE Pipe Installed in 1997
