EFFECTS OF CRACKS IN REINFORCED CONCRETE CULVERT PIPE

Based on the report Diamond Bar Culvert, A Study of Corrosion of the Steel Reinforcement Relative to Crack Widths in Reinforced Concrete Pipe.

Prepared by The Technical Committee of The California Precast Concrete Pipe Association, February, 1976.

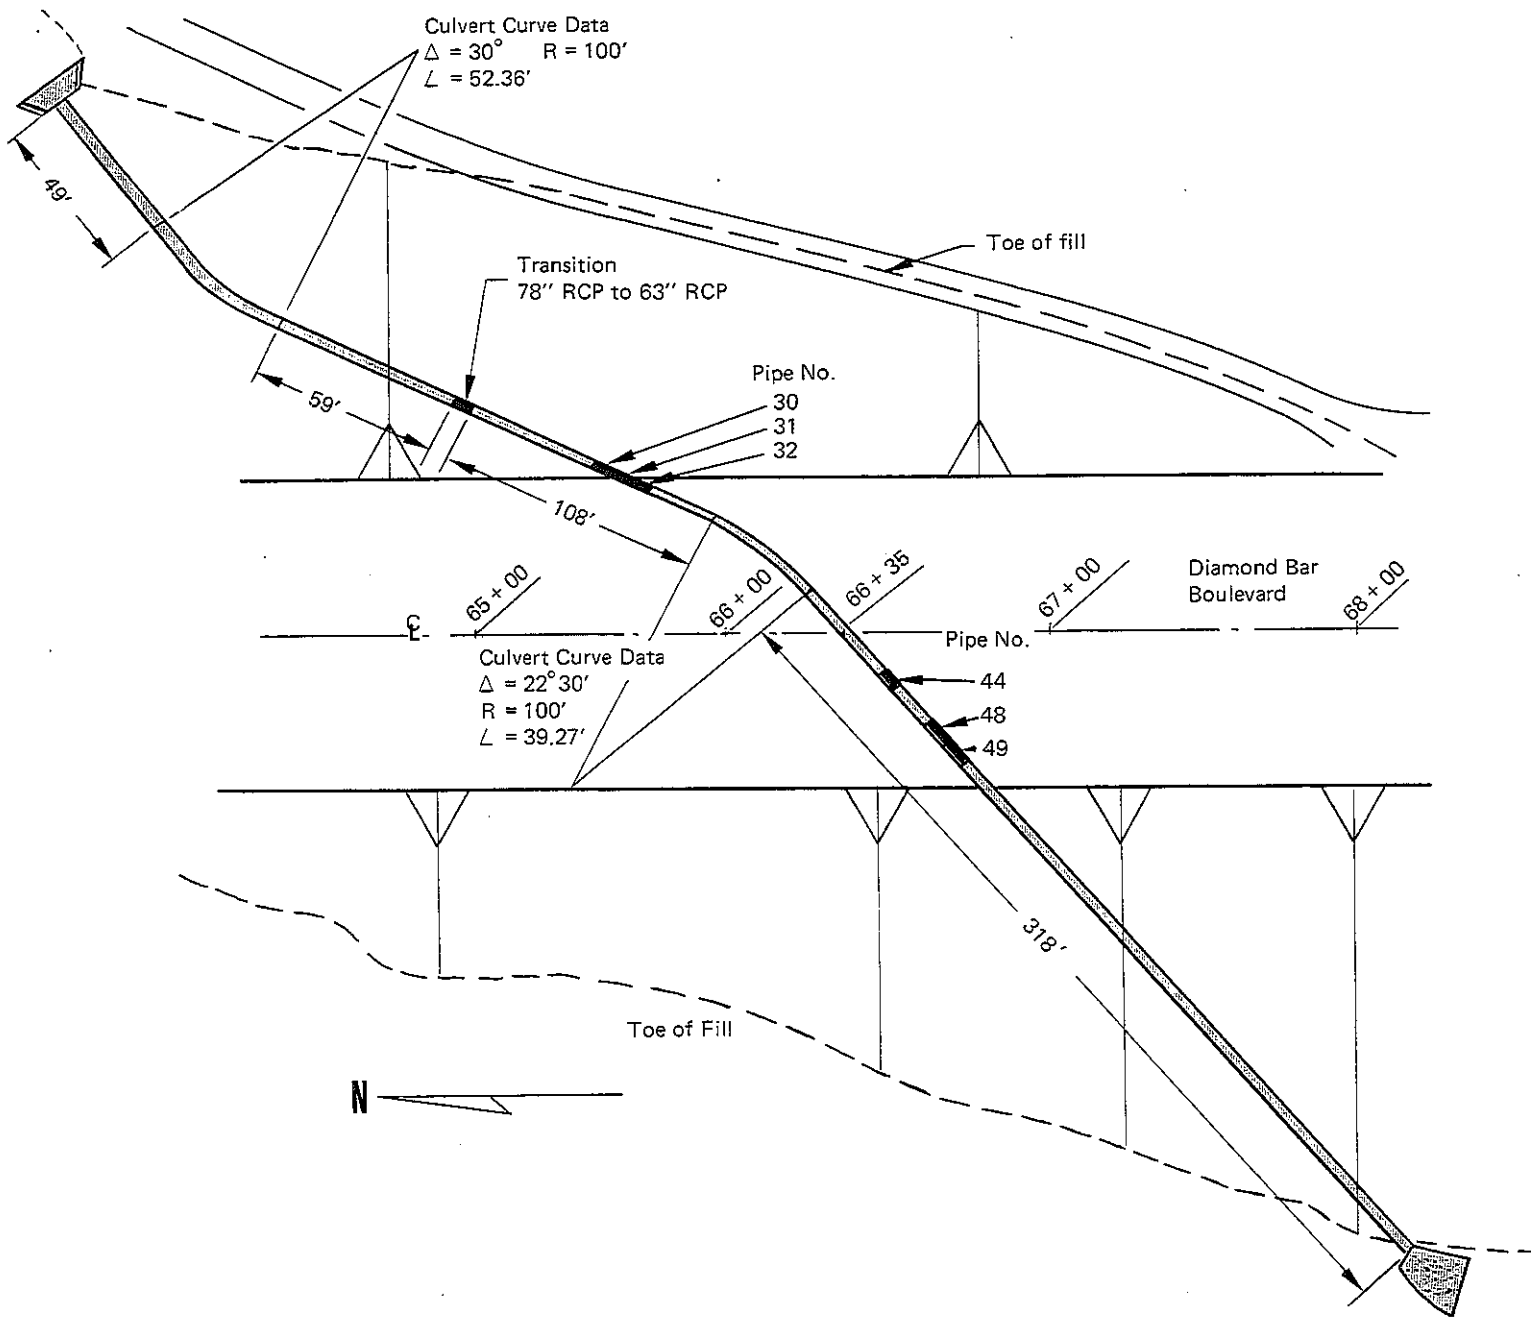
FIGURE 1: DIAMOND BAR BOULEVARD — CULVERT PIPE PLAN VIEW.

The Diamond Bar Culvert, an existing flood control culvert shown in Figure 1, Plan View, was selected as it had the desired characteristics for the investigation. The inside diameter of the pipe is 78 inches at the entrance reducing to 63 inches approximately 160 feet downstream with a total culvert length of 680 feet. The 78-inch pipe is a 1,750 D-load with single deformed elliptical reinforcing and the 63-inch pipe is a

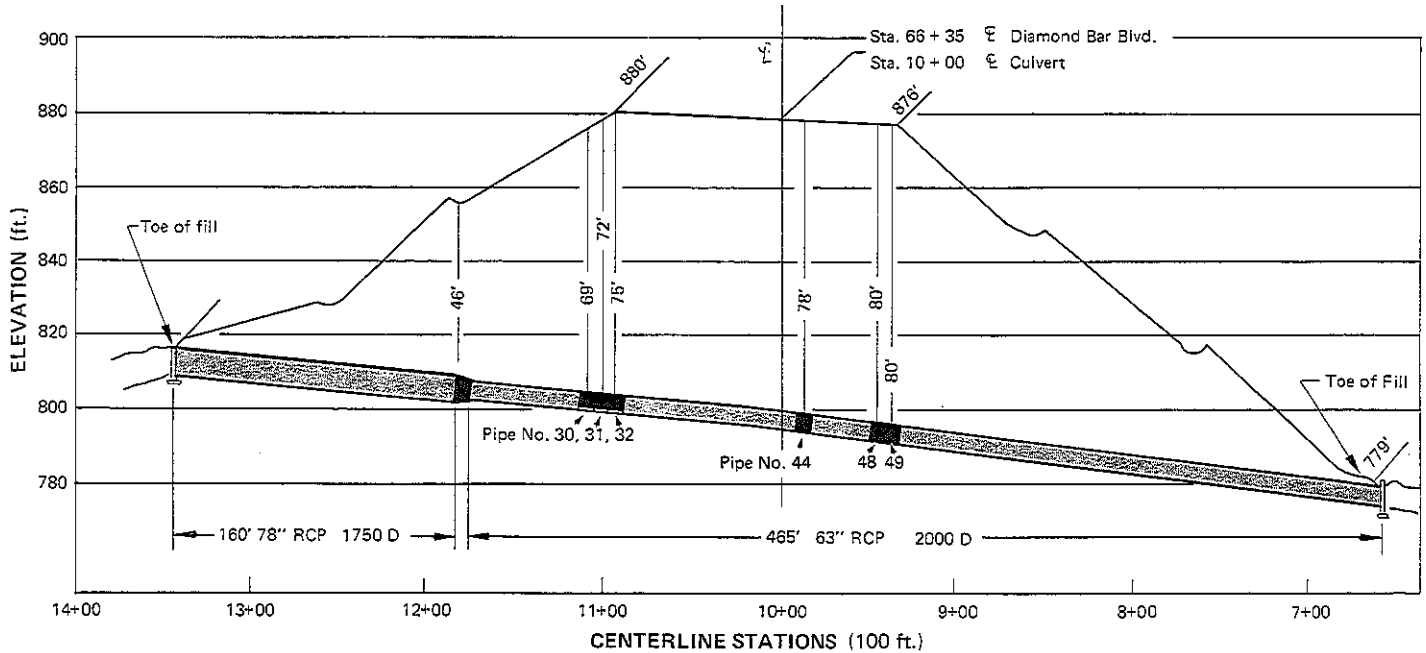
FIGURE 2: DIAMOND BAR BOULEVARD — CULVERT PIPE PROFILE VIEW.

Department surveyed the pipe in 1962-64 and found that all pipe except the first 10 and the last 18 lengths exhibited hairline or larger cracks and had cracks continuous from the spigot end to the bell. The cracks were located at either the pipe crown, invert or both. Six pipe lengths numbered 30, 31, 32, 44, 48 and 49, as shown in Figure 2, Profile of Culvert, were selected for evaluation. Vertical and horizontal diameter measurements

were taken. The initial measurements taken in November, 1962 disclosed that pipe 31 had the maximum increase in horizontal diameter, two inches, and the maximum decrease in vertical diameter, one inch. During the following fifteen month period additional measurements indicated the subsequent maximum additional increase in horizontal diameter was 0.102 inch and the maximum additional decrease in vertical diameter was 0.200 inch.

Although the pipe design and manufacture were in accordance with the project specifications, the loads on the pipe after installation were found to be unsymmetrical and not as anticipated. This resulted in deflections causing vertical to horizontal diameter differences of over three inches which produced "slabbing," and flexural cracking. "Slabbing" can be defined as radial tension failure of the concrete and can be visualized as the tendency of the curved re-

inforcing to straighten out under load. Some of the cracks were repaired during the period 1962-63 with epoxy pressure grouting.
