Evaluation of HDPE Pipe Performance
on
Kentucky DOT and Ohio DOT
Construction Projects

by Pipeline and Drainage Consultants
a subsidiary of Spartan Construction

EVALUATION OF HDPE PIPE PERFORMANCE ON KENTUCKY DOT CONSTRUCTION PROJECTS

EVALUATION OF HDPE PIPE PERFORMANCE ON OHIO DOT CONSTRUCTION PROJECTS

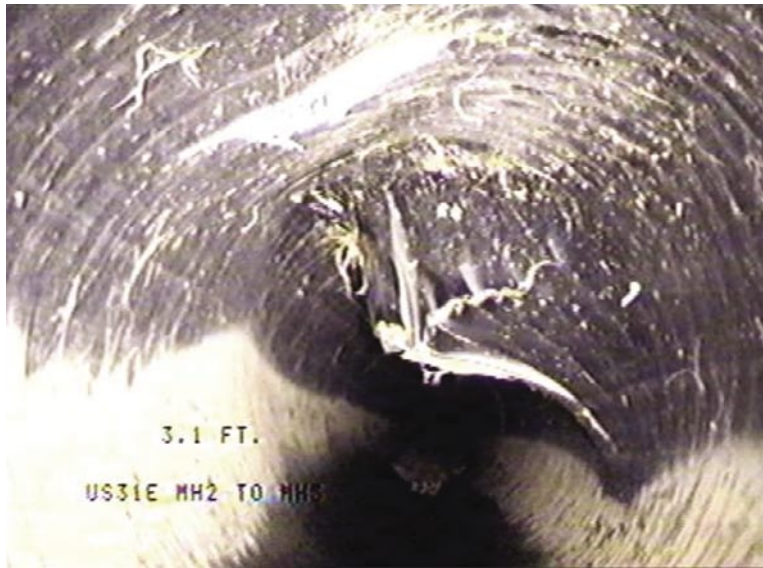
Video image on Project 4, US 31e, Hodgenville, failure in 18 inch storm drain due to deflection of approximately 50%.

Significant to severe deflections, crown flattening, racking, and cracking are observed in several of the pipe sections throughout this site. Cracking is observed in approximately 8% of the pipe sections and sagging is noted in 33% of the pipe sections. The failed 18" storm drain has 50% deflection and should be removed and replaced.

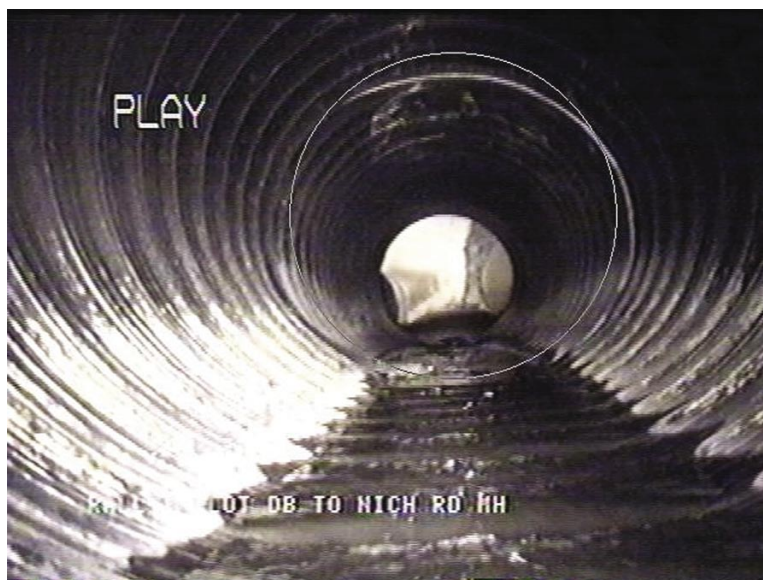
Current laser deflection measurement (July 2005) indicates that several of the line segments (MH to MH) have areas deflected over 5% with one location approaching 10%. Radial cracking, crown and invert flattening, and corrugation expression (growth) have also increased. Radial cracking is observed in 16% of the pipe and sagging in 24% of the pipe sections.

Video Image on Project 1, Nicholasville Road, showing 10% deflection and corrugating growth.

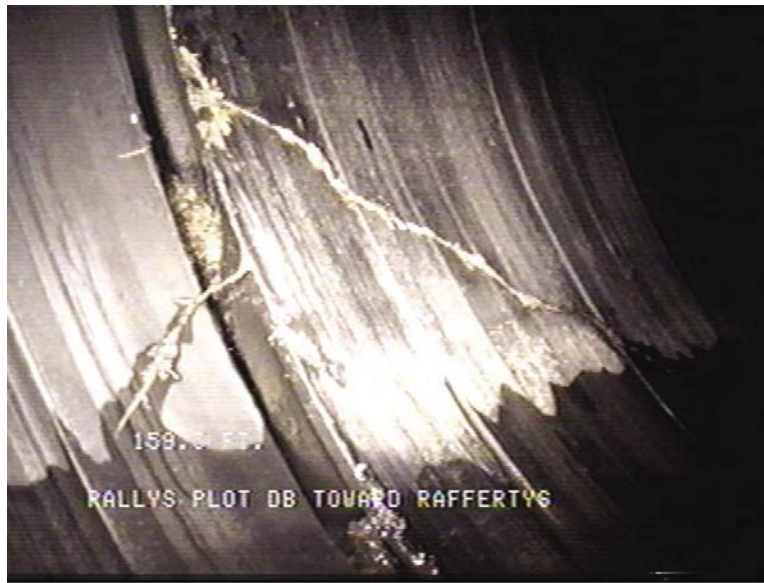
Video Image on Project 1, Nicholasville Road, showing severe radial cracking near a joint.

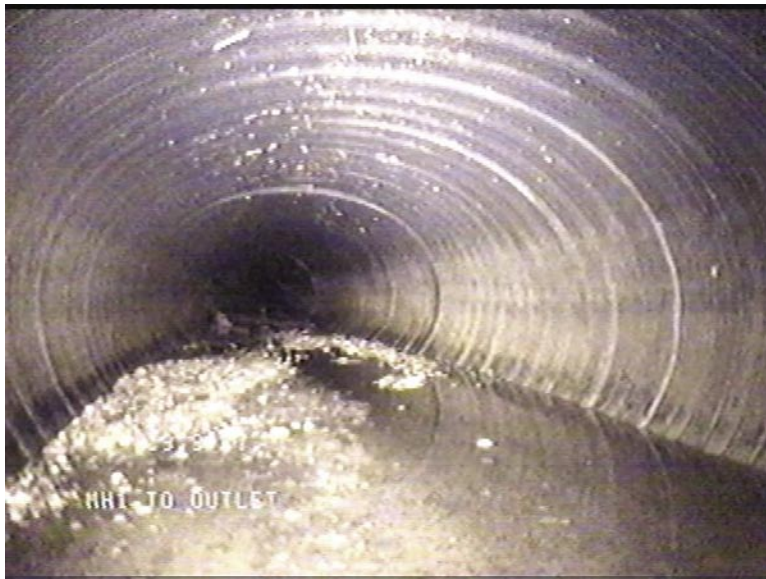
Video Image on Project 2, US 68/KY 80, showing approximately 20% deflection.

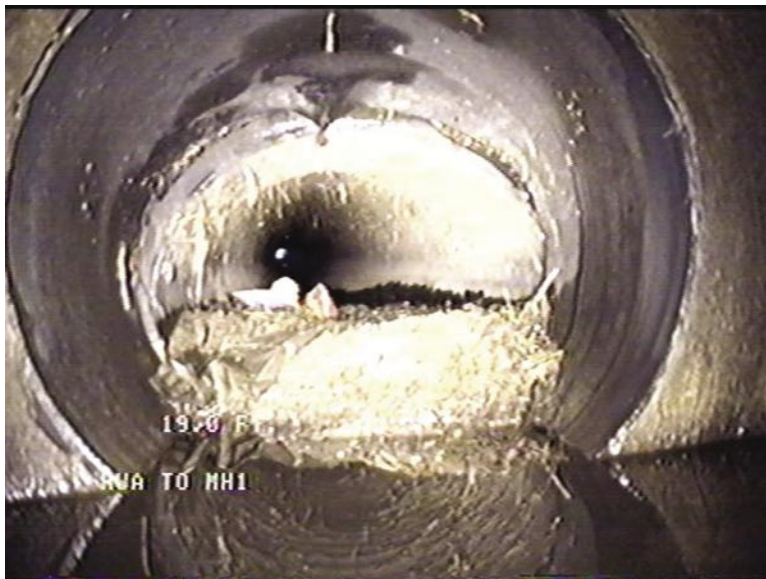
Video Image on Project 2, US 68/KY 80, with severe damage due to deflection and joint separation.

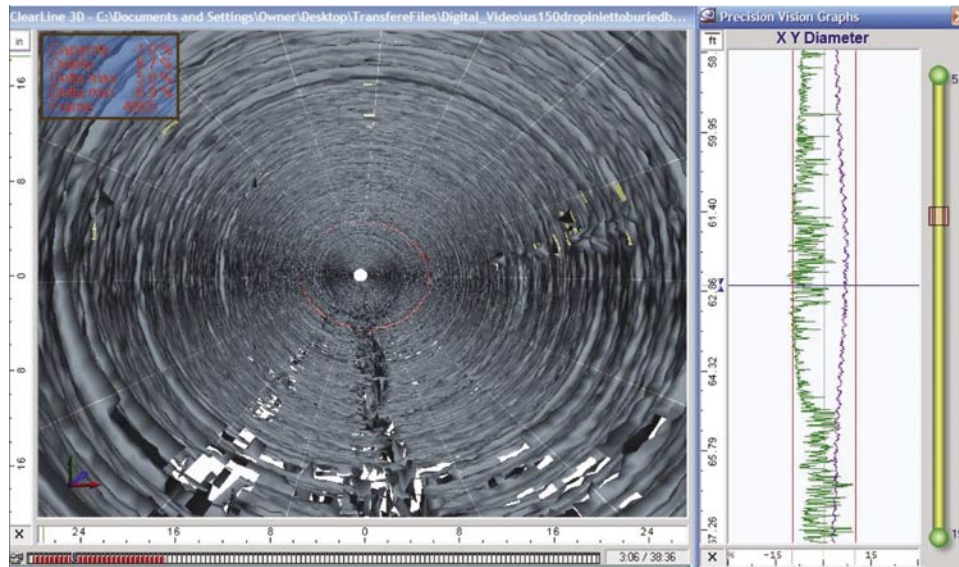
In July 2005, several of the lines segments have deflected approximately 10%. Sagging is observed in 36% of the pipe sections. Cracking is not observed in any of the line sections that were inspected.

Video Image on Project 5, US 150, Stanford , 3D model and strip chart showing approximately 10% vertical deflection at 62 feet.

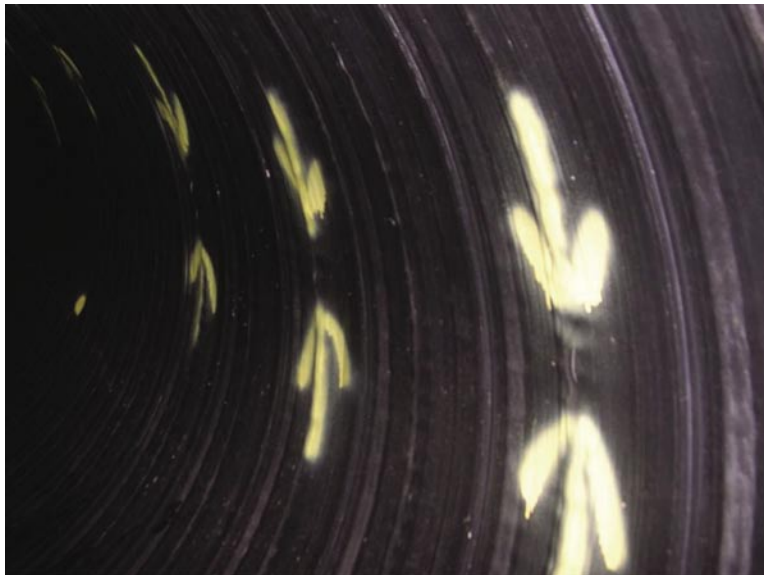
Video Image on Project 6, US 127, Owen County.

Deflection measurement of the 36-inch pipe was taken by Wiss, Janney, Elstner Associates, Inc in 2002. The cross drain was inspected again in June 2005, by KTC and PDC. At the time of the inspection there were no signs of significant distress or deflections. Corrugation growth (liner pushing inward) is the only noticeable issue.

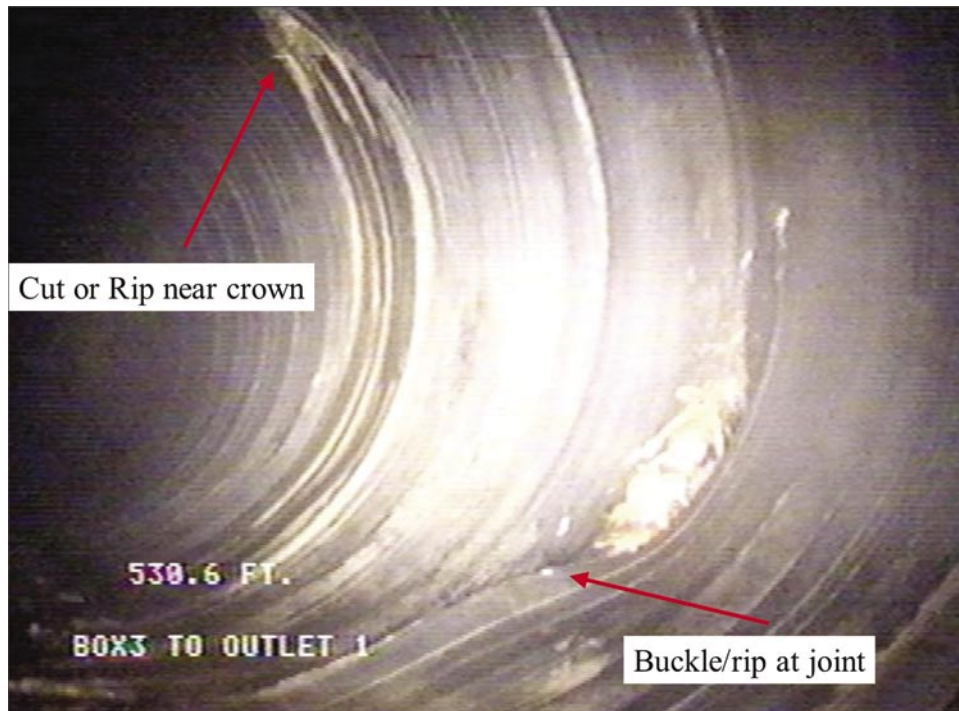
In July 2005, 905 feet of pipe were inspected on this project. Laser deflection measurements were not conducted, due to limited access to buried manholes and possible dangerous conditions resulting from unknown laterals. The video inspection did indicate that several areas of the lines are significantly deflected. Several estimated deflection readings in the 36-inch outfall line appear to exceed 10 and 12%. These percentages are significantly higher than what was observed in 1991. The 2005 investigation shows that 33% of the pipes have signs of radial cracking and sagging is observed in approximately 4.5% of the lines.

Video Image on Project 7, KS 207, Flatwoods, with buckling and ripping at joint and crown.

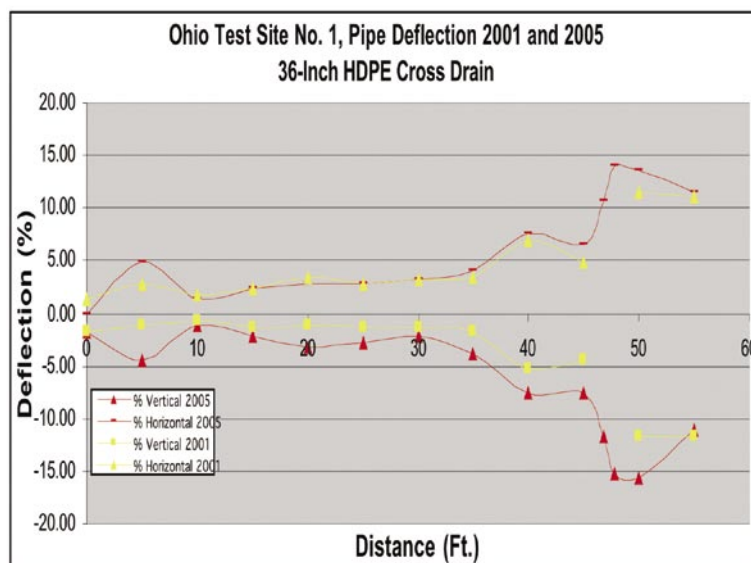
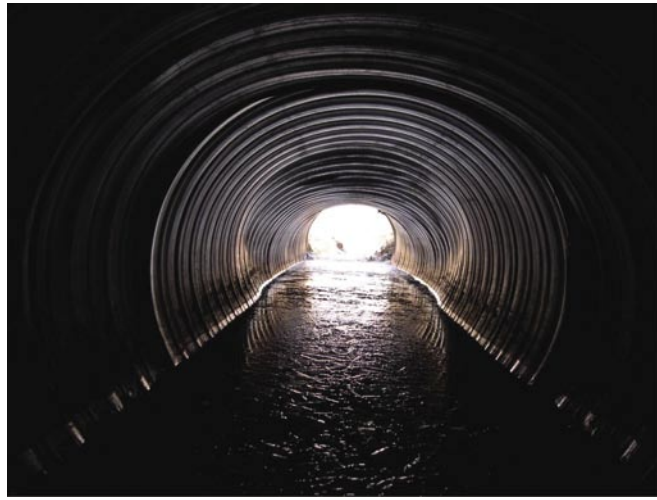
Wall buckling and dimpling were noted in the areas of deflection of 7.5% or greater. This was noted in the 2001 inspection and appear to have increased. Manual deflection measurements taken in 2005 indicate that the pipe has continued to deflect with a maximum deflection recorded in 2001 of 11.81%, and a maximum deflection of 15.63 % in 2005. Approximately 23% of the vertical measurements taken in 2001 would not pass a 5% deflection test and approximately 43% would not pass in 2005. Deflection readings indicate changes vertically and horizontally occurred near the outlet and inlet ends of the pipe. The 2001 report documented one crack, and seven cracks are documented in 2005.

Video Image on Project 1, Harpster, showing significant change in pipe deflection near outlet.

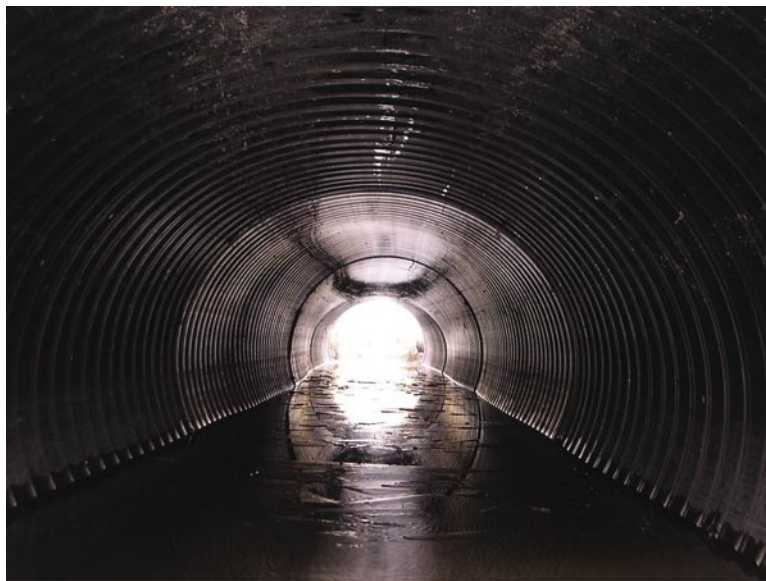
The 60-inch cross drain was installed in 1995 near Dola, Ohio, with a maximum depth of cover of 5 feet or less. The pipe was inspected in 2001 and on December 6, 2005. No buckling or dimpling is noted during the 2005 inspection. Manual deflection measurements taken in 2005 indicate that the pipe has severely deflected outside the roadway. Vertical deflection readings indicate that 53% of the pipe has deflected greater than 5%. Vertical readings were not taken in 2001. Crown flattening and racking is apparent in some areas. Cracking was not documented in 2001. One radial crack is noted in the 2005 inspection. Crown flattening is apparent at both the inlet and the outlet ends where deflections are near or greater than 10%. Creasing may be occurring at 10 and 2 o'clock where deflection is near 10%.

Video Image on Project 2, Dola showing vertical deflection and racking

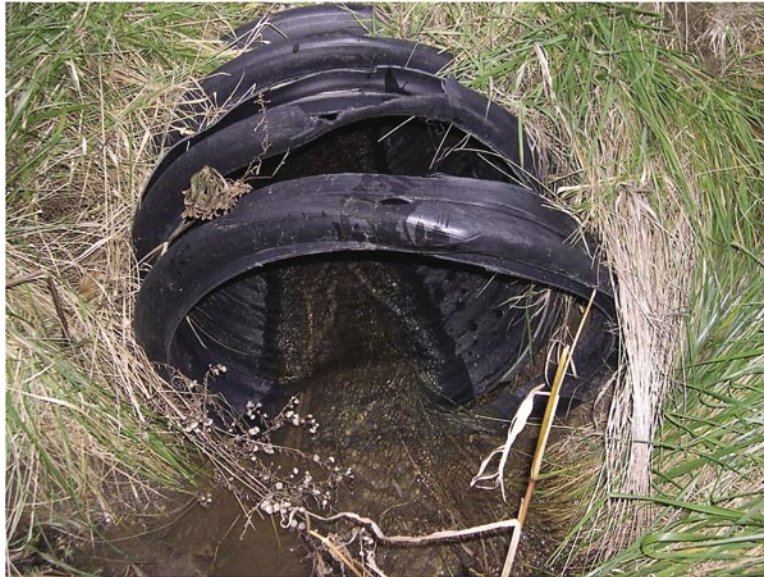
Project 5, Danville, inlet

The 30-inch cross drain was installed in 1997 near Danville, Ohio. It appeared that the pipe had less than 2 feet of cover. No buckling or dimpling is noted during the 2005 inspection. No significant deflections greater than 5% were noted in 2005. It does appear that the pipe is undergoing some possible defor-

mation from dynamic/wheel loading. One crack was documented in 2001 and additional cracking has occurred since 2001. A spiraling crack is noted, going from 13-feet to 13.5-feet from the inlet end. The inlet end of the HDPE pipe has been severely damaged. It is uncertain if these deflections were introduced during installation or have occurred over time.

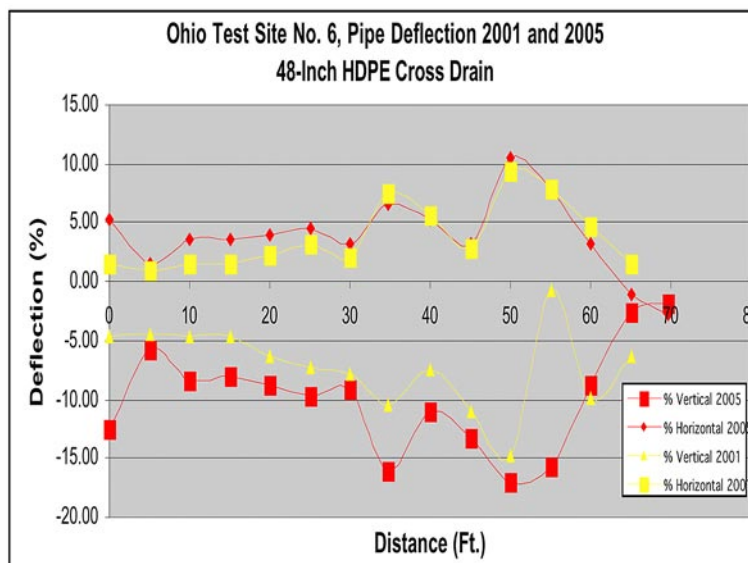
The 48-inch, 70-foot long cross drain was installed in 1999 near Danville, Ohio. It appeared that the pipe had a maximum of 2 feet of cover. Dimpling and wall buckling were not significantly observed. Bulging at the invert was documented in 2001 at 12, 34, and 45 feet and cracking was also documented on top of the bulges. Additional bulging is documented in the 2005 survey at 1 and 48 ft. The 2001 report indicated that 60 percent of the vertical readings would not pass a 5% deflection test. Vertical deflection readings taken in 2005 indicate that 87% of the pipe is greater than 5% deflected. The 2001 report documented the greatest deflection of 14.84 percent at 50 ft. Deflection has increased to 17% and longitudinal cracking has occurred in the crown of the pipe. Cracking was documented in three locations in 2001 and in eight areas in 2005. A large portion of these cracks occur in bulged areas at the invert. Several of the cracks appear to have penetrated the entire invert of the pipe.

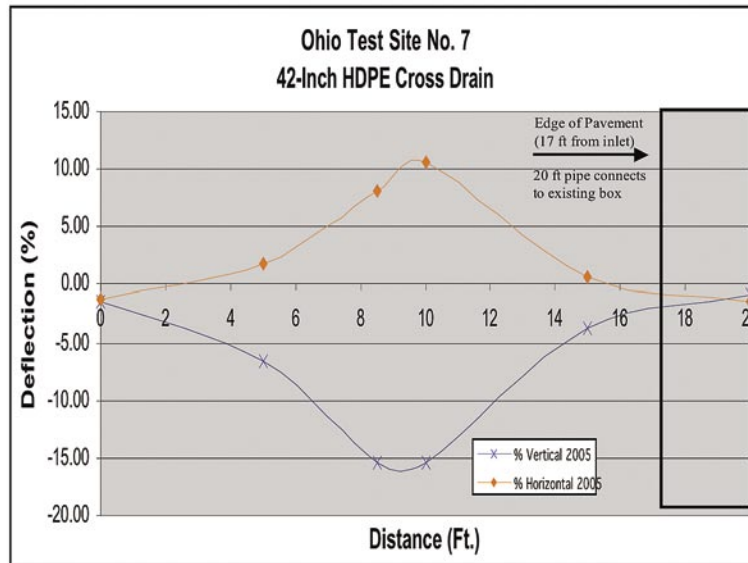
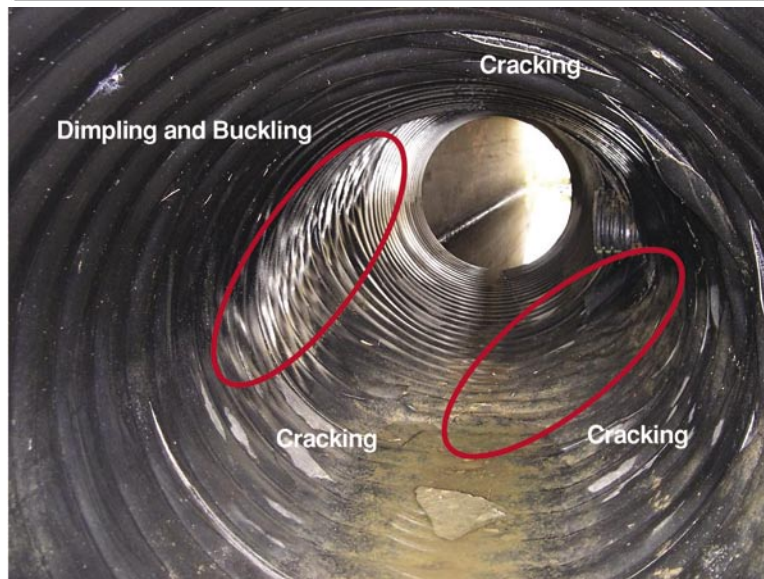
The 42-inch, 20-foot long cross drain was installed in 1992 near Danville, Ohio. The pipe ties into a concrete box culvert. Dimpling and wall buckling are present in several areas throughout a large portion of the HDPE pipe, documented in 2001 and 2005. It is evident that the pipe has continued to deflect since the 2001 inspection with a maximum deflection recorded in 2001 of 11.61% and 15.48% in 2005. In 2001 cracking was documented at 4, 7, 10, and 13 feet. Additional cracking is documented at 4.9, 5.2, 11, and 12 feet in 2005.

Project 7, SR 715, Danville, showing buckling, cracking and dimpling.

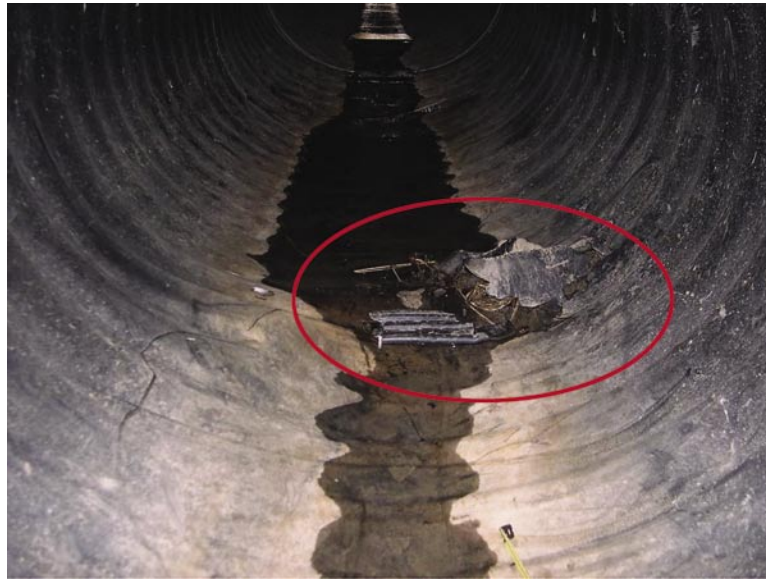
The 42-inch, 62-foot long cross drain was installed in 1999 near Newcastle, Ohio. The HDPE pipe had a maximum cover of approximately three feet. No significant wall buckling or dimpling was noticed during the 2001 or the 2005 inspection. Severe deflection is observed in several areas of the culvert. Maximum deflection recorded in 2001 was 13.39% and the maximum deflection recorded in 2005 is 15.77%. In 2001 approximately 66.67% of the vertical deflection exceeded 5%, and approximately 71% exceeds 5% in 2005. Cracking is observed at 10, 16, 17, and 50 ft in 2001 and additional cracking is observed at 18, 30, 33.5, 35, 44.2, 47.9, and 52.2 in 2005. It appears that the pipe was not properly bedded

due to the material pushing through the invert of the pipe.

Video Imaging of Project 8, Newcastle showing large rock pushing through lower haunch

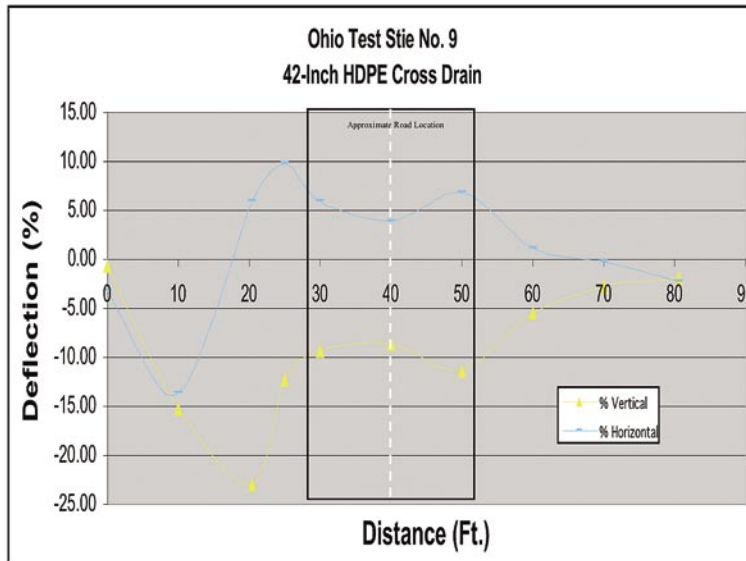
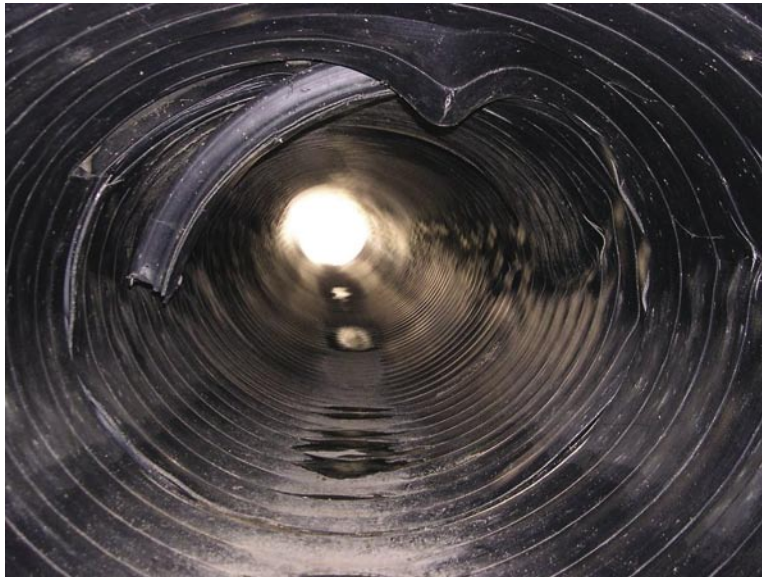
Project 9, Millwood

The 42-inch, 80-foot long HDPE pipe cross drain was installed in 1994 near Millwood, Ohio. The maximum fill height was approximately 10 to 11 ft. Rippling/dimpling was documented in the side walls throughout the pipe in 2001. Significant buckling has occurred in several areas since the 2001 inspection. Pipe deflection had significantly increased since the 2001 inspection with a maximum vertical deflection of 14.29% in 2001 and 22% in 2005. Inverse curvature of the crown has occurred, and 6" sections of the pipe wall have broken away at 20 feet. A large portion of the cracking has occurred in dimpled areas at the springline. The 2001 report only document 10 cracks (52, 54, 59, 63, 68, 70, 73, 75, and 79 feet), but in the 2005 inspection over 100 cracks are documented. It appears that the pipe was backfilled with a sand gradation and sand backfill is observed through cracks in the wall of the pipe in several areas. Geotextile fabric is also observed at the joints of each pipe section. Severe distress is apparent throughout large portions of the pipe.

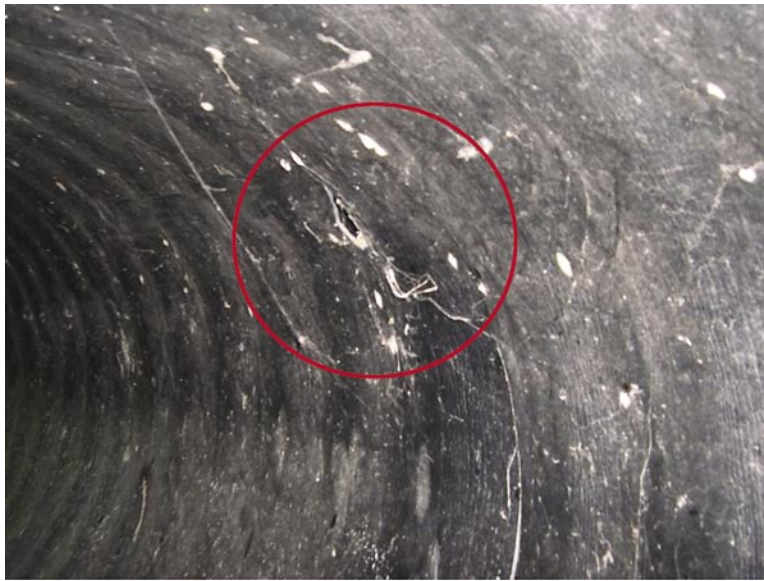
The 42-inch, 55-foot long cross drain was installed in 1999, under SR 661 near Homer, Ohio. The maximum fill height was approximately 2 to 3 ft. Limited wall buckling is observed in 2005. It appeared that dimpling has occurred and is cracking at 37.5 ft from the outlet. Corrugation compression is observed from 50 to 51.5 ft. Approximately 1" or greater corrugations are observed in the crown in this area. A long block of cut stone or concrete is observed over the crown of the HDPE pipe in the overlying file. Deflection readings in 2005 show a 0.89 % outlet deflection, an 8.93 % inlet deflection at 5 feet with a maximum inlet deflection of 13.24% at 10 feet. No cracking was observed in the 2001 inspection, but three cracks are observed in 2005.

Project 11, Homer, showing cracking and buckling approximately 2 feet from outlet

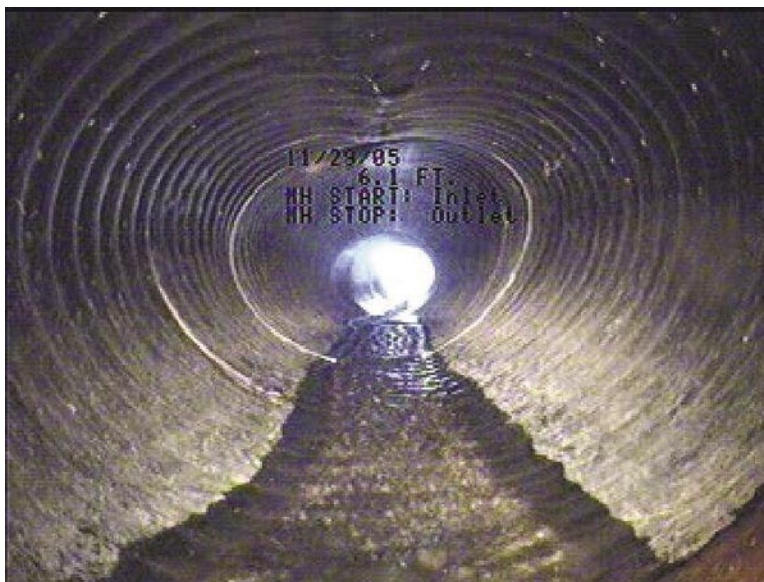
The 48-inch, 55-foot long cross drain was installed in 1999, near Jacksontown, Ohio. The maximum fill height was approximately 7 ft. Wall dimpling was apparent in several sections of the pipe. Dimpling was documented at 2 and 8 o'clock from 40 to 48 feet, and at 9-10 o'clock from 6 to 13 feet. The maximum deflection recorded in 2001 was 9.9% and in 2005 the maximum recorded vertical deflection was 13%. The area of greatest deflection occurred in the area underlying the guardrail structure. Cracking was not documented in 2001, but is observed in five locations in 2005. A significant portion of the observed distresses appear to be occurring where the pipe is deflected greater than 5%.

Project 12, Jacksontown, showing crown inverted and cracking
