An educational document from the American Concrete Pipe Association for users and specifiers

Fire in the Hole

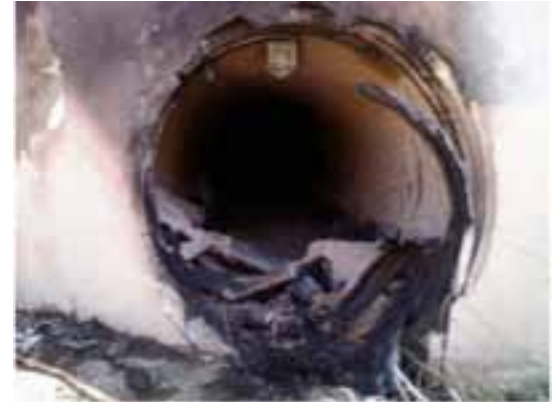
On March 6, 2010 at approximately 6:30 PM residents of a Tucson, Arizona neighborhood were alarmed when black smoke began pouring out of the storm drain inlet and manhole in their residential neighborhood. Several people called in to report that fire was coming from a manhole in the residential neighborhood and the sheriff's department was dispatched to investigate. Several other residents called after seeing the thick smoke and stating that they thought a house was on fire somewhere in the neighborhood. Upon arrival by the sheriff's department the deputy noticed that there was smoke coming from a drainage wash area running north-south and from the housing development directly to the east of the wash. As the deputy got closer to the wash he noticed that flames were coming out of the 36-inch HDPE storm drain pipe that emptied into the bottom of the wash. A second deputy arrived in the neighborhood where heavy smoke was coming out a storm outlet and manhole that were connected upstream of the HDPE pipe that emptied into the wash.

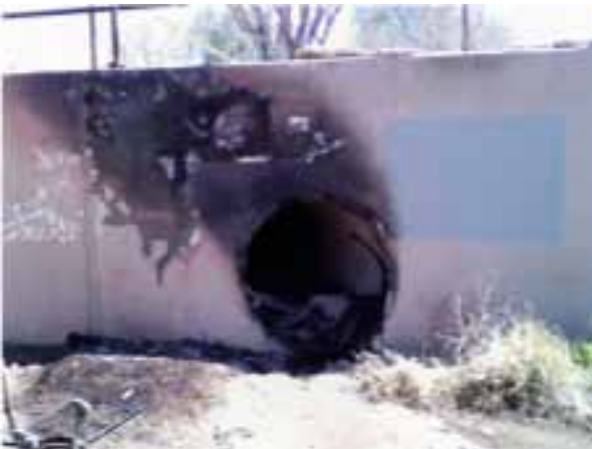
The flames grew quickly and were observed to be shooting up past the 7-foot wall of the wash. Because the flames were now above the wash the first deputy began to divert traffic away from the fire. In the short time from the deputy's arrival and his initial assessment of the situation, he noted that the flames coming from the wash area had gotten bigger and more severe and were now reaching 15 to 25 feet in the air. The deputy acting quickly began evacuating people in the neighborhood due to the large amount of fire and smoke that he observed and not knowing if the buried gas lines in the area of the HDPE storm drain that was burning had been compromised. When HDPE burns the combustion products include hydrogen cyanide, formaldehyde, carbon monoxide and acrolein in levels that exceed the National Institute for Occupational Safety and Health (NIOSH) Immediately Dangerous to Life or Health Concentrations (IDLH).

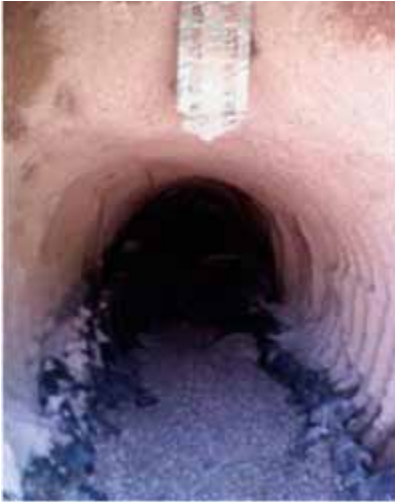
The fire area was identified as impacting approximately 50 feet of 36-inch diameter HDPE storm drain. Once the fire was extinguished the fire investigation indicated that the fire had started in the opening of the HDPE storm drain where it empties into the wash and quickly spread to the HDPE pipe itself which generated the high flames and large volumes of black smoke. The fire then traveled up the storm drain system and the smoke began to exit from the storm water inlet and manhole upstream. Due to the structural danger that the collapsed HDPE culvert now represented the fire department decided to make a visual inspection of the

culvert and not to make entry. The visual inspection looking inward into the burnt and melted HDPE pipe revealed that approximately 60% of the HDPE pipe had completely combusted or melted away. Black plastic could be seen hanging down from the top of the HDPE pipe that had not been consumed by the fire. A firefighter had also entered the end of the tunnel that opens into the manhole and also reported a structural collapse of the HDPE pipe. The street that the storm drain was under was barricaded off until the storm drain system could be inspected, evaluated structurally and repairs could be made to ensure safe use of the road. It is believed that the fire was started in the pipe by either a transient or vandals as they frequent the wash area. The HDPE storm drain was installed by a private developer when the residential neighborhood was developed although there are restrictions to using HDPE by the local municipality due to fire concerns.

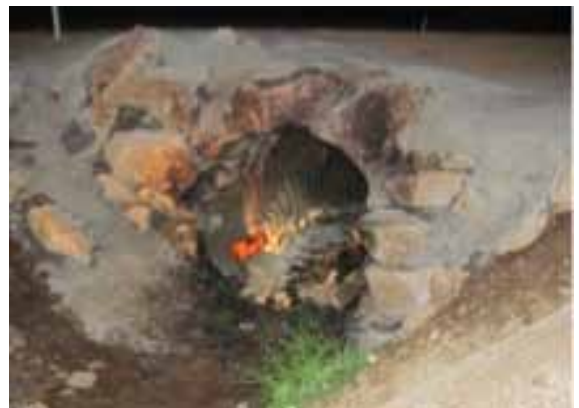
As the fire crew began to extinguish the flames from both the inlet and the outlet (fire origination) locations of the pipe, they noticed the roadway above began to give way and called the police to close traffic in fear that a car driving by might break through the road surface. The 48" HDPE culvert pipe had slurry to the top of the trench since only 2' of cover was obtained in design. After 15 minutes, the fire was successfully extinguished. Engine 53 was called to the scene to conduct a survey of the confined space in the event that someone remaining in the pipe had been overcome by the fumes from the burning plastic. Engine 53 was not able to examine the entire pipe so the City of Prescott utility department used a remote camera to finish the inspection. Fortunately, there were no victims found in the pipe. There were no witnesses on scene, but the fire was determined to be intentionally set.

The total pipe length of the crossing was 250' of which 20' of burned 48" HDPE was replaced with CMP using slurry to the top of the trench along with a concrete collar to connect the CMP to the existing HDPE. CMP was used as a replacement due to the fact it was readily available in the county supply yard. Traffic was restricted to 1 lane during the replacement and the repair area had to be repaved as well.

The replacement was completed in two days at a cost of \$8,000.00 not including the hardship to local residents. Since the fire, Yavapai County no longer uses HDPE and will be using RCP and CMP exclusively.
