# **FLOTATION (BUOYANCY) COMPARISON**

American **Concrete Pipe** Association

## Flotation (Buoyancy) Comparison: Concrete vs Flexible Pipe

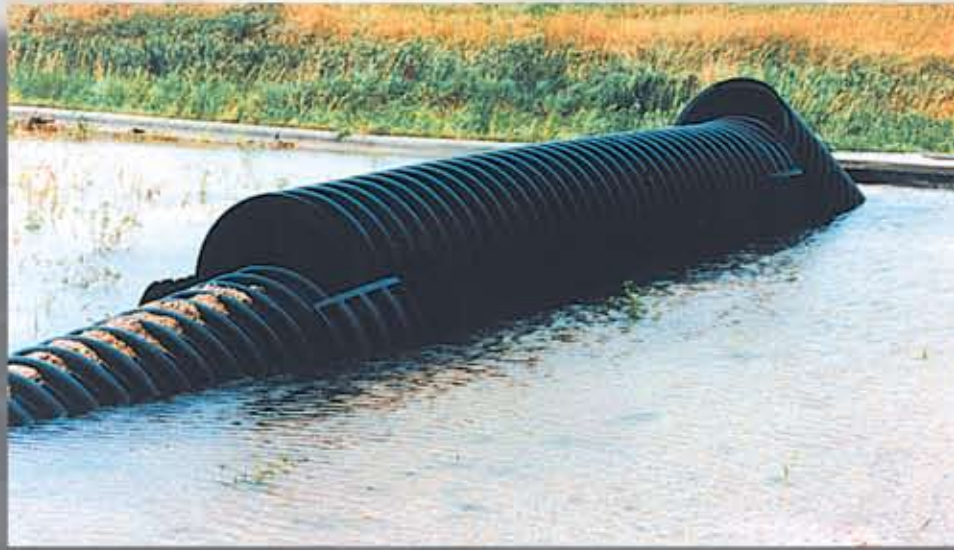
## Saukville, WI

After completion of the site work for a Wal-Mart store, a portion of a line of 36-inch diameter corrugated polyethylene pipe with an interior liner floated out of the ground. This line was part of the parking lot drainage. The pipe had approximately one foot of cover. Fortunately, the pavement had not been completed at this time.

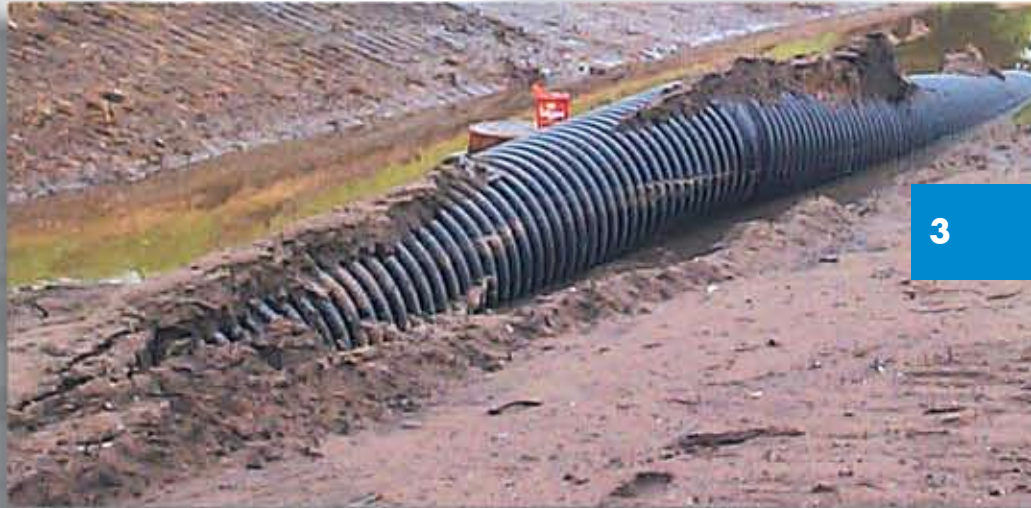
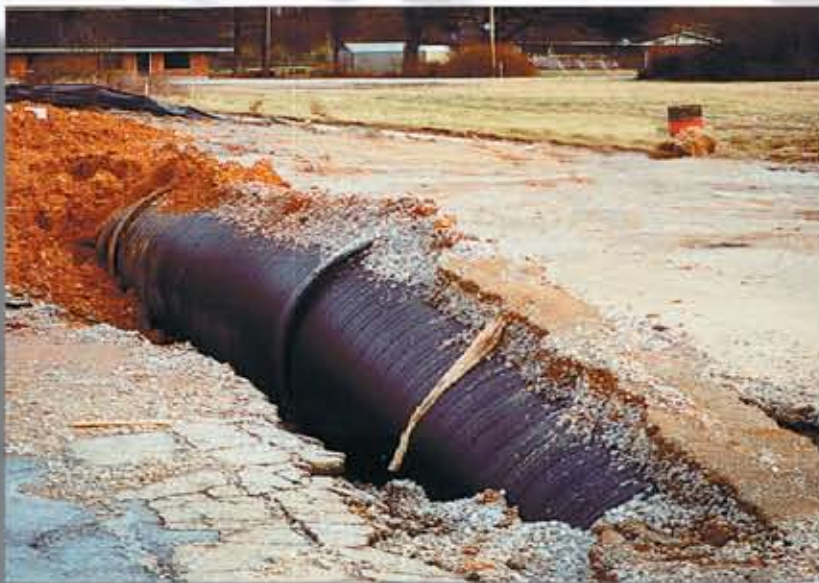
## St Paul, MN

The pipe used in a ditch realignment project was 24-inch diameter corrugated polyethylene pipe with interior liner. Although the pipe was installed parallel to the ditch and with two feet of cover, two sections of the pipe floated out of the ground after a day of steady rainfall.

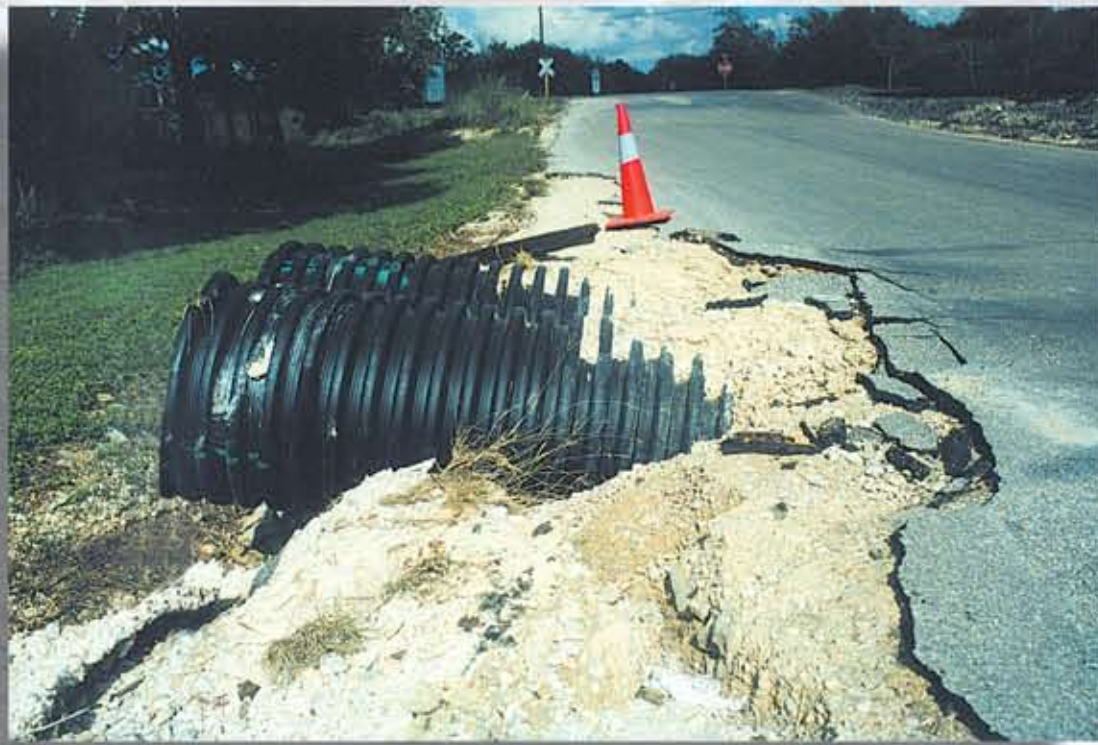
## New Braunfels, TX

The corrugated polyethylene pipe with interior liner floated on one end of a street crossing after heavy rainfall. This installation consisted of two lines of 24-inch diameter pipe with approximately one foot of cover under pavement.

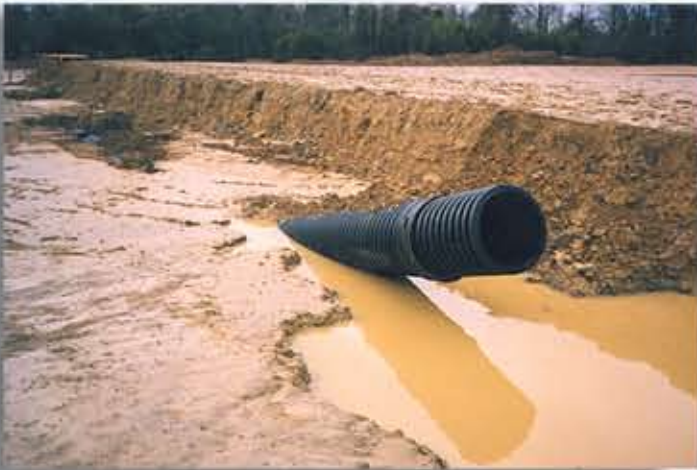
## Baton Rouge, LA

The contractor was in the process of connecting the catch basins to this 18-inch diameter corrugated polyethylene pipe with interior liner when a sudden downpour caused it to float out of the ground. The pipe was being installed under a parking lot with approximately 15 inches of cover.

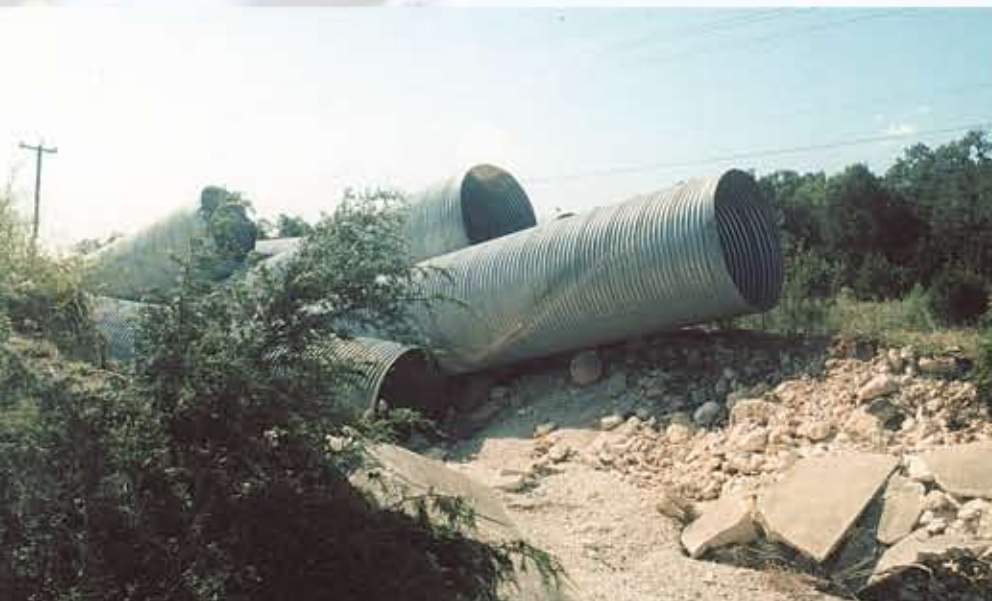
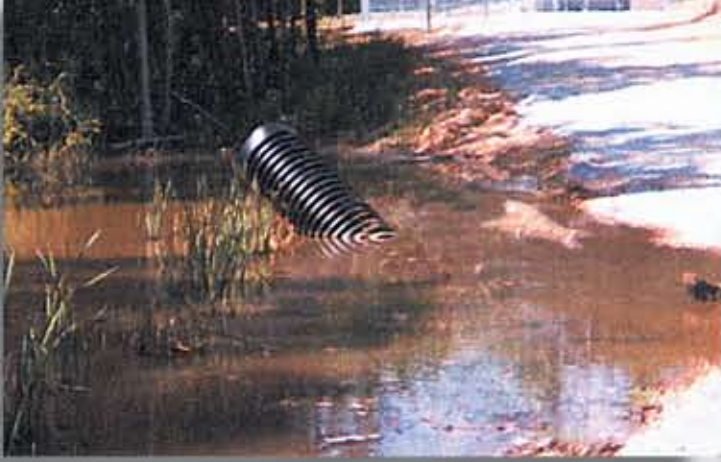
## San Antonio, TX

A few hundred feet of a double 108-inch diameter corrugated metal pipeline floated completely out of the ground after heavy rain. The pipe, which received water from a ditch with a paved inlet, had approximately two feet of cover.

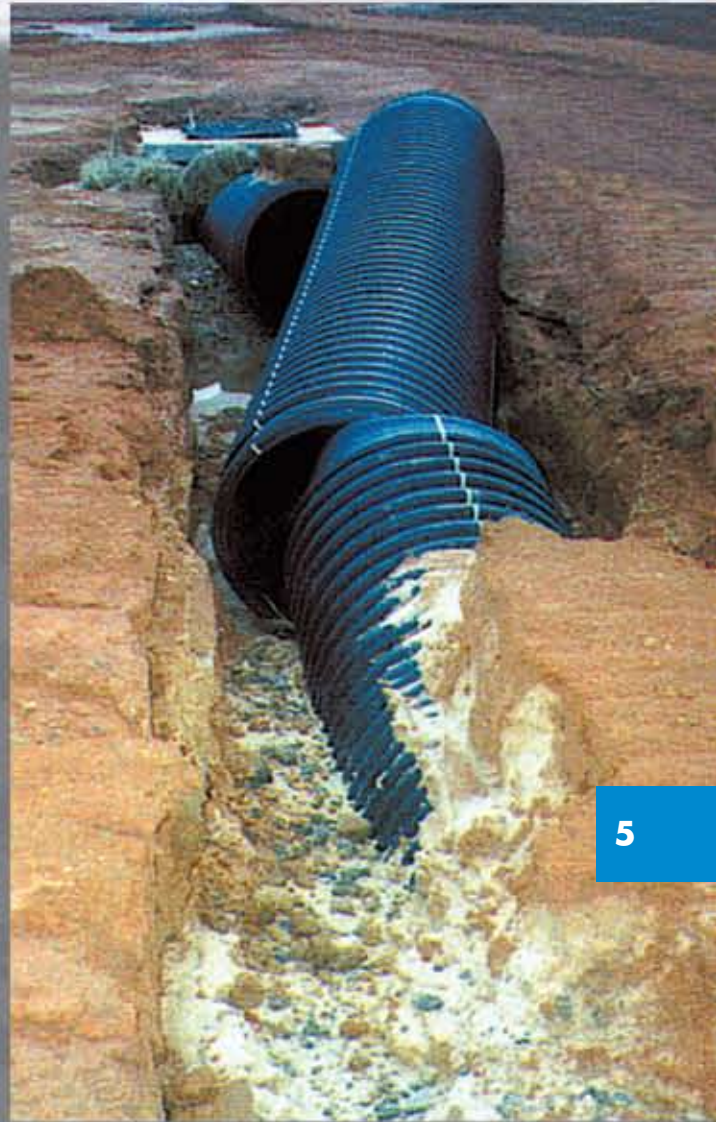
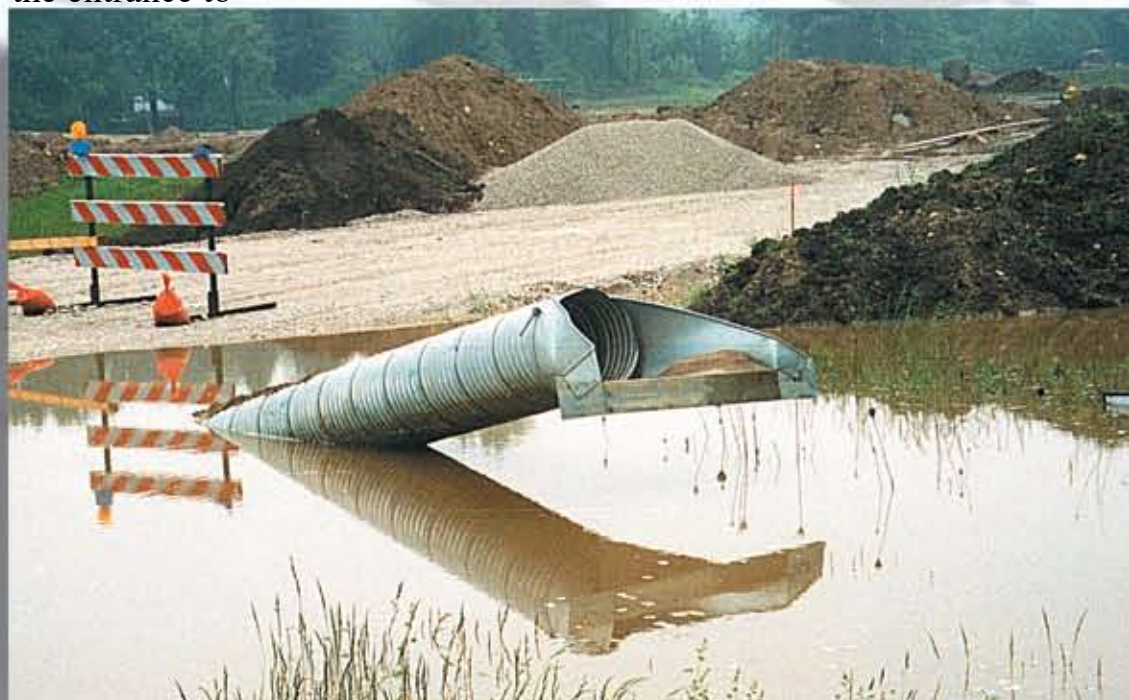
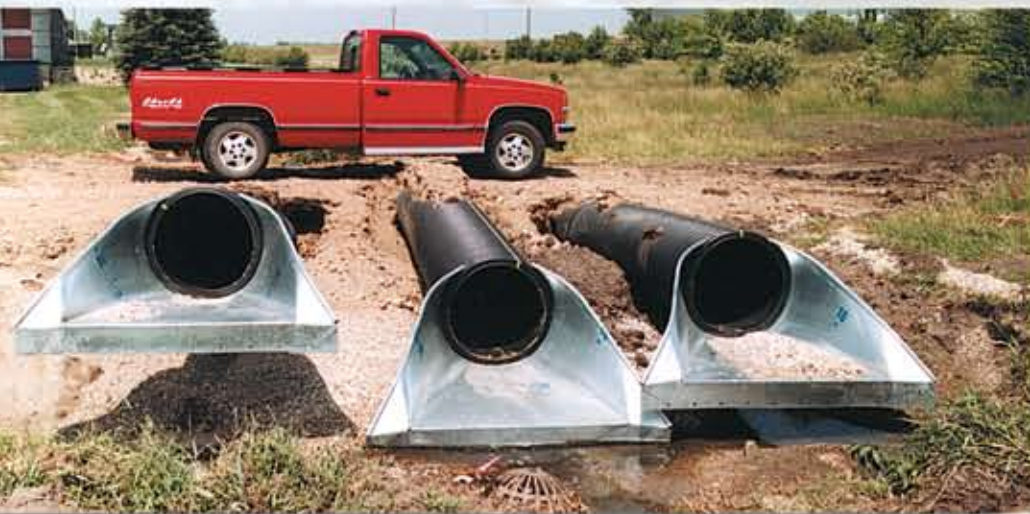
## Waukesha, WI

This 24-inch diameter corrugated metal pipe was installed under the entrance to a new housing subdivision off Cleveland Avenue. Heavy rains and runoff from the construction site and the surrounding area caused one end of the pipe to float out of the ground. The pipe had approximately 30 inches of cover.

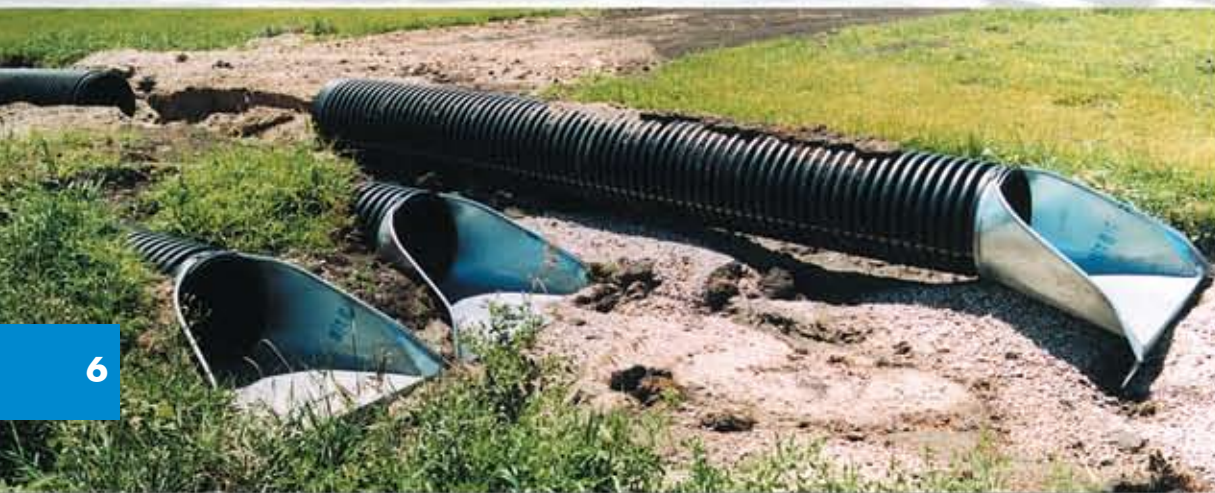
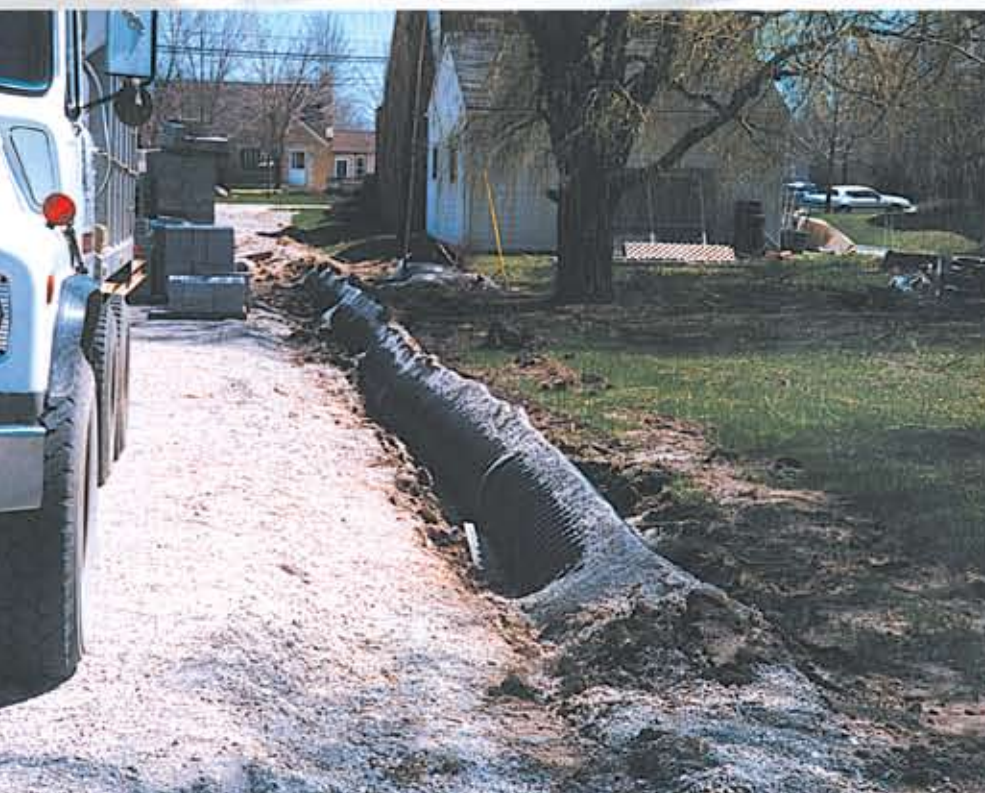
## Sheldon, IA

A triple line 24-inch diameter culvert under a bicycle/walking trail floated out of the ground after very little rainfall. The corrugated polyethylene pipe had approximately one foot of cover. The pipe was reinstalled with the

An approximate 1/2" rainfall caused one of the three lines to separate and blow outward on the outlet end.

inlet ends encased in concrete.

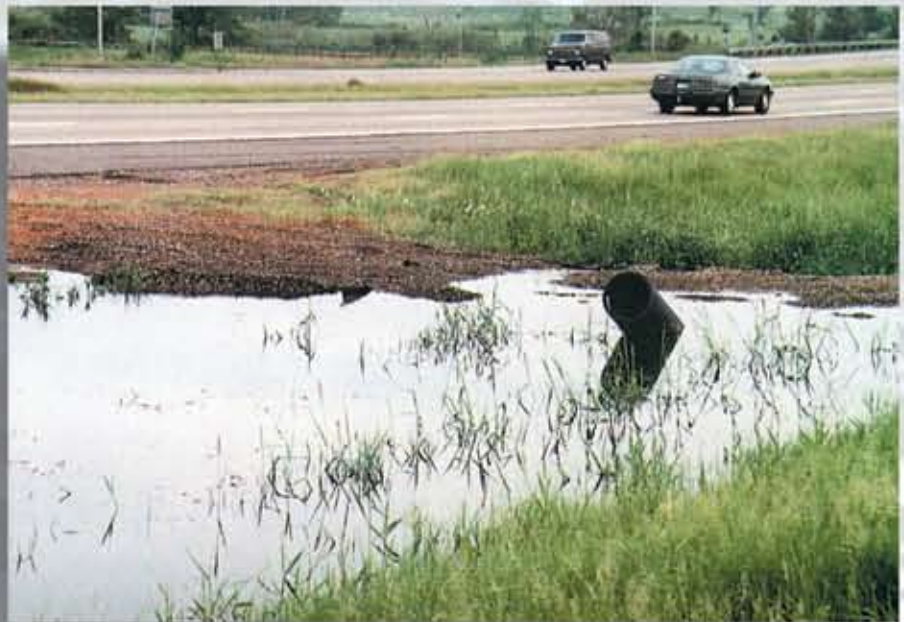
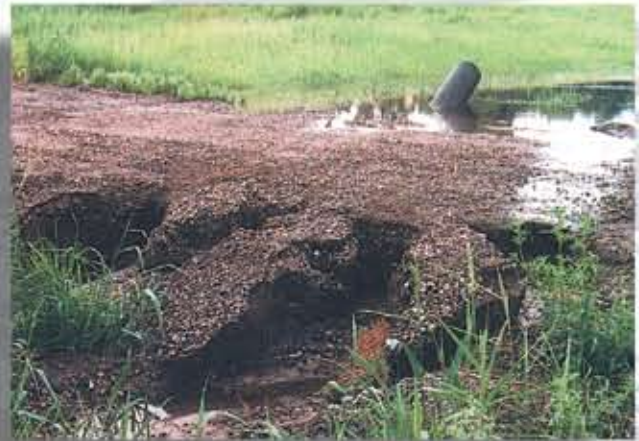
## Maple Grove, MN

These photographs depict a culvert installation under a gravel access road to Interstate 94 in Maple Grove, Minnesota. The installation consists of two 20-foot sections of HDPE pipe joined with a coupling band. A rainstorm and subsequent drainage created upstream ponding at the culvert. Hydrostatic forces caused the upstream 20-foot section to float out of the ground. The ponded water also overtopped the gravel access road, saturated the entire roadbed, washed-out a portion of the roadbed and rendered the access road impassible.

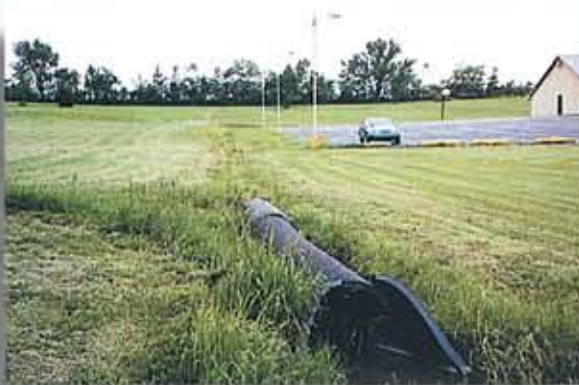
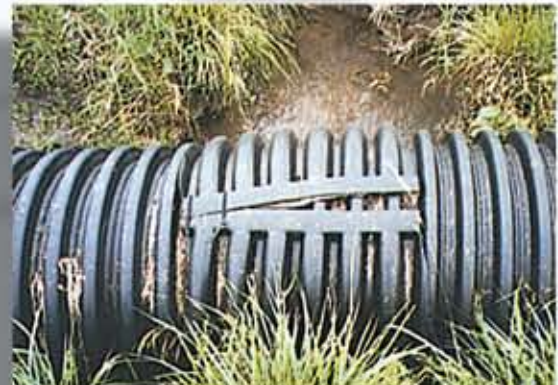
## Kansas City, MO

This culvert drains a church parking lot just west of Kansas City, Missouri. It is installed in an open field with no live load. Water ponds near the outlet of the HDPE pipe. The hydrostatic forces have caused the coupling bands and end section of the HDPE line to become dislodged and ineffective.

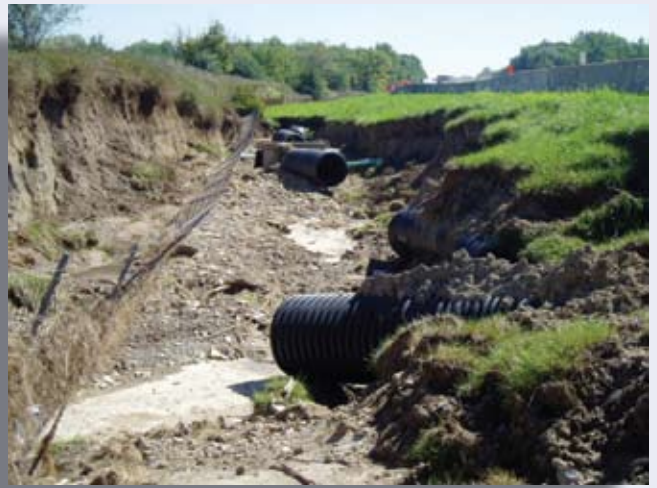
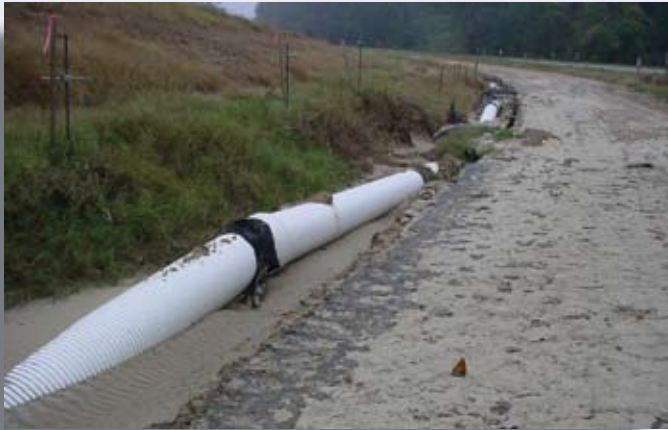
## Bluffton, OH

Heavy rains in Northwest Ohio cause Riley Creek to overflow its banks flooding Interstate 75 and the Bluffton Quarry near Bluffton, Ohio. Approximately 100' of 36" HDPE pipe had been installed along the quarry levee to carry storm water from I75 to Riley Creek. The storm caused the HDPE pipe to float and have joint failure due to internal pressure. The HDPE piping had minimal cover and did not appear to have any ODOT approved bedding or backfill material. A number of the HDPE pipe sections completely floated away, ending up at the bottom of the quarry. This was the second time in four years (2003) that the HDPE pipe installed in this location did not stay in place.

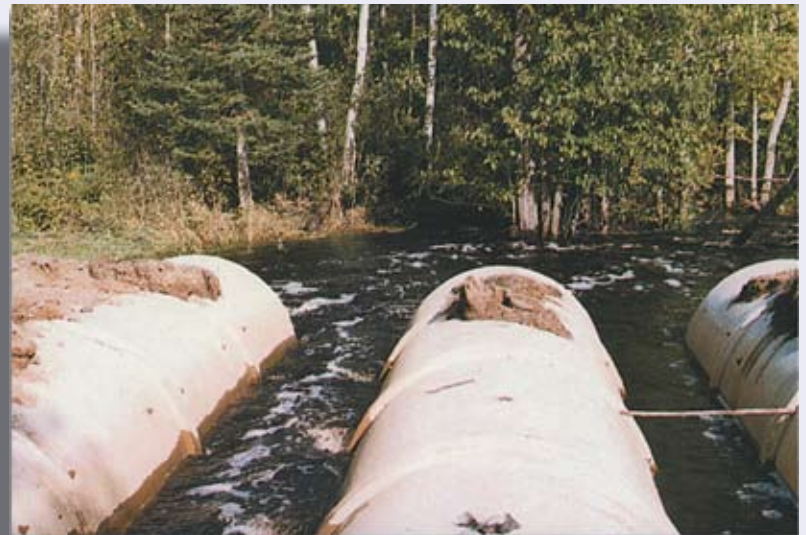
## Minnesota

Three reinforced concrete culverts were installed under a gravel roadbed in northern Minnesota. The watershed for this area received an abnormal amount of rainfall. Hydrostatic forces resulting from the storm washed-out the gravel roadbed. However, the concrete pipe remained in place because of its weight and the use of pipe joint ties. This allowed quick replacement of the roadbed and vehicle access to the area.
