**Condition Investigations of HDPE Pipe In-Service
In the United States (Six States)
for
The American Concrete Pipe Association
Irving, Texas**

WJE No. 991592

January 24, 2002

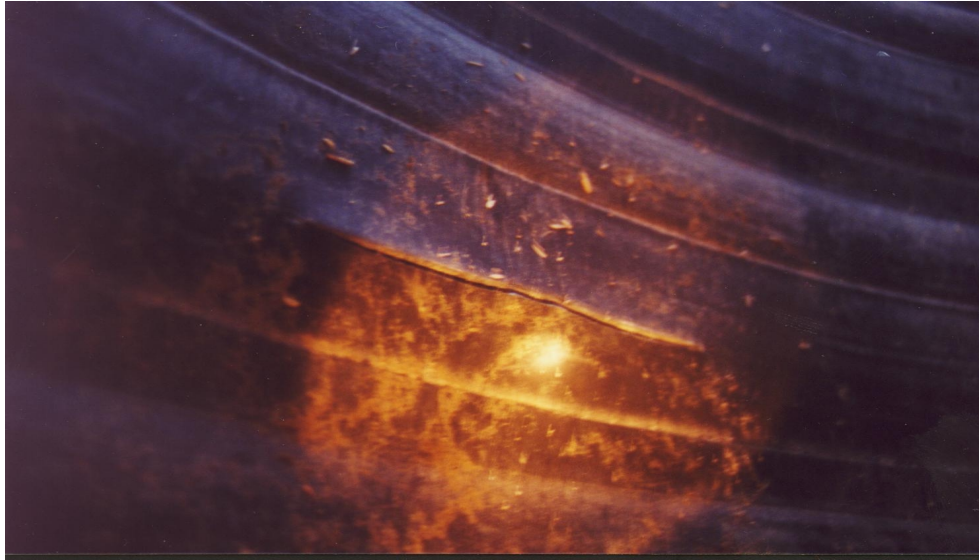
Pipe 1 - This 36-in diameter pipe was installed in 1992 and has a maximum depth of cover of 5-ft. A swell in the pipe is present from 37-ft to 42-ft, where water is ponding. A 7-in long crack has also formed at 38-ft. From 40-ft to 55-ft, the deflection of the pipe is easily noticed (see picture below). Wall buckling (rippling) has occurred from 37-ft to 39-ft at about 270 degrees. Joint separations range from 1 1/2-in to 2-in.

Crack in pipe at 38-ft – Pipe 1

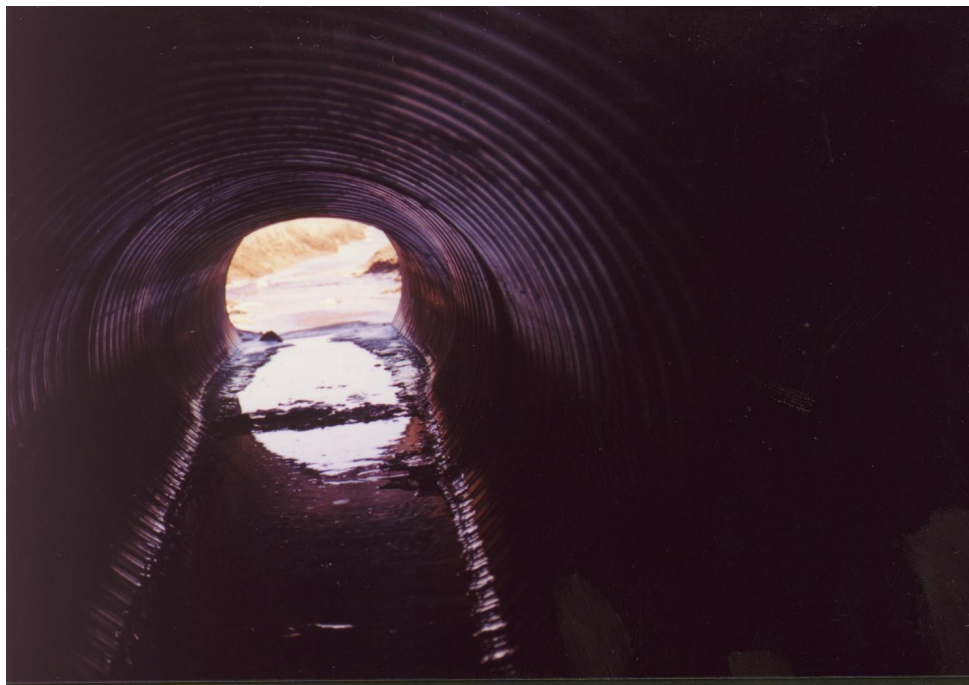
Obvious deflection of the pipe- Pipe 1

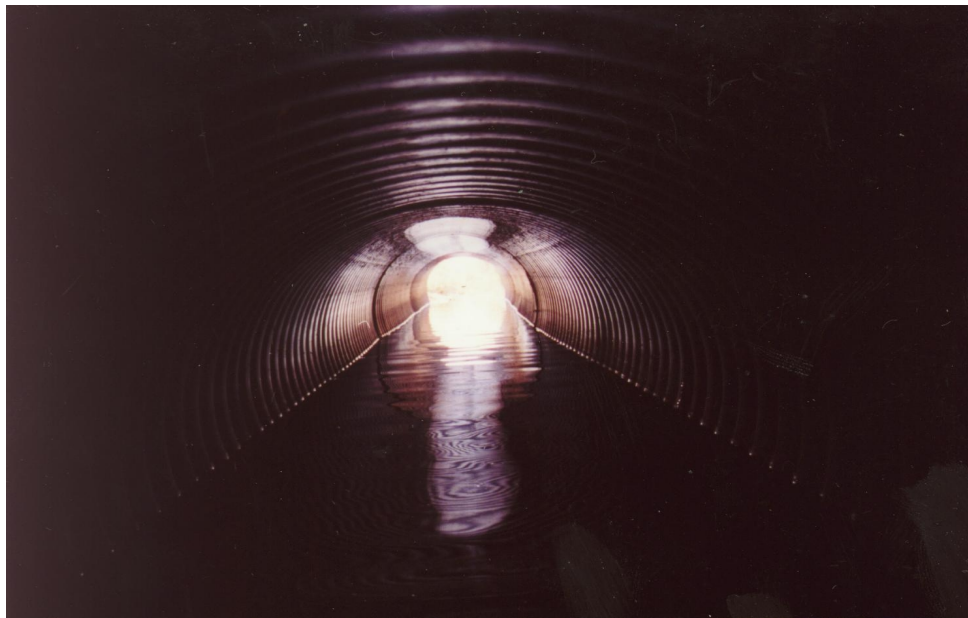
Profile of pipe – Pipe 2

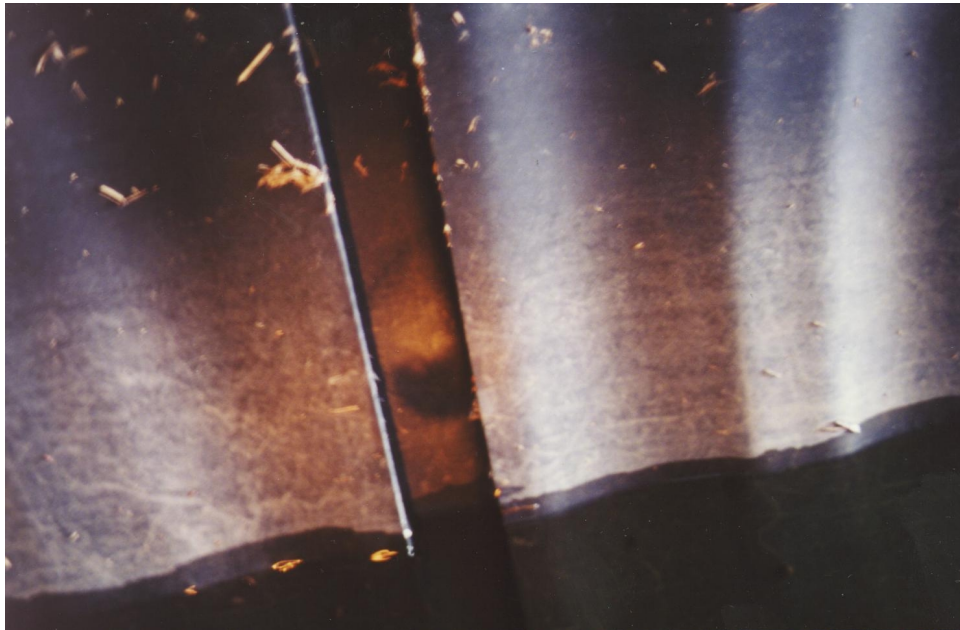
Separation at Joint 1 – Pipe 2

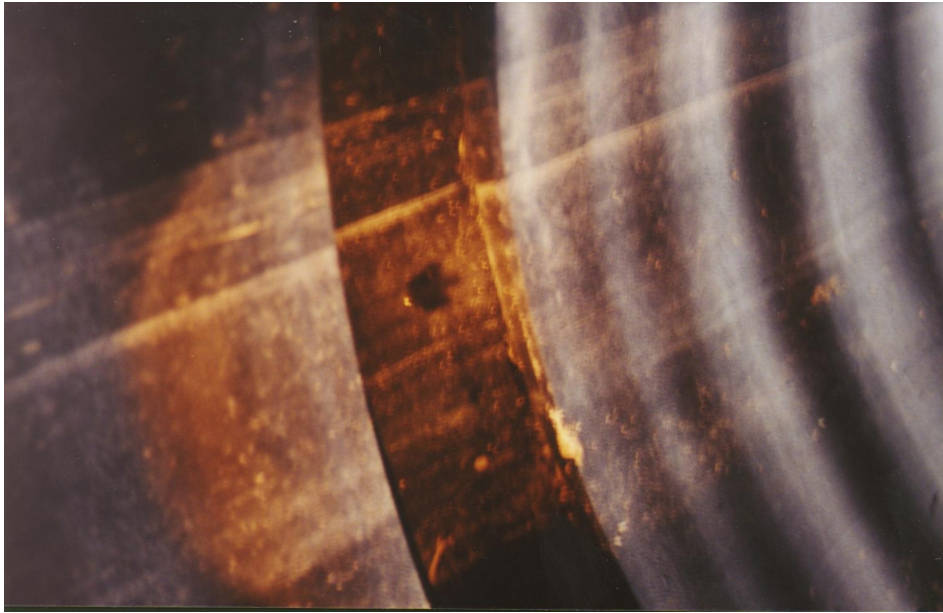
Pipe 3 - This 42-in. diameter pipe was installed in 1996. The pipe is 70-ft. long and has approximately 5-ft. of cover. This pipe is a storm drain that empties from a concrete box culvert. Separations as large as 5 1/2-in have developed at the joints (see picture below). There is a 2-in. drop from pipe 3 to 4 (see picture below). No other areas of distress were found.

5 1/2 -in separation at Joint 3 – Pipe 3

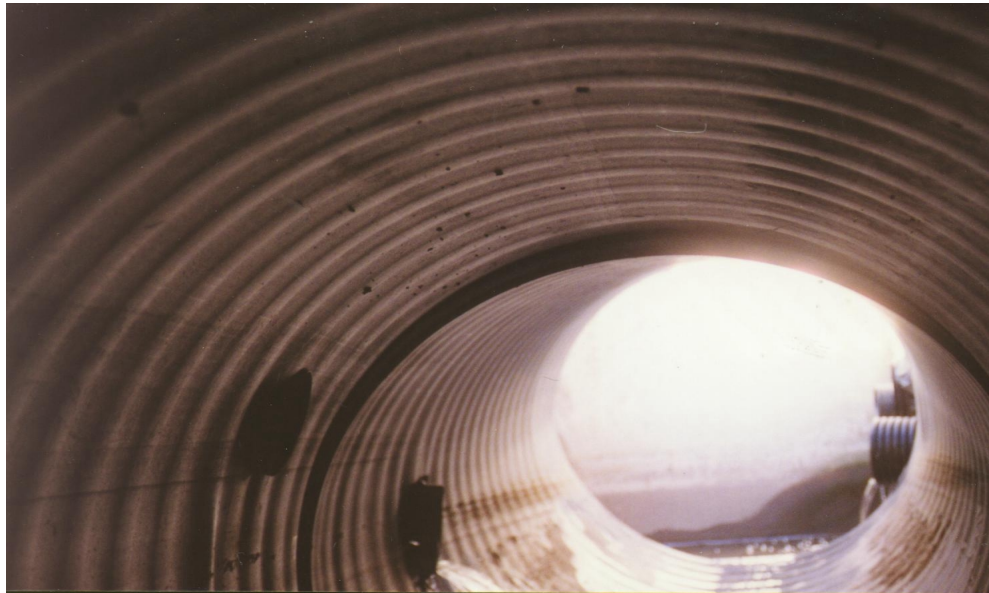
Two-inch drop – Pipe 3

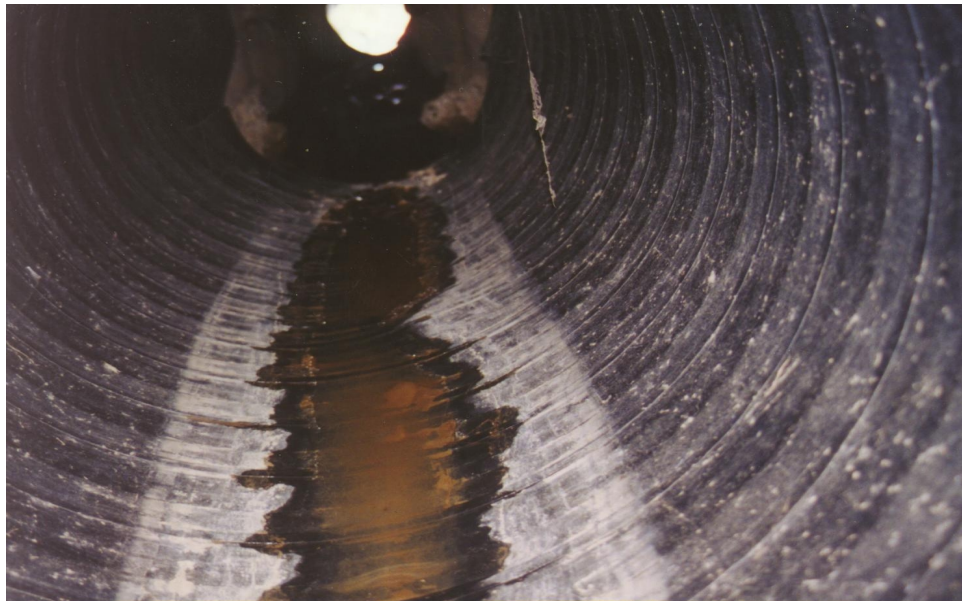
Pipe 4 - This pipe was installed in 1998. The pipe consists of two 15-ft. lengths of pipe that are connected by a 40-ft. concrete pipe. The pipe has a diameter of 30-in, and the depth of cover is about 4-ft. Wall buckling has developed on the sidewalls of the south pipe from 12 to 13-ft. In the north pipe, a bulge in the bottom of the pipe is apparent at 10-ft. (see picture below), and a crack was found at 11-ft. extending from 45 to 135 degrees.

Bulge in the bottom of the north pipe – Pipe 4

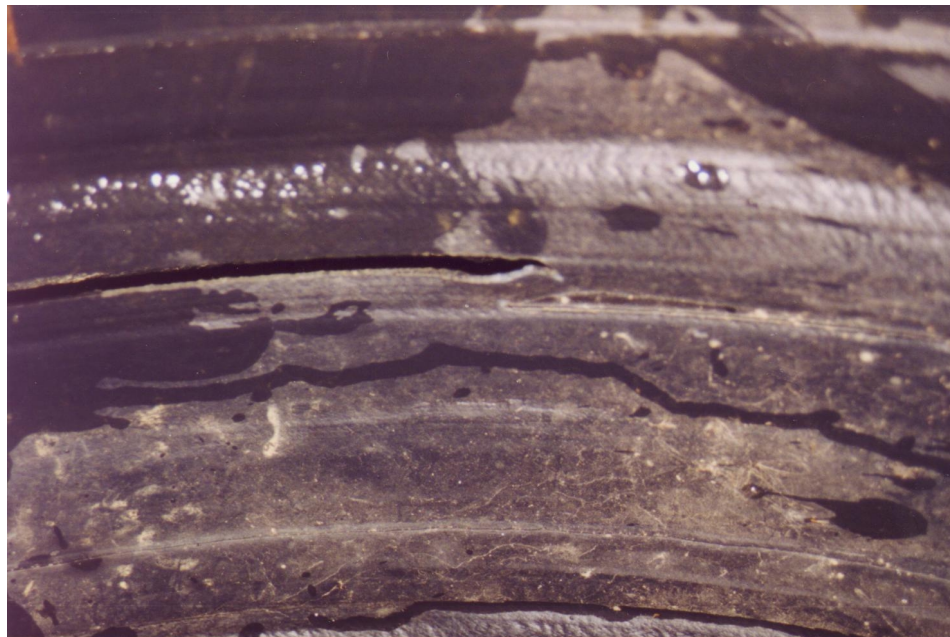
Pipe 5 - This pipe was installed in 1997. The pipe is 60-ft. long and has a diameter of 30-in. Separations less than 2-in. have developed in the two joints of this pipe. A crack was found at 10-ft. extending from 80 to 110 degrees. No other areas of distress were found. Only one diameter measurement or 2 % exceeded 5% deflection.

Crack at 10-ft. – Pipe 5

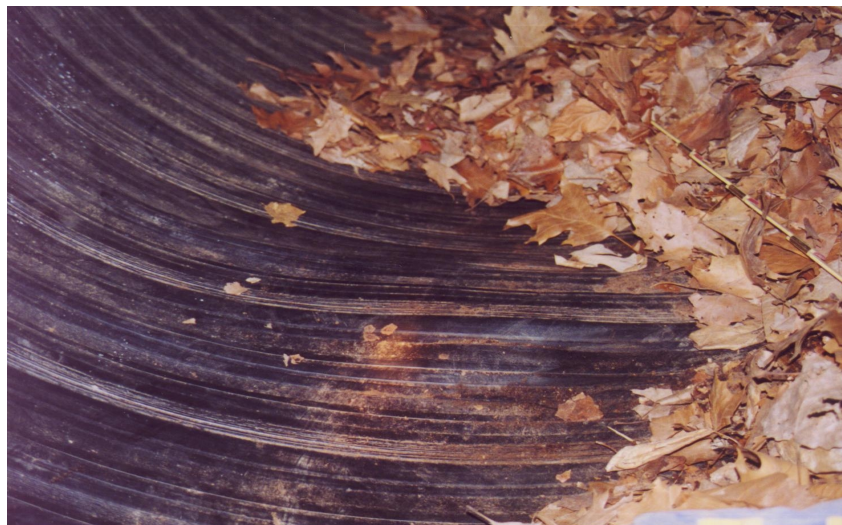
Three bulges have developed in the bottom of this pipe, at 12, 34, and 45-ft. Cracks have developed on the tops of these bulges (see picture below). The deflection of the pipe was easily noticed. Twenty-three percent of all the deflection calculations exceeded the 5% criteria. Five percent of the measurements exceeded 10% deflection with a maximum of 15% deflection occurring at 50-ft.

Bulge in bottom of pipe –Pipe 6

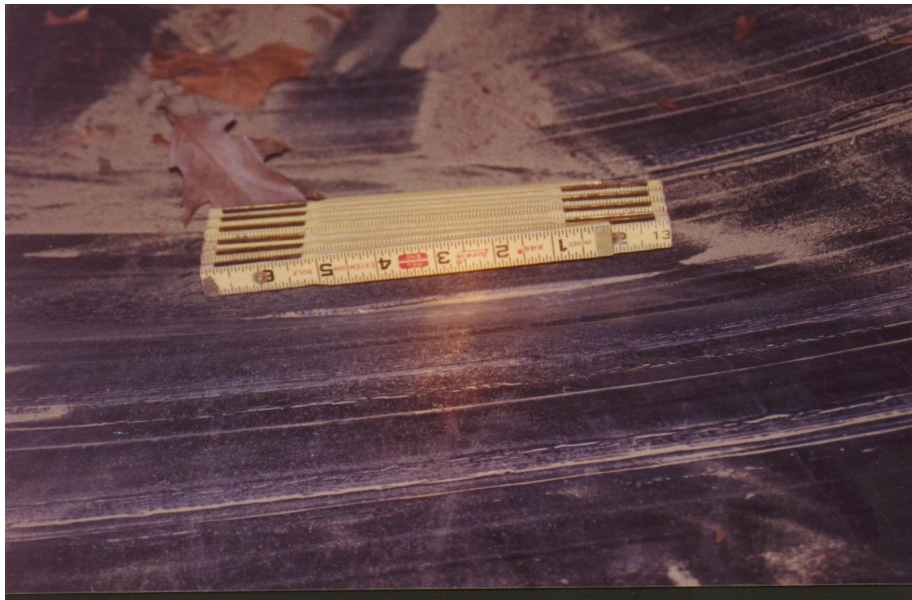
Crack on top of the bulge at 34-ft – Pipe 6

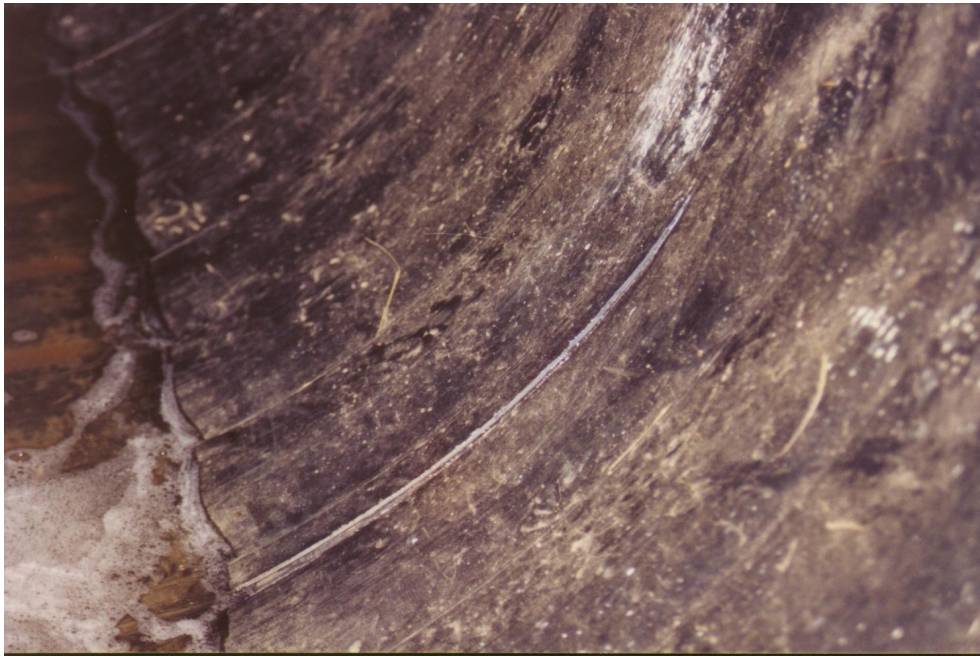
Crack at 4-ft. – Pipe 7

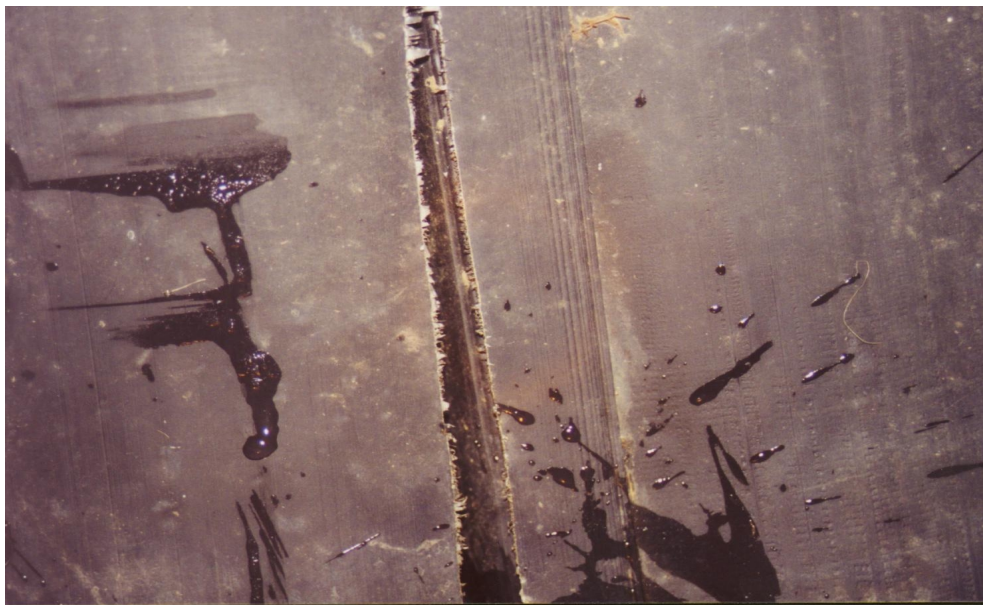
Crack at 7-ft. – Pipe 7

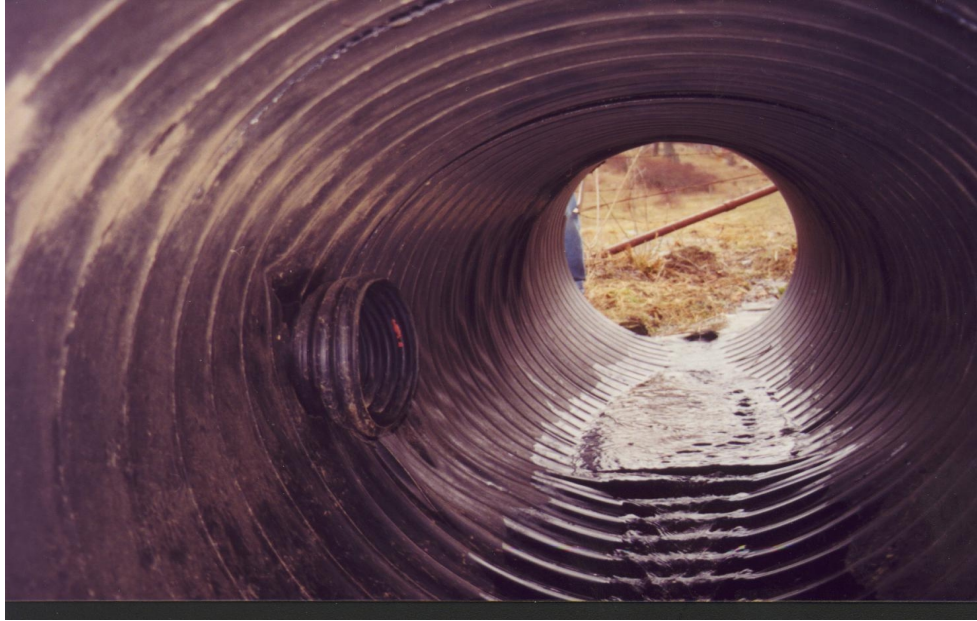
Bulge at the bottom of the pipe and cracks in the top of the pipe – Pipe 7

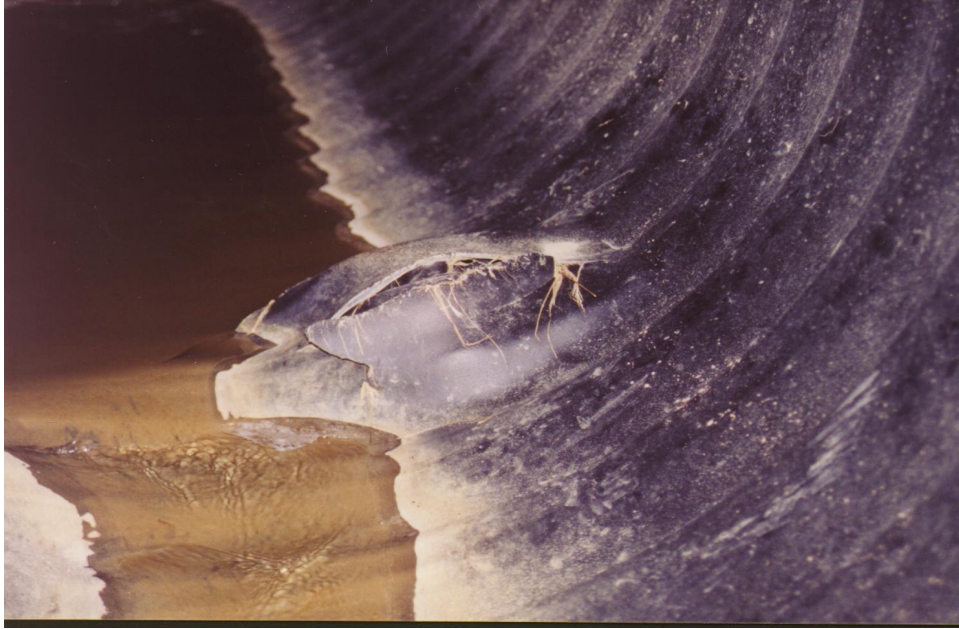
Pipe 8 - This 42-in. diameter pipe was installed in 1999. The pipe is 60-ft. long and has a maximum cover of 3-ft. An obvious bulge and crack has developed in the bottom of the pipe at 10-ft. The bulge elevates the pipe about 3 to 4-in. and has an area of about 1/2-ft² (see picture below). Beyond the bulge, a swell in the pipe has occurred, creating ponding of the water. Three wall cracks were found: at 16-ft, 17-ft and 50-ft. The deflection of the pipe was easily noticed. Significant separations of the joints have also occurred.

Bulge and crack in bottom of pipe – Pipe 8

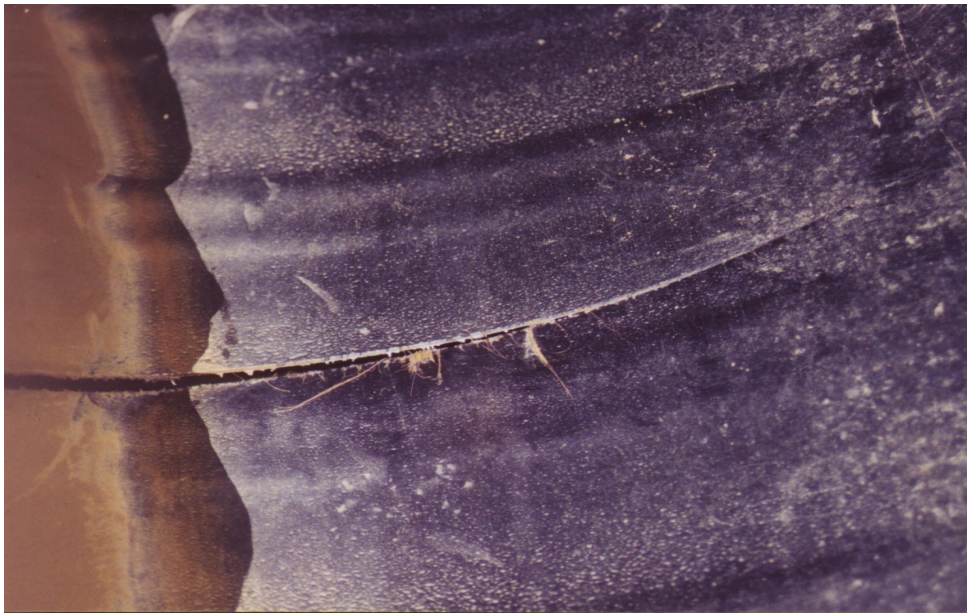
Crack at 50-ft. - Pipe 8

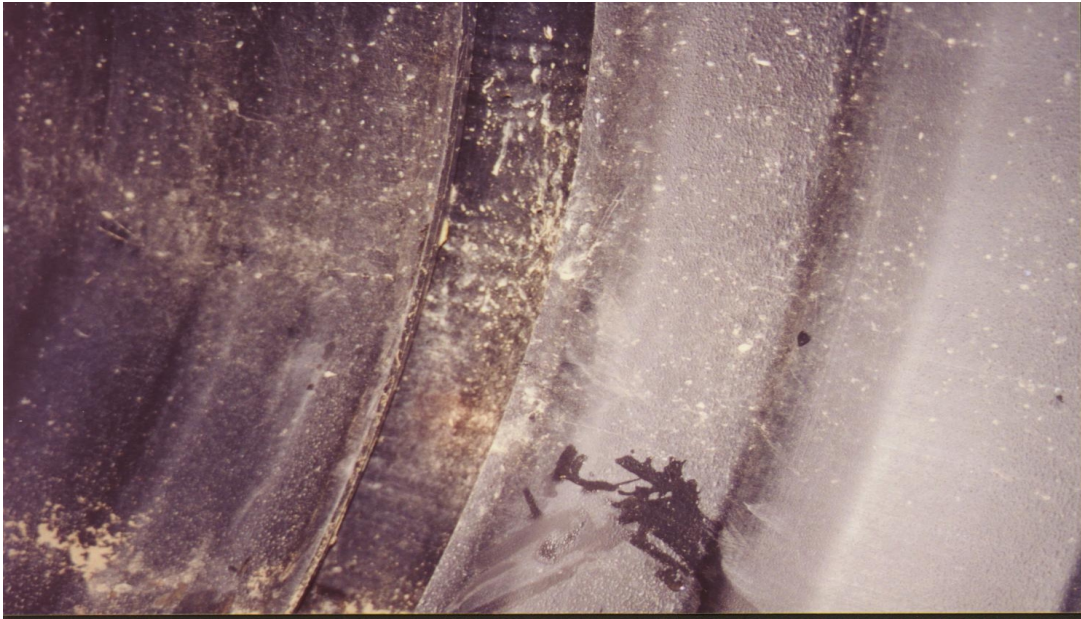
Separation at Joint 1 – Pipe 8

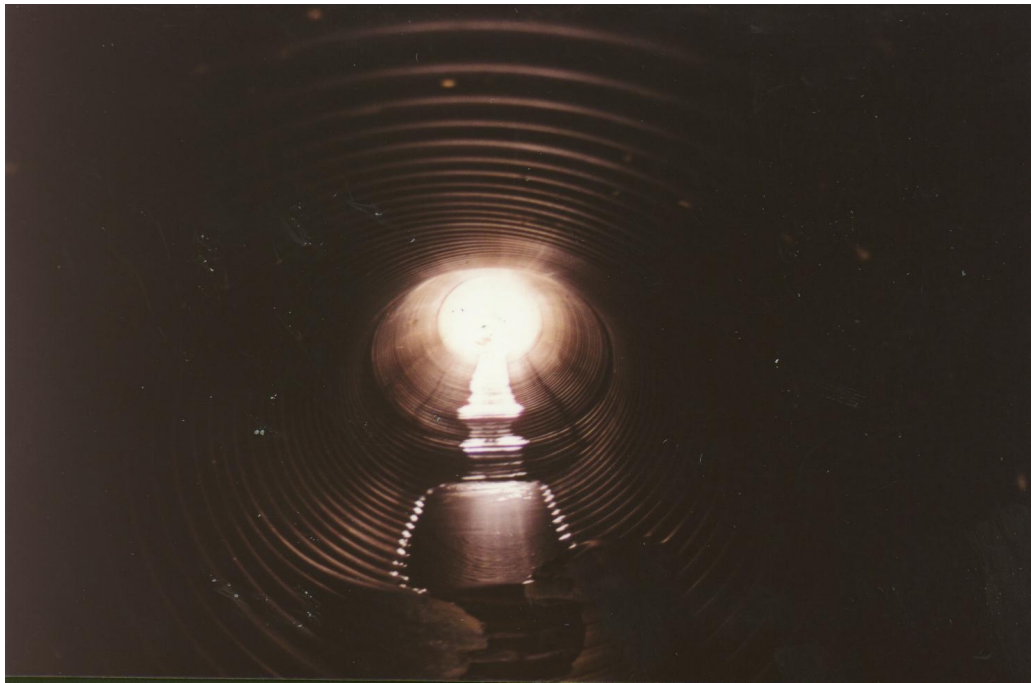
Note oval shape of pipe, swell in bottom of pipe, and bulge – Pipe 8

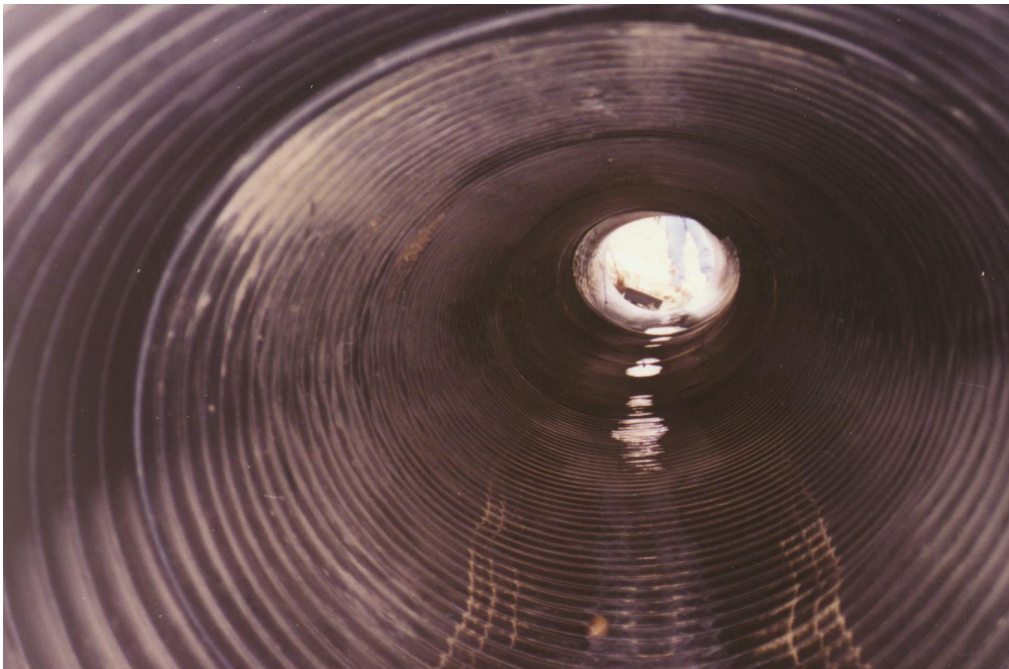
Profile of pipe: Note wall buckling and obvious oval shape – Pipe 9

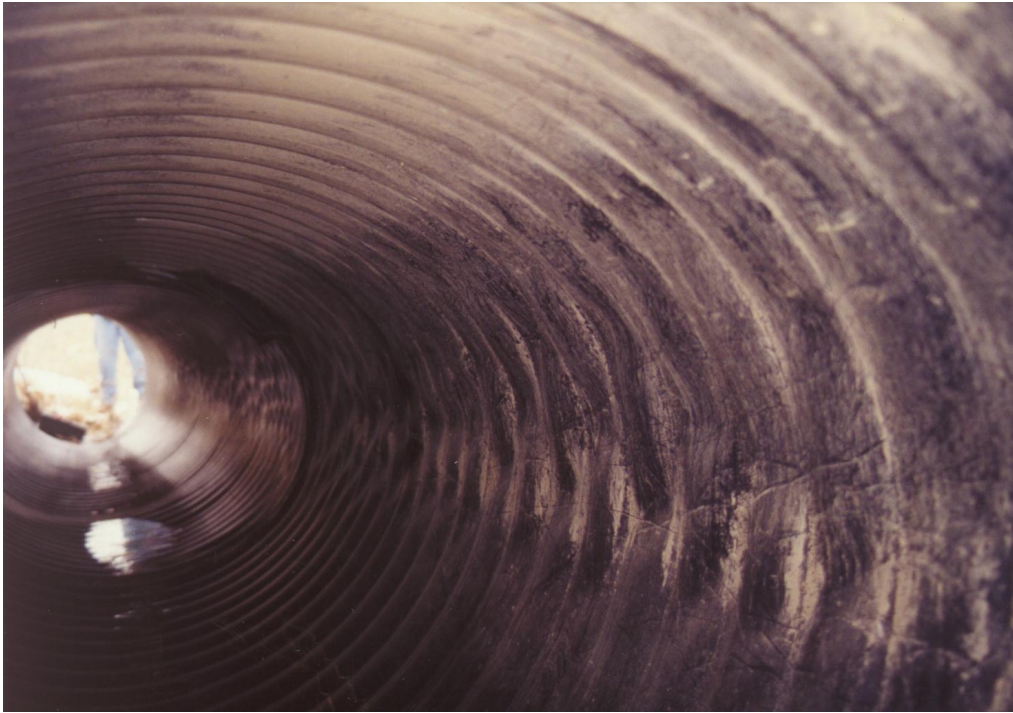
Separations of the joints ranged from 1 to 3-in. Rippling of the sidewalls is apparent throughout the length of the pipe (see picture).

Rippling of the sidewalls – Pipe 9

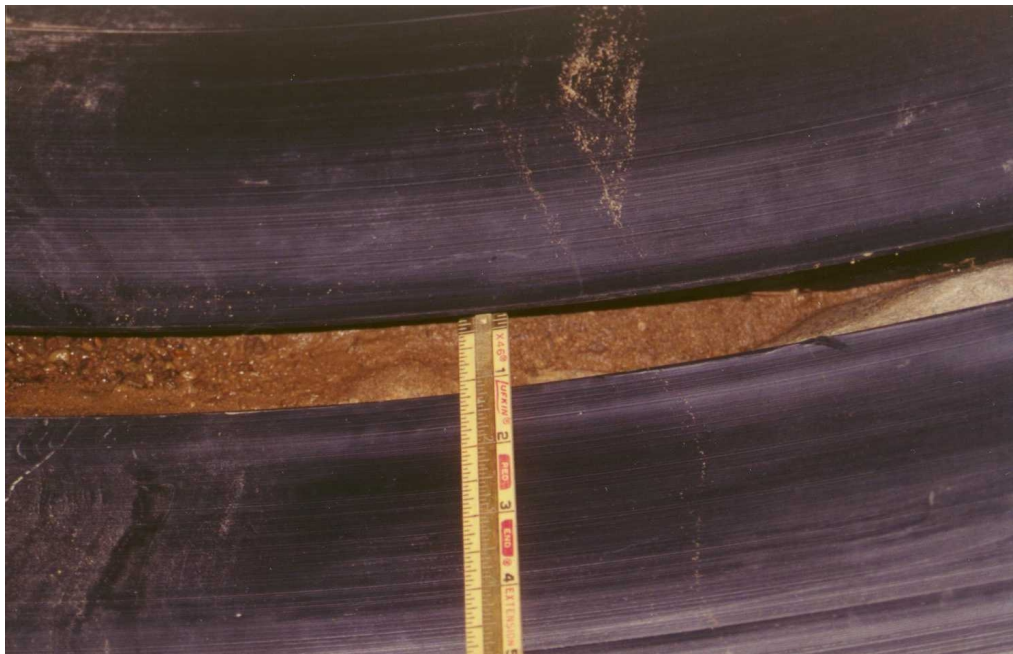
Separation at Joint 1 – Pipe 9

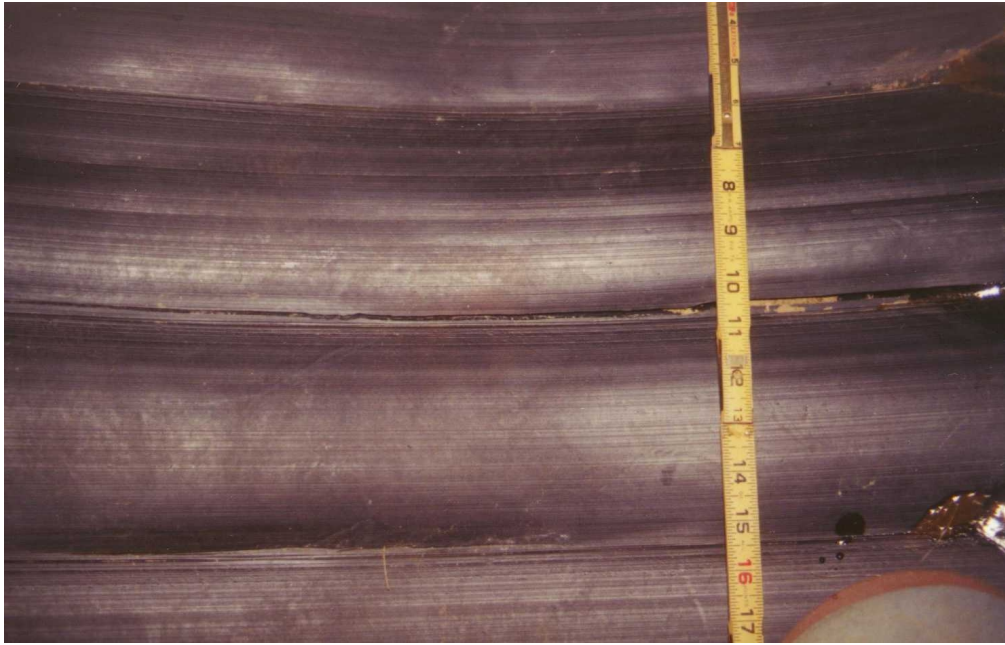
Crack at 63-ft. – Pipe 9

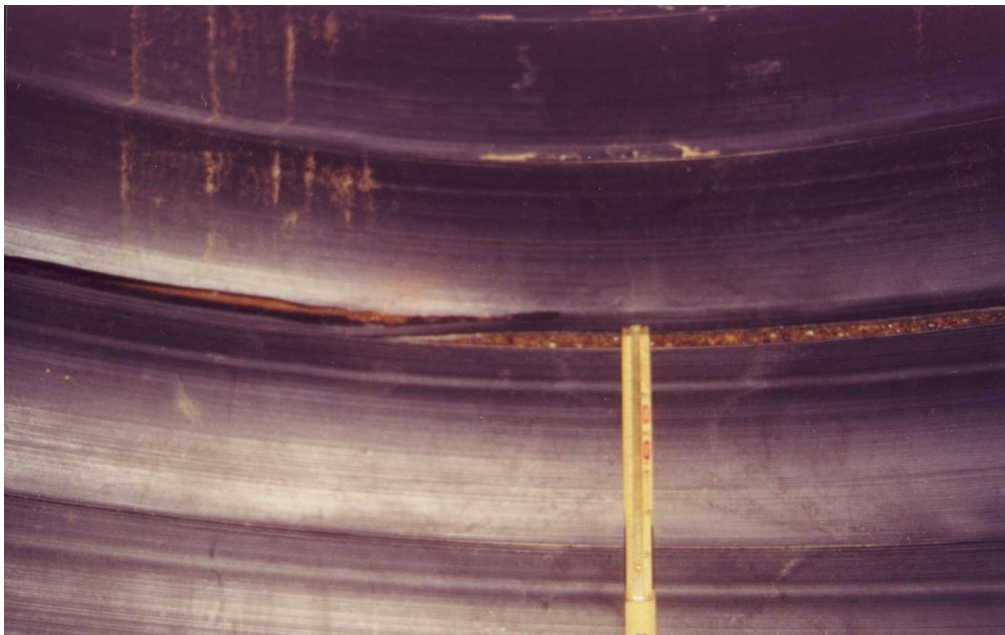
Crack at 75-ft. – Pipe 9

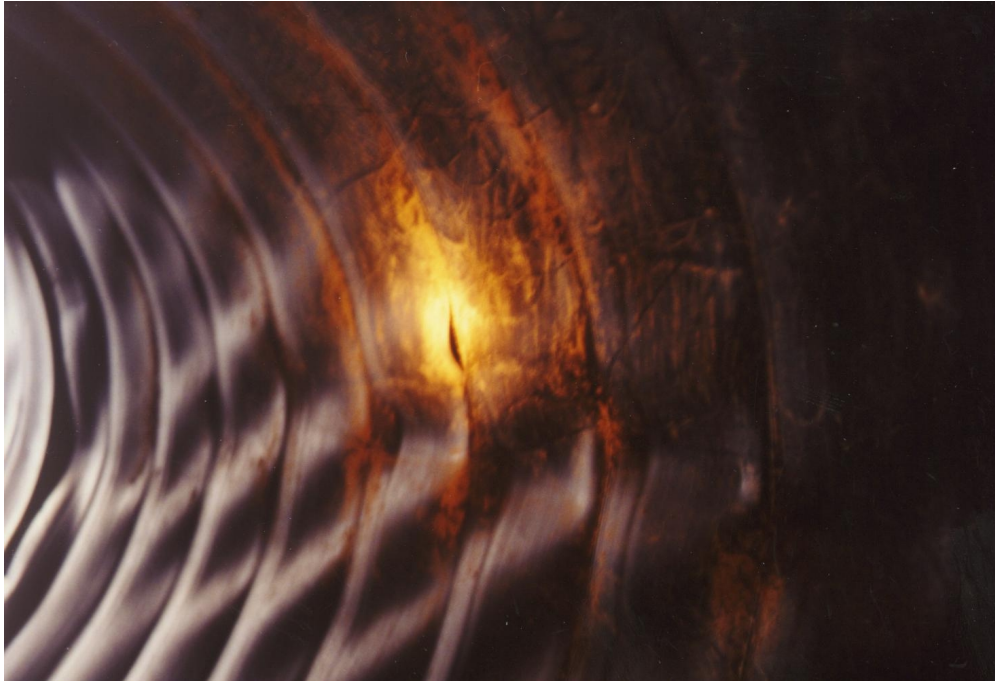
Small crack at 57-ft. Note wall rippling – Pipe 9

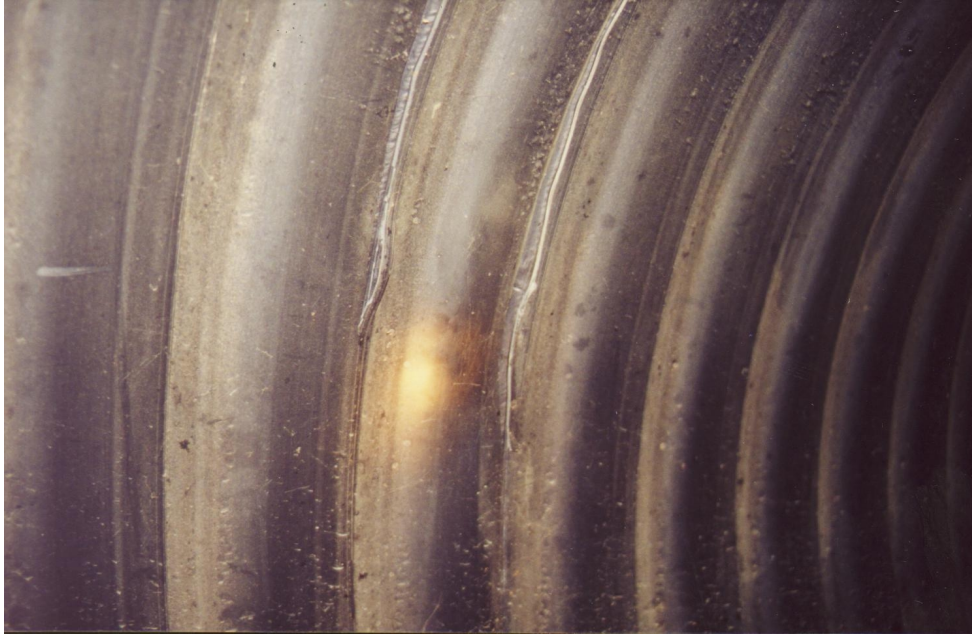
Pipe 5 - This 48-in. pipe is 70-ft. long. Two cracks have developed in this pipe: one at 10-ft. extending around the entire circumference of the pipe and another at 10.5-ft. extending from 270 to 300 degrees. Corrugation deflection of 3/8-in. were measured at 15-ft. and at 35-ft. A small swell was apparent in the bottom of the pipe at 35-ft. followed by a bulge at 40-ft. Wall rippling has developed in the sidewalls along the entire length of pipe. Joint separations ranged from 0.5 to 1.5-in.

Two cracks that have developed in the pipe – Pipe 5

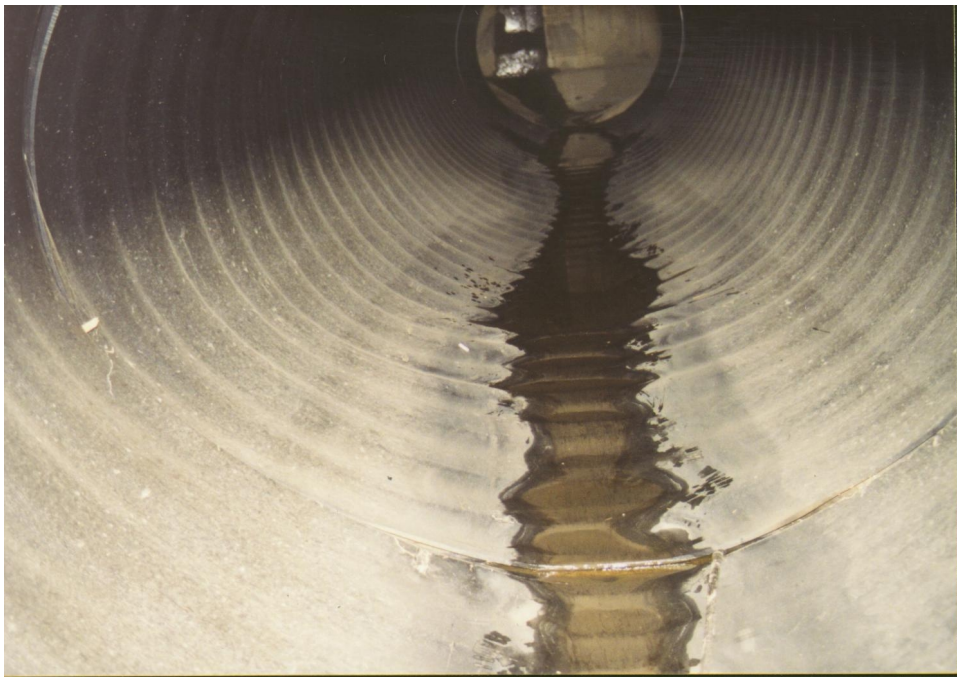
Bulge in the bottom of Pipe 6

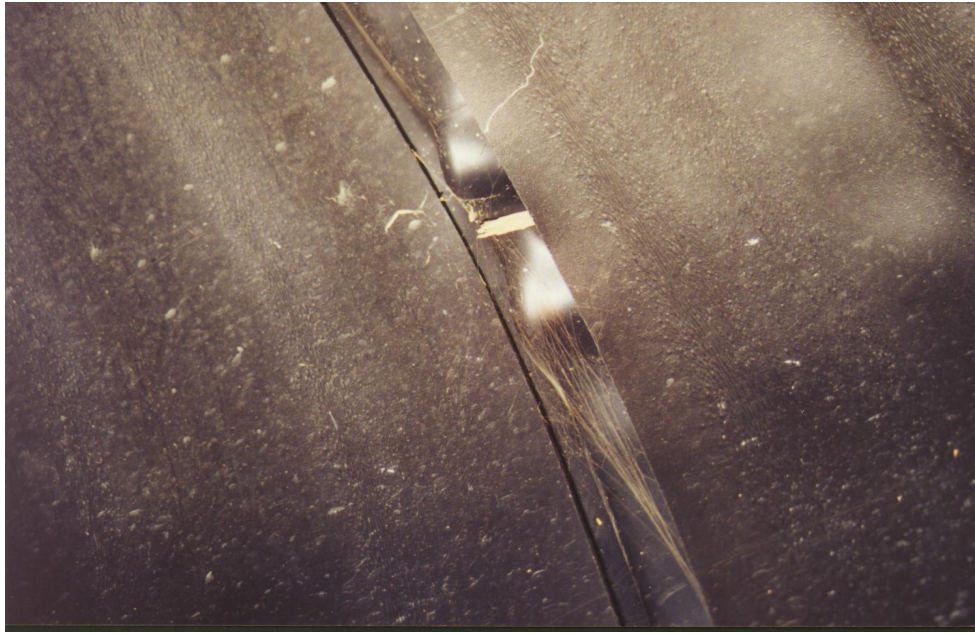
Separation of Joint 1, Pipe 6

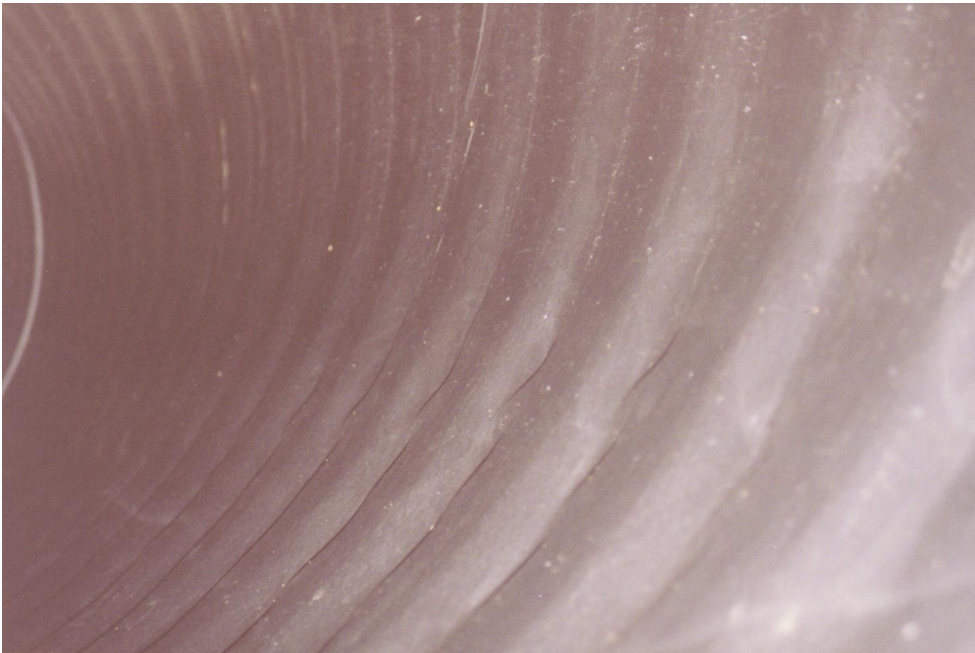
Wall rippling of Pipe 7

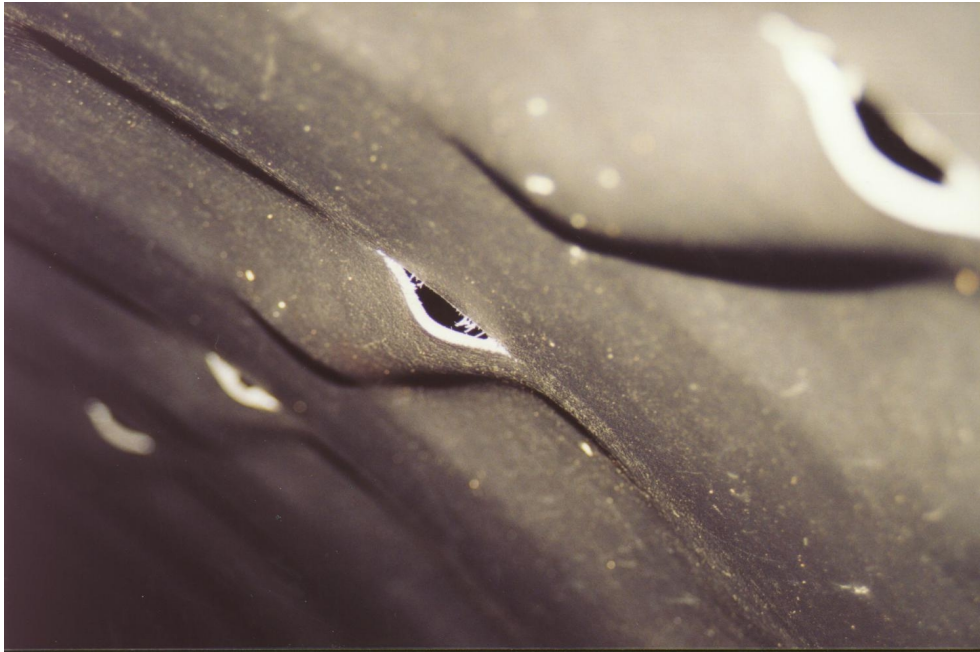
Splitting of Pipe 6

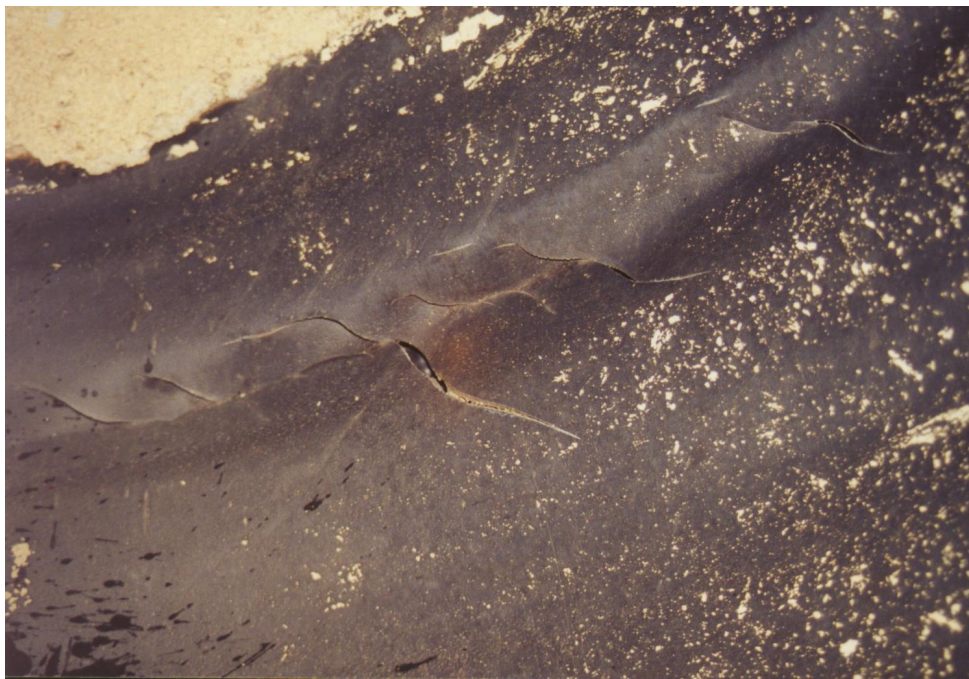
Cracking of Pipe 7

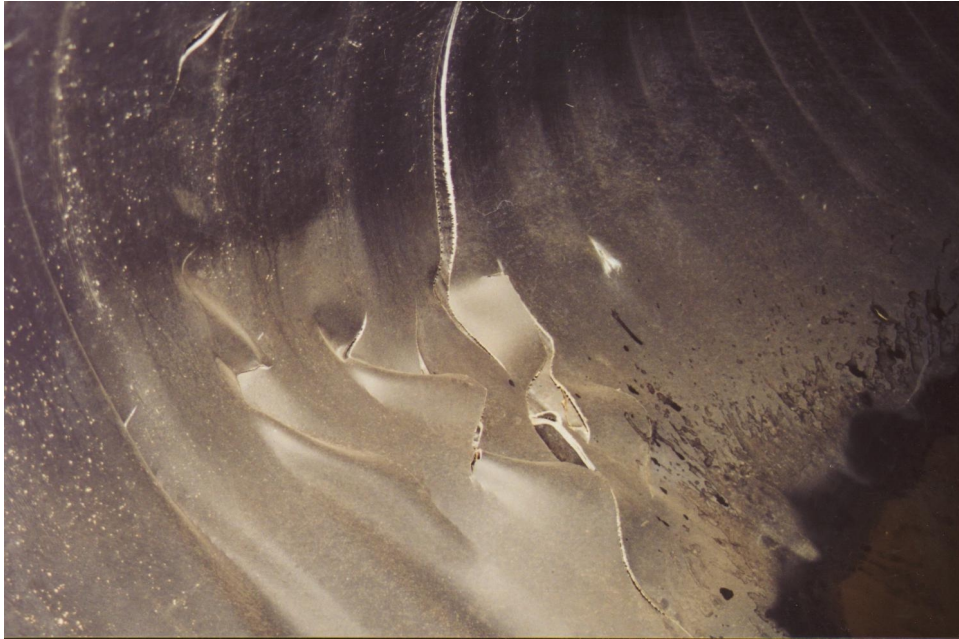
Cracking of Pipe 7

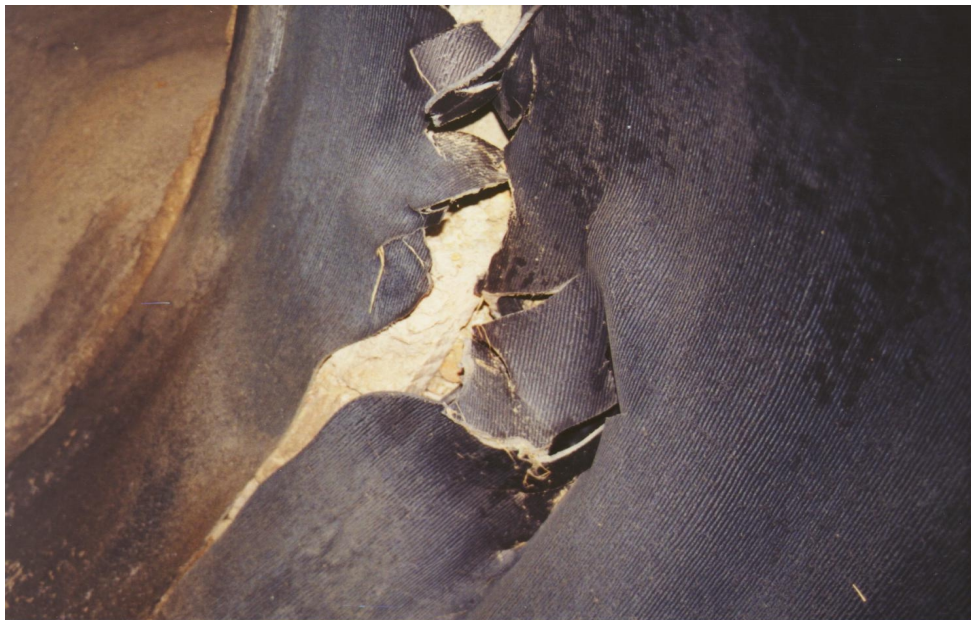
Cracking at outlet of Pipe 7

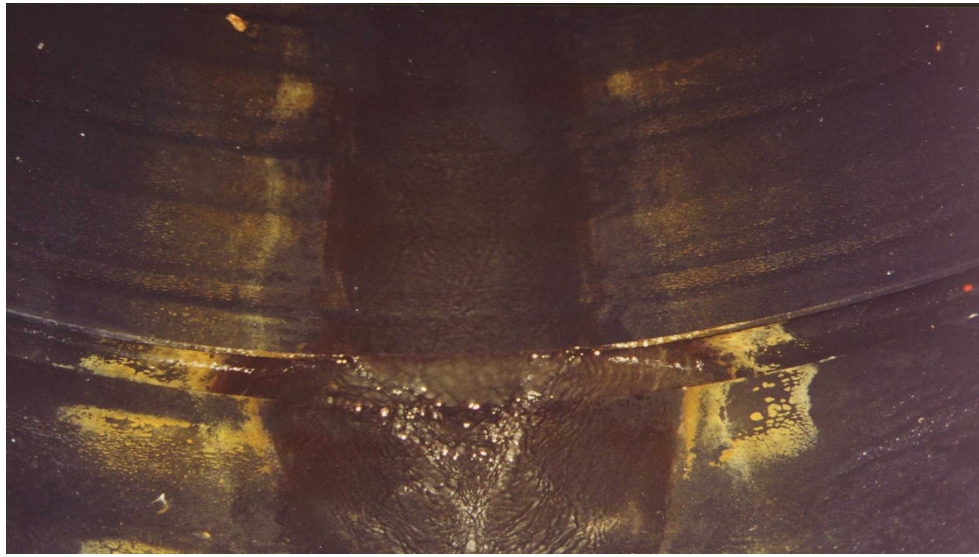
Pipe 1 - This 54-in. diameter pipe was installed as a test installation in 1996 as a cross drain. The maximum depth of cover is about 9.5 ft. The overall condition of pipe appeared to be good. However, separations ranging up to 2-in, and exfiltration was noticed at both joints in the pipe. The photograph below shows the joint separation.

Separation at Joint 2 –Pipe 1

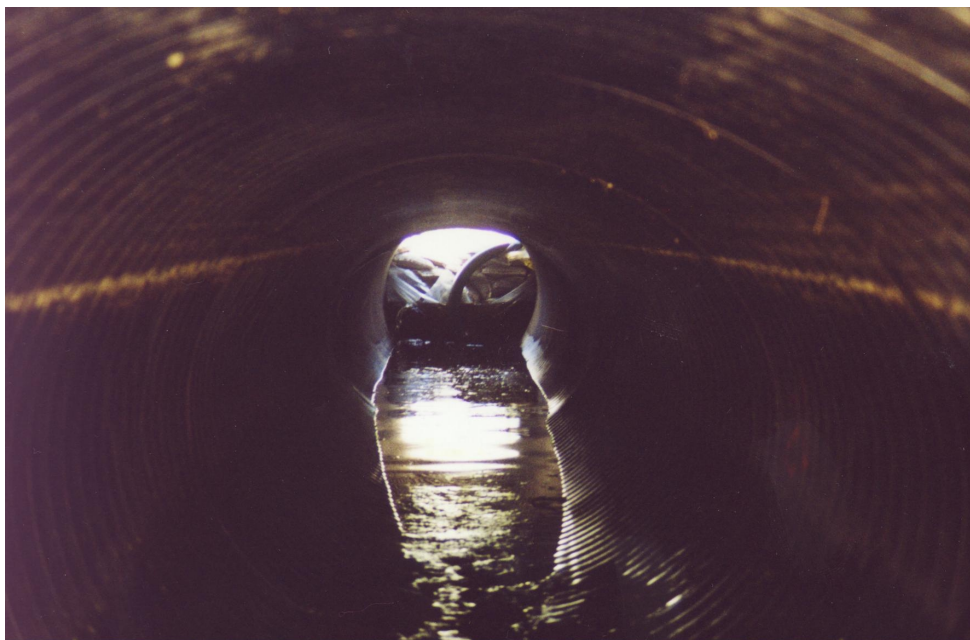
Pipe 3 - This 42-in. diameter pipe was installed in 1994 as a cross-drain culvert. The maximum depth of cover is between 2 to 3 ft. Significant deflection changes have occurred in this pipe, and the oval shape of the pipe is easily noticed. Pipe vibrations were noticed during traffic. The springlines of the pipe showed a few local buckling wrinkles (ripples) along the pipe lengths. Exfiltration was observed at Joint 1, and a 4-in. bulge was observed upstream of Joint 2 in the crown.

Oval shape of the pipe – Pipe 3

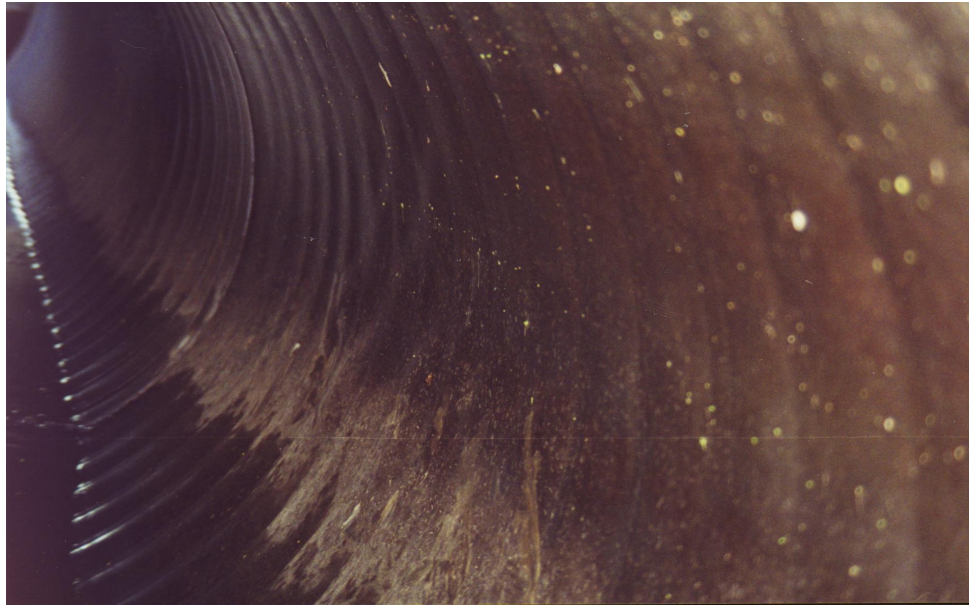
Wall buckling – Pipe 3
