**Condition Investigations of HDPE Pipe In-Service
In the United States (Six States)
for
The American Concrete Pipe Association
Irving, Texas**

WJE No. 991592

January 24, 2002

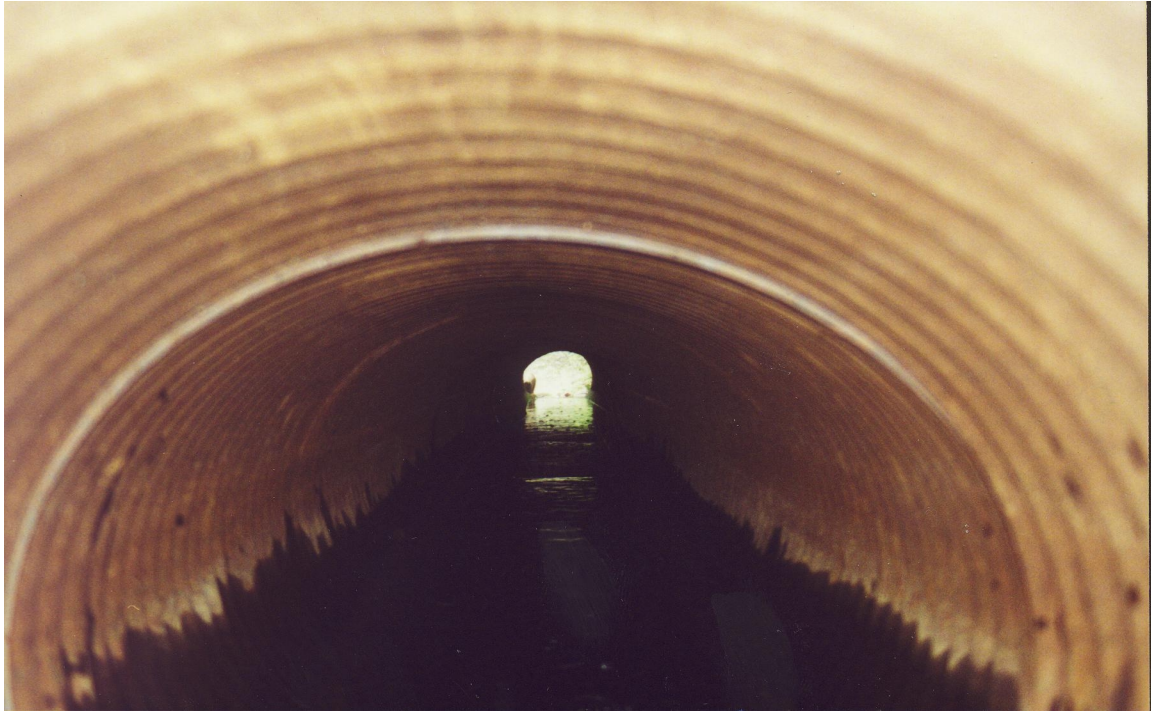
Pipe 4 - This 30-in. diameter pipe was installed as a cross-drain culvert. The amount of soil cover ranges from about 6-ft. at the inlet to about 9-ft. at the outlet. An oval shape to the pipe is apparent throughout the entire length of the pipe, and horizontal misalignment is easily noticed (see picture below). Separation of all joints was apparent.

Note oval shape of profile – Pipe 4

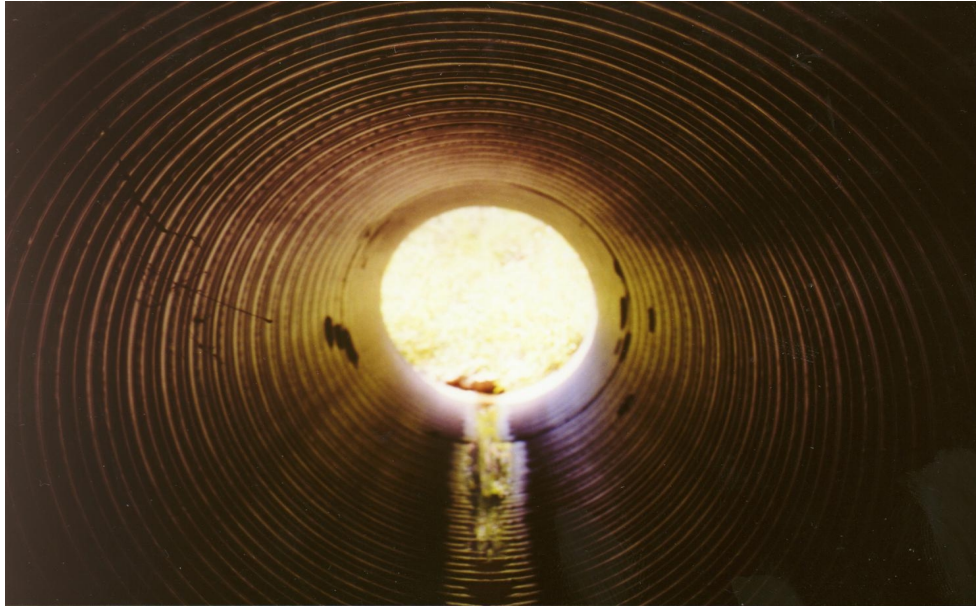
Pipe 3 - This 48-in. diameter pipe was installed as a cross-drain culvert, due to a previous wash out of a steel pipe during a hurricane. The pipe is 45-ft. long and has about 2-ft. of cover. The pipe is in overall good condition. However, Joints 1 and 2 have separations as large as 1½ in. Both ends of the pipe are exposed, and the outlet end appears to be slightly delaminated due to exposure to the sun. No other areas of distress were observed. The traffic volume over the pipe is very low.

Good shape and alignment – Pipe 3

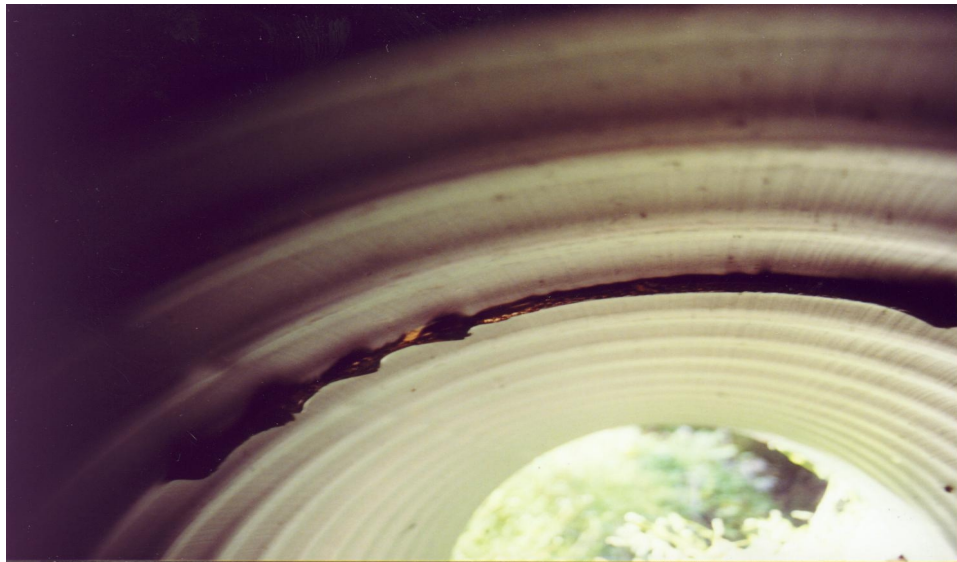
Pipe 4 and Pipe 5 (Twin-pipe installation) - These two 36-in. diameter parallel pipes were installed in 1998 as a cross-drain culvert. The pipes are 60-ft. long and have about 2-ft. of cover. The pipes run north and south. Pipe deflection and the vertical misalignment were easily noticed (see picture below). Four lacerations of the east pipe were found in the top of the pipe near Joint 2. It is probable that these lacerations are from the forks of a backhoe. In the east pipe, exfiltration and a 2-in. gap was observed at Joint 1, and undermining was apparent upstream of Joint 2. In the west pipe, a 1 1/2-in. separation was measured at Joint 1, and 3/4-in. elevation difference at Joint 1 was apparent. A gap of 1/2-in. has developed at Joint 2 and exfiltration was occurring.

Lacerations in top of pipe – Pipe 5

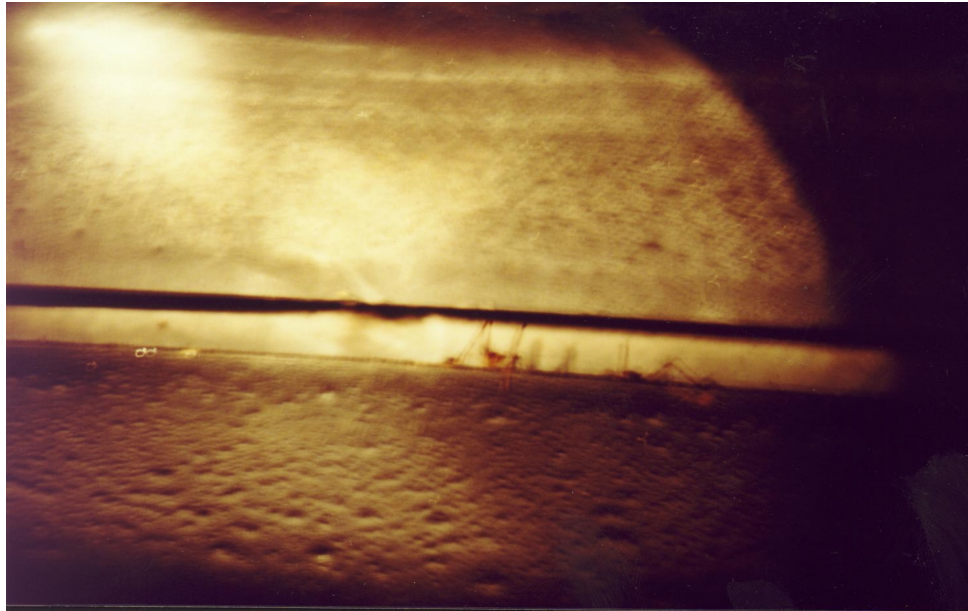
Pipe 6 - This 120-ft. long, 30-in diameter pipe was installed in 1987 as a test pilot for use of HDPE as a culvert material. The depth of soil cover ranges from 4-ft. at the inlet to 15-ft. at the outlet. At the time of the inspection no water was present. Every joint in the pipe has experienced some separation with 1 3/4-in. as the maximum separation. The pipe has significant vertical and horizontal alignment problems. A sag of about 3-in. was apparent upstream of Joint 4. Some sections of the pipe liner were missing near the inlet of the pipe.

Typical joint separation – Pipe 6

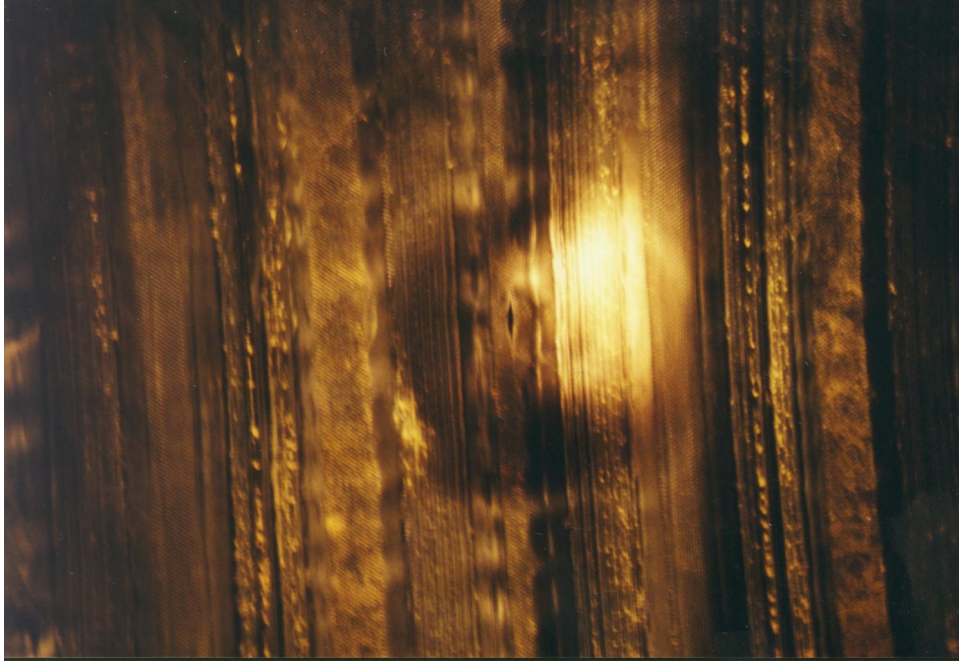
Pipe 1 - This 48-in. diameter pipe is approximately 215-ft. long and was installed as a test installation in 1996. The maximum soil cover is about 20-ft. A 1-in long crack has developed in this pipe at 73-ft. (see picture below). Rippling (buckling) of the sidewalls has occurred from 82 to 86-ft. The alignment of the pipe is pretty good except for at joint 5 where the pipe dropped 3-in., and minimal joint separation has occurred. Three splits were found at 99-ft. at the top of the pipe. These splits were caused during installation (as documented by construction records).

Small crack that has developed – Pipe 1

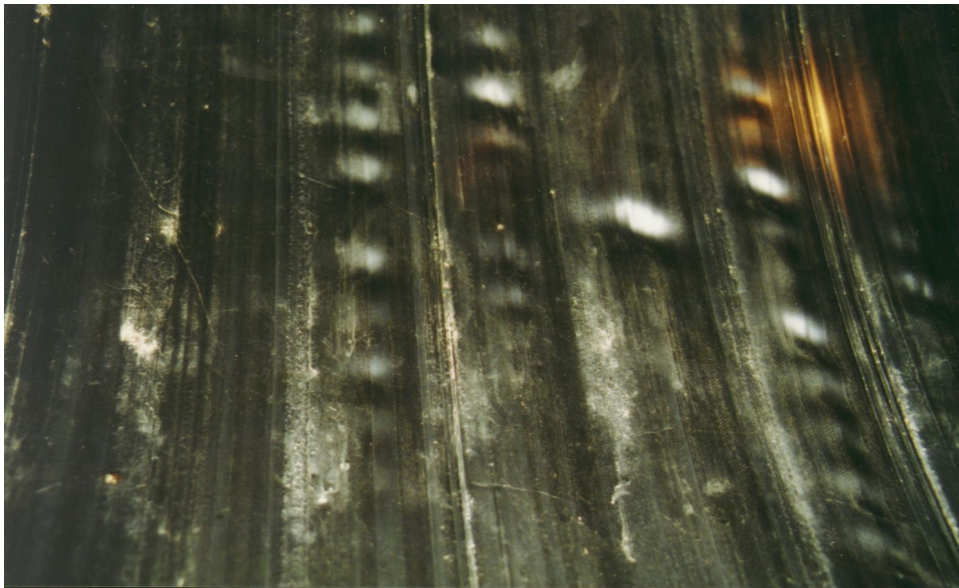
Rippling of the side walls – Pipe 1

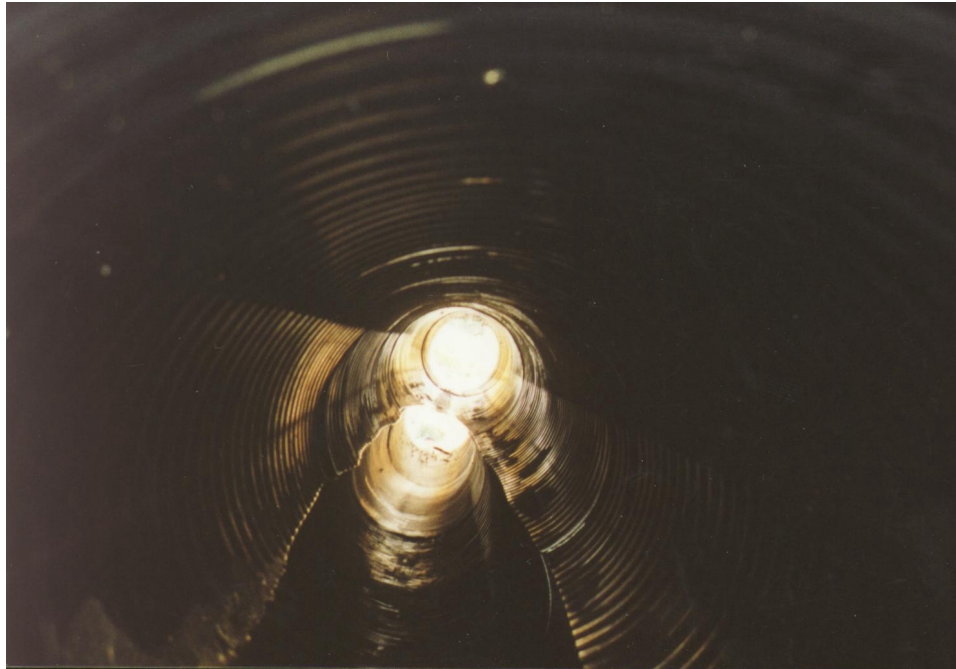
Profile of pipe – Pipe 1

Pipe 1 - This pipe was installed in 1992. This pipe is 120-ft. long and has a diameter of 30-in. Since the pipe was 3/4 full of water, the pipe ends were blocked and the water was pumped until 3 to 4-in. of water was left. The pipe was in good condition and no major areas of distress were noted. A few small bulges and swells were observed in the bottom of the pipe. Separations of the joints ranged from 1 to 2-in.

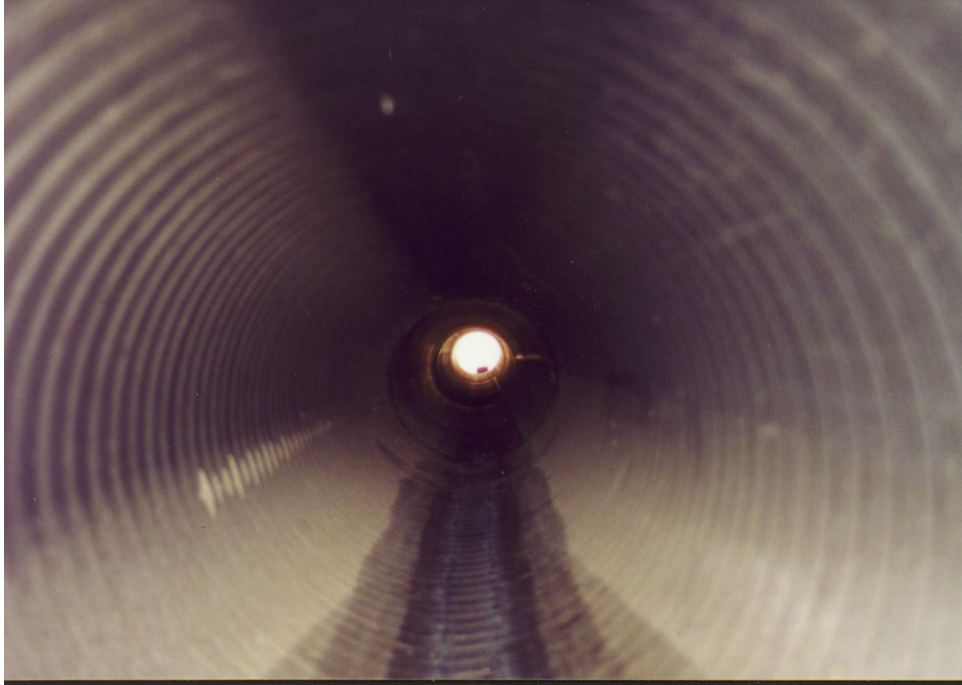
View of pipe - Pipe 2

Pipe 2 – This pipe was installed in 1999. The pipe has a diameter of 24-in. and is 75-ft. long. The overall condition and the alignment of the pipe is good. No significant areas of distress were found. Separations of the joint ranged from 0.5 to 1-in.
