Service Life of Aluminized Type 2 Coated Steel Pipe: Predictions vs. Actual

The last comprehensive inspection of the metal pipe test site on the Natchez Trace Parkway was documented in Report No. FHWA-RD-97-140, titled *Durability Analysis of Aluminized Type 2 Corrugated Metal Pipe* from inspections that dated October 1994 to December 1996. The American Concrete Pipe Association (ACPA) performed an inspection on November 12, 2014 and the findings are presented herein.

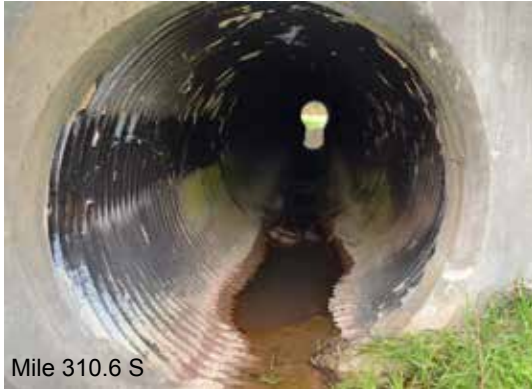
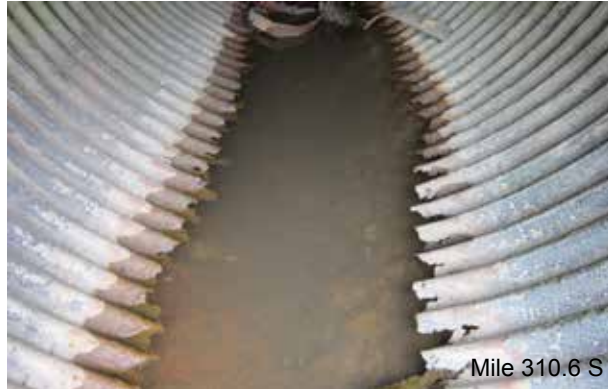
Mile 310.6 S

This 60" diameter galvanized and bituminous coated pipe is experiencing minor bedload and approximately 36" of rust across the invert. For approximately the first 10' of culvert on the inlet end, approximately 24" across the invert is completely gone. Because of terrain conditions at the inlet end, this culvert is carrying much more water and bedload than the parallel pipe 310.6 N (which has been the case for almost the entire service life).

310.6 S	Galv. Bituminous Coated	16	60"	Minor	33	Approximately 36" rusting across invert with 24" completely gone for the first 10' of the inlet, which appears to be from abrasion and corrosion.

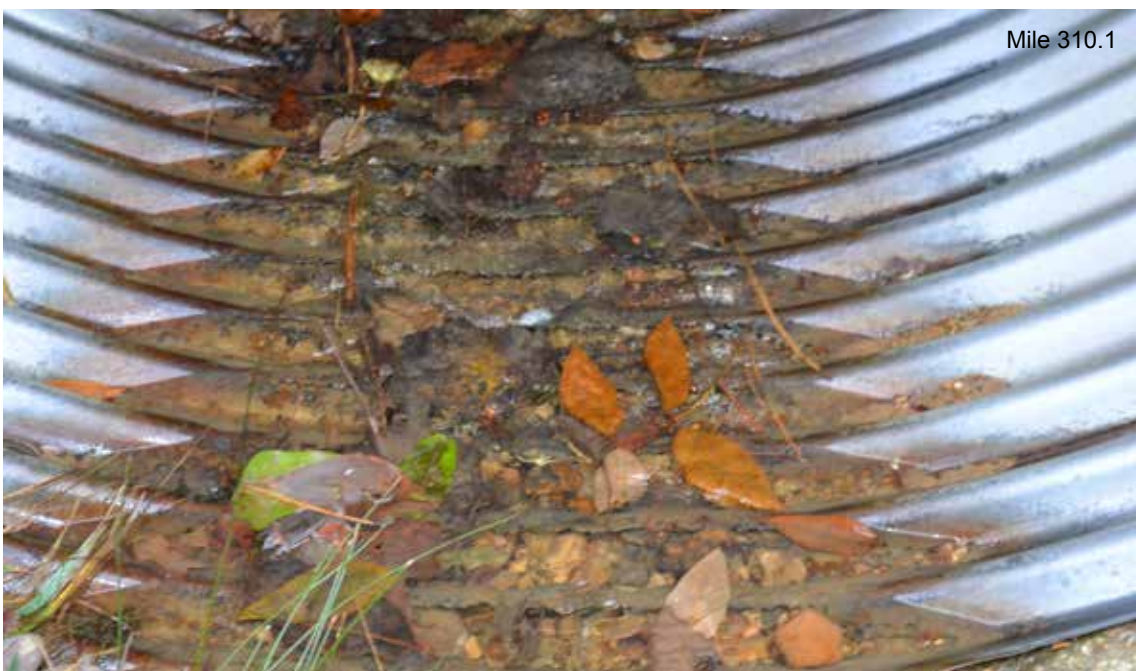
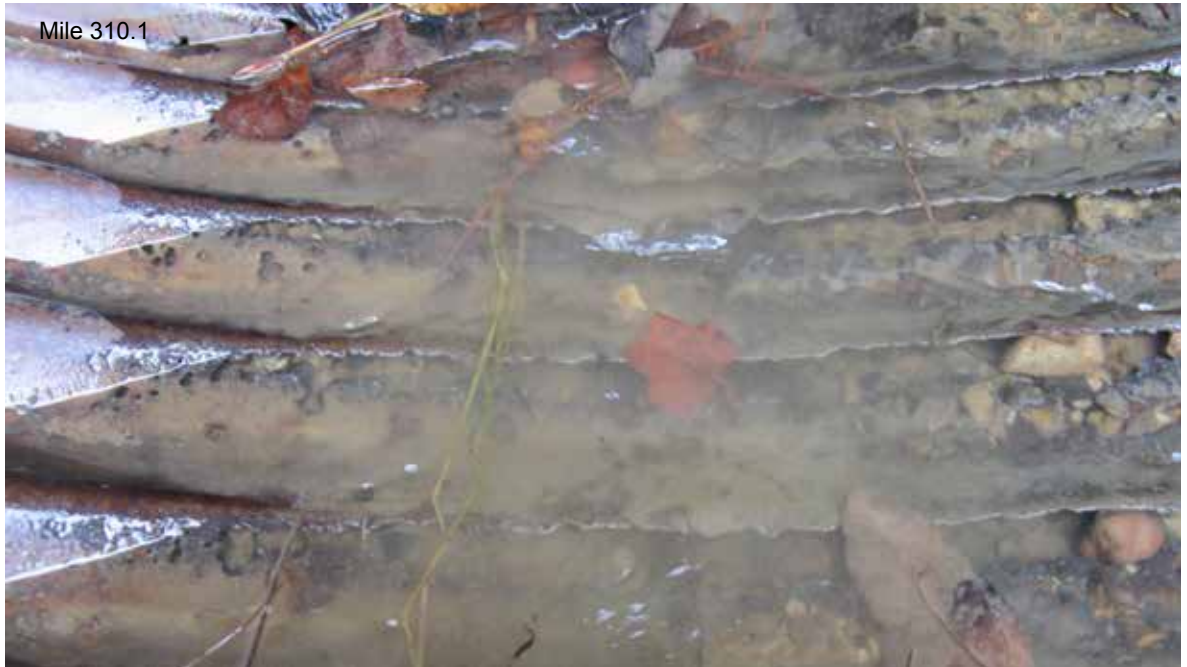
Mile 310.1

This 72" diameter Aluminized Type 2 pipe is experiencing moderate abrasion and there is approximately 30" of corrosion across the invert with approximately 18" of invert fully perforated. The pipe is considerably distorted (deflected) at the 1:00 o'clock position when looking upstream.

310.4*	Al Type 2	16	54"	None	33	Coating gone in spots with some rust in invert and crown.
310.1	Al Type 2	16	72"	Moderate	33	Approximately 30" along width of invert corroded with 18" of that fully perforated. Pipe is considerably distorted (deflected) at the 1:00 o'clock position when looking upstream.

The culvert at mile marker 310.0 collapsed and was lined (rehabilitated) with Snap-Tite in its 33rd year. The culverts at mile markers 310.6 South, 310.1, and 309.4, which appear to be nearing the end of their service life, will likely need repair or replacement in the near future (we recommend owner inspection for further action). Therefore, these culverts did not meet the service life predictions. Of the predictions in the above table, the COE predictions are the closest. If the multiplier of 2.0 or greater for Al Type 2 is disregarded, then the COE predictions would be a lot closer to reality. For example, the prediction for the culvert at mile marker 310.0 would be 43 years instead of 86 and it had to be lined (rehabilitated) at 33 years. Additionally, the COE prediction of 37 years for the culvert at 310.6 South, which is **Galvanized** and Bituminous Coated, is closer to reality and is experiencing approximately the same service life as the Al Type 2 culvert at mile marker 310.0 in similar environmental conditions.

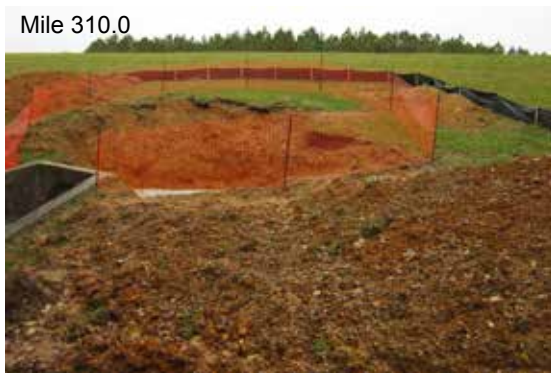
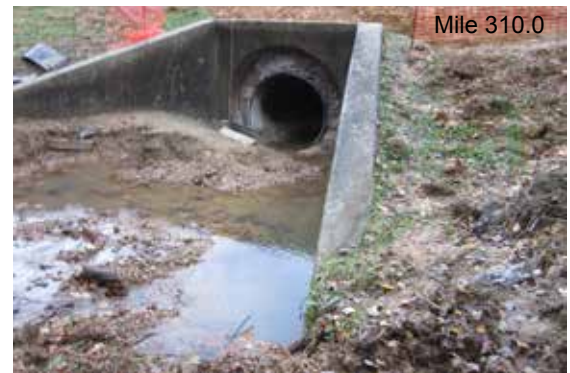
Mile 310.0

This 72" diameter Aluminized Type 2 pipe had failed and had just undergone rehabilitation with a 50" diameter Snap-Tite liner prior to this inspection (construction clean-up still in progress at the time of this inspection).

310.0	Al Type 2	16	72"		33	Recently rehabilitated with 50" diameter liner.
309.5	Al Type 2	16	30"	None	33	Aluminum coating in invert gone and minor perforations along the entire barrel length.

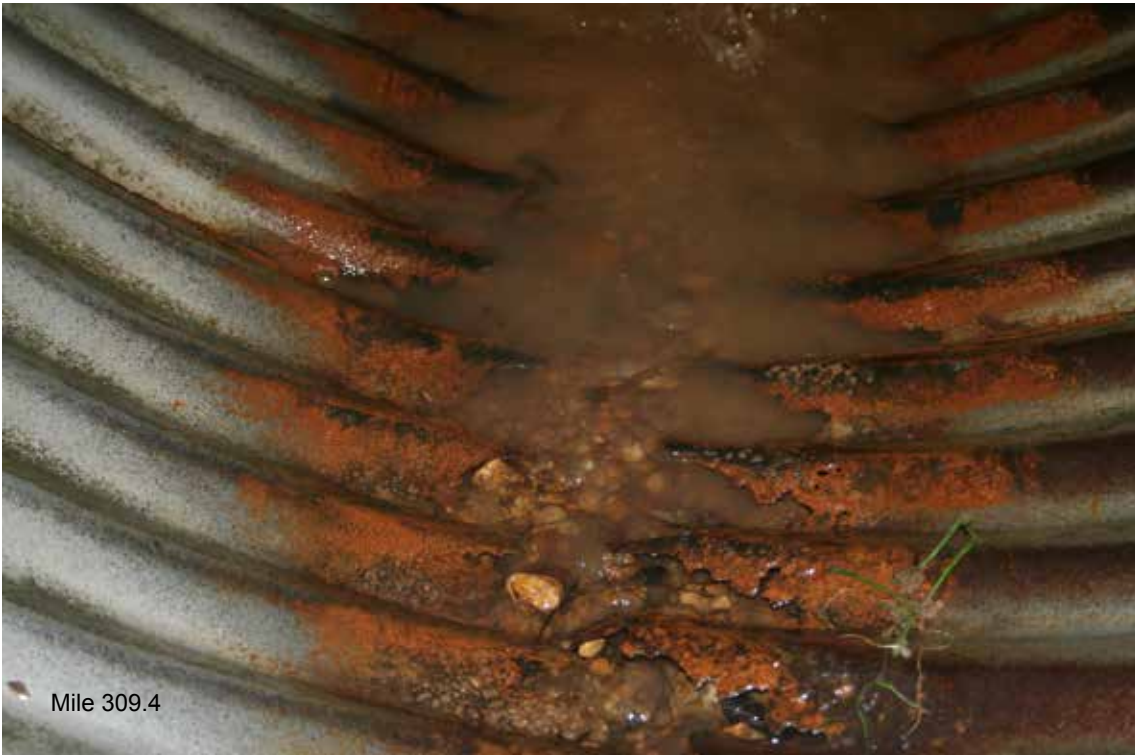
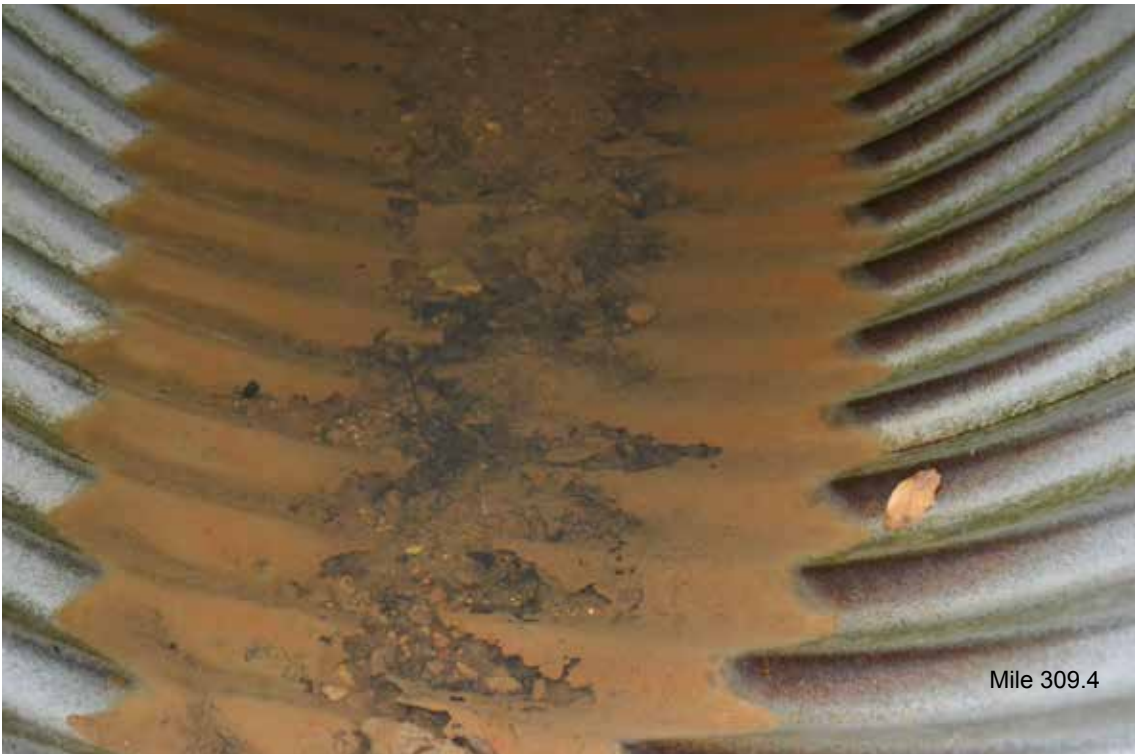
Mile 309.4

This 42" diameter Aluminized Type 2 coated steel pipe is experiencing moderate abrasion and there is approximately 18" of corrosion across the invert with approximately 6" of invert fully perforated.

309.4	Al Type 2	16	42"	Moderate	33	Approximately 18" of corrosion across the invert with 6" of that fully perforated due to abrasion and corrosion.
