the
infrastructure

is
collapsing!

**Concrete Pipe
Stays In Shape!**

The following are examples of recent COLLAPSES.

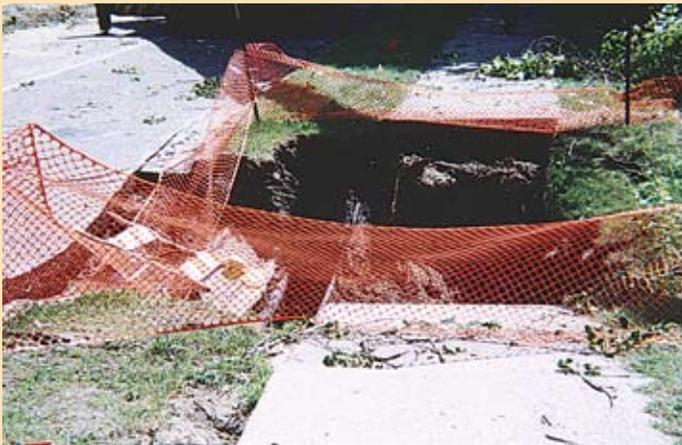
◀ Muskegon

The failure of a 60" diameter CMP culvert caused: a) a street closure of five weeks, b) the shutdown of a 48" diameter water transmission line (which traversed the 20 feet deep excavation), and c) the detour of an 8" diameter water line. Additionally, replacement of the CMP with precast concrete pipe called for the diversion of the creek carried by the culvert. The replacement cost was \$160,000, which did not include the social and economic costs associated with the detours and consequent lost time to commerce and residents.

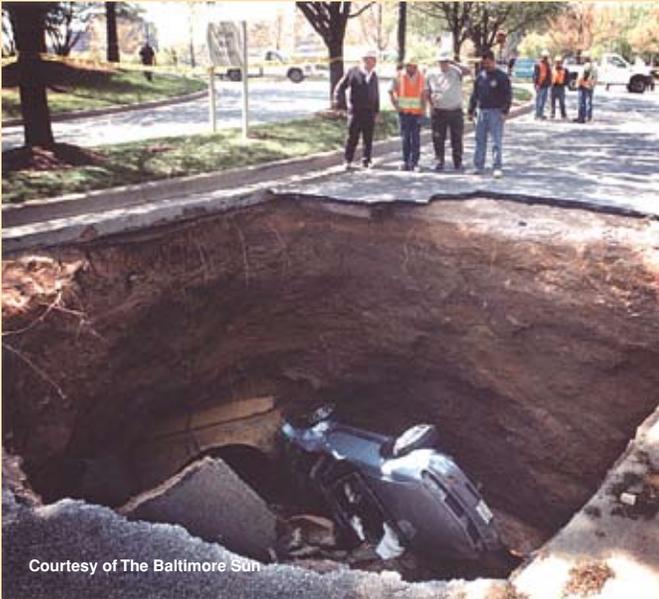
◀ Owings Mills (Baltimore County)

A mother and daughter were injured when their car fell into a 20' long by 30' wide by 20' deep sinkhole caused by the failure of a 17-year old, 84" diameter CMP. But, it could have been worse. The rescue workers later learned that more than 13,000 volts of electricity coursed through feeder lines just below the car.

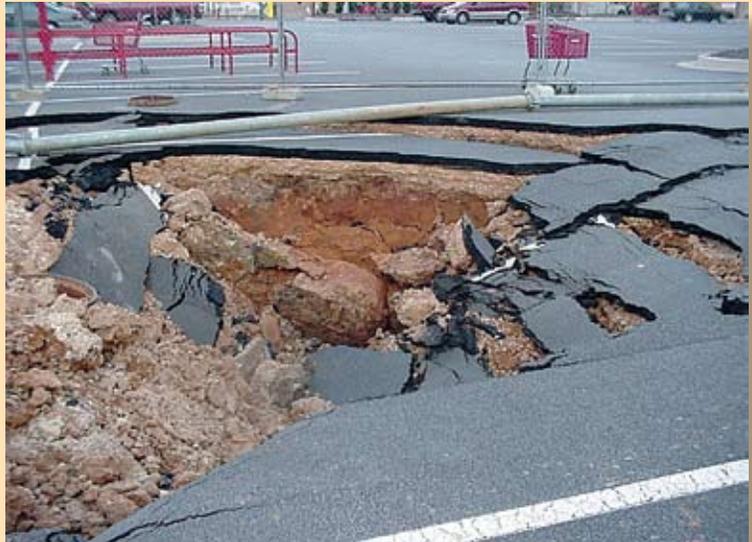
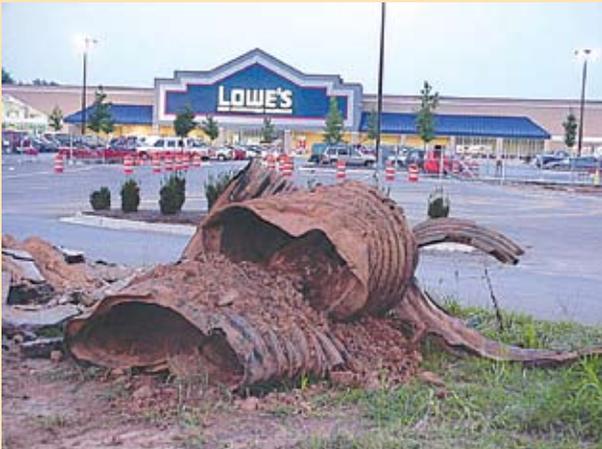
▼ Timonium ▶

A 4-year old, 48" diameter HDPE pipe collapsed in the parking lot at the Lowe's Home Improvement Warehouse. At a cost of \$500,000, the contractor replaced the failed pipe with precast concrete pipe.

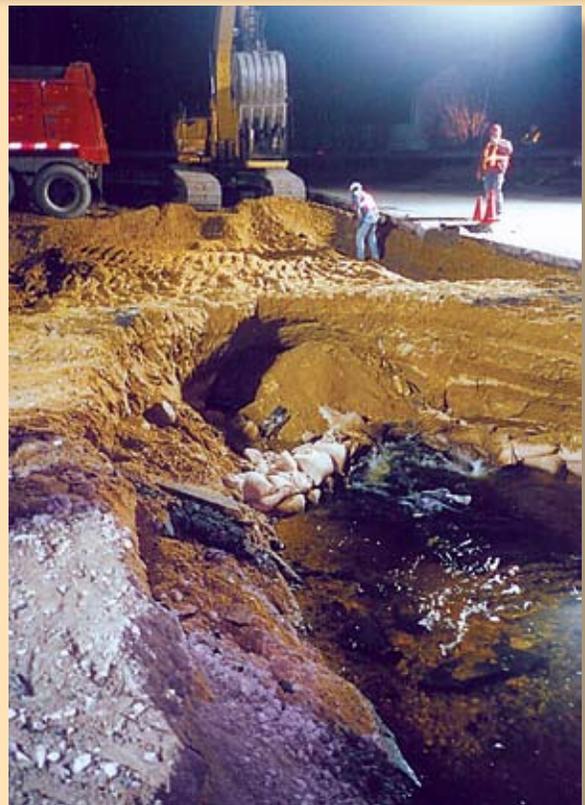
Nashua ▶

NH Route 101A, a major artery carrying nearly 50,000 vehicles per day, was closed due to the collapse of a 25-year old, 108" diameter CMP which carried Pennichuck Brook under the roadway. After two temporary repairs, the waters had receded to the point where permanent construction could take place. The CMP was replaced with precast concrete box culverts at a cost of \$889,500.

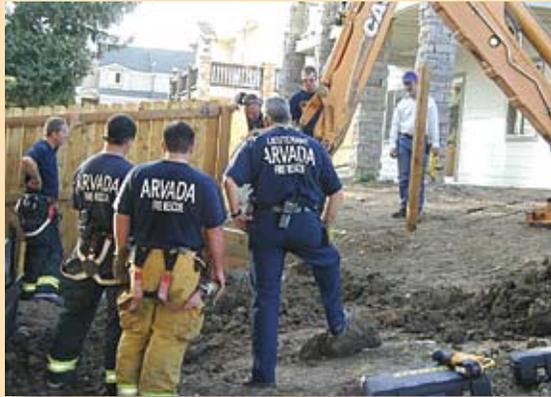
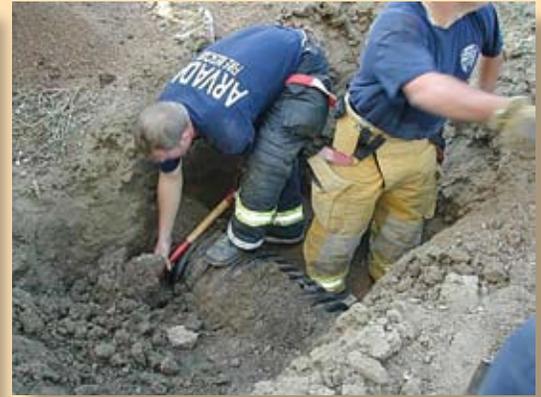
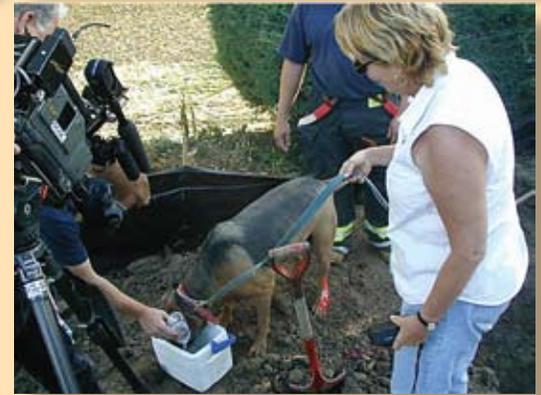
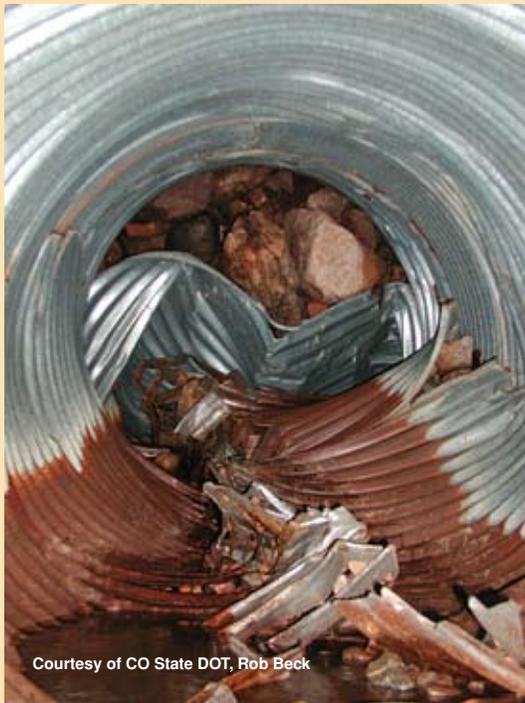
Arvada ▶

911 Emergency equipment was tied up for hours when a dog had to be rescued by fire and rescue personnel after getting stuck in a 24" diameter HDPE pipe that had collapsed to about one half (12") its height. The pipe was part of a residential storm sewer installed through backyards with only three feet of earth load and no traffic load.

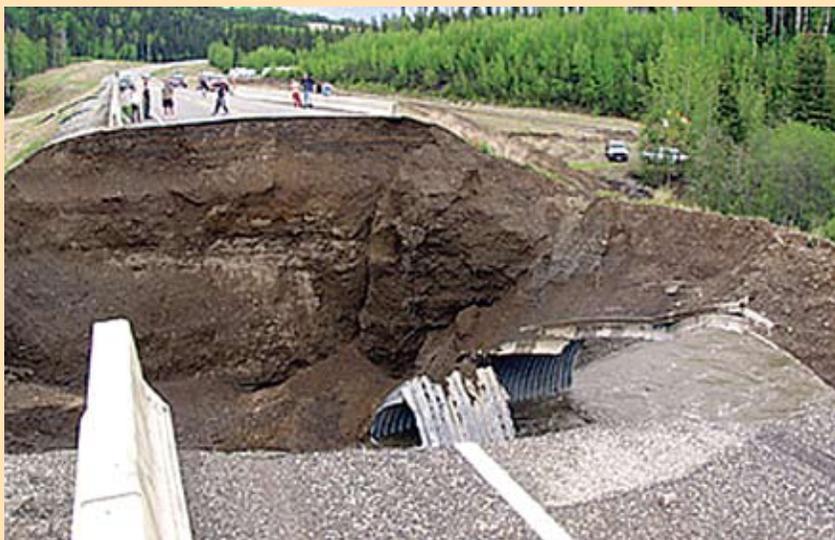
◀ British Columbia, Canada

Approximately three years after installation, the "World's Largest Corrugated Steel Arch" collapsed on the Alaska Highway. The 100' wide gaping hole was temporarily replaced with a one-lane Bailey bridge. Delays were expected to be experienced for years before a new bridge would be built.

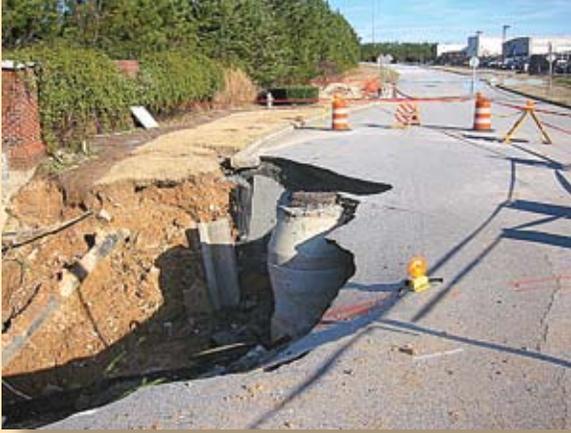
◀ **Gwinnett County** – A rash of CMP failures and road closures has caused the county to reconsider its specifications and to look for ways to fund the costs of repairs. The cost to repair one such collapse of a 102” diameter CMP could reach up to six figures while the nearby 48” diameter concrete pipe is fine.

The estimated cost for repairs from the collapse of a 10 to 12-year old, 60” diameter CMP is \$475,000. The maximum depth of this pipe is approximately forty feet. In addition to the commercial/residential street closure, an exposed water line, which crossed the hole on one side, burst before the drainage repairs were made and caused additional damages (not included in the initial estimate).

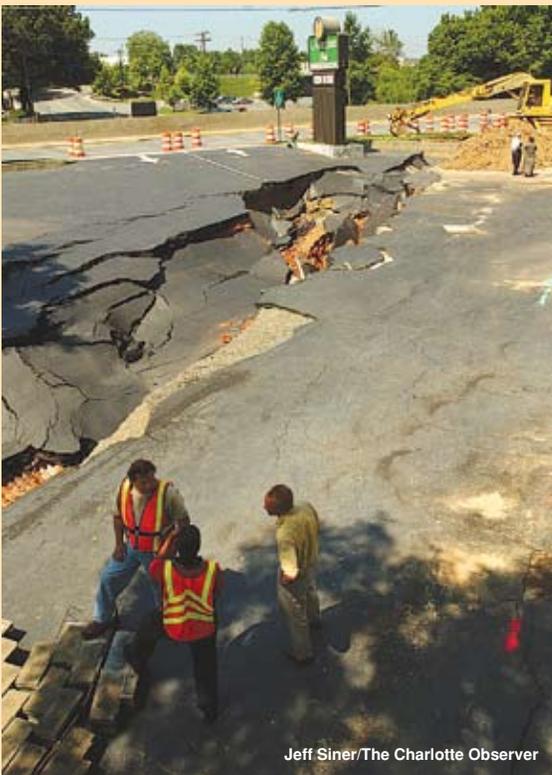
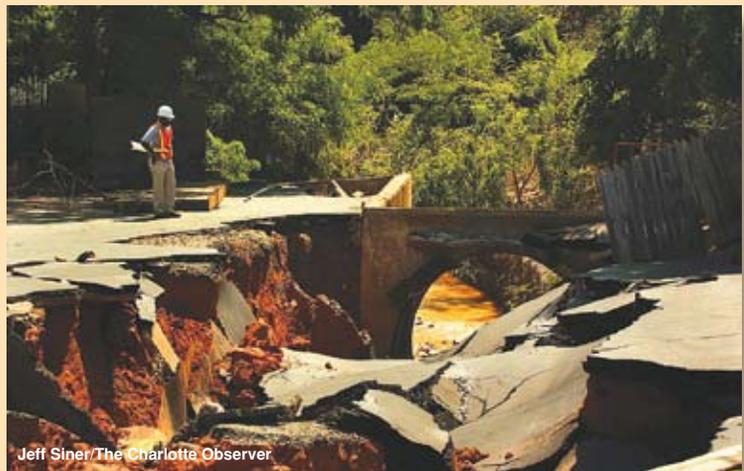
▼ Charlotte ►

A massive sinkhole, formed by a failed 20-year old, 126” diameter CMP swallowed a Mustang and flooded the lobby and ground floor of a hotel. The cost of replacement was approximately \$300,000.

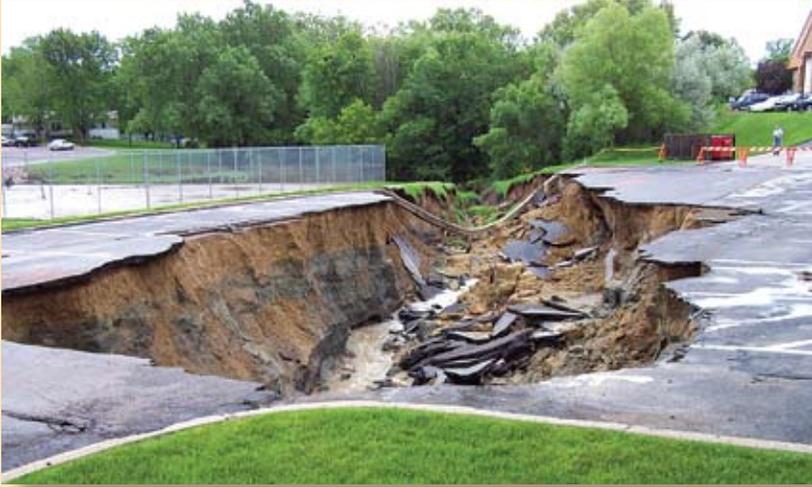
◀ Sioux Falls

The failure of a 20-year old, 84" diameter CMP resulted in a parking lot sinkhole approximately 75' wide, 250' long, and 25' deep. Fortunately there were no casualties or injuries since the culvert, which extended to a busy street crossing, collapsed just one hour prior to employees being present in the parking lot. The CMP was replaced with precast concrete pipe and the project cost was about \$.5 M.

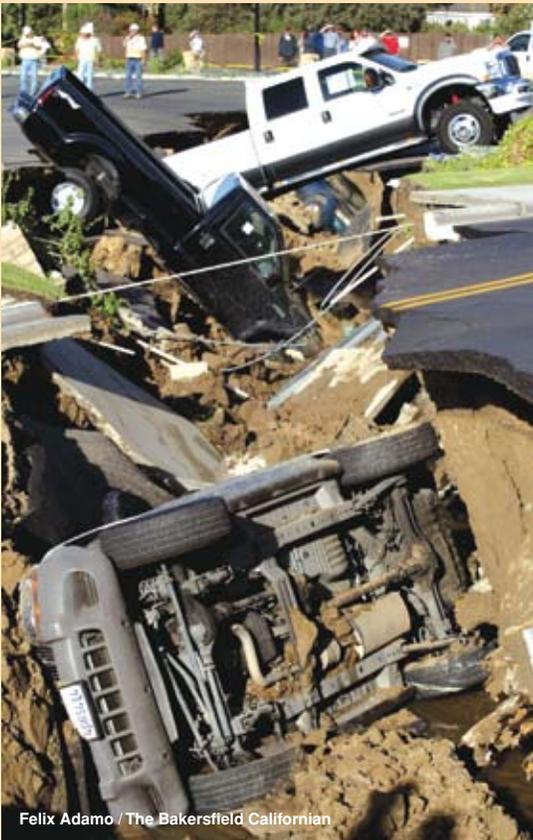
◀ Bakersfield

As a result of the following incident, CMP is no longer permitted. The collapse of a 30-year old CMP in the downtown area caused a commuter headache and precipitated the inspection of other road crossings by the city. Most of the failed pipe and the balance of the line were replaced with concrete box culvert and precast concrete pipe.

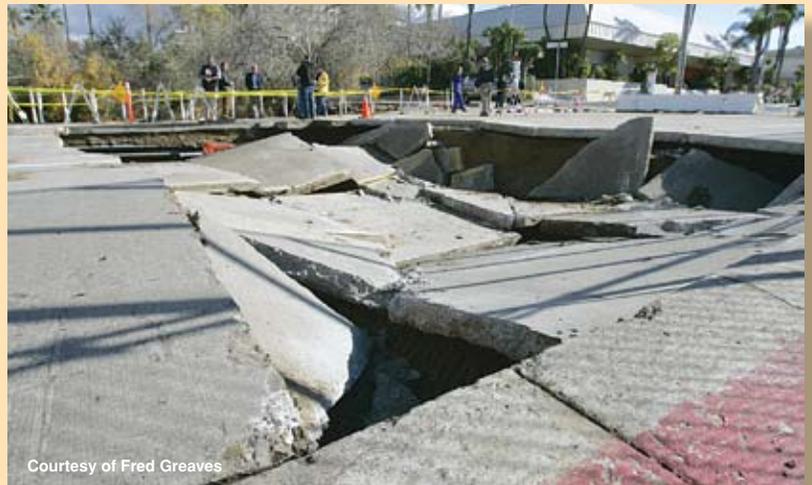
▲ San Diego

A section of a busy roadway collapsed into a sinkhole approximately 8 feet deep and 24 feet wide. The collapse, in an area concentrated with retail businesses, was caused by the failure of multiple lines of large CMP that carried the San Diego River under the street. The street was closed and the time for repairs was estimated to be one month. The corrugated metal pipe was replaced with precast concrete pipe. City officials estimate the cost of replacing metal pipe throughout the city to be at least \$37 M.

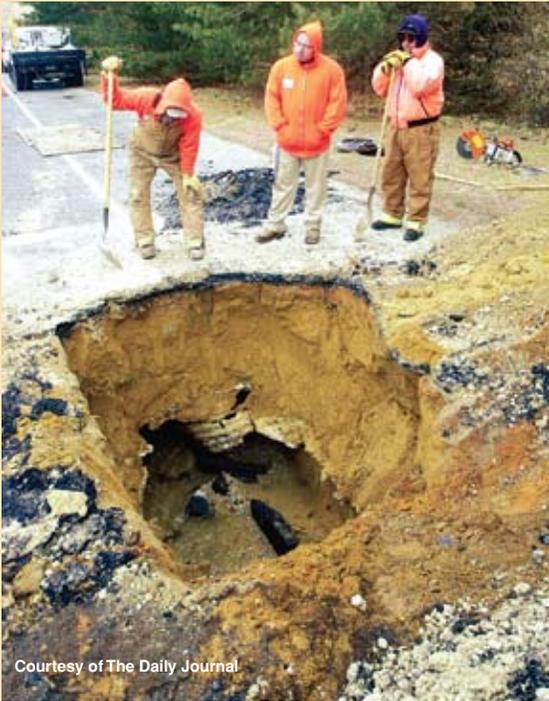
◀ Vineland

A corroded 54" diameter aluminum pipe caused an enormous sinkhole in a city roadway. Luckily, a local couple reported the sinkhole after peering through a crack in the road. Closer inspection revealed that a substantial section of the roadway was merely a layer of asphalt spanning a deep cavern.

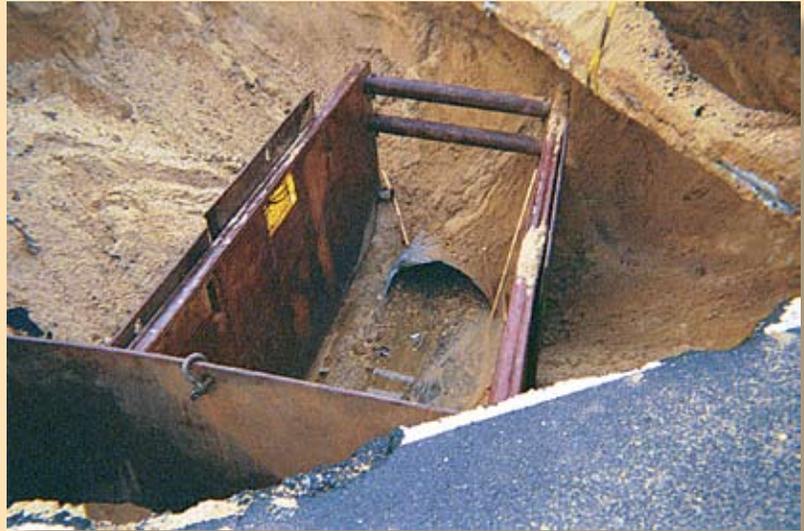
Ocean County ▶

A 60" diameter CMP failure was the cause of a huge sinkhole in the Ocean County Mall parking lot.

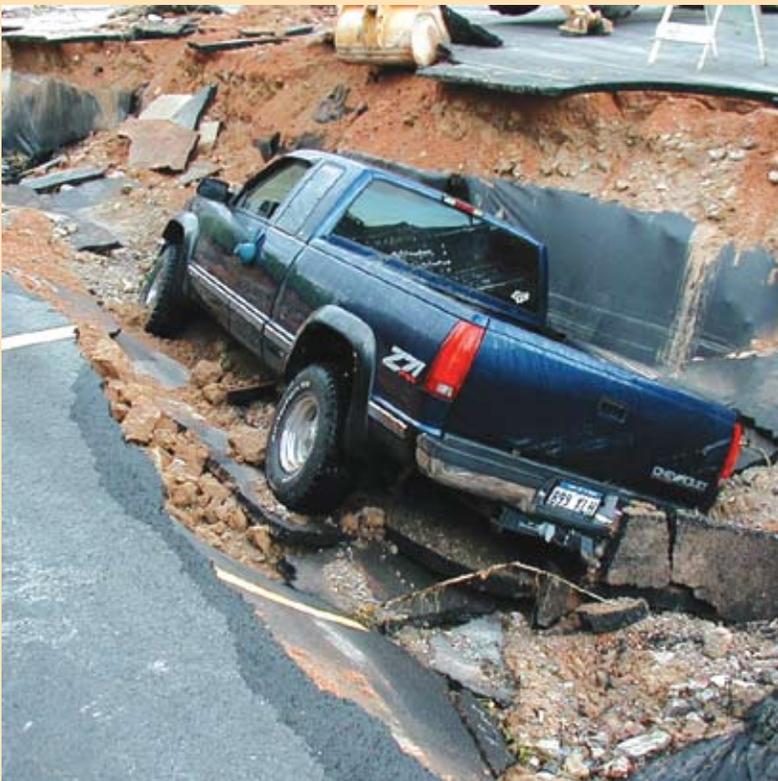
◀ West Bountiful

A 30-year old, 96" diameter CMP collapsed in a church parking lot, causing a sinkhole, which swallowed a pickup truck and flooded a nearby home. Fortunately, the teenagers in the truck were not injured. The pipe was replaced with concrete box culvert.

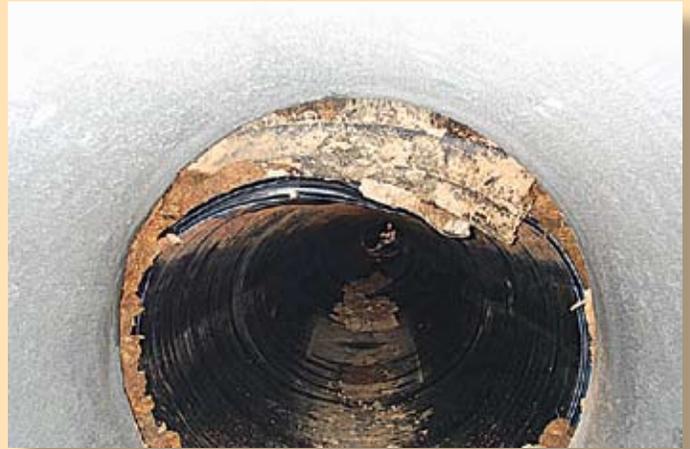
Pelham ▶

After only a few years in a new subdivision, the 42" and 48" diameter HDPE pipe collapsed in the backyards between houses. The HDPE pipe, which had approximately three feet to seven feet of earth cover, was replaced with precast concrete pipe.

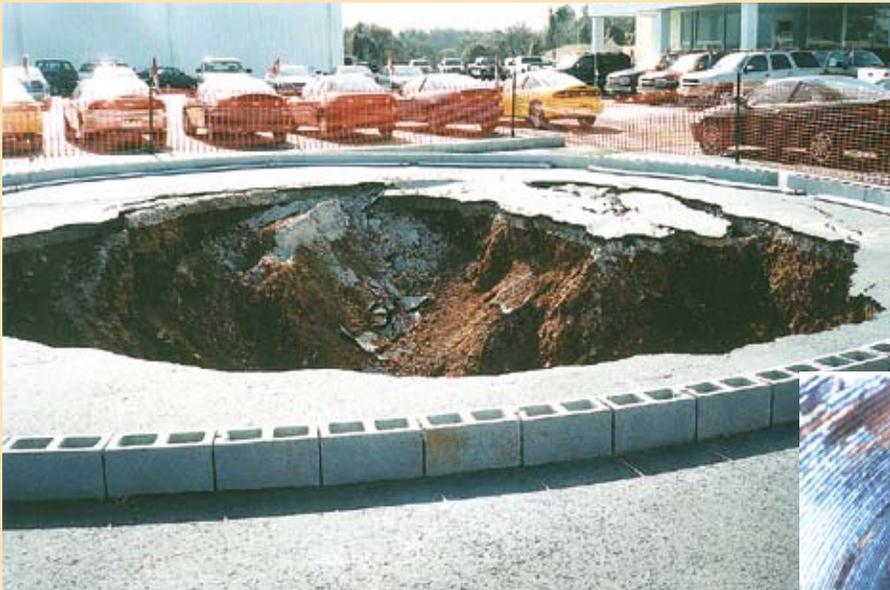
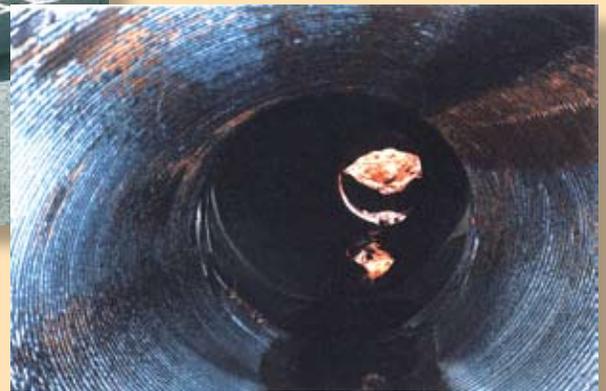
◀ Florence ▼

A 23-year old, 90" diameter CMP collapsed in an auto dealership lot. Fortunately, a customer noticed a small hole in the pavement and notified the dealership, who moved the new automobiles before the huge sinkhole appeared.

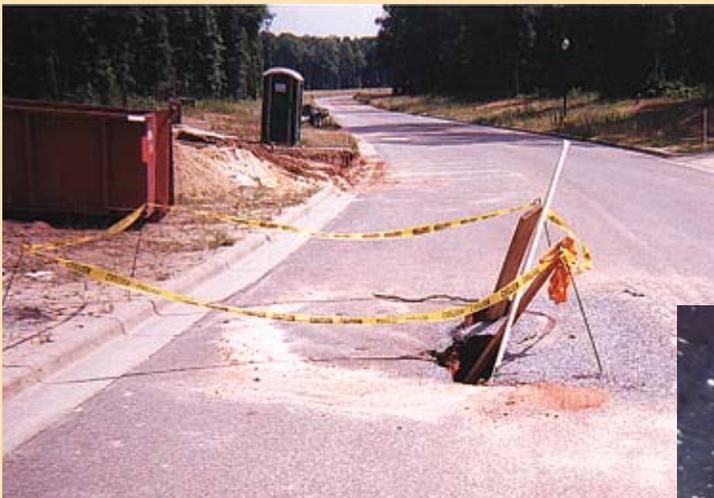
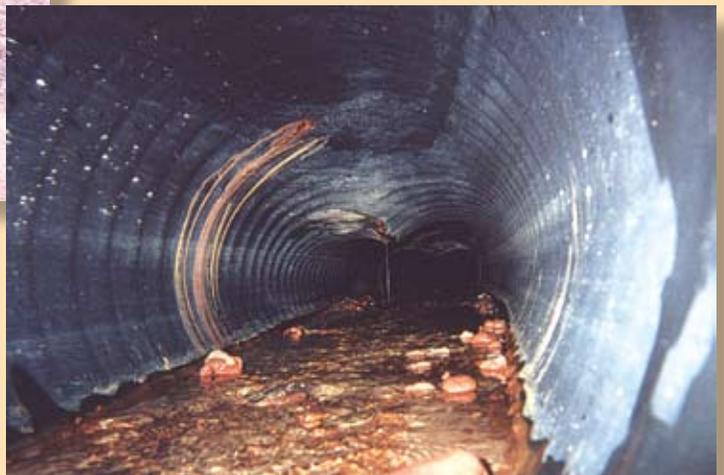
▲ Elmore County ▶

A 24" diameter HDPE pipe collapsed under a new subdivision street causing a sinkhole. The HDPE pipe, which had only been installed two years earlier, was replaced with precast concrete pipe.

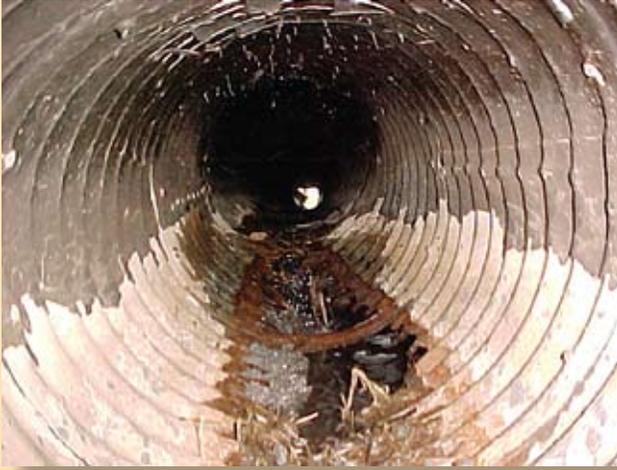
Topeka – A sinkhole developed under the weight of an asphalt – milling machine (working on a street resurfacing project) because of the failure of an approximately 38-year old 72” x 44” Arch (60” round equivalent) CMP. While replacing that pipe with precast concrete pipe, a newer but badly corroded section of CMP was thought to be close to complete failure and it also had to be replaced. The pipe replacement cost was approximately \$60,000. The 42-year old concrete pipe in this same street was in perfect condition.

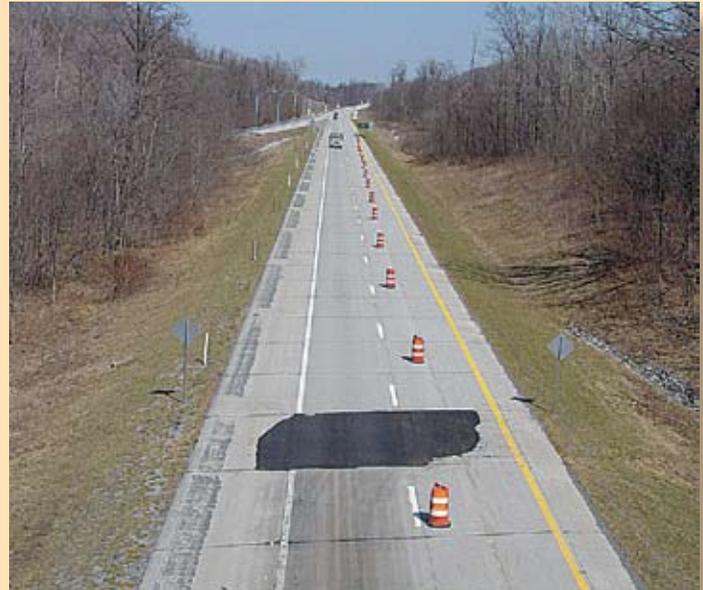
Hollidaysburg ▶

The southbound lane of I-99 was closed after the collapse of 18-year old, 42” and 48” diameter CMP. The CMP was replaced with precast concrete pipe at a cost of \$150,000.

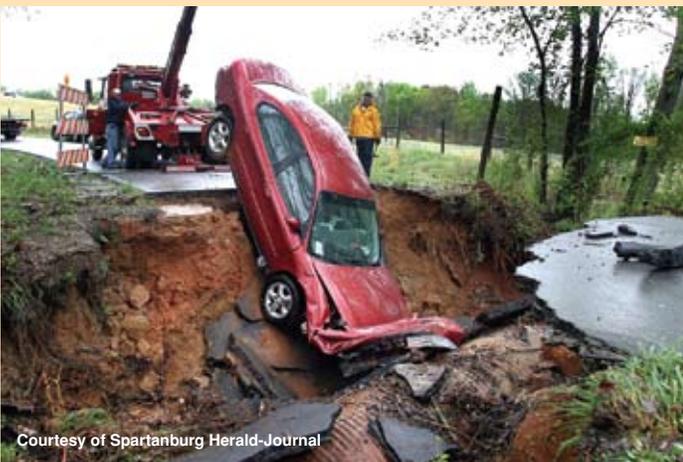
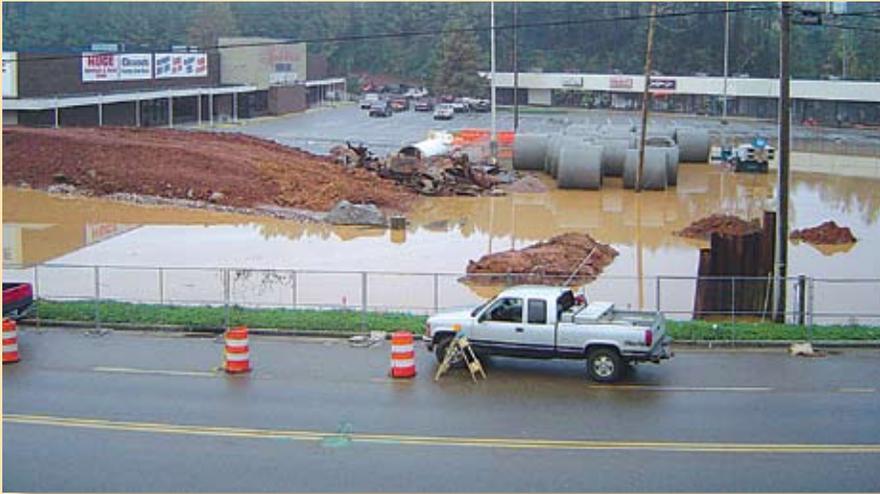
▼ Anderson and Spartanburg Counties

Spartanburg County has had four road collapses in a seven month period that were caused by failures of steel culverts installed during the 1970's. The estimate to replace more than 40 culverts in the next decade amounts to \$2.6M. The county plans to apply a \$25 fee on vehicles to fund this road maintenance. Concrete culverts, which the county anticipates will last 75 to 100 years, are the primary choice now in Spartanburg County. The majority of road closures in Anderson County in recent years have resulted from collapsed steel culverts. The estimate to replace corroded culverts in Anderson County over the next several years also amounts to millions of dollars. As quoted by the Spartanburg Herald-Journal, the Anderson County transportation director stated that “It was an immediate, cheaper solution, (to install steel culverts) but, in the long run, it was not a good solution.”

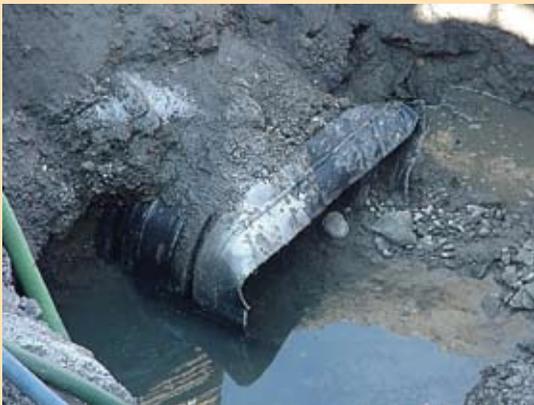
◀ **Corning** – Failure of a 60” diameter HDPE pipe line at the Youth Sports Complex has caused three sink holes in the past three years. The pipe had only been installed for two years before the first sink hole appeared. Specimens of the pipe failed the stress crack resistance test and the carbon black content requirement. HDPE pipe was chosen for the project as it represented an initial savings of \$3000 versus precast concrete pipe. Repairs have cost approximately \$70,000 and the entire line will be replaced with precast concrete pipe.
