Evaluation of HDPE Pipelines Structural Performance

UT Arlington Center for Structural Engineering Research

November 2010

**As a Part of the Initiative on the Underground Structural Health
Monitoring and Equipment Development**

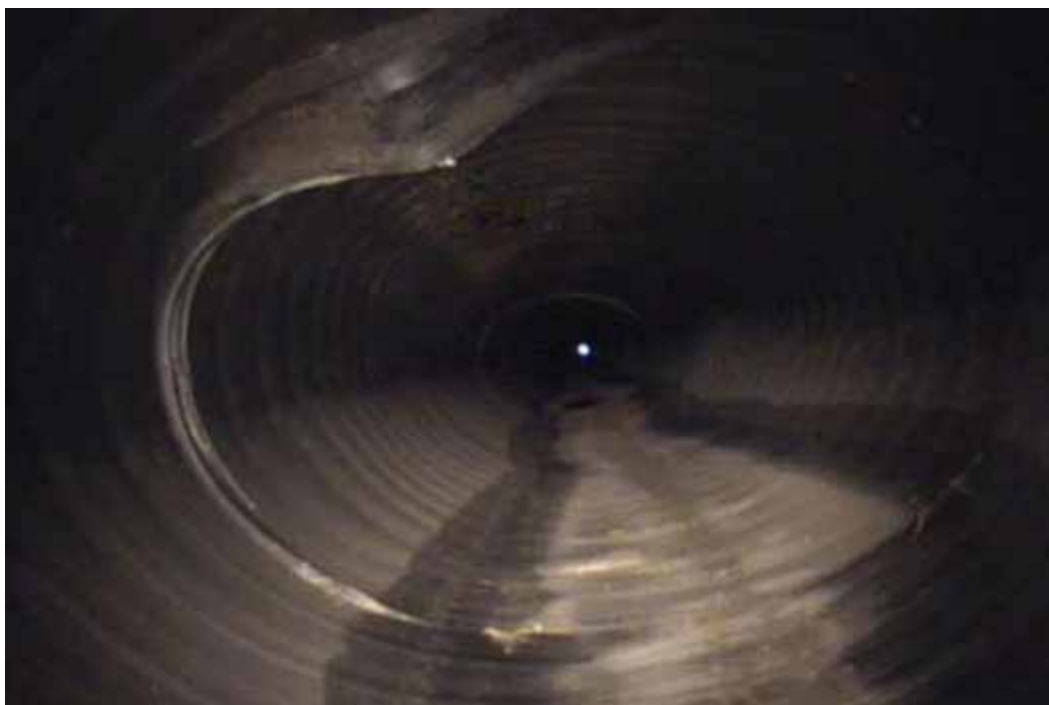
Figure 22 Inverse curvature and corrugation growth failure modes for pipeline No. 1 (Site No. 1: San Antonio – HW 1604 & 1560)

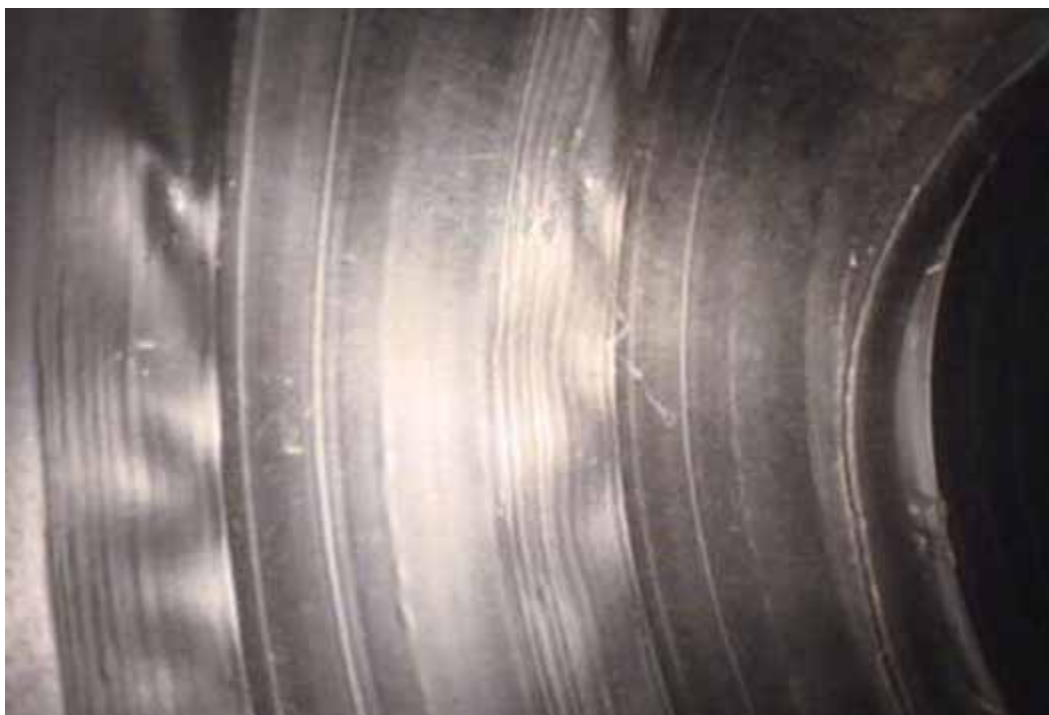
Figure 23 Buckling failure for pipeline No. 1 (Site No. 1: San Antonio - HW 1604 and 1560)

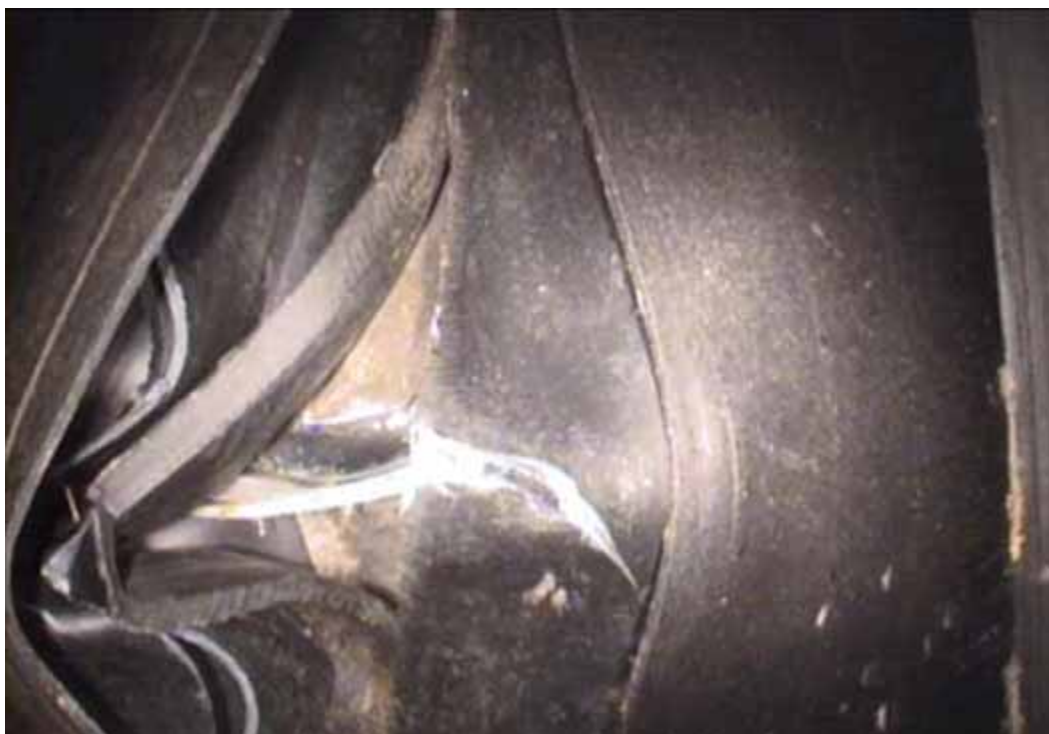
Figure 24 Cracking/fracture and buckling failures for pipeline No. 1 (Site No. 1: San Antonio - HW 1604 and 1560)

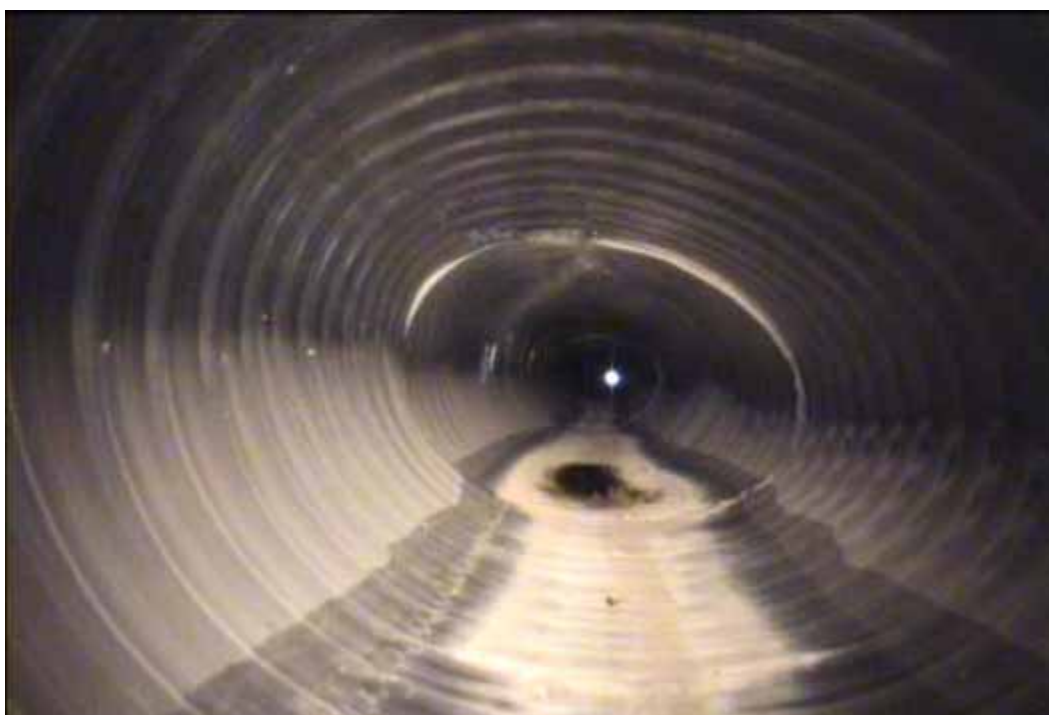
Figure 25 Excessive deformation and corrugation growth failure modes for pipeline No. 1 (Site No. 1: San Antonio - HW 1604 and 1560)

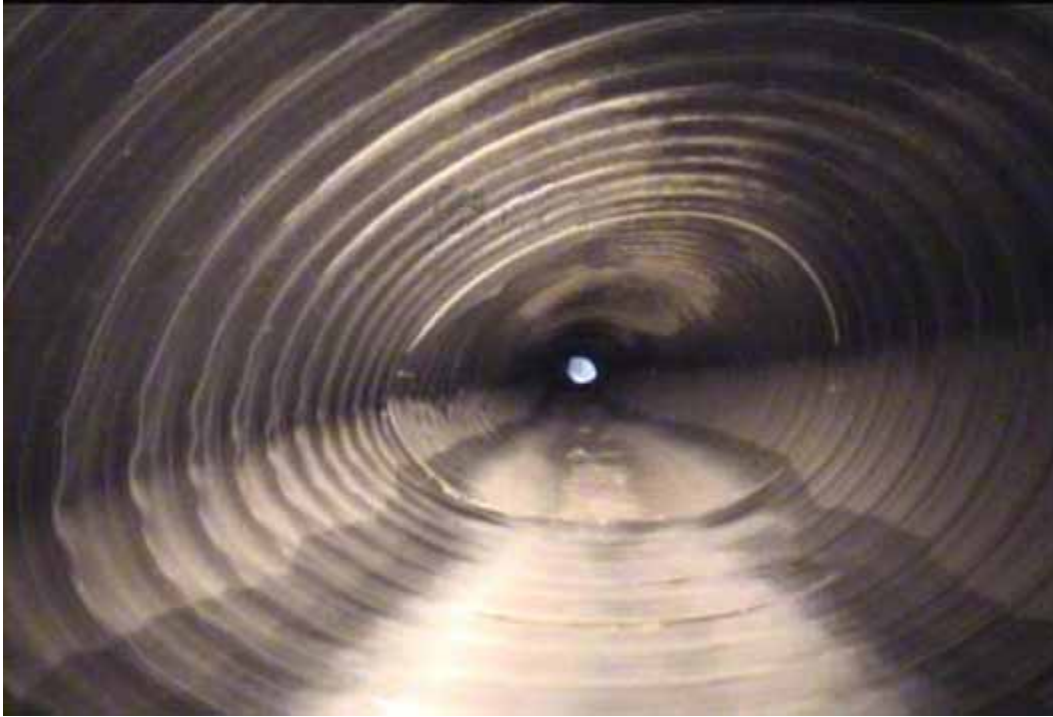
Figure 27 Buckling and excessive deformation failures for pipeline No. 2 (Site No. 1: San Antonio - HW 1604 and 1560)

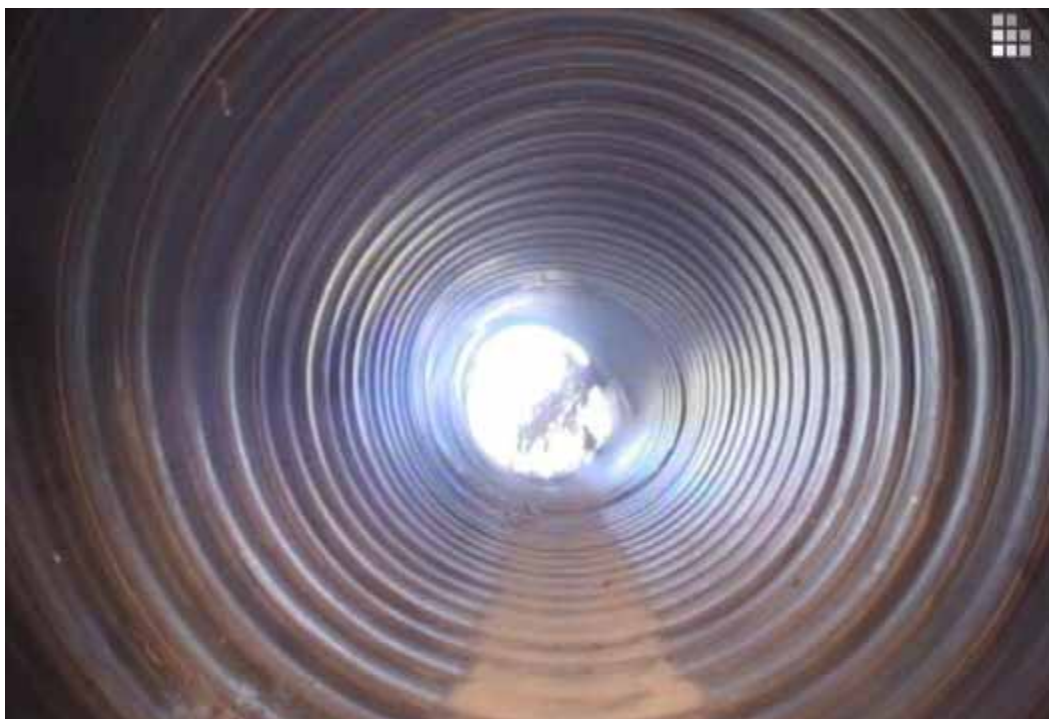
Figure 30 Corrugation growth and excessive deformation failures for pipeline No. 3 (Site No. 1: San Antonio - HW 1604 and 1560)

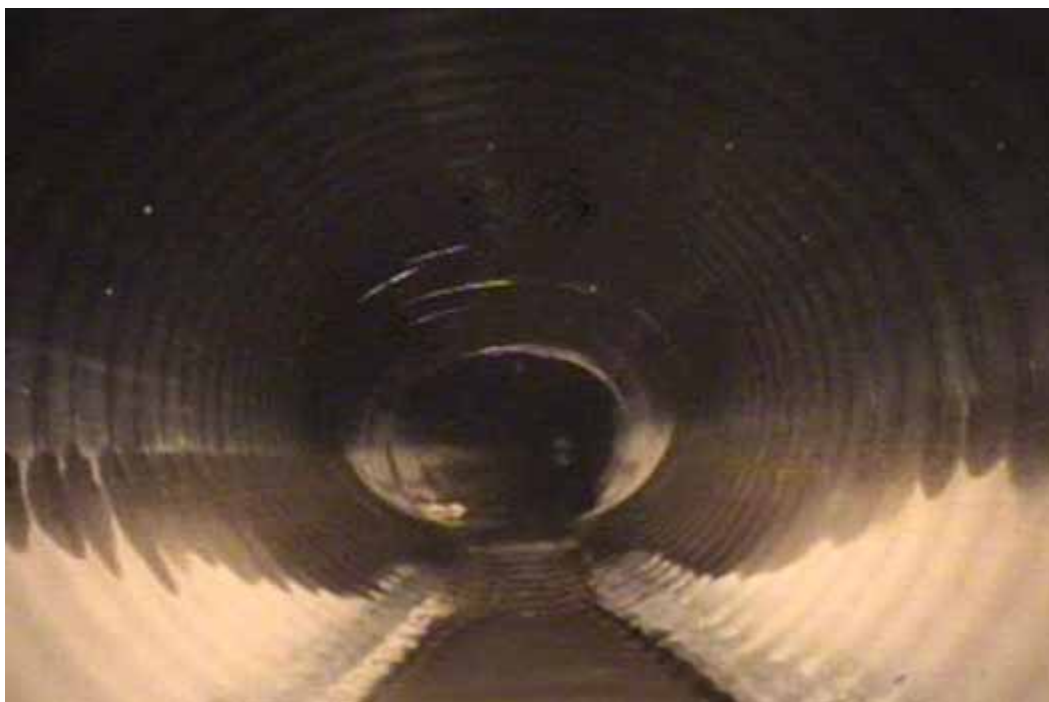
Figure 43 Excessive deformation and corrugation growth failures for pipeline No. 19 (Segment 1) (Site No. 8: Houston – Fennell)

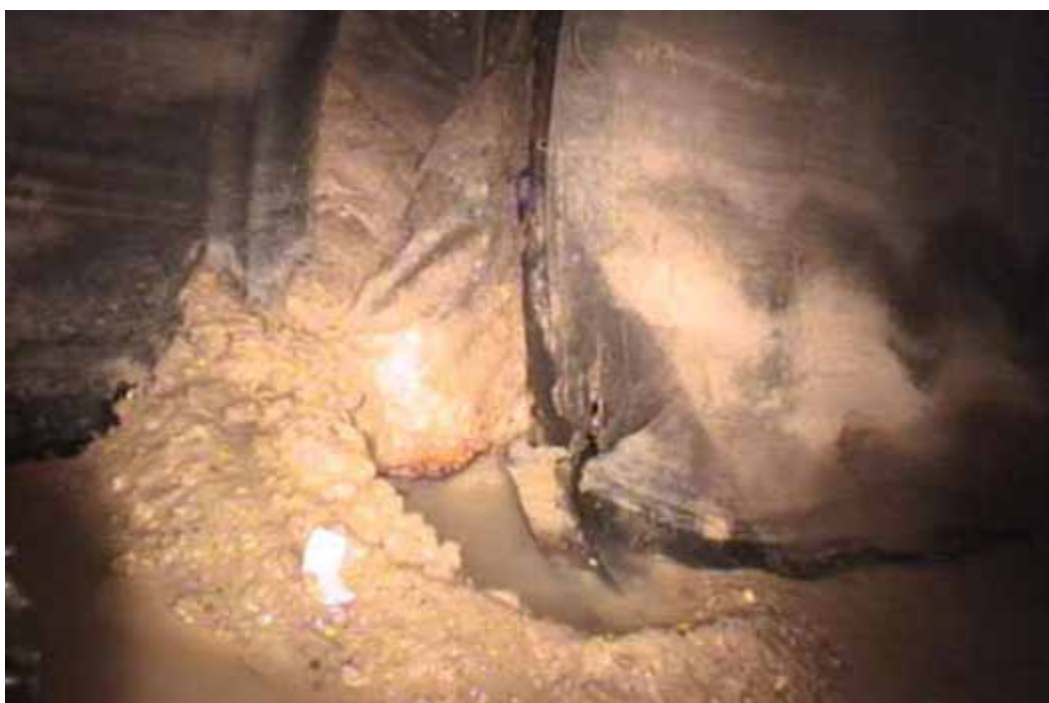
Figure 44 Major joint displacement failure for pipeline No. 19 (Segment 1) (Site No. 8: Houston – Fennell)

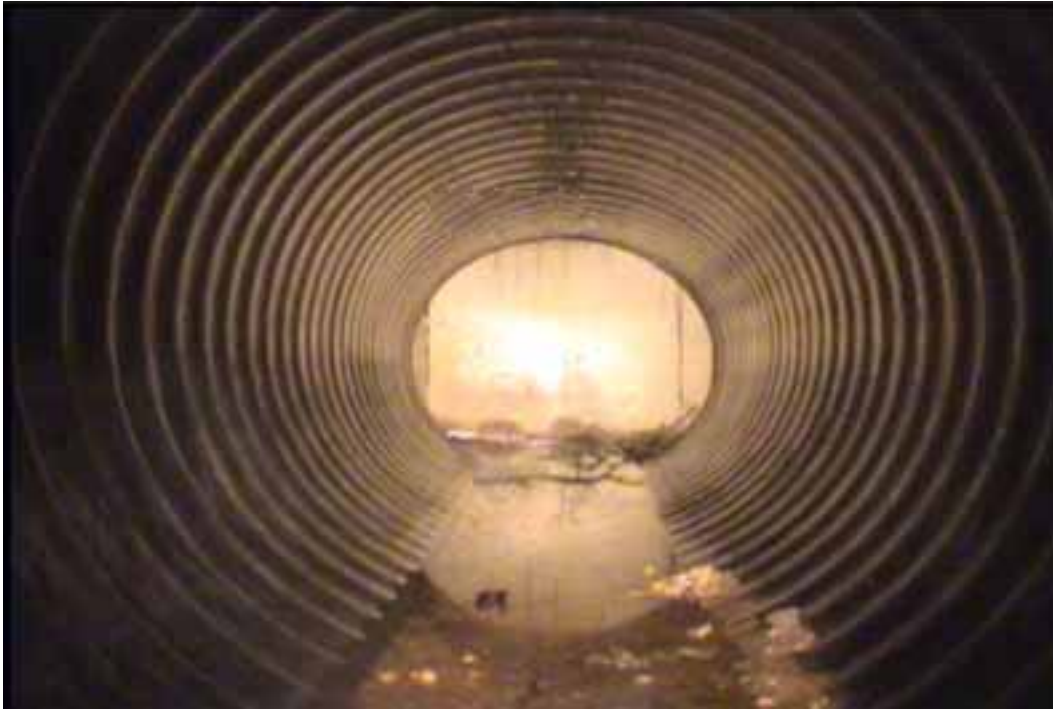
**Figure 45 Excessive deformation and corrugation growth failures for pipeline No. 19
(Segment 1) (Site No. 8: Houston – Fennell)**

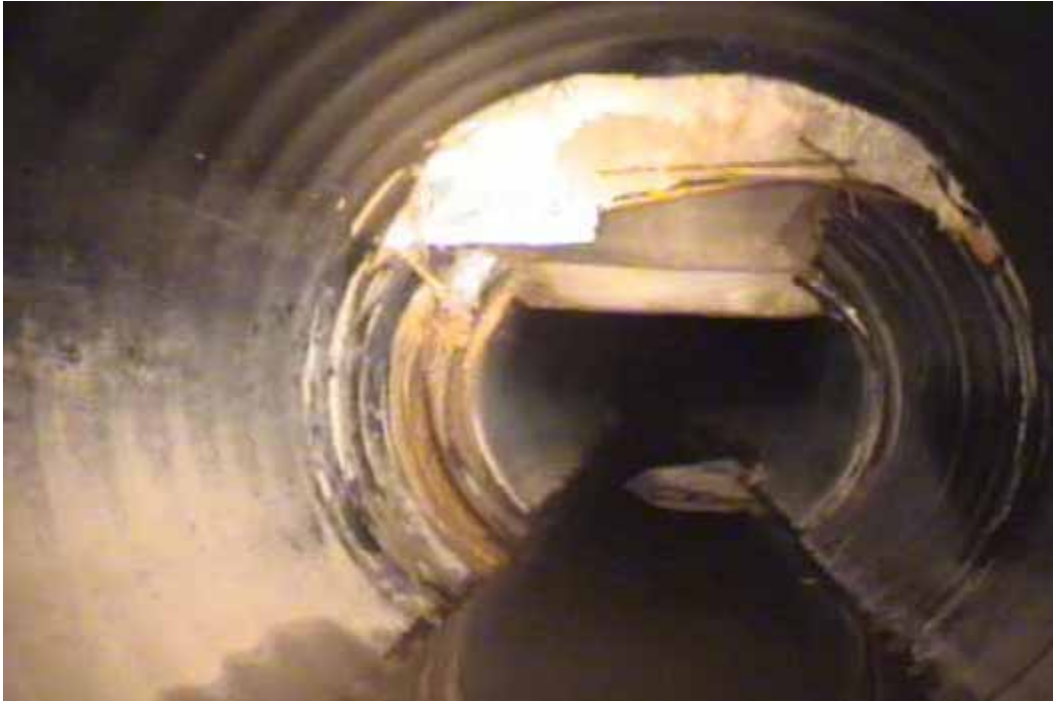
Figure 47 Major joint displacement, major cracking/fracture and inverse curvature failures for pipeline No. 19 (Segment 2) (Site No. 8: Houston – Fennell)

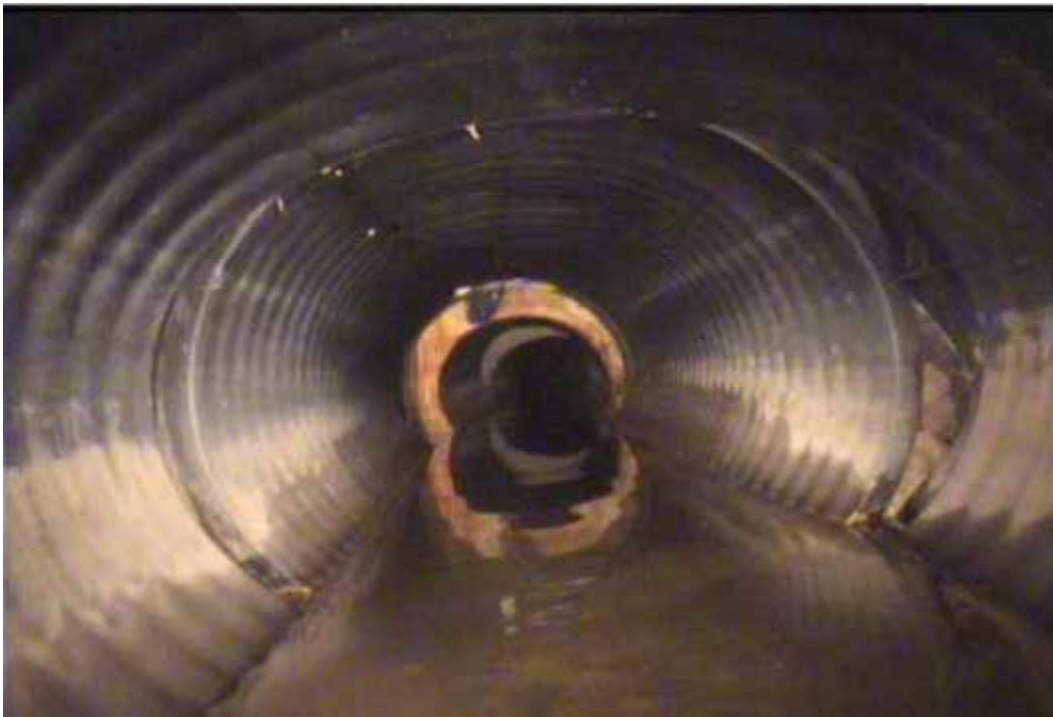
Figure 48 Major joint displacement and excessive deformation failures for pipeline No. 19 (Segment 2) (Site No. 8: Houston – Fennell)

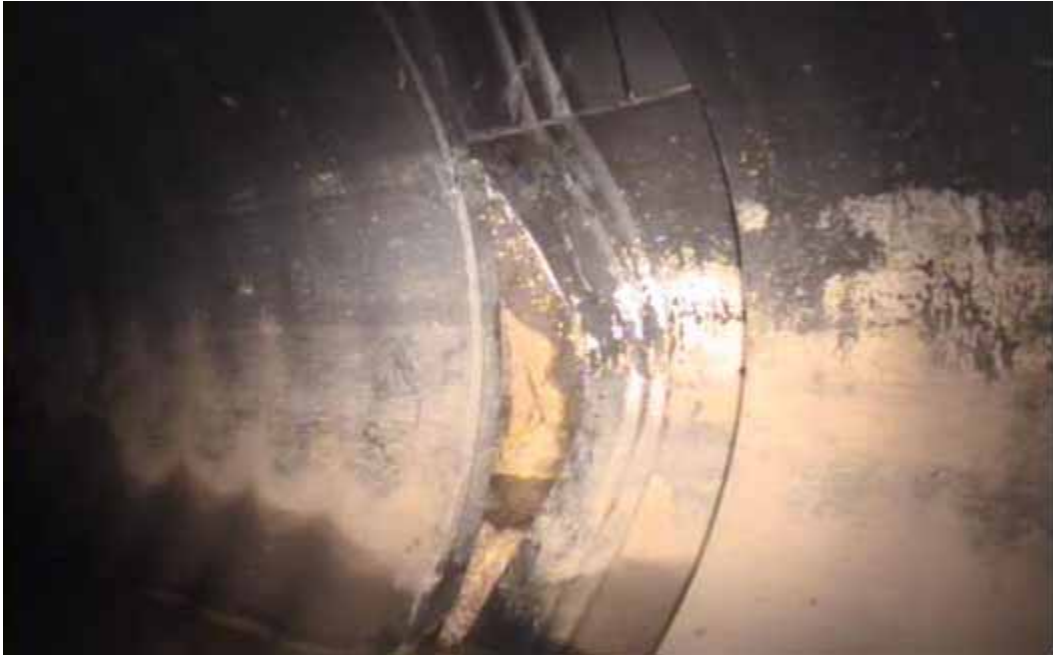
Figure 49 Major joint displacement, minor cracking/fracture and inverse curvature failures for pipeline No. 19 (Segment 2) (Site No. 8: Houston – Fennell)

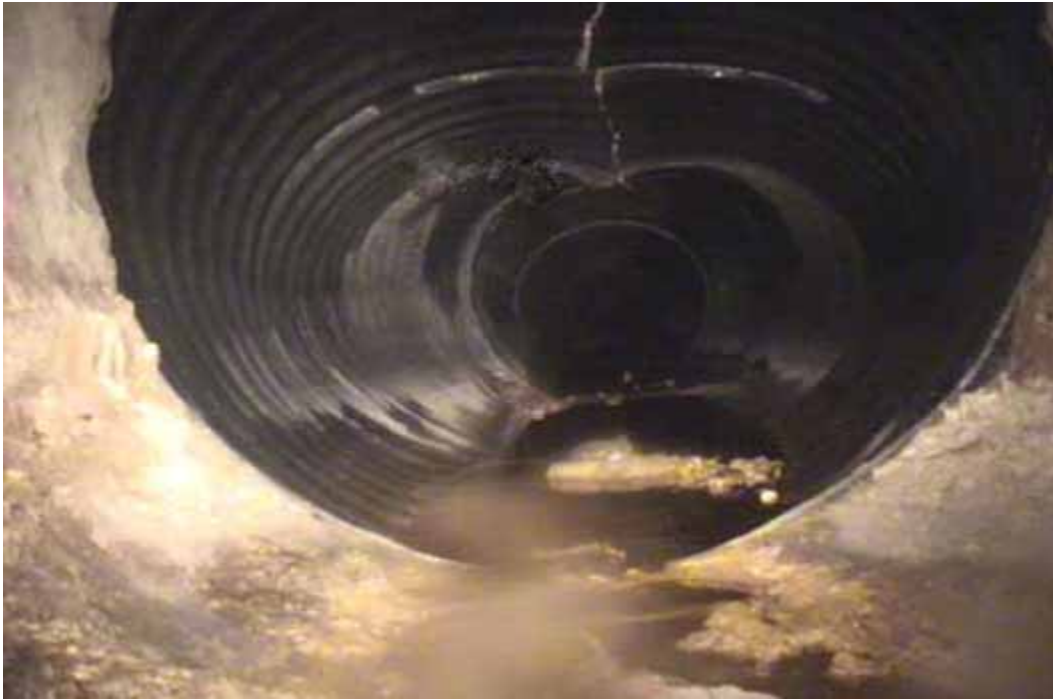
Figure 50 Excessive deformation, inverse curvature, and cracking/fracture failures for pipeline No. 20 (Segment 1) (Site No. 8: Houston – Fennell)

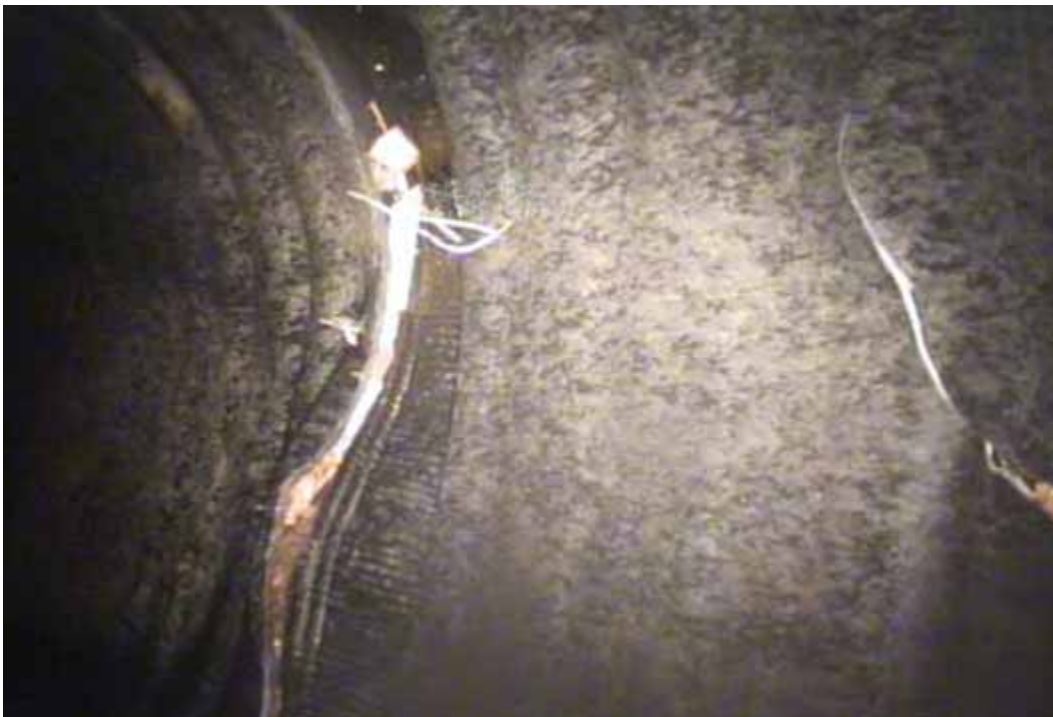
Figure 51 Joint displacement, buckling and cracking/fracture failures for pipeline No. 20 (Segment 1) (Site No. 8: Houston – Fennell)

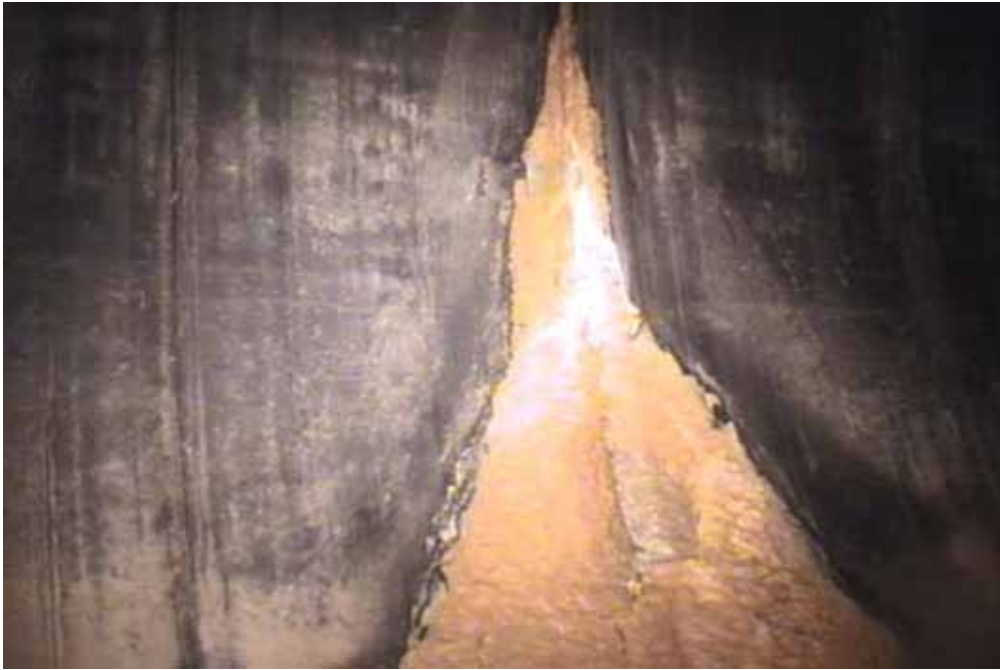
Figure 54 Cracking/fracture failure for pipeline No. 20 (Segment 2) (Site No. 8: Houston – Fennell)

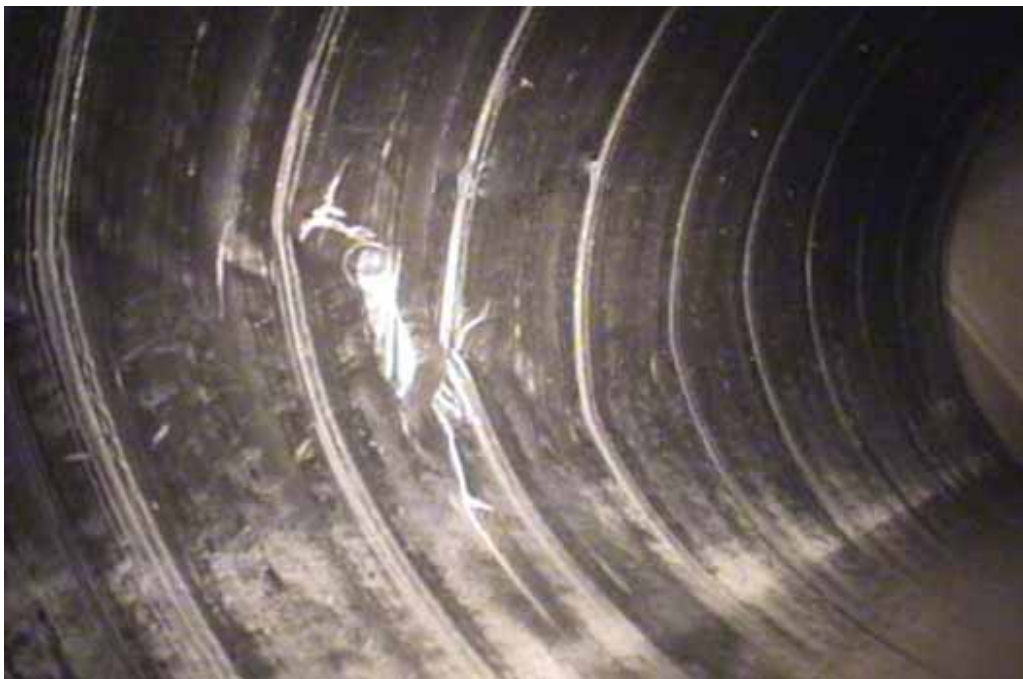
Figure 55 Cracking/fracture and corrugation growth failure for pipeline No. 20 (Segment 2) (Site No. 8: Houston – Fennell)

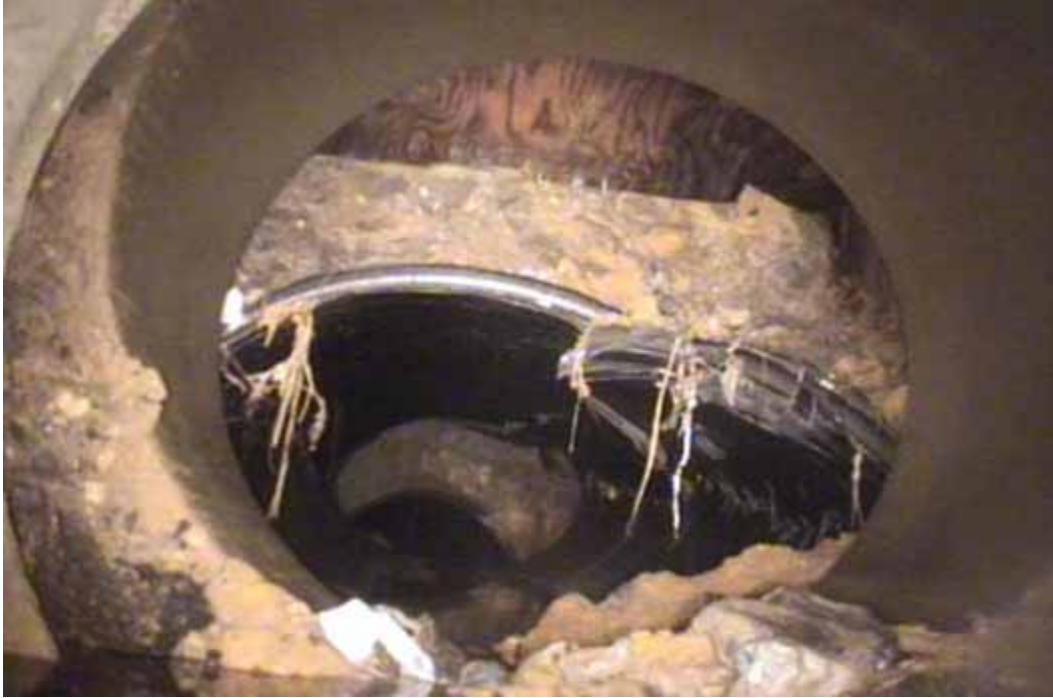
Figure 56 Major cracking/fracture, minor cracking/fracture, and inverse curvature failures for pipeline No. 20 (Segment 2) (Site No. 8: Houston – Fennell)

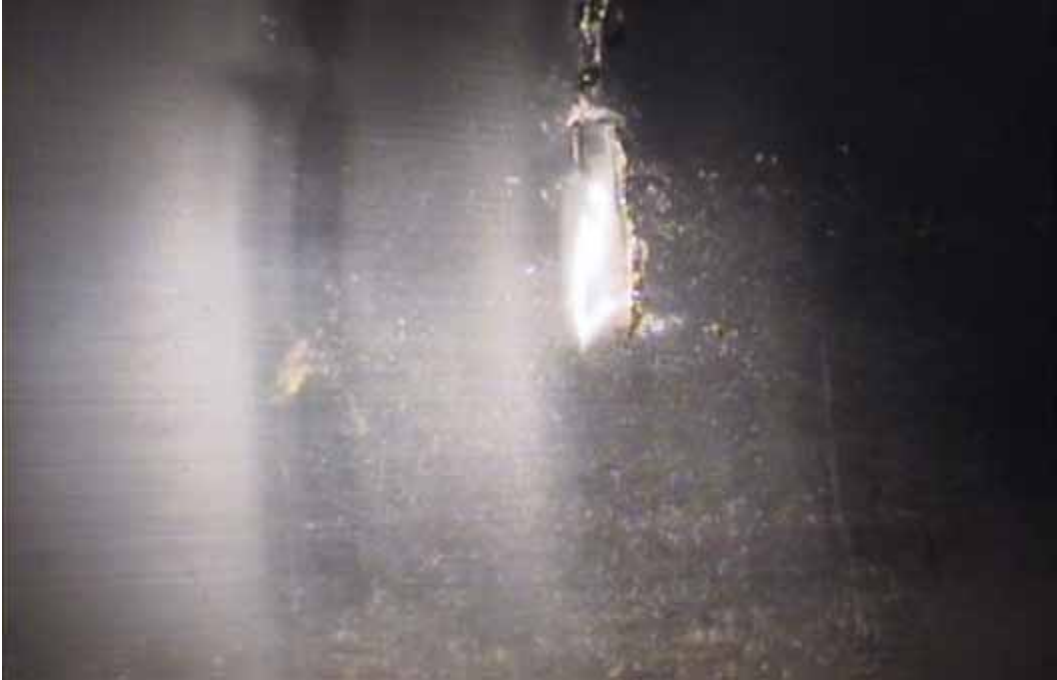
Figure 65 View of cracking failures for pipeline No. 5 (Site No. 2: Elm City – Lake Wilson Rd)

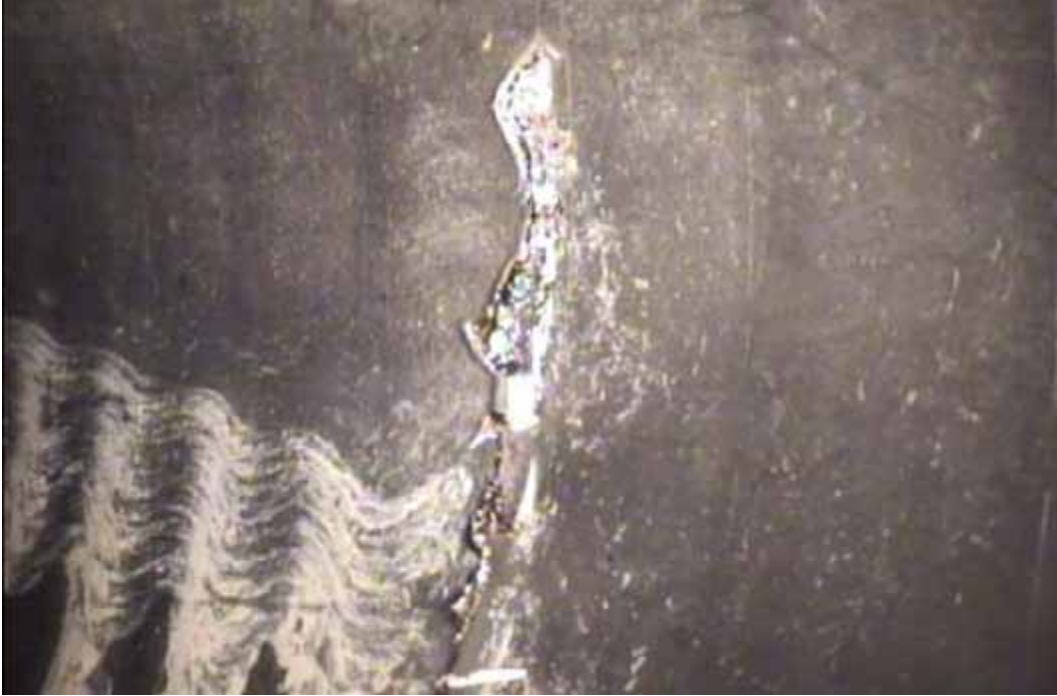
Figure 67 View of cracking failures for pipeline No. 5 (Site No. 2: Elm City – Lake Wilson Rd)

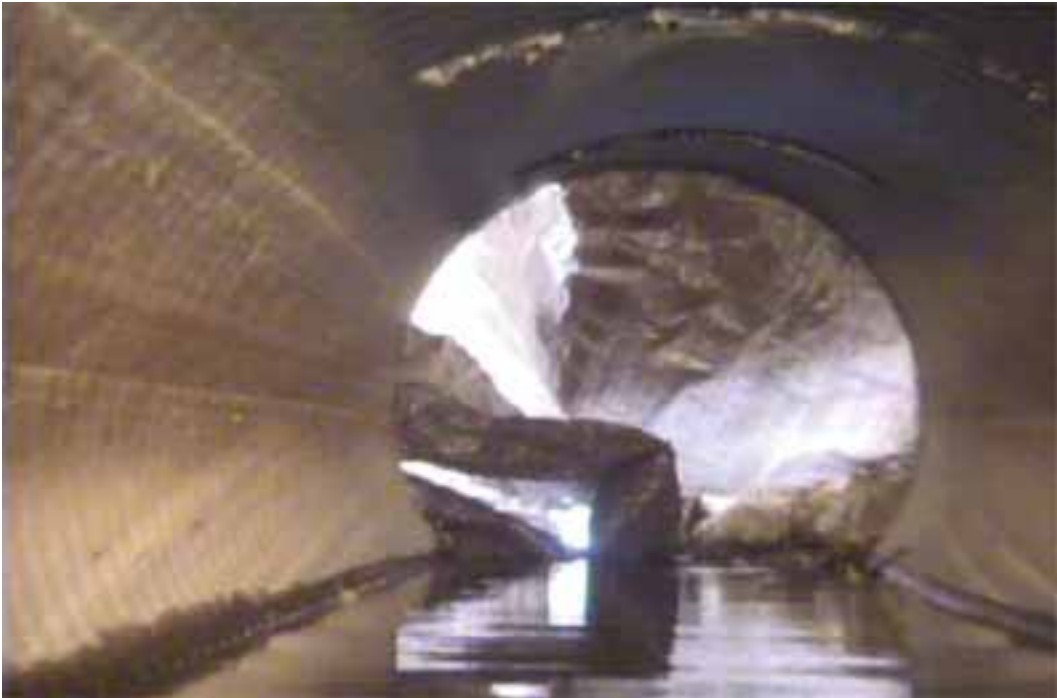
Figure 68 View of cracking failure for pipeline No. 5 (Site No. 2: Elm City – Lake Wilson Rd)

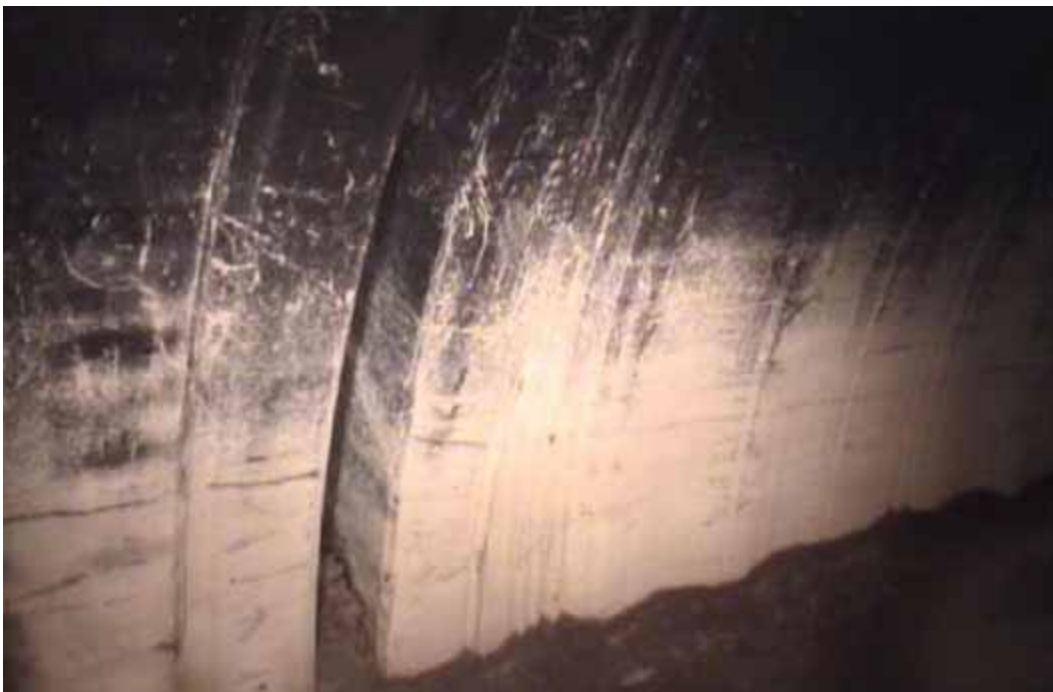
Figure 72 View of major joint displacement failures for pipeline No. 7 (Site No. 4: Wendell – Huntzell Main Drive)

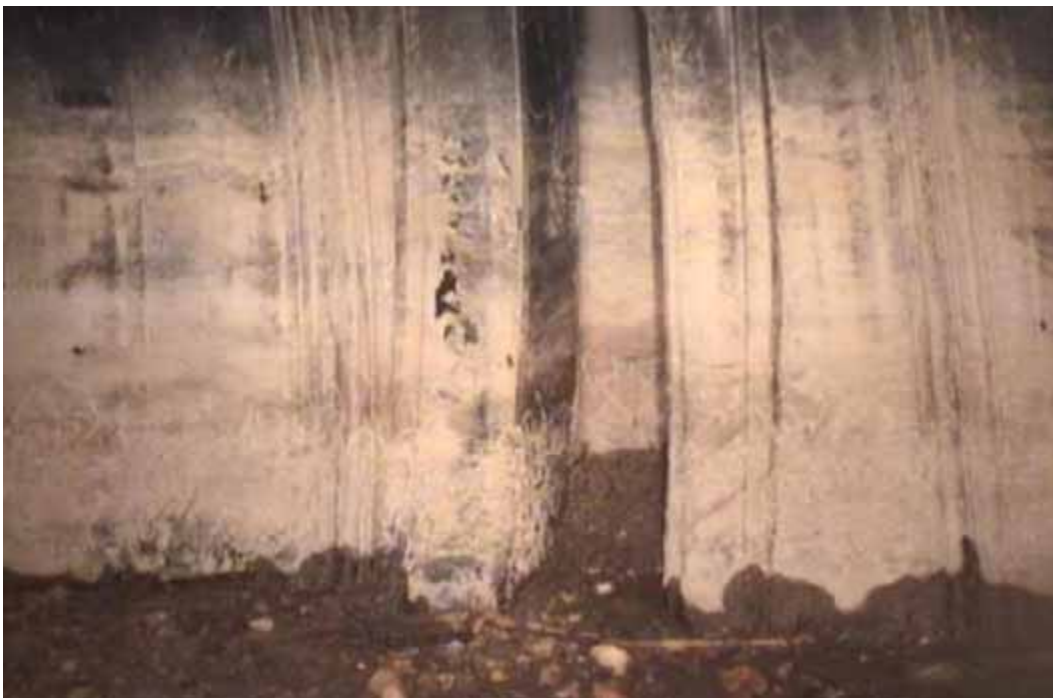
Figure 76 View of major joint displacement failure for pipeline No. 8 (Site No. 4: Wendell – Huntzell Main Drive)

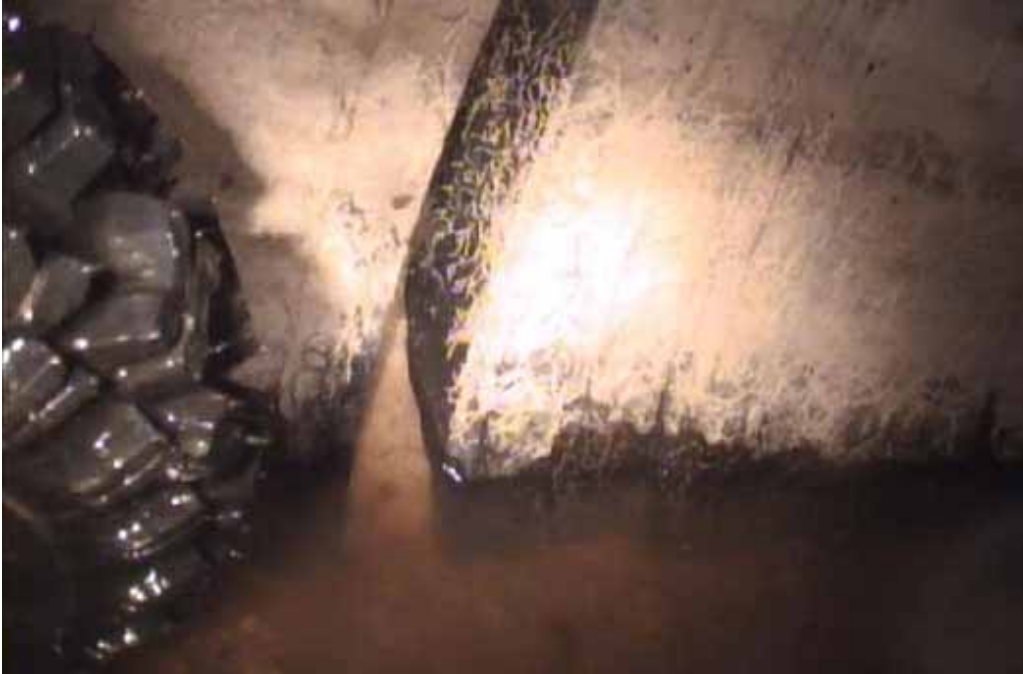
**Figure 77 View of and joint displacement failures for pipeline No. 8 (Site No. 4: Wendell –
Hunt dell Main Drive)**

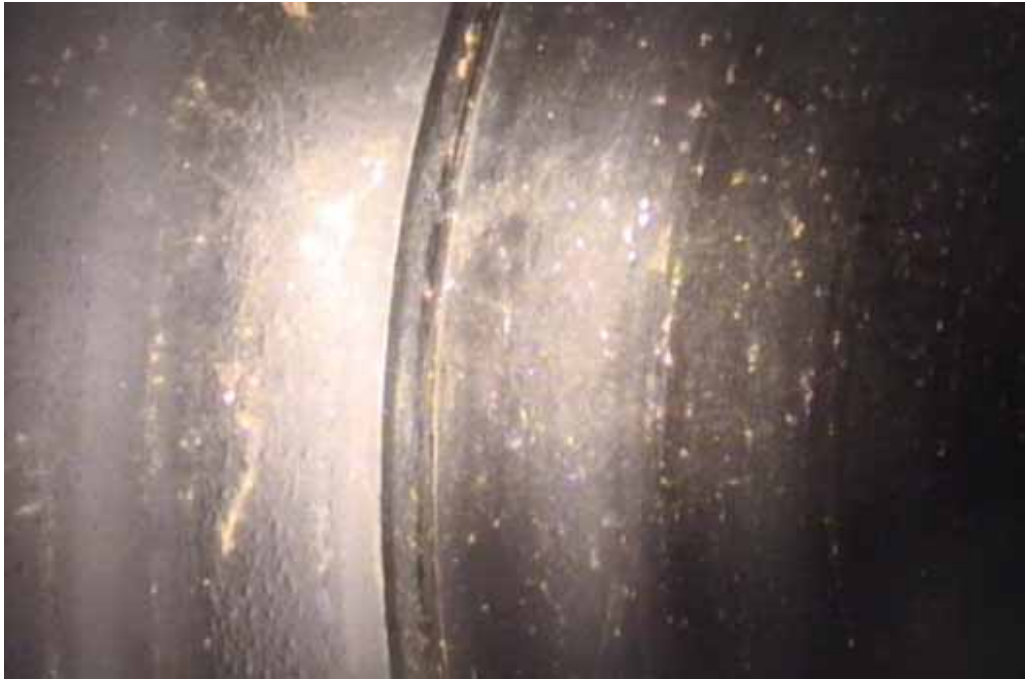
Figure 78 View of joint displacement failure for pipeline No. 9 (Site No. 5: Hickory – Oxford School Rd)

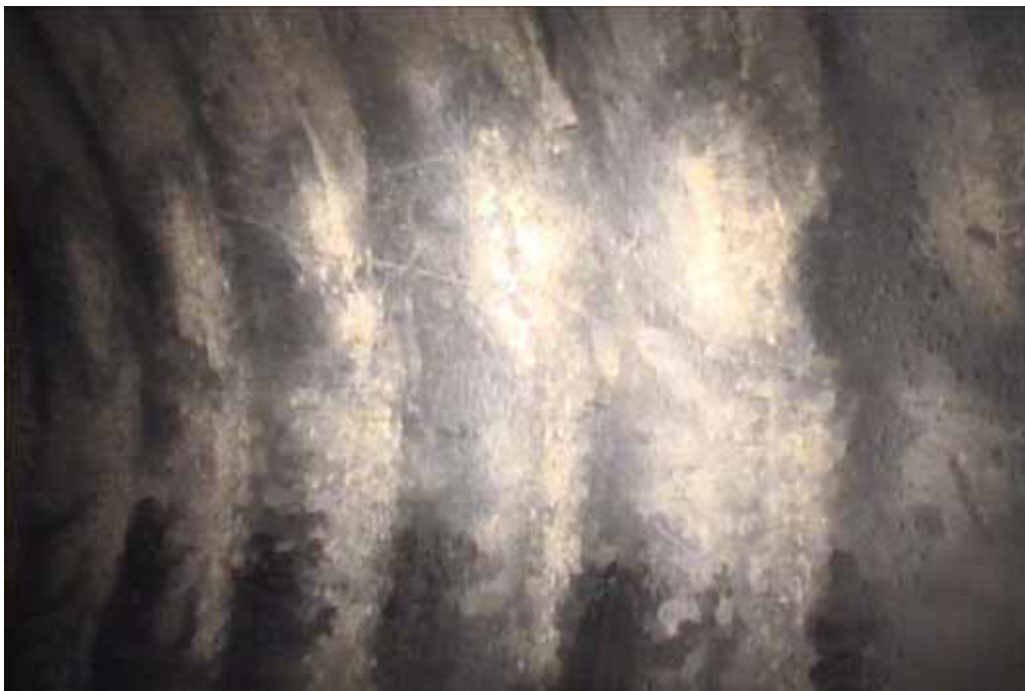
Figure 79 View of corrugation growth failure for pipeline No. 9 (Site No. 5: Hickory – Oxford School Rd)

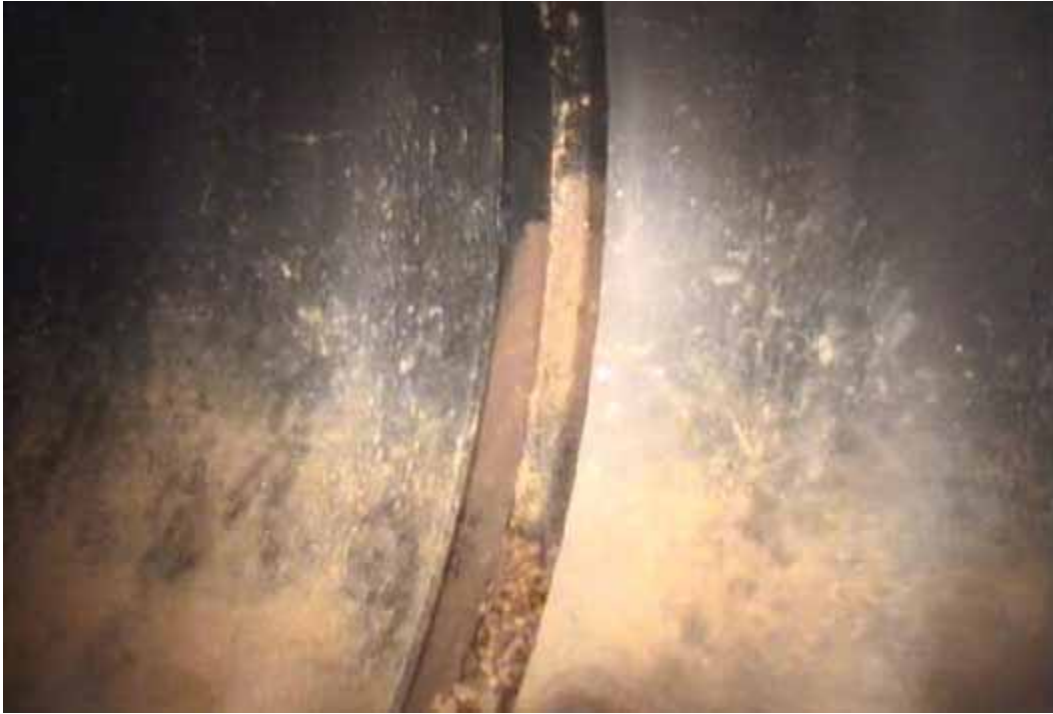
Figure 80 View of major joint displacement failure for pipeline No. 9 (Site No. 5: Hickory – Oxford School Rd)

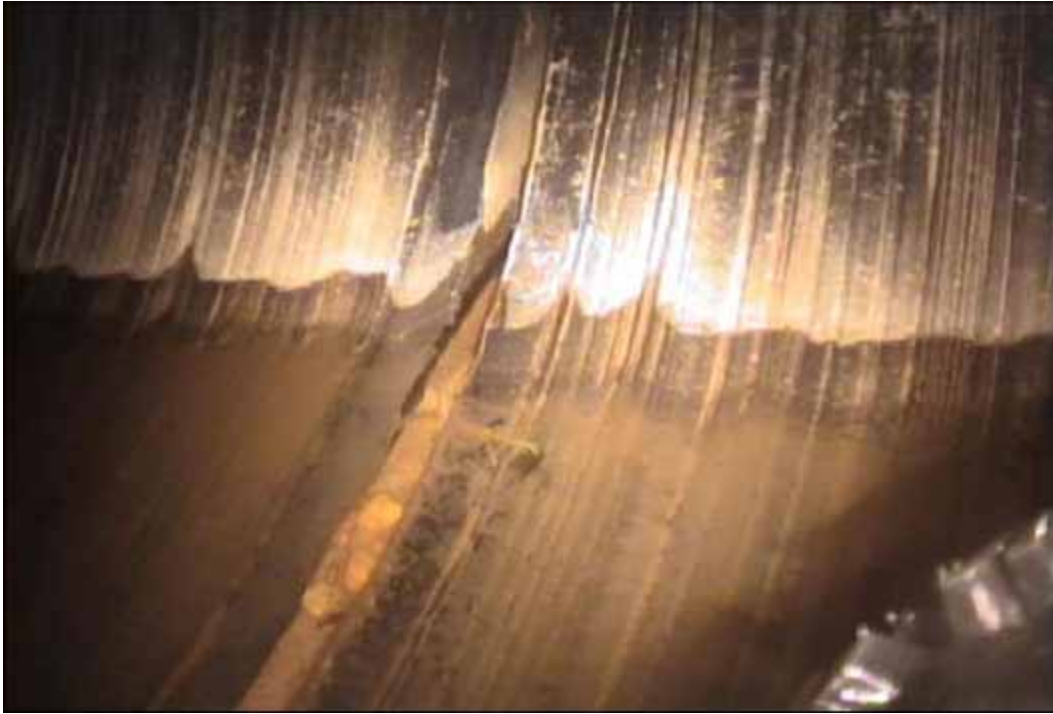
Figure 82 View of joint displacement failure for pipeline No. 10 (Site No. 6: Rockingham – Love Ln)

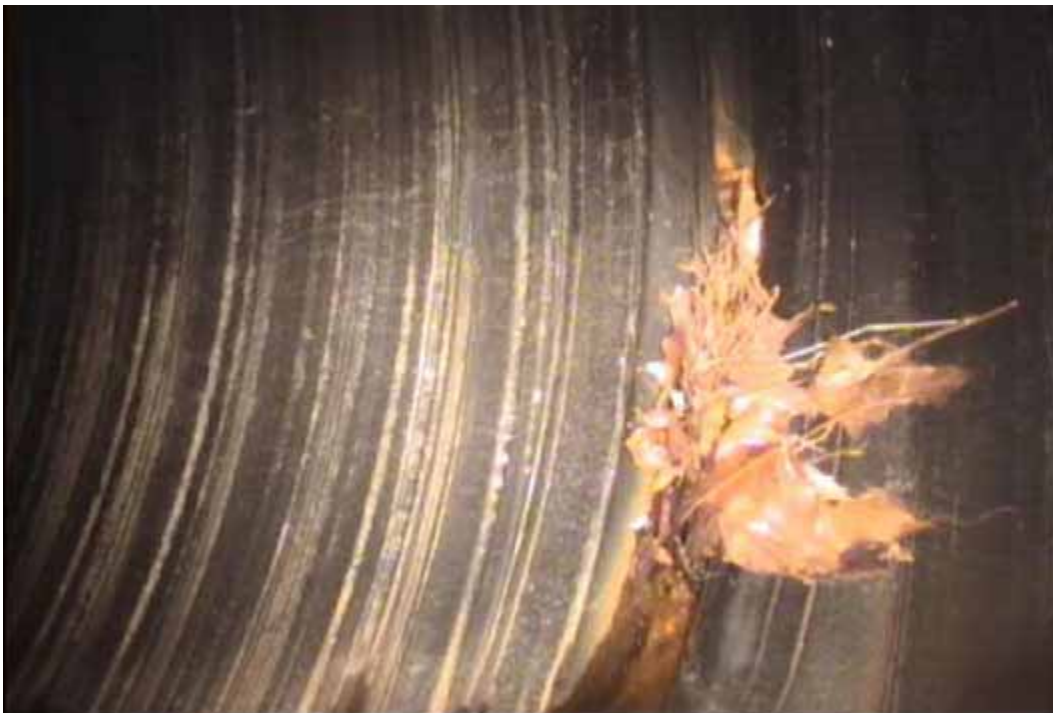
Figure 83 View of major joint displacement failure for pipeline No. 10 (Site No. 6: Rockingham – Love Ln)

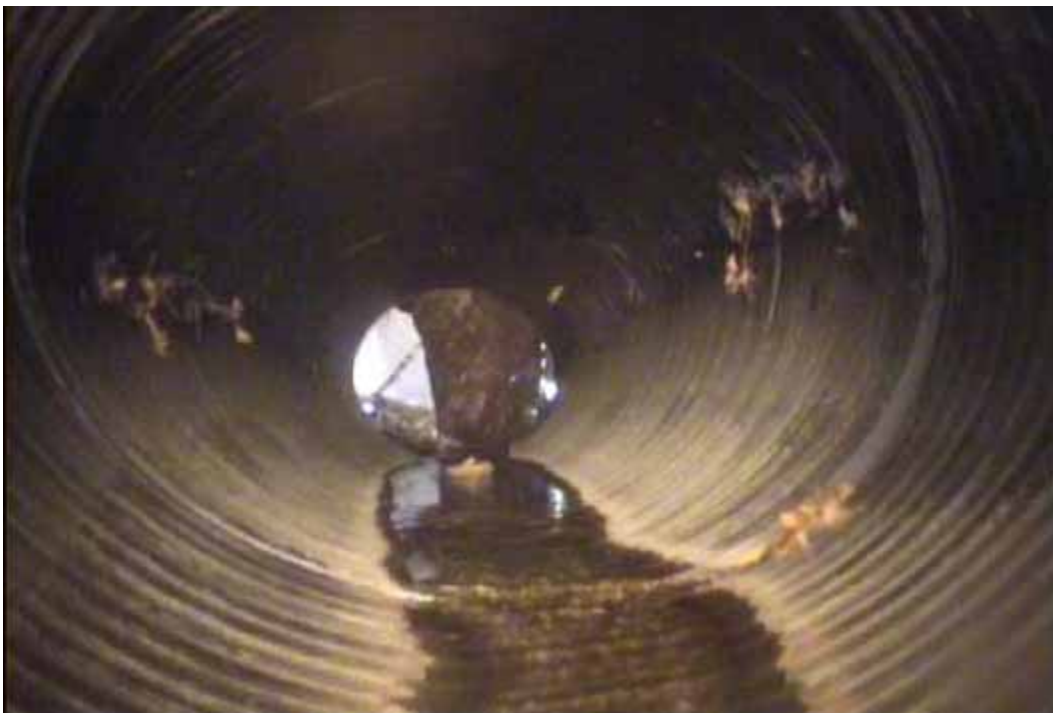
Figure 85 View of excessive deformation failure for pipeline No. 10 (Site No. 6: Rockingham – Love Ln)

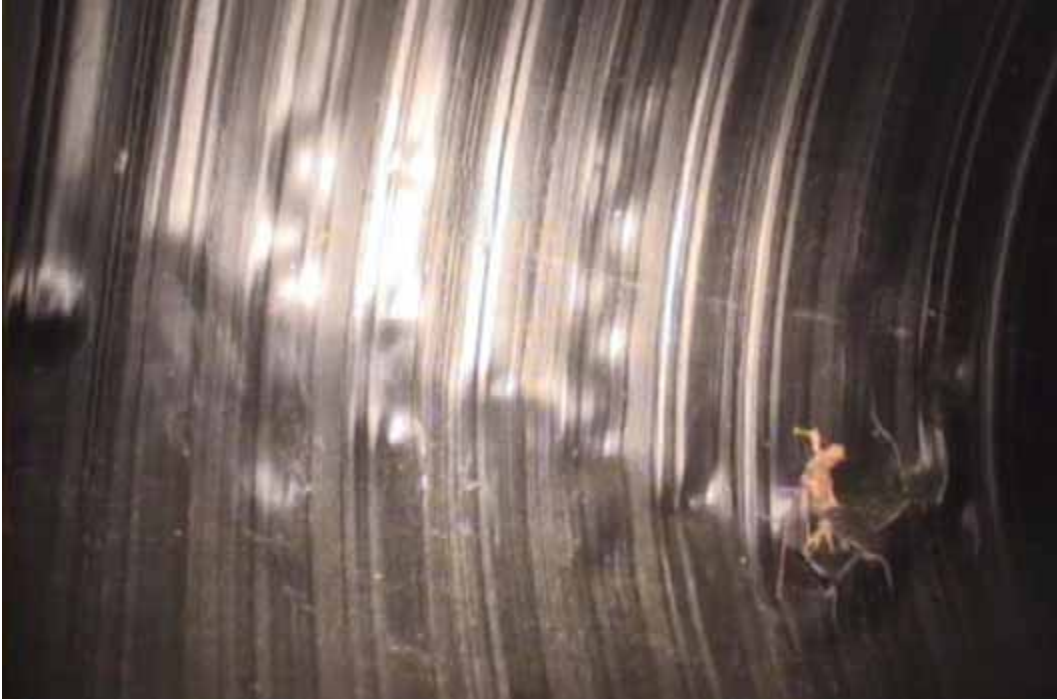
Figure 86 View of buckling and cracking failures for pipeline No. 10 (Site No. 6: Rockingham – Love Ln)
