Evaluation of HDPE Pipelines Structural Performance

UT Arlington Center for Structural Engineering Research

November 2010

**As a Part of the Initiative on the Underground Structural Health
Monitoring and Equipment Development**

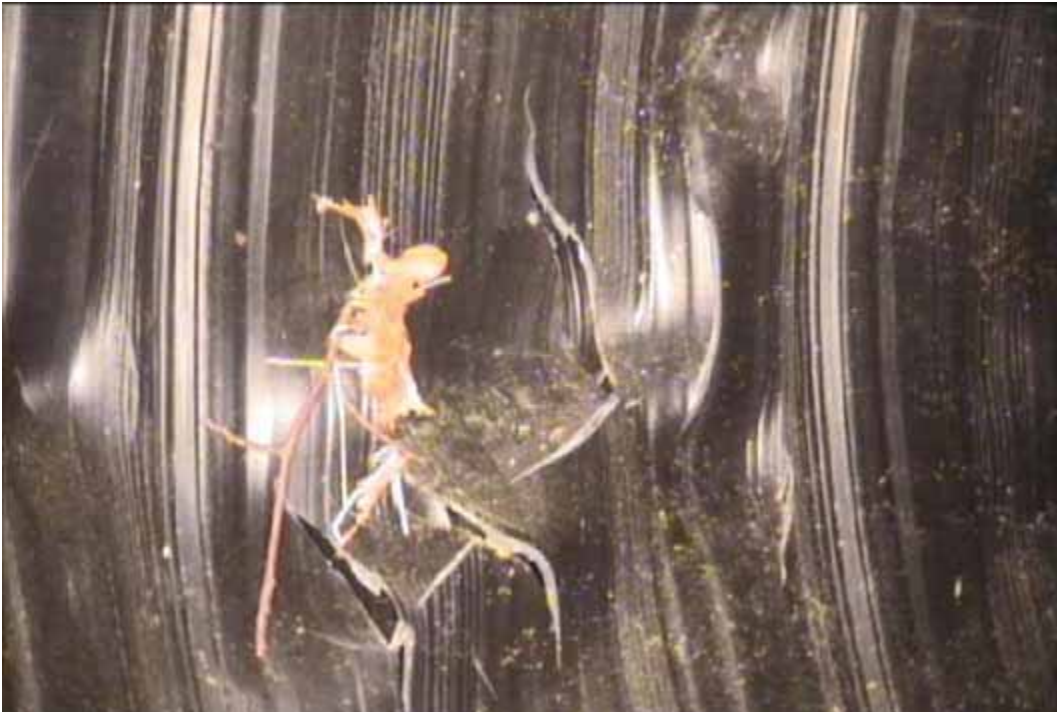
Figure 87 View of cracking failure for pipeline No. 10 (Site No. 6: Rockingham – Love Ln)

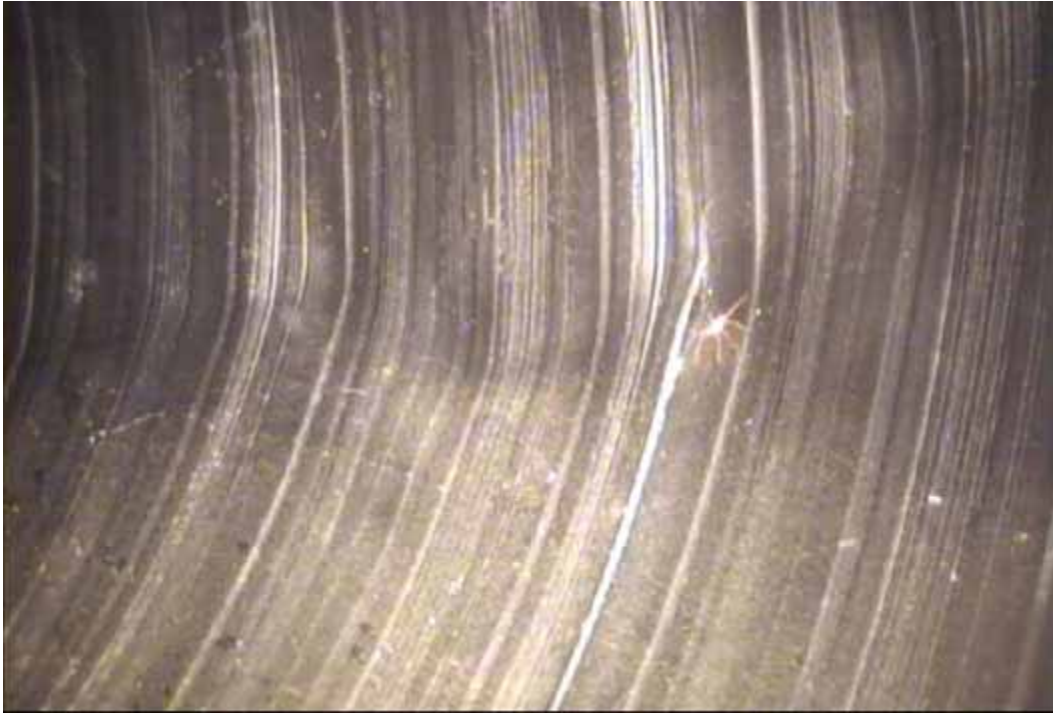
**Figure 88 View of cracking and buckling failures for pipeline No. 10 (Site No. 6:
Rockingham – Love Ln)**

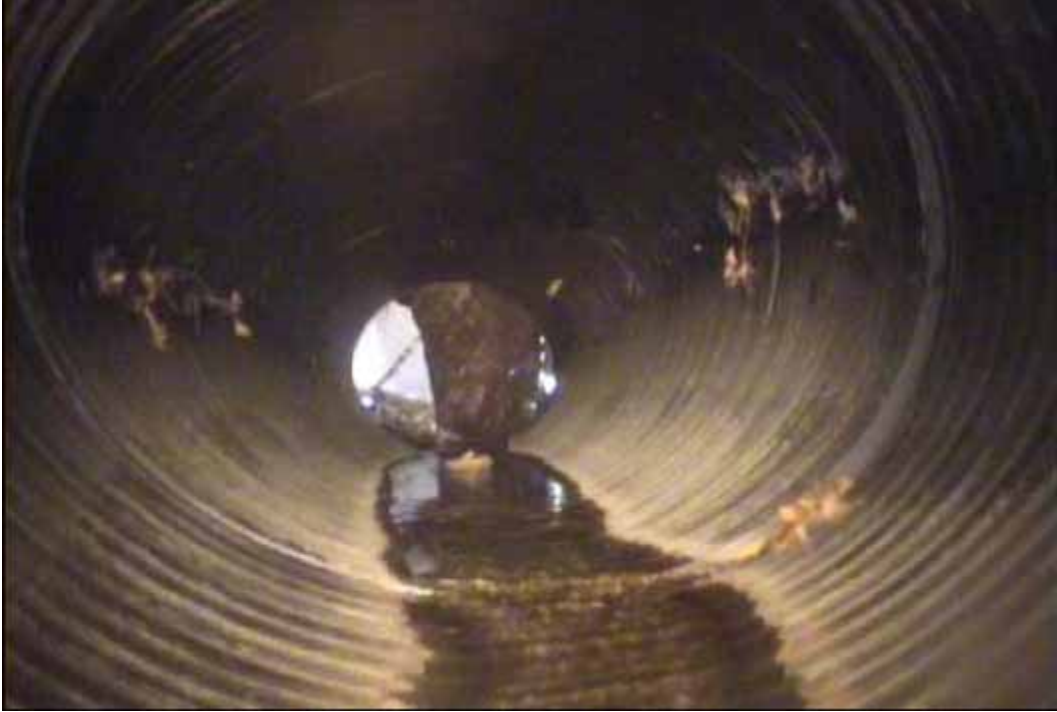
Figure 90 View of excessive deformation failure for pipeline No. 11 (Site No. 6: Rockingham – Love Ln)

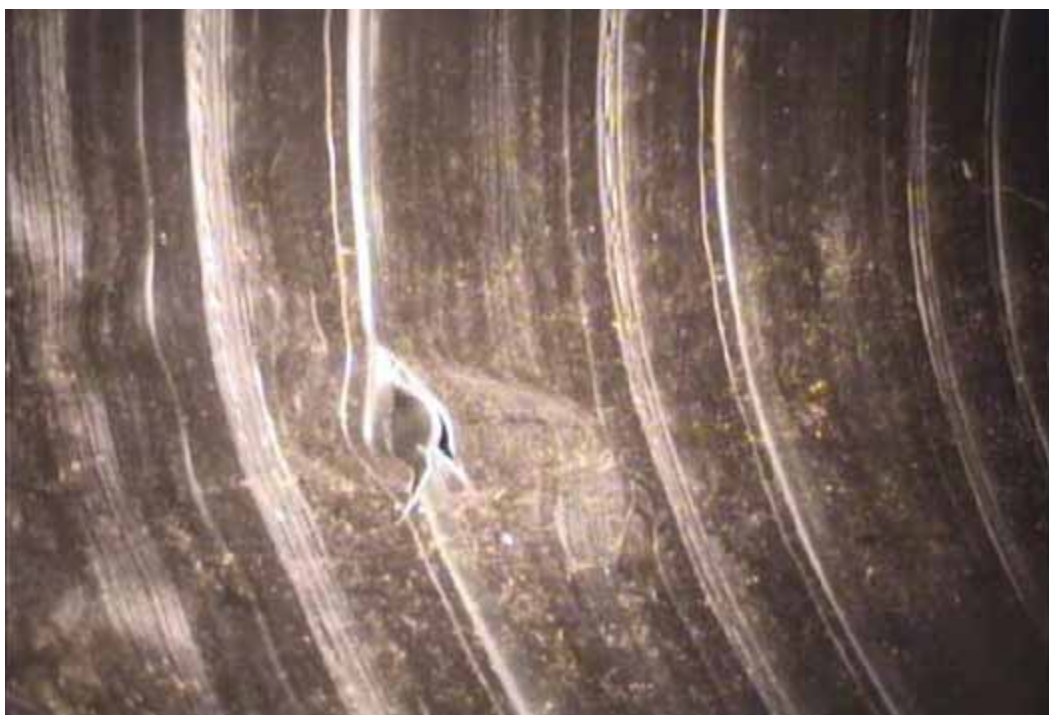
Figure 93 View of buckling and cracking failures for pipeline No. 11 (Site No. 6: Rockingham – Love Ln)

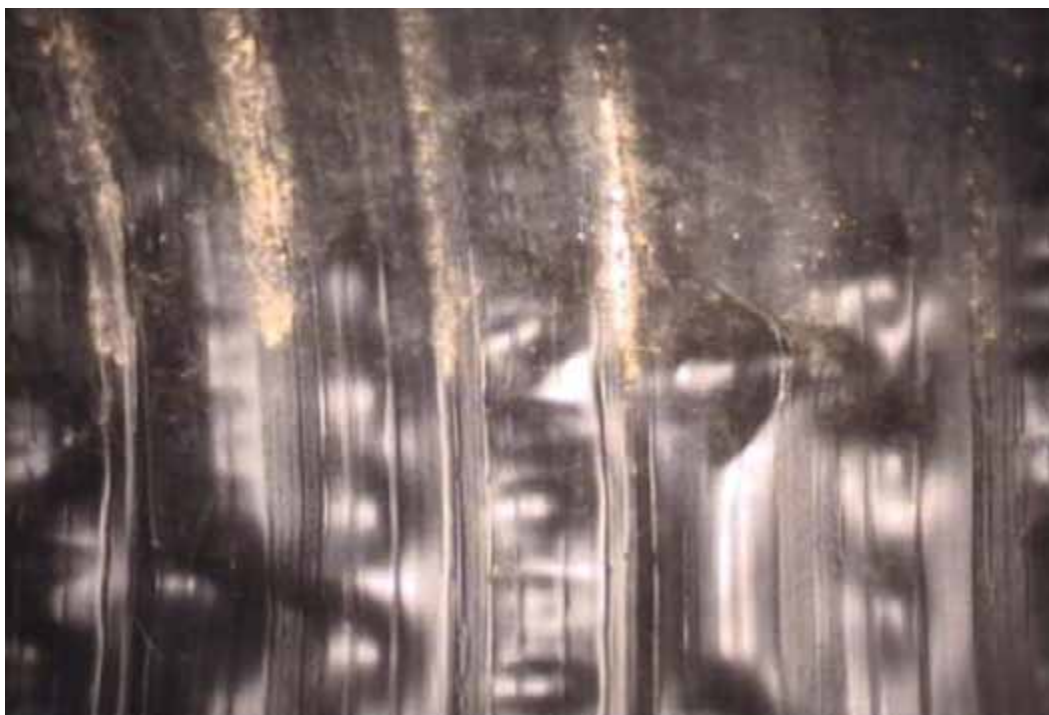
Figure 95 View of buckling failure for pipeline No. 11 (Site No. 6: Rockingham – Love Ln)

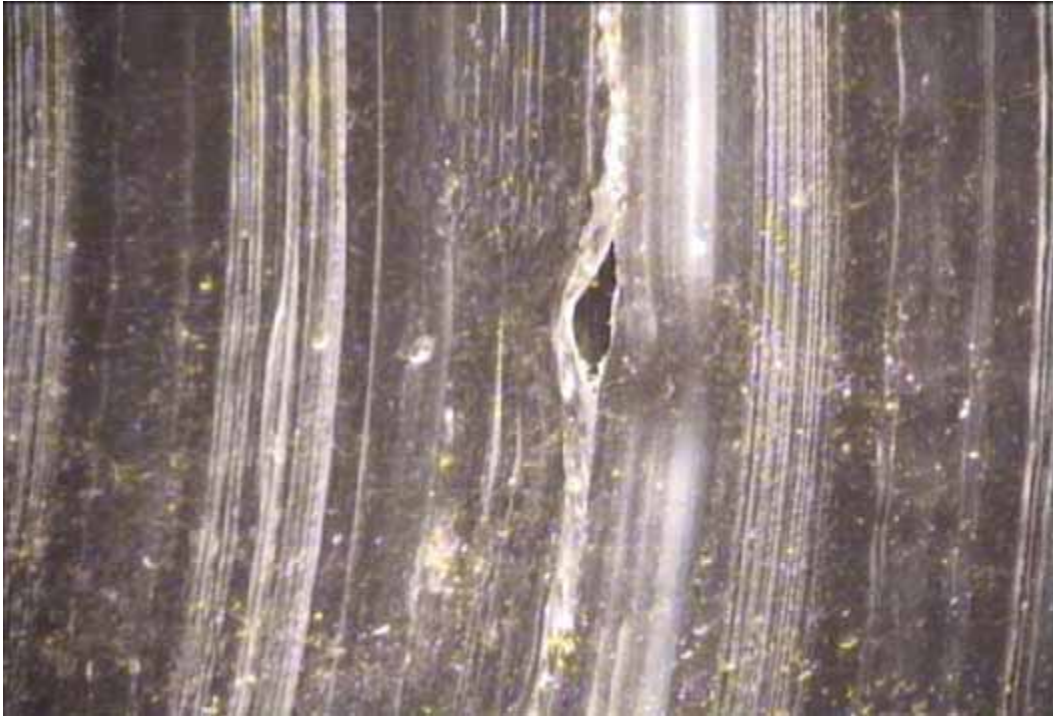
Figure 100 View of cracking failure for pipeline No. 11 (Site No. 6: Rockingham – Love Ln)

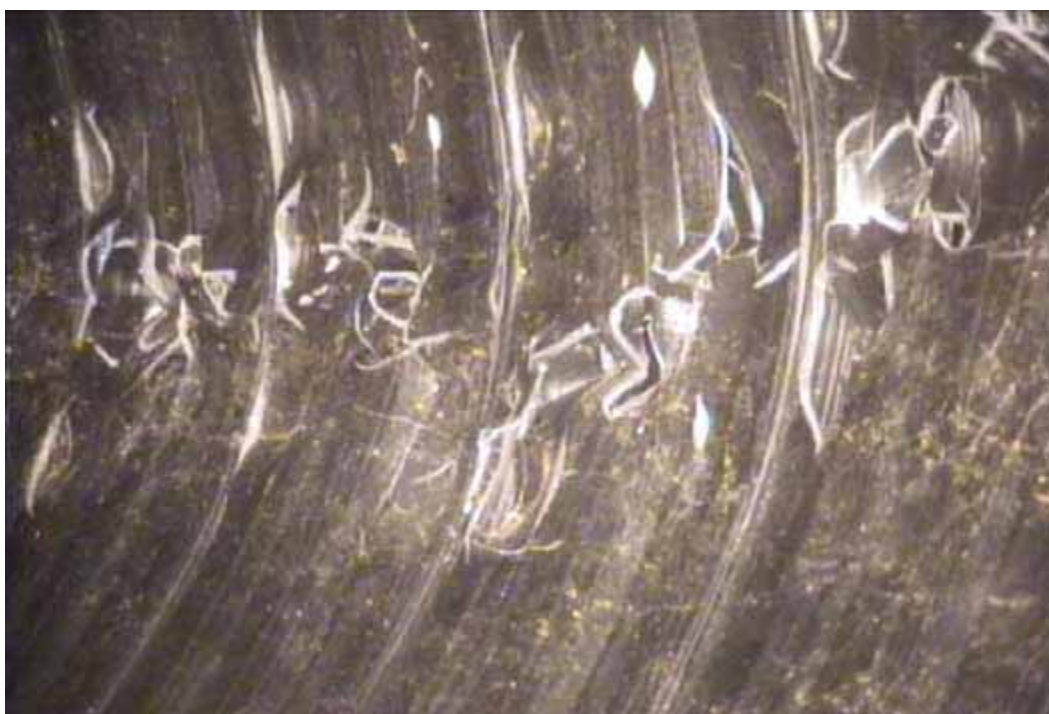
Figure 103 View of buckling and cracking failures for pipeline No. 11 (Site No. 6: Rockingham – Love Ln)

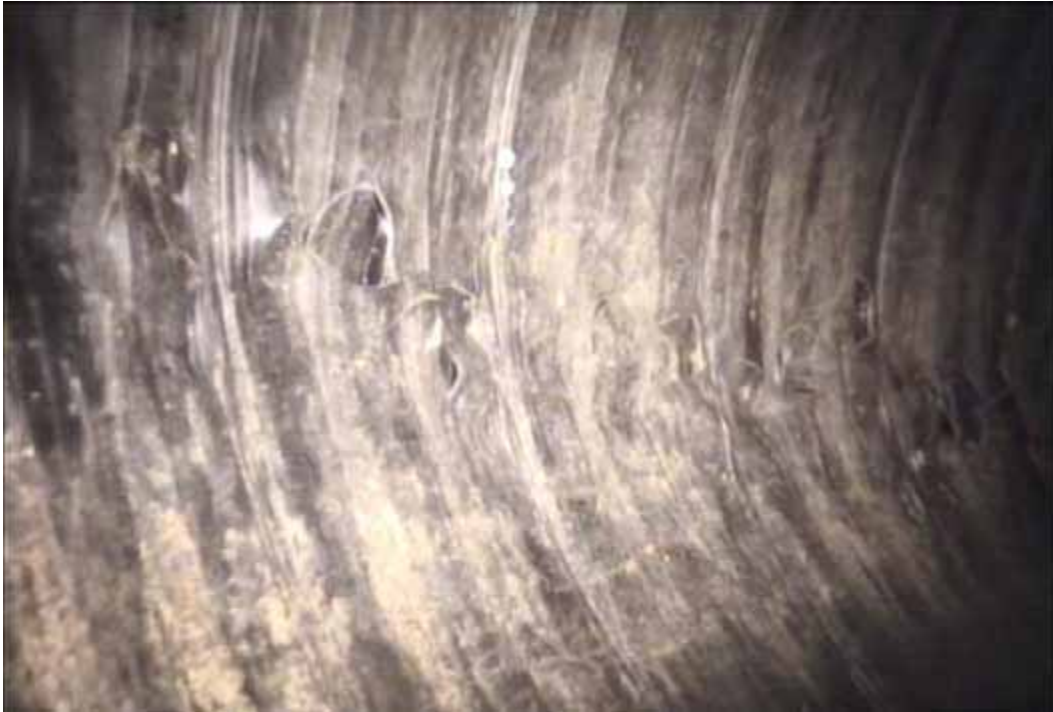
Figure 104 View of buckling and cracking failures for pipeline No. 11 (Site No. 6: Rockingham – Love Ln)

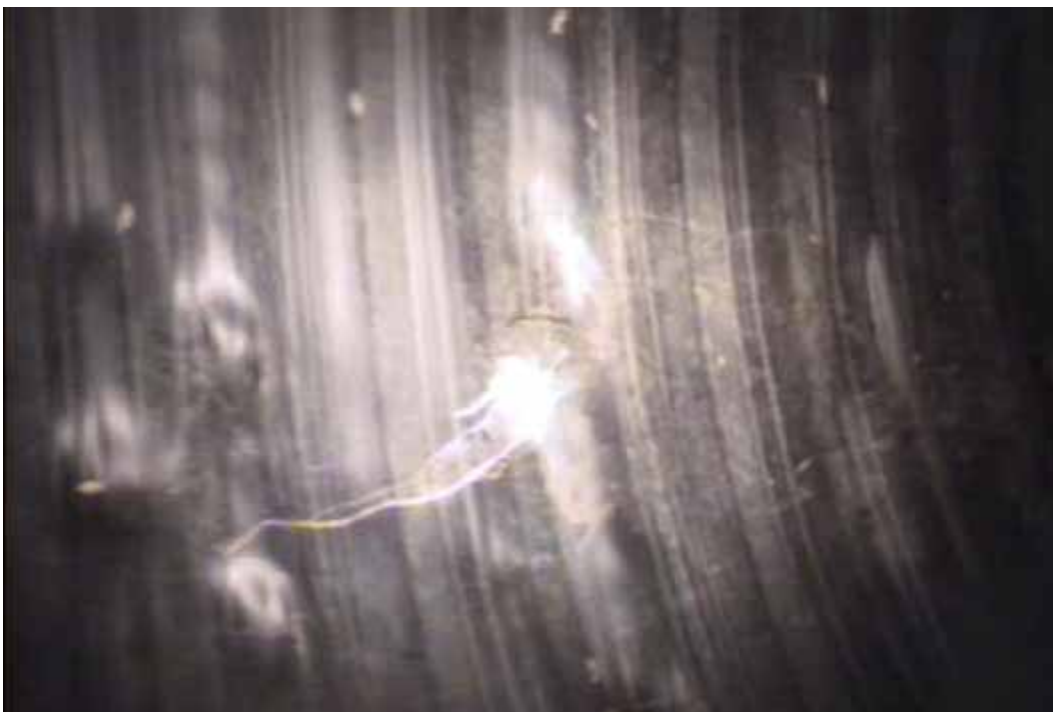
Figure 105 View of cracking failures for pipeline No. 11 (Site No. 6: Rockingham – Love Ln)

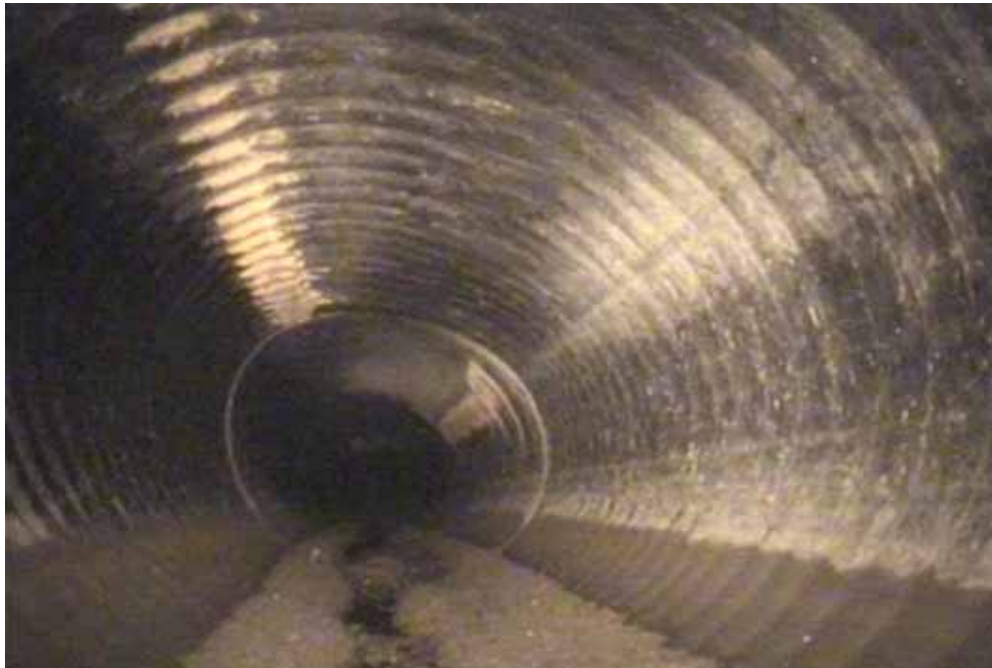
Figure 108 View of the corrugation growth failure for pipeline No. 1 (Site No. 1: Chesterfield - Commonwealth Pkwy)

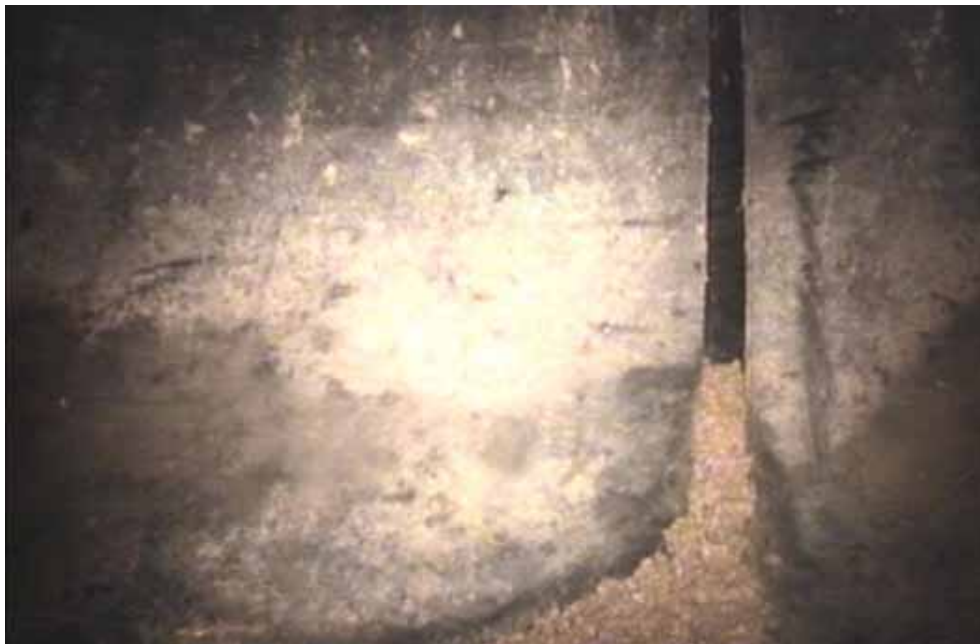
Figure 109 View of the joint displacement failure for pipeline No. 1 (Site No. 1: Chesterfield - Commonwealth Pkwy)

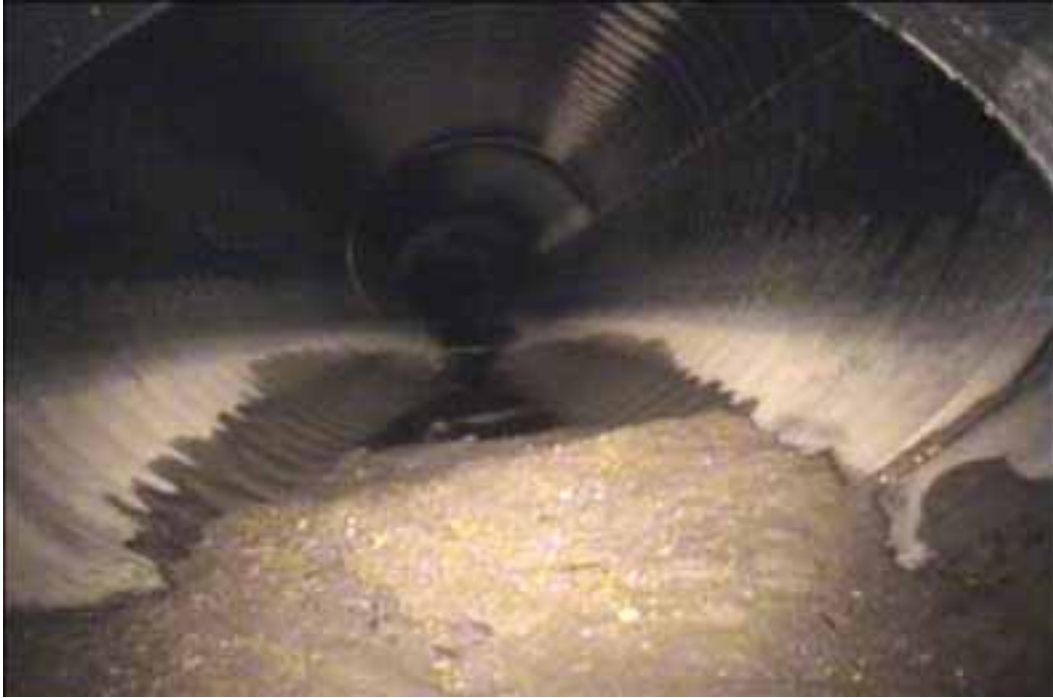
Figure 111 View of opening of the pipe for pipeline No. 2 (Site No. 1: Chesterfield - Commonwealth Pkwy)

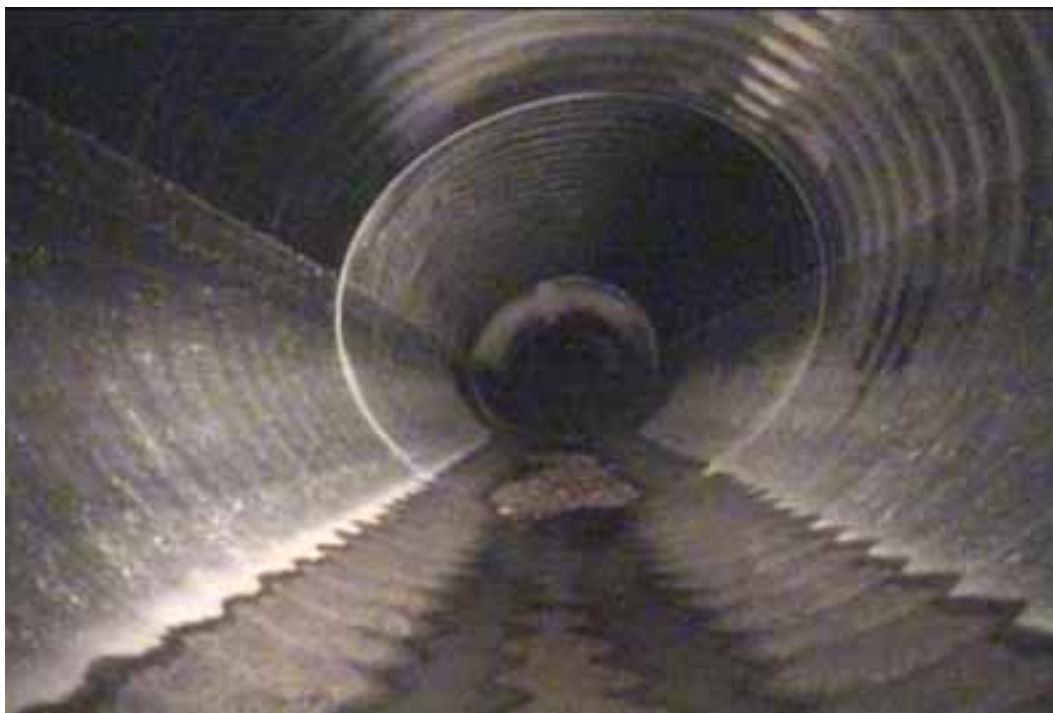
Figure 112 View of the excessive deformation failure for pipeline No. 2 (Site No. 1: Chesterfield - Commonwealth Pkwy)

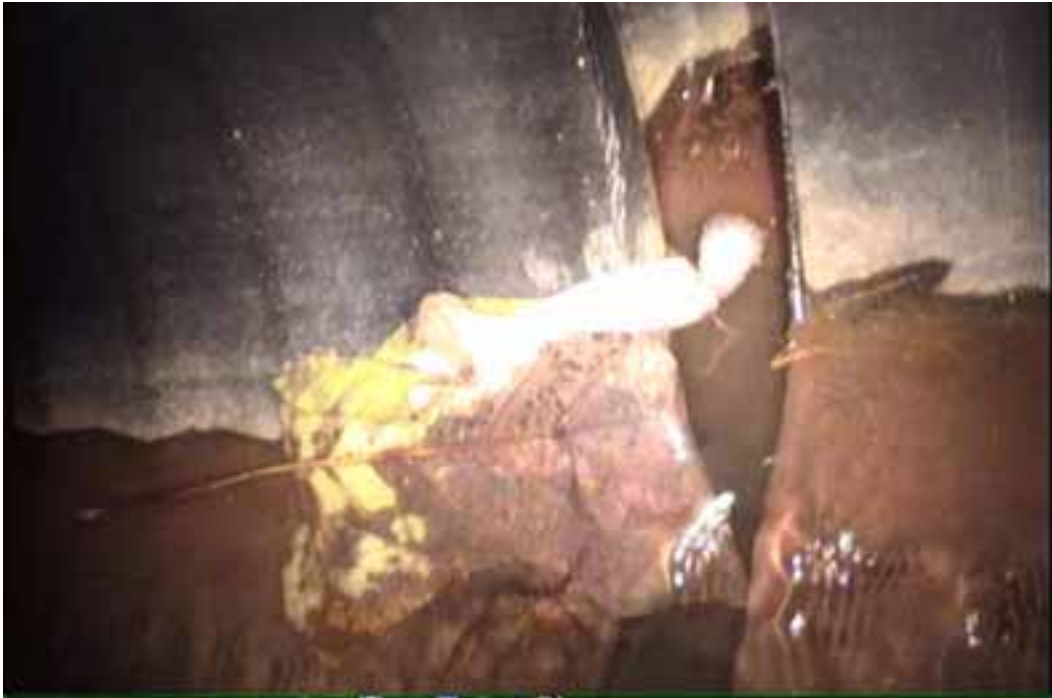
Figure 114 View of major joint displacement failure for pipeline No. 3 (Site No. 2: Chesterfield – Bandermill)

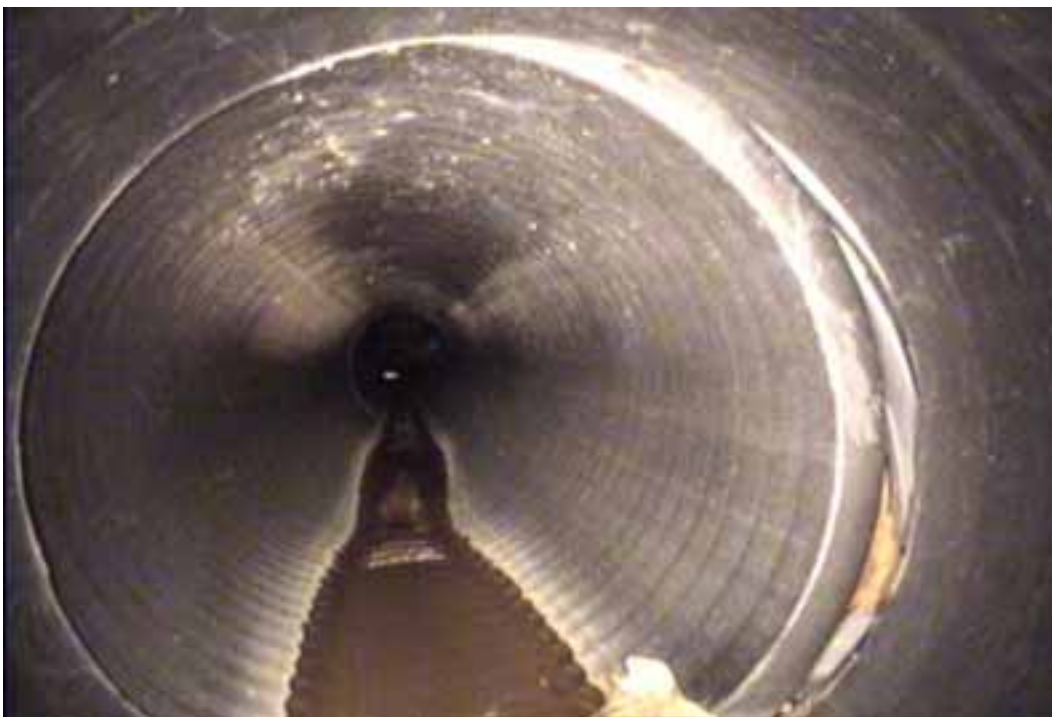
Figure 115 View of cracking/fracture failure for pipeline No. 3 (Site No. 2: Chesterfield – Bandermill)

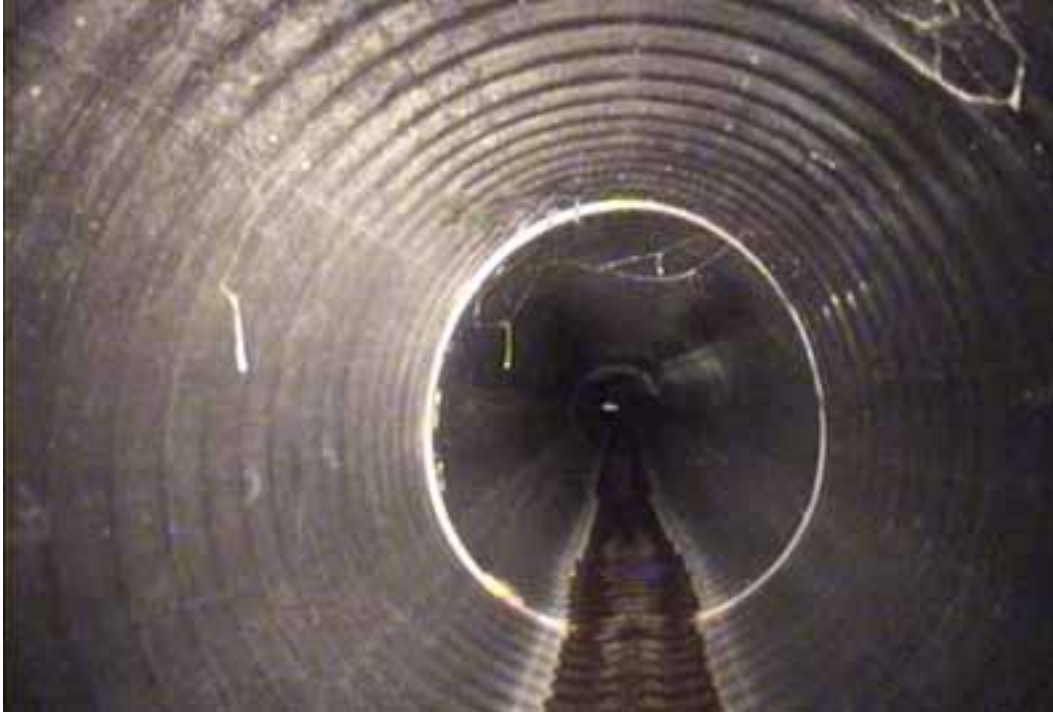
Figure 116 View of the excessive deformation failure for pipeline No. 3 (Site No. 2: Chesterfield – Bandermill)

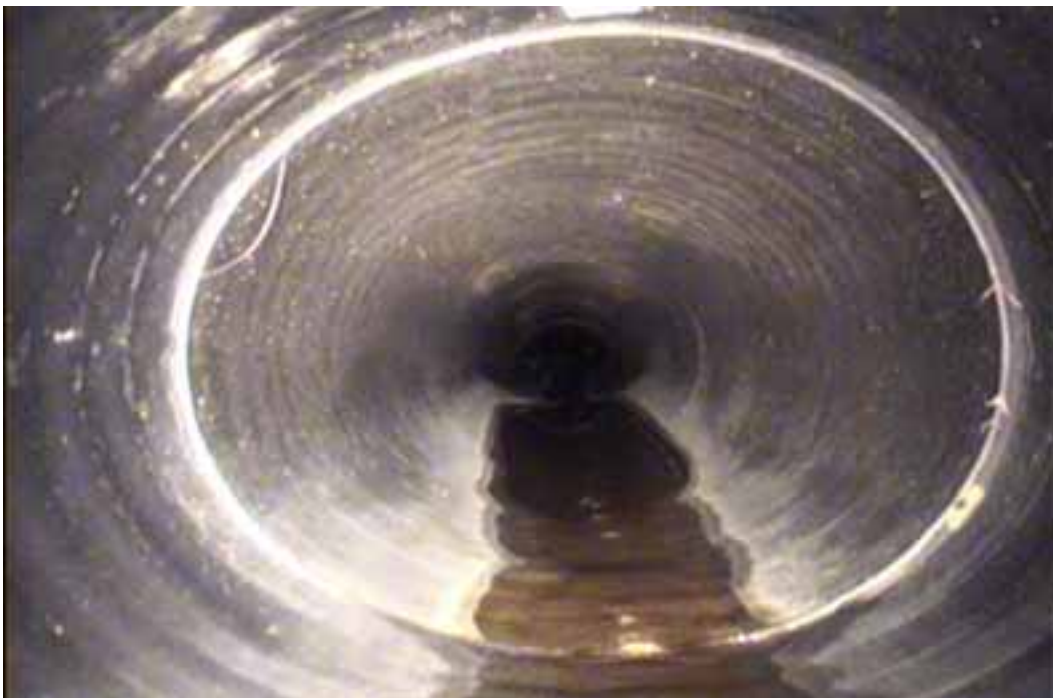
Figure 119 View of excessive deformation failure for pipeline No. 4 (Site No. 3: Spotsylvania County)

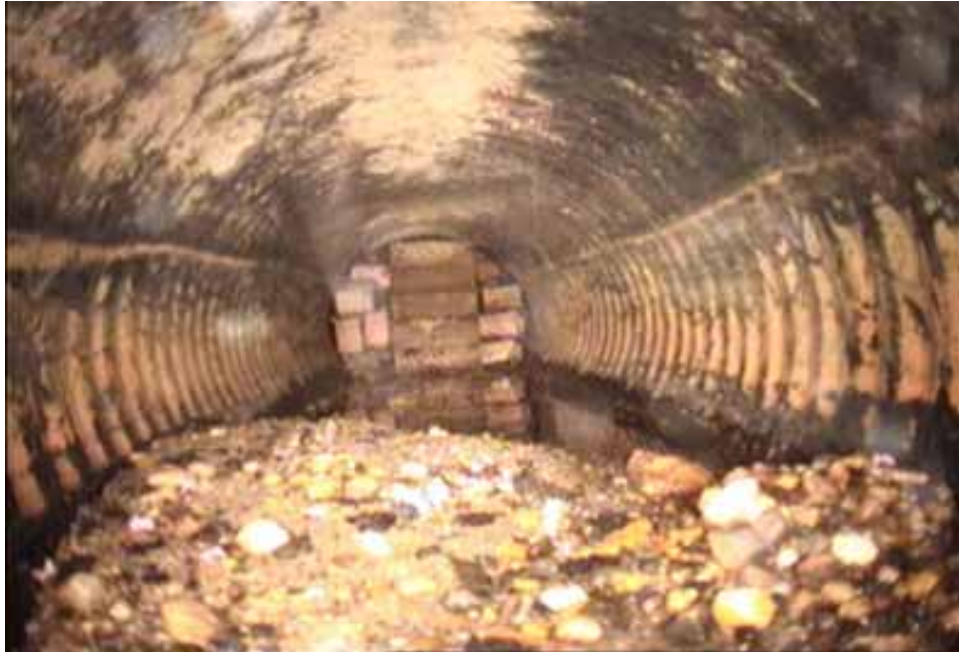
Figure 123 View of corrugation growth failure for pipeline No. 5 (Site No. 3: Spotsylvania County)

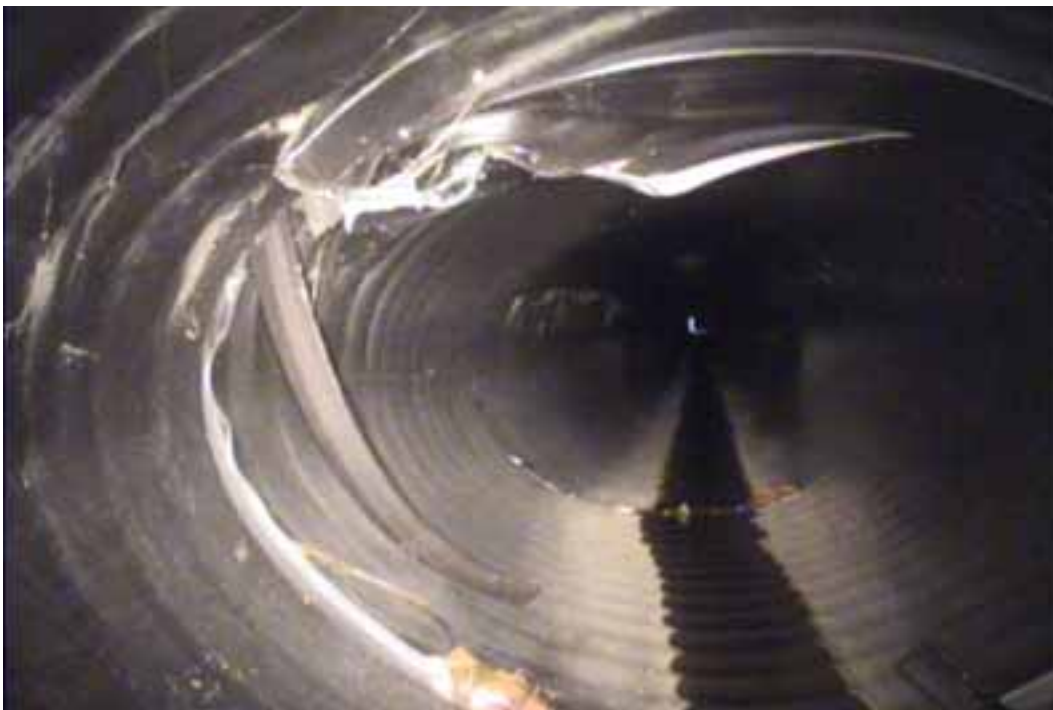
Figure 126 View of cracking/fracture and excessive deformation failures for pipeline No. 6 (Site No. 4: Mechanicsville)

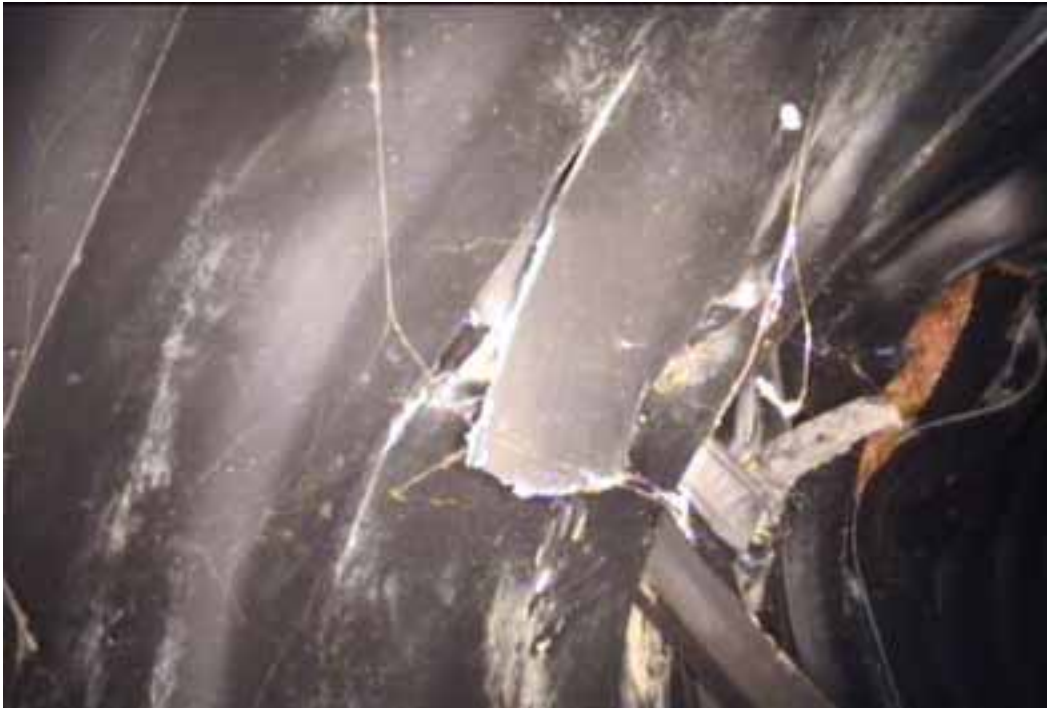
Figure 127 View of cracking/fracture failure for pipeline No. 6 (Site No. 4: Mechanicsville)

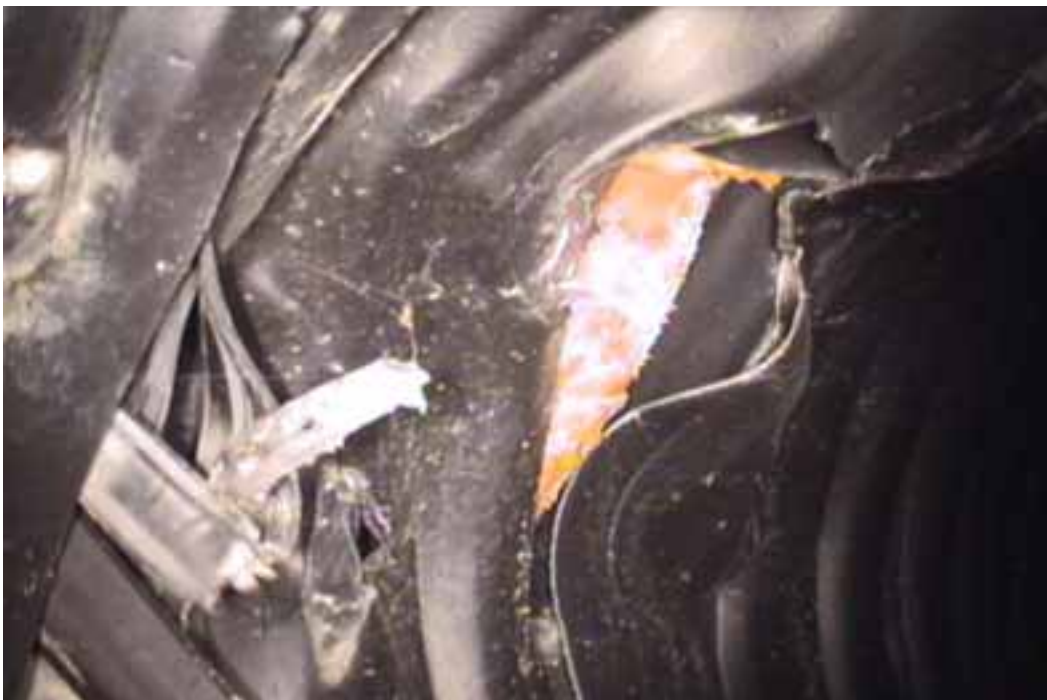
Figure 128 View of cracking/fracture failure for pipeline No. 6 (Site No. 4: Mechanicsville)

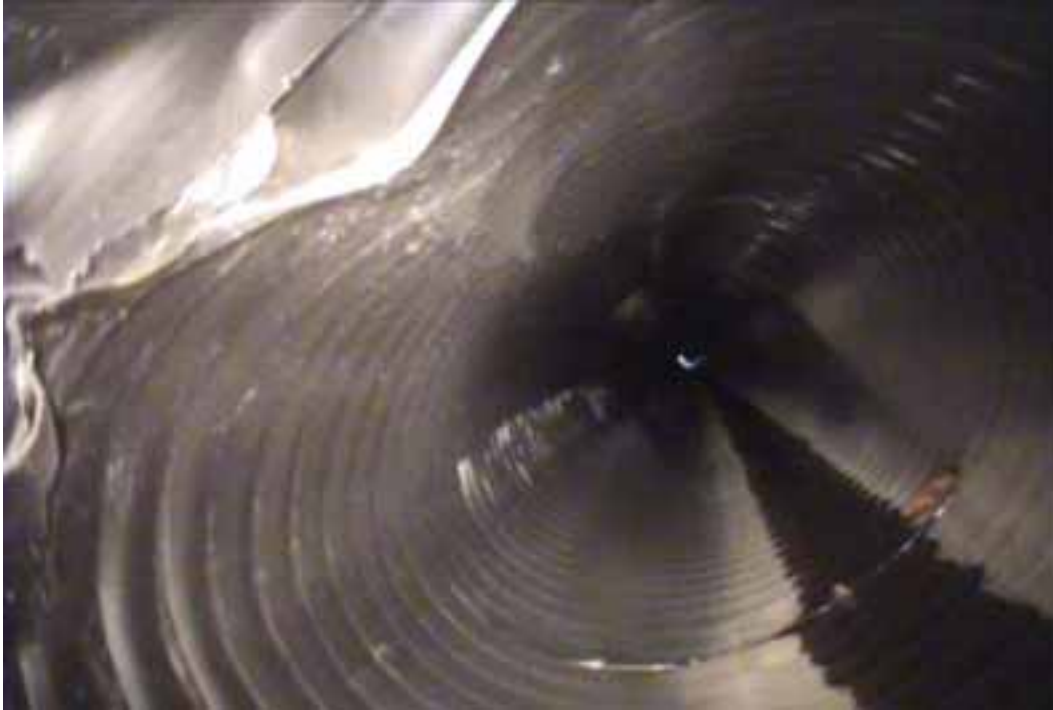
Figure 129 View of cracking/fracture failure for pipeline No. 6 (Site No. 4: Mechanicsville)

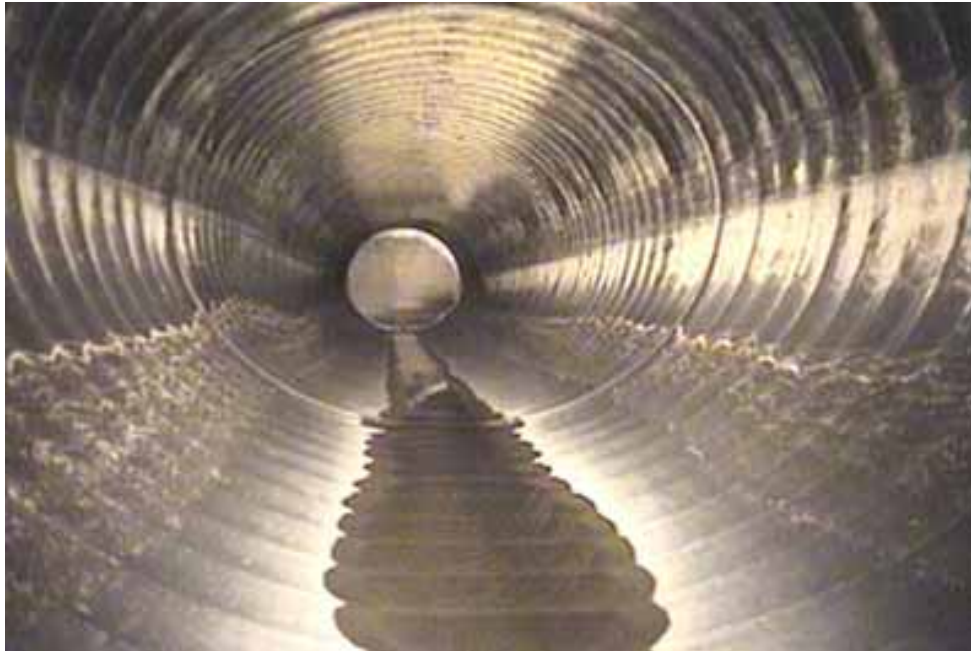
Figure 130 View of excessive deformation and corrugation growth failures for pipeline No. 7 (Site No. 4: Mechanicsville)

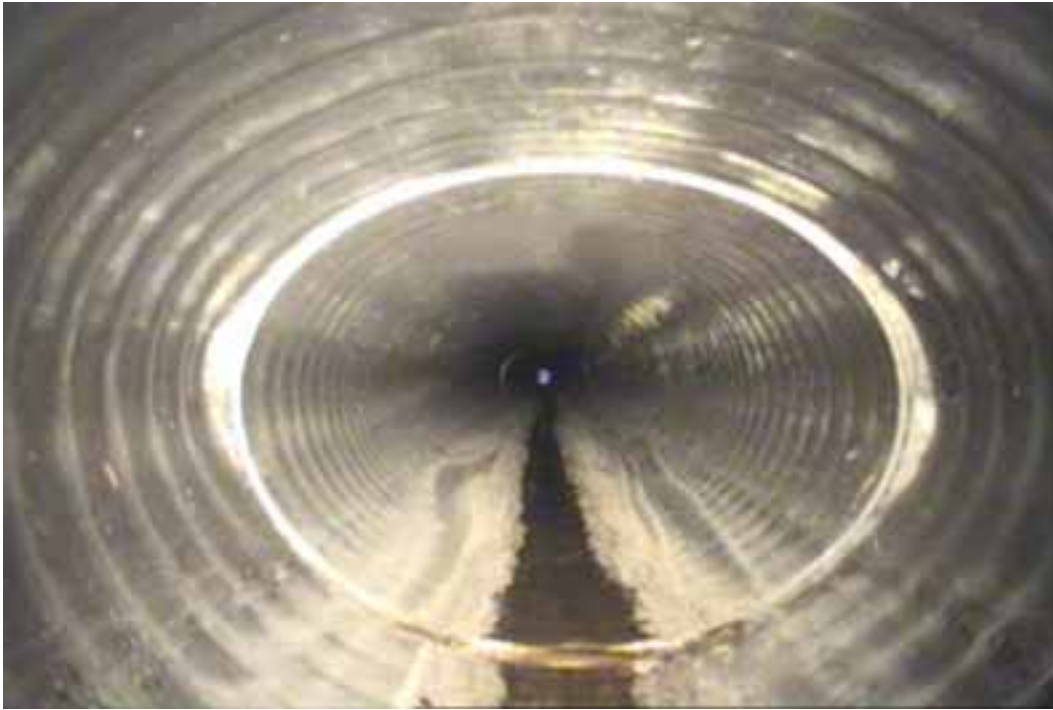
Figure 132 View of excessive deformation and corrugation growth failures for pipeline No. 8 (Site No. 4: Mechanicsville)

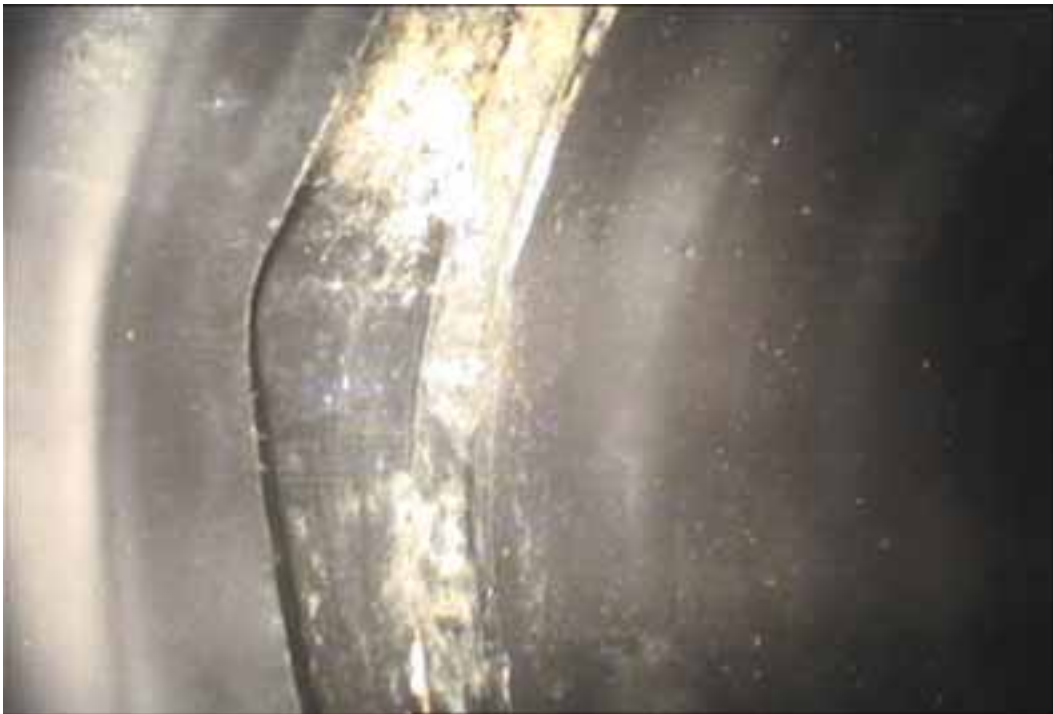
Figure 133 View of deformation of the pipe for pipeline No. 8 (Site No. 4: Mechanicsville)

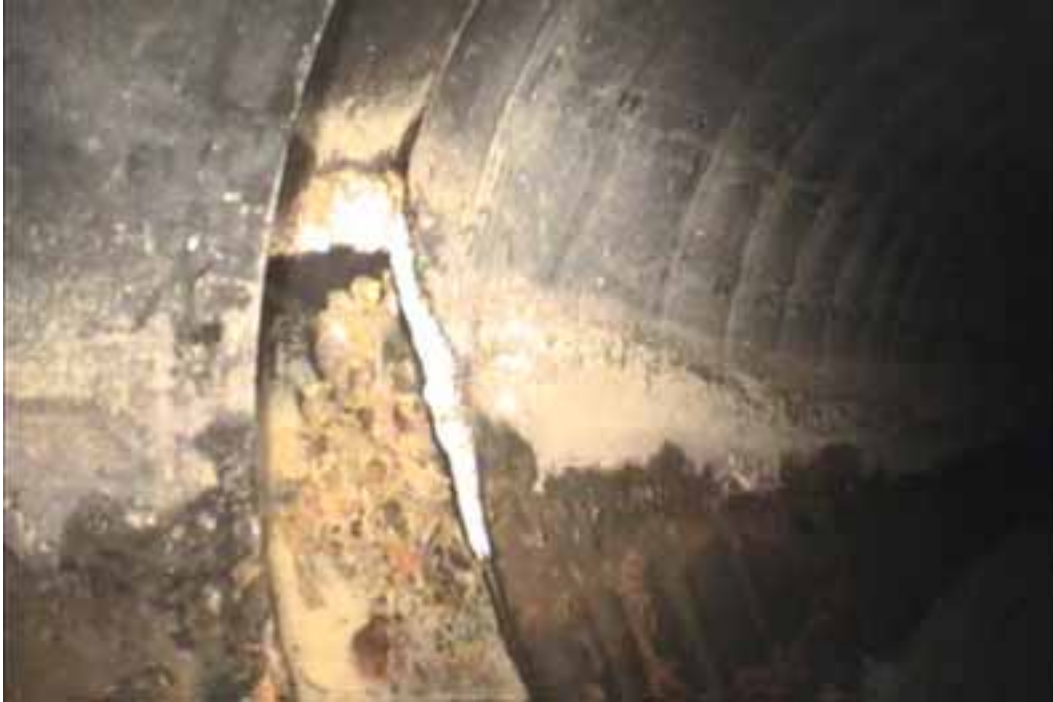
Figure 134 View of major joint displacement failure for pipeline No. 8 (Site No. 4: Mechanicsville)

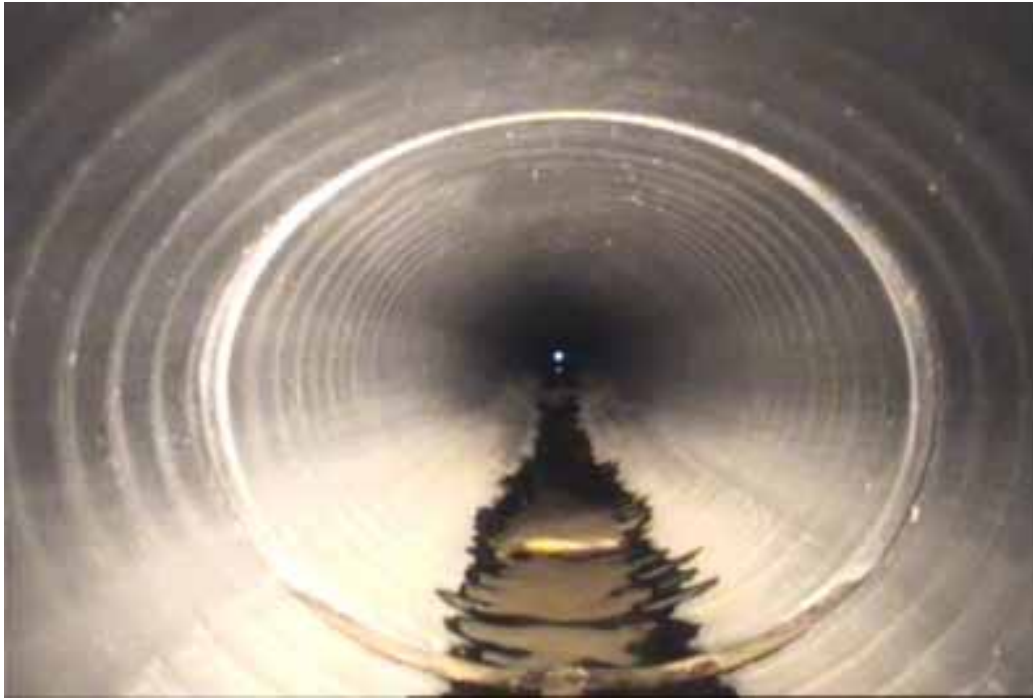
Figure 135 View of excessive deformation failure for pipeline No. 9 (Site No. 4: Mechanicsville)

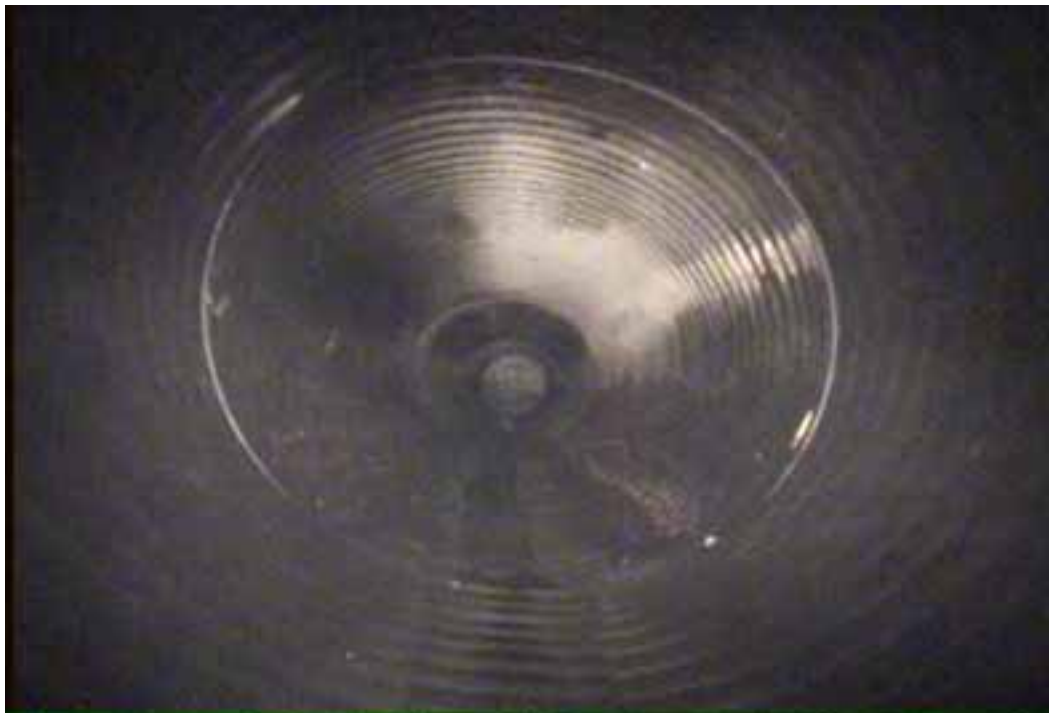
Figure 137 View of excessive deformation failure for pipeline No. 10 (Site No. 5: Staunton)

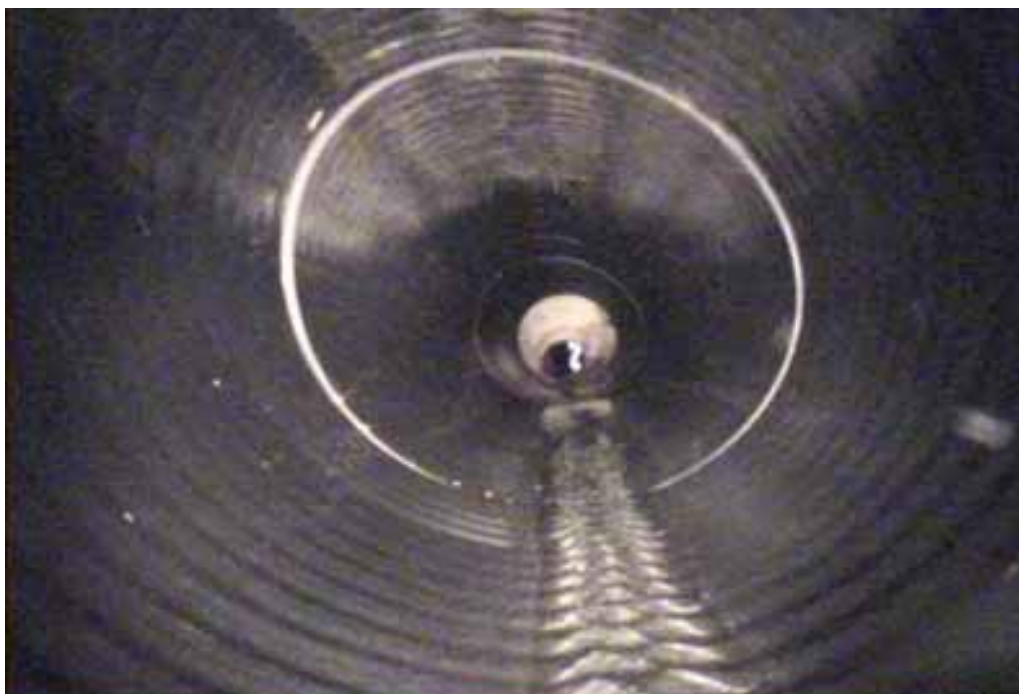
Figure 138 View of excessive deformation failure for pipeline No. 11 (Site No. 5: Staunton)

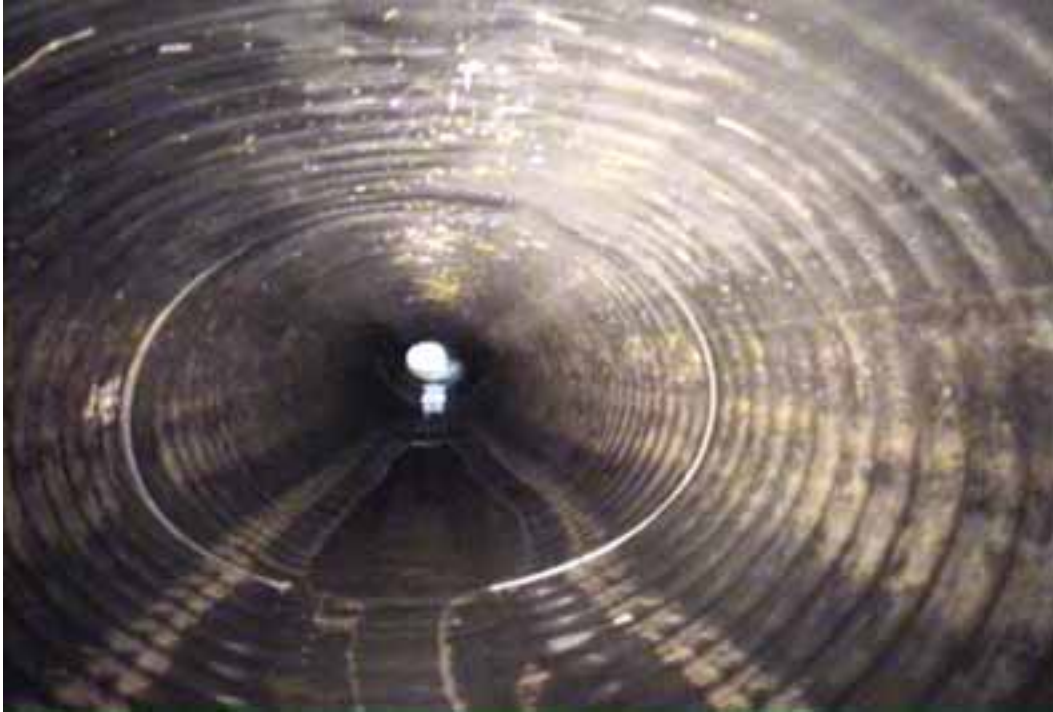
Figure 140 View of excessive deformation failure for pipeline No. 12 (Site No. 5: Staunton)
