Evaluation of HDPE Pipelines Structural Performance

UT Arlington Center for Structural Engineering Research

November 2010

**As a Part of the Initiative on the Underground Structural Health
Monitoring and Equipment Development**

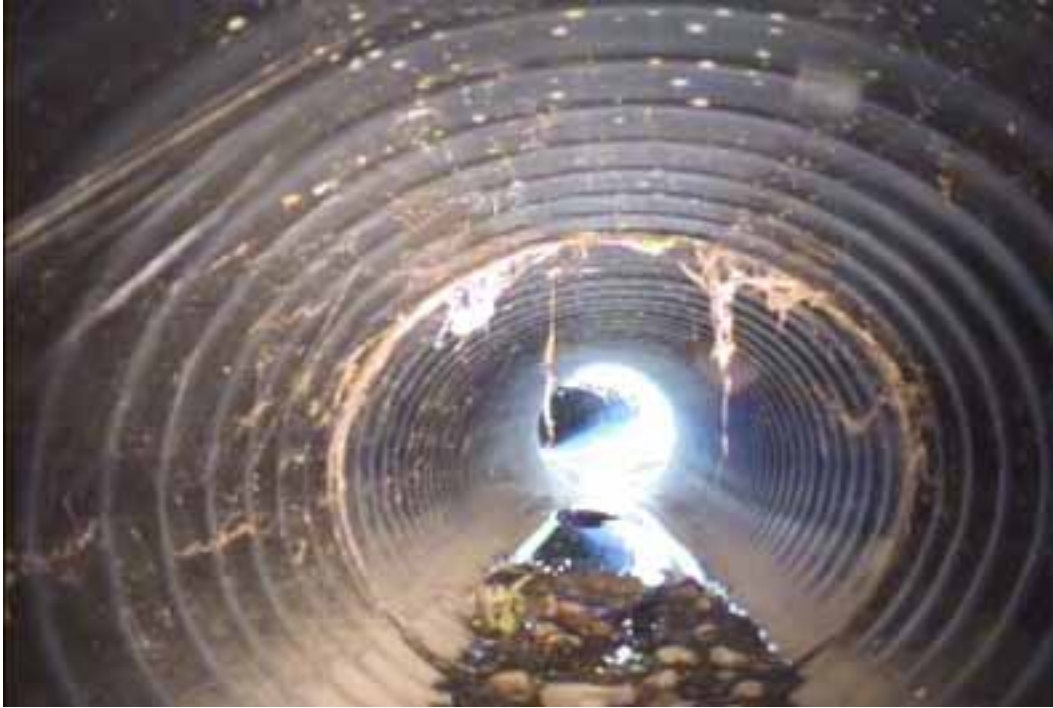
Figure 142 View of excessive deformation and major joint displacement failures for pipeline No. 14 (Site No. 6: Winchester)

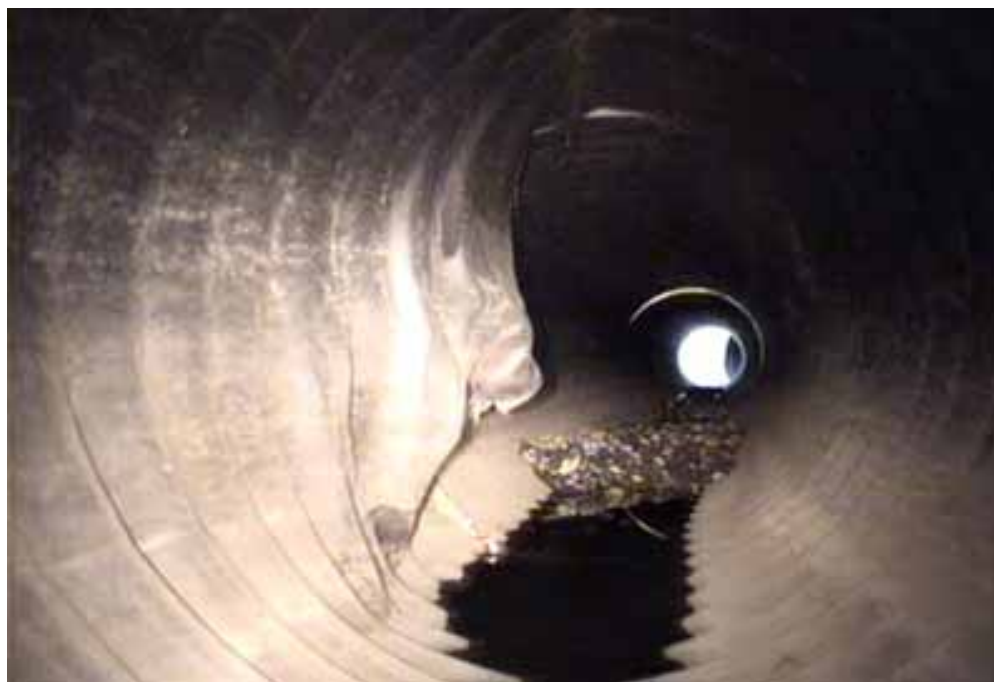
Pipeline No. 15 (Site No. 6: Winchester)

Figure 143 View of cracking/fracture failure for pipeline No. 15 (Site No. 6: Winchester)

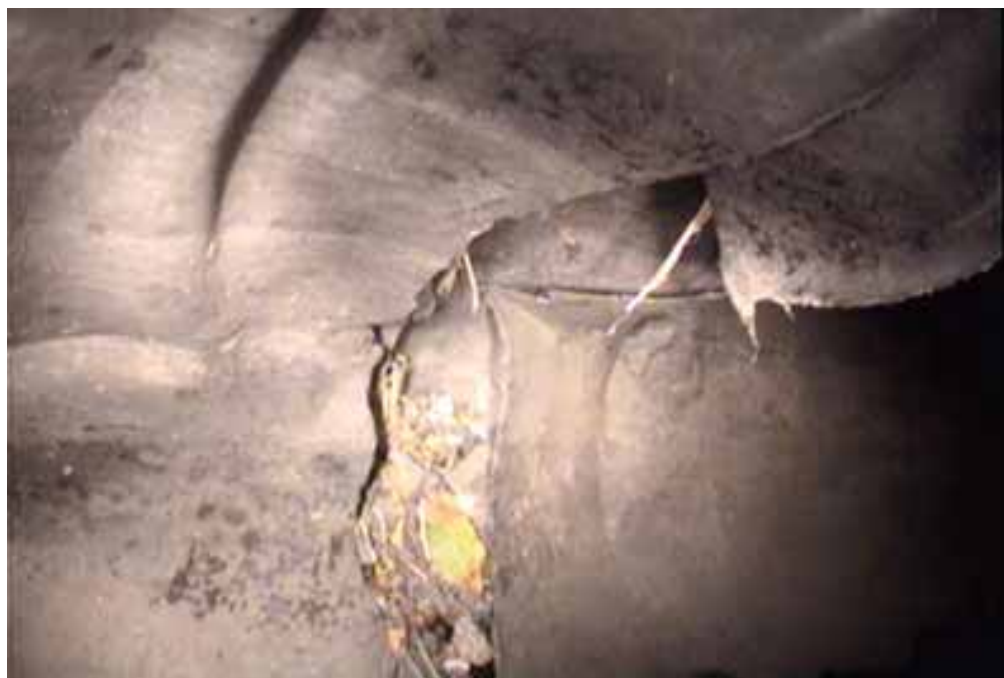
Figure 144 View of cracking/fracture failure for pipeline No. 15 (Site No. 6: Winchester)

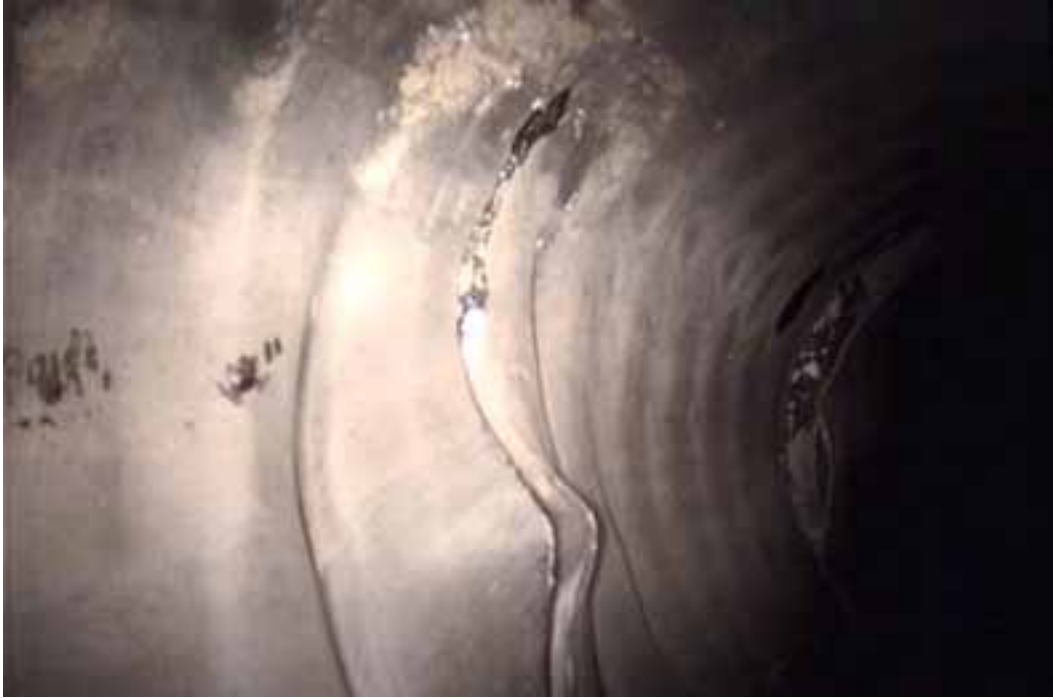
Figure 148 View of buckling and cracking/fracture failures for pipeline No. 16 (Site No. 6: Winchester)

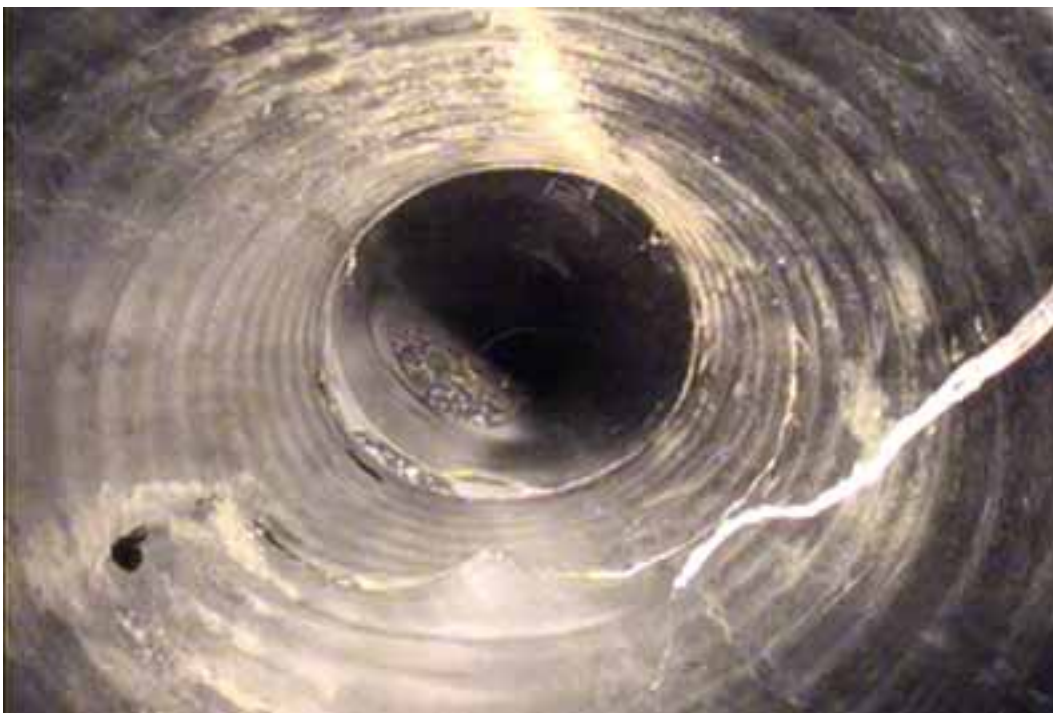
Figure 149 View of cracking/fracture failure for pipeline No. 16 (Site No. 6: Winchester)

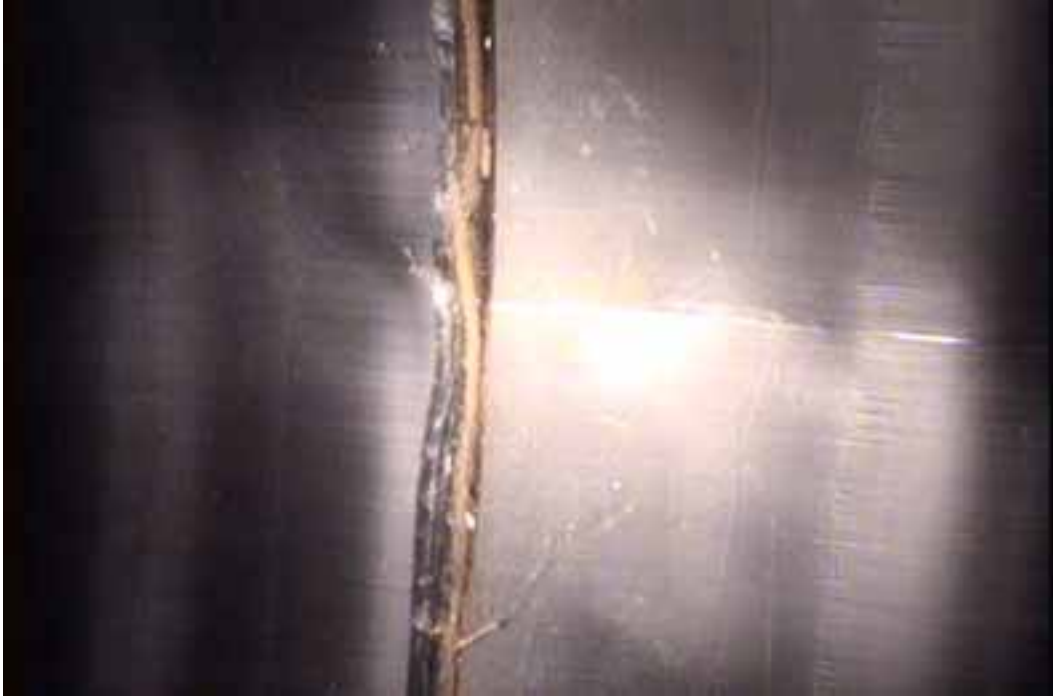
Figure 150 View of buckling failure for pipeline No. 16 (Site No. 6: Winchester)

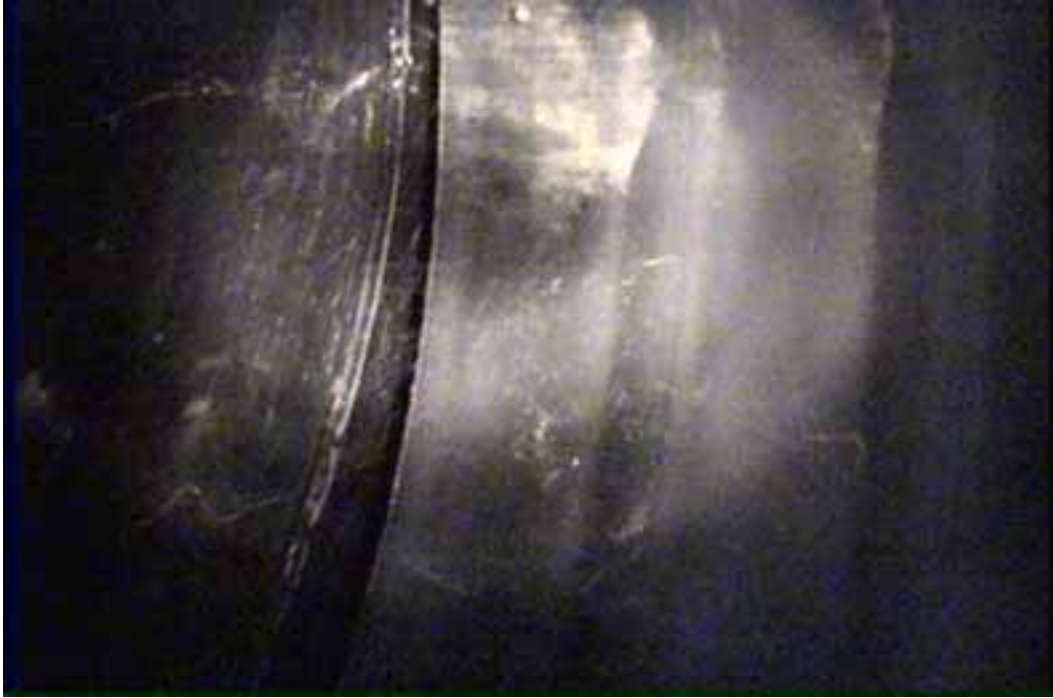
Figure 153 View of joint displacement failure for pipeline No. 18 (Site No. 6: Winchester)

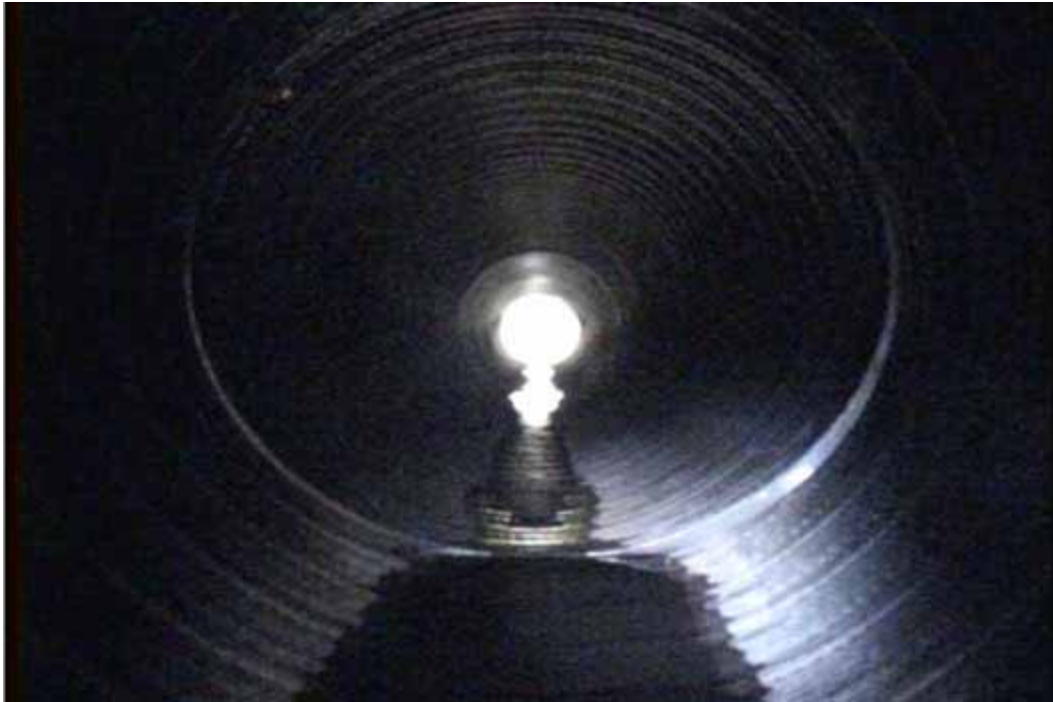
Figure 155 View of corrugation growth failure for pipeline No. 19 (Site No. 6: Winchester)

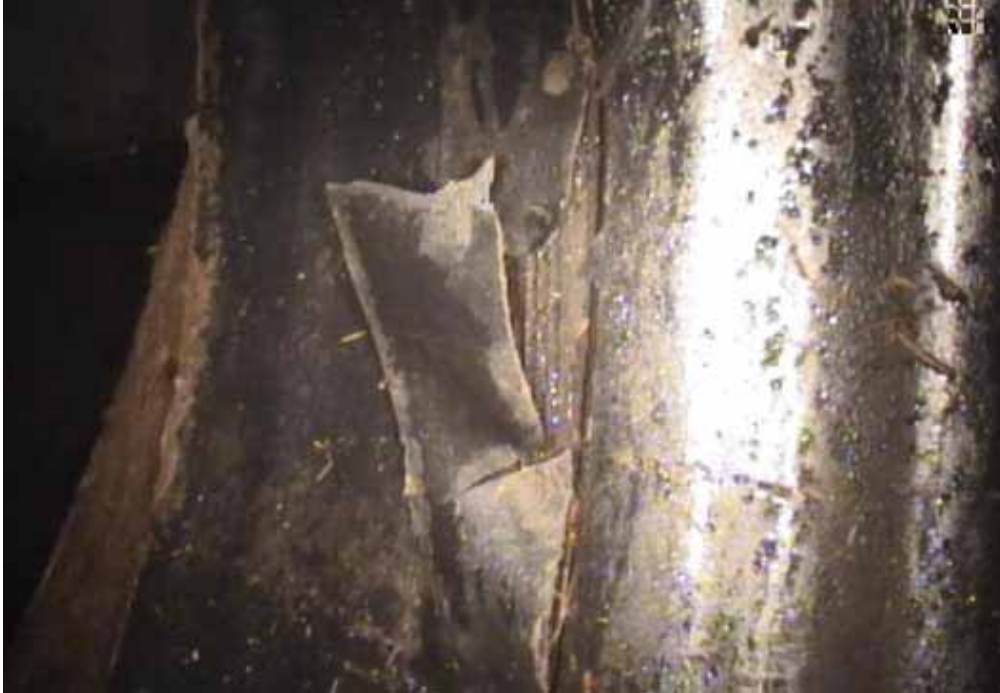
Figure 161 View of the cracking/fracture failure for pipeline No. 3 (Site No. 1: Brooklyn Park - 64th Ave)

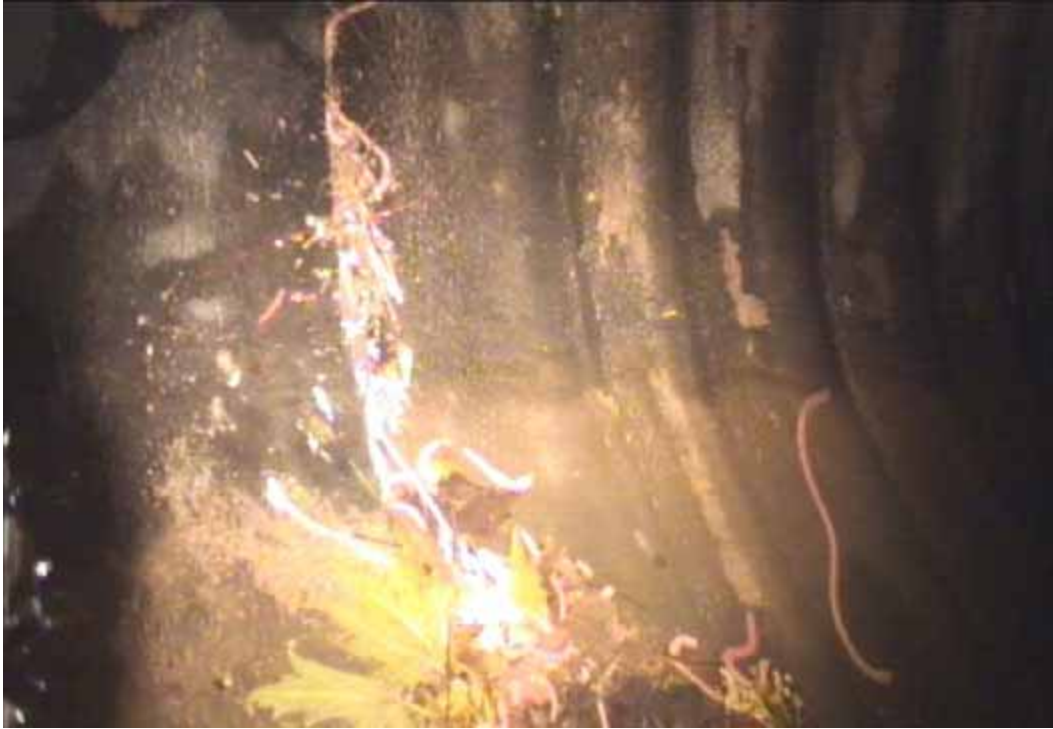
**Figure 164 View of the major joint displacement failure for pipeline No. 5 (Site No. 2:
Brooklyn Park - 71st Ave)**

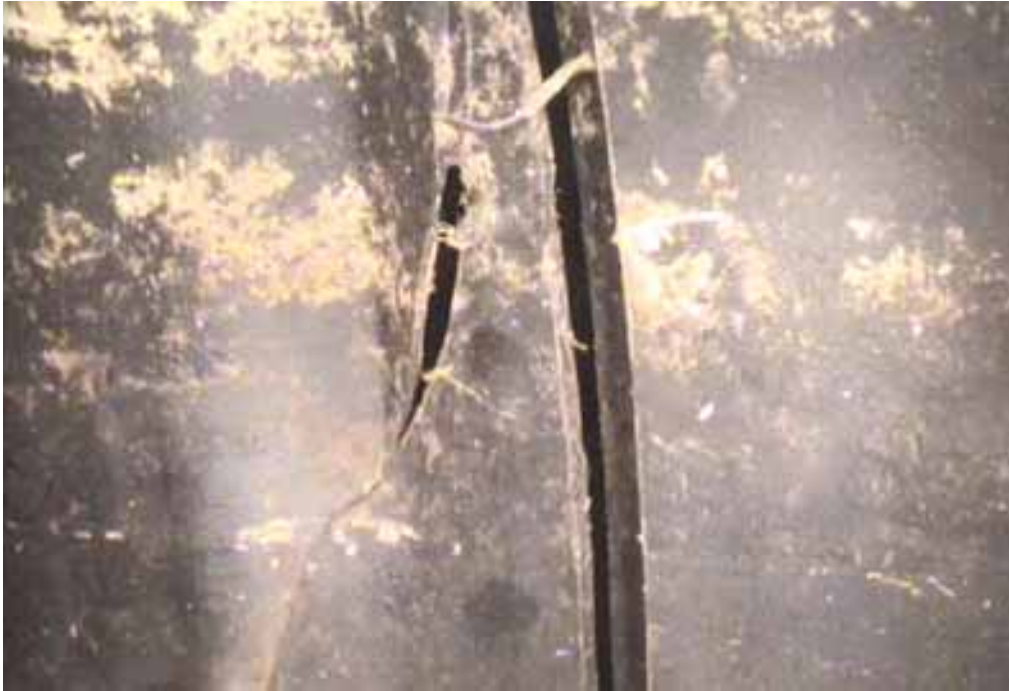
Figure 169 View of cracking/fracture failure for pipeline No. 9 (Site No. 3: Blaine - Xylite)

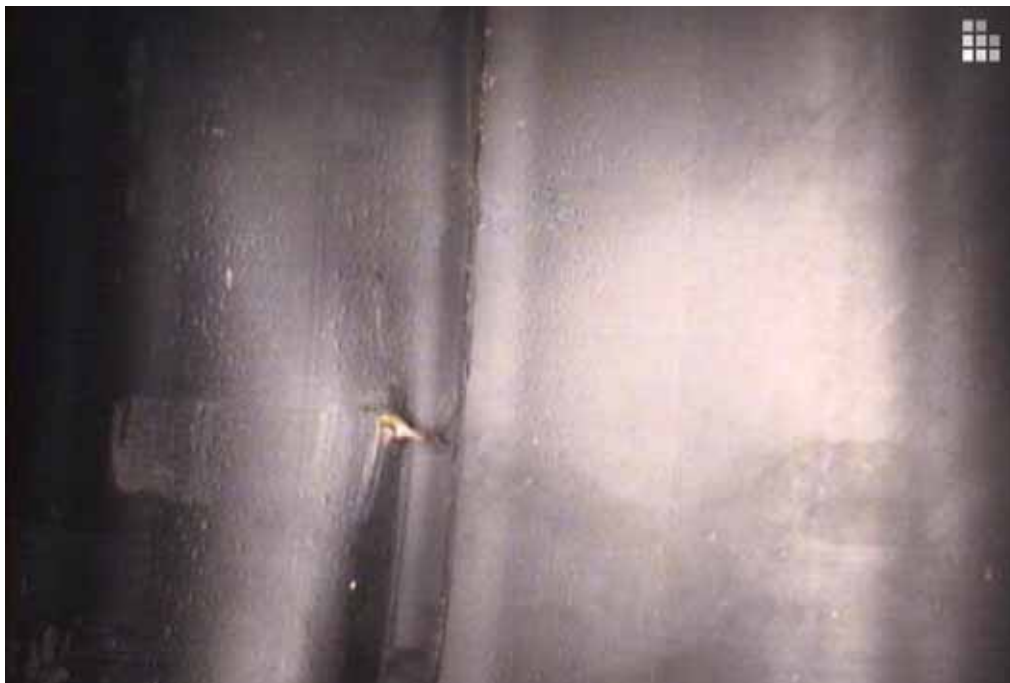
Figure 170 View of cracking failure for pipeline No. 12 (Site No. 3: Blaine - Xylite)

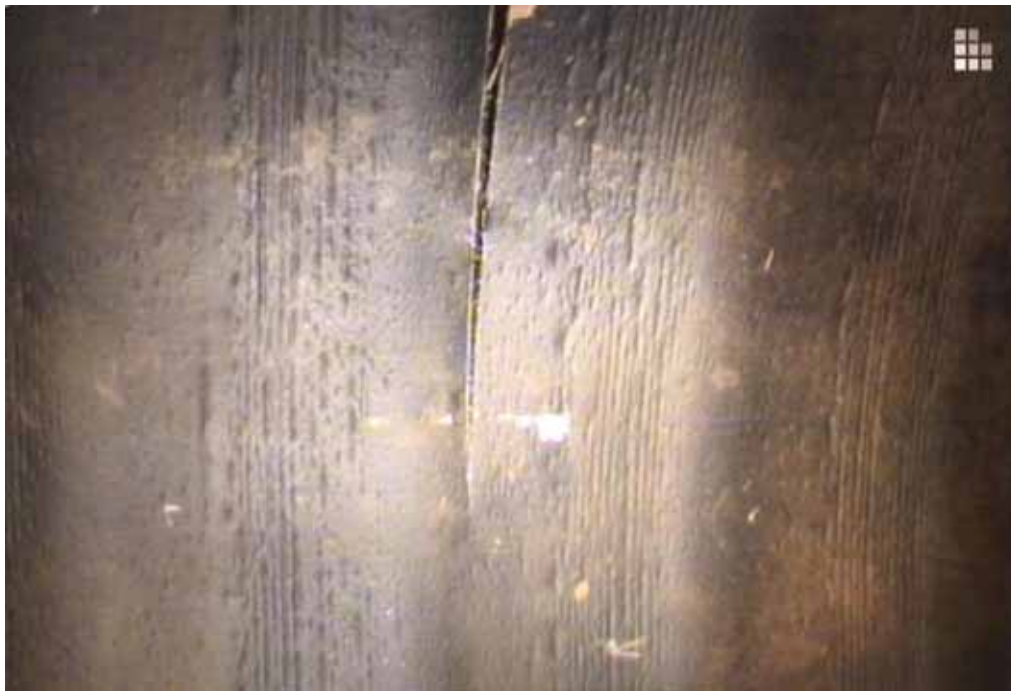
Figure 173 View of cracking/fracture failure for pipeline No. 15 (Site No. 5: McGregor)

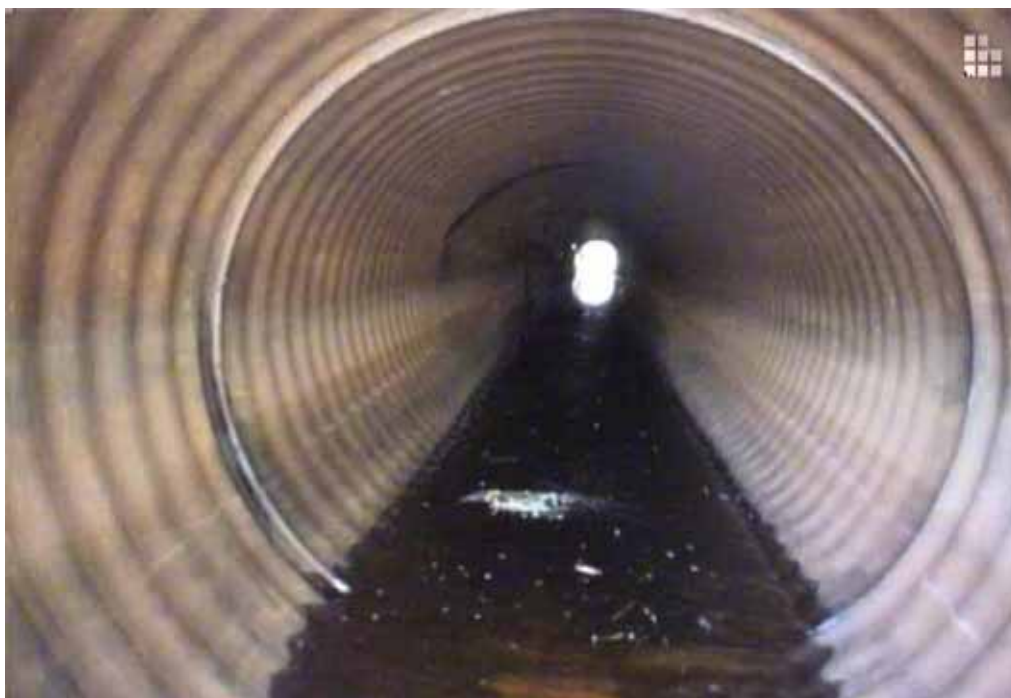
Figure 174 View of corrugation growth and excessive deformation failures for pipeline No. 15 (Site No. 5: McGregor)

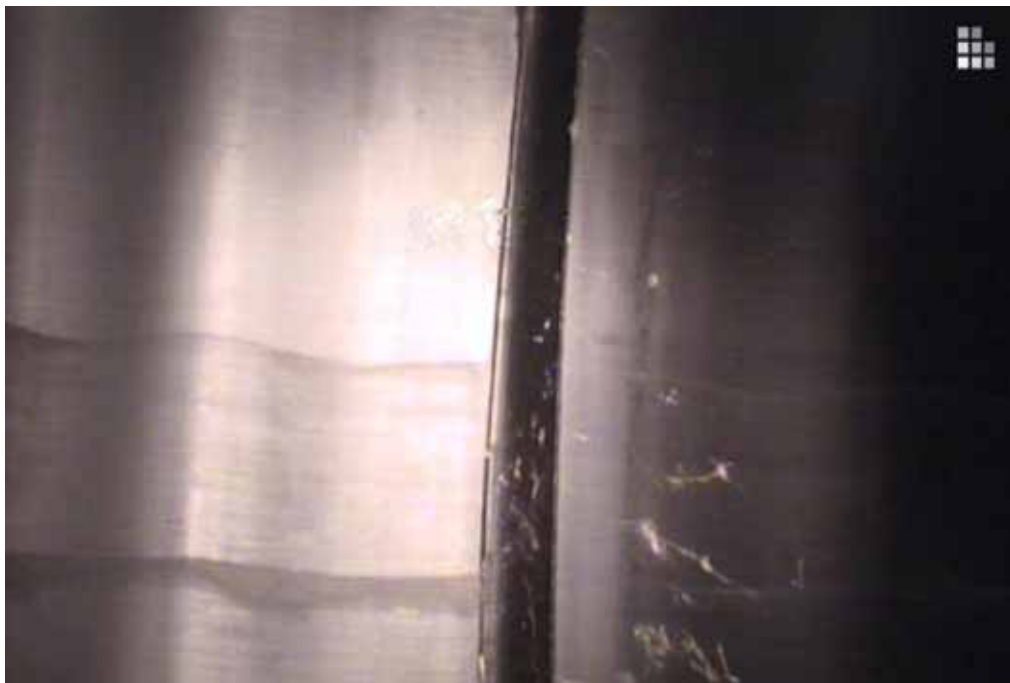
Figure 179 View of joint displacement failure for pipeline No. 18 (Site No. 6: Brooklyn Park - DuPont)

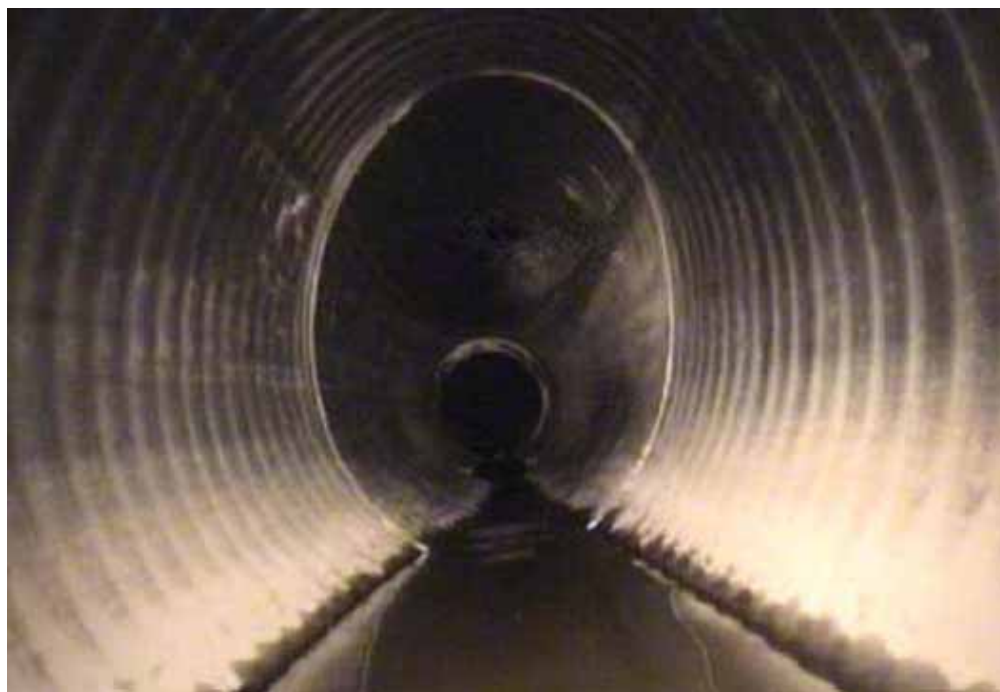
Figure 180 View of corrugation growth and excessive deformation failures for pipeline No. 18 (Site No. 6: Brooklyn Park - DuPont)

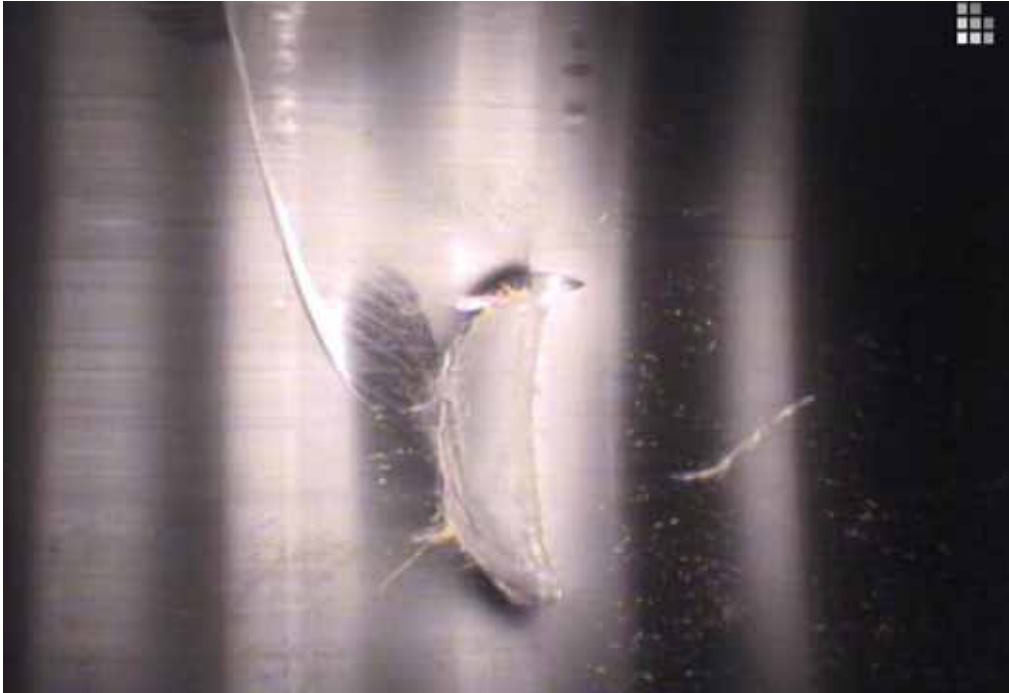
Figure 182 View of cracking/fracture failure for pipeline No. 19 (Site No. 6: Brooklyn Park - DuPont)

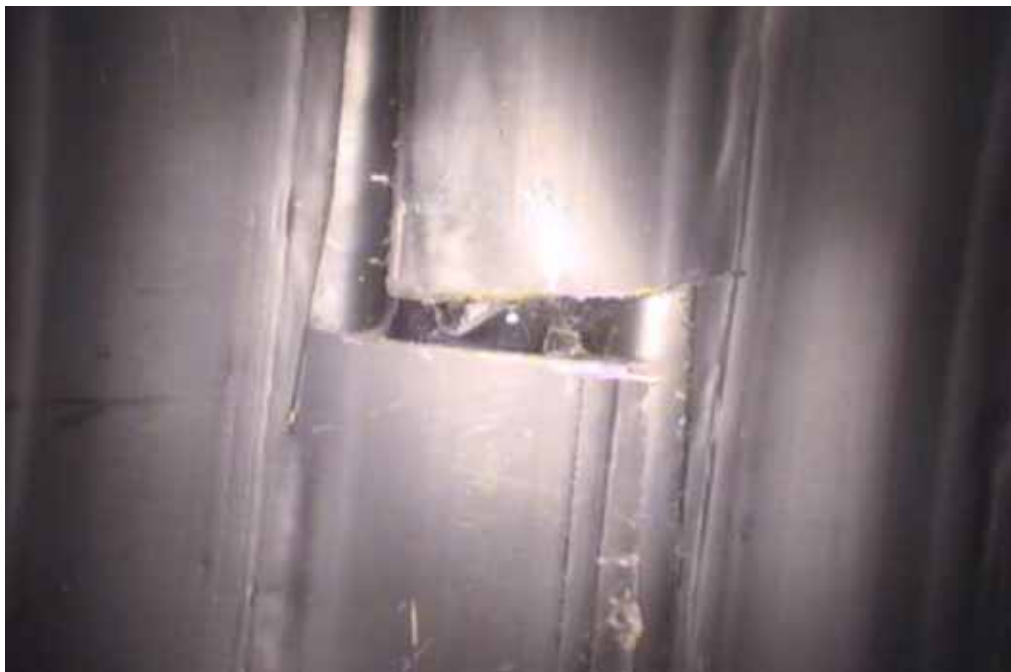
Figure 191 View of cracking/fracture failure for pipeline No. 27 (Site No. 8: Fairmont)

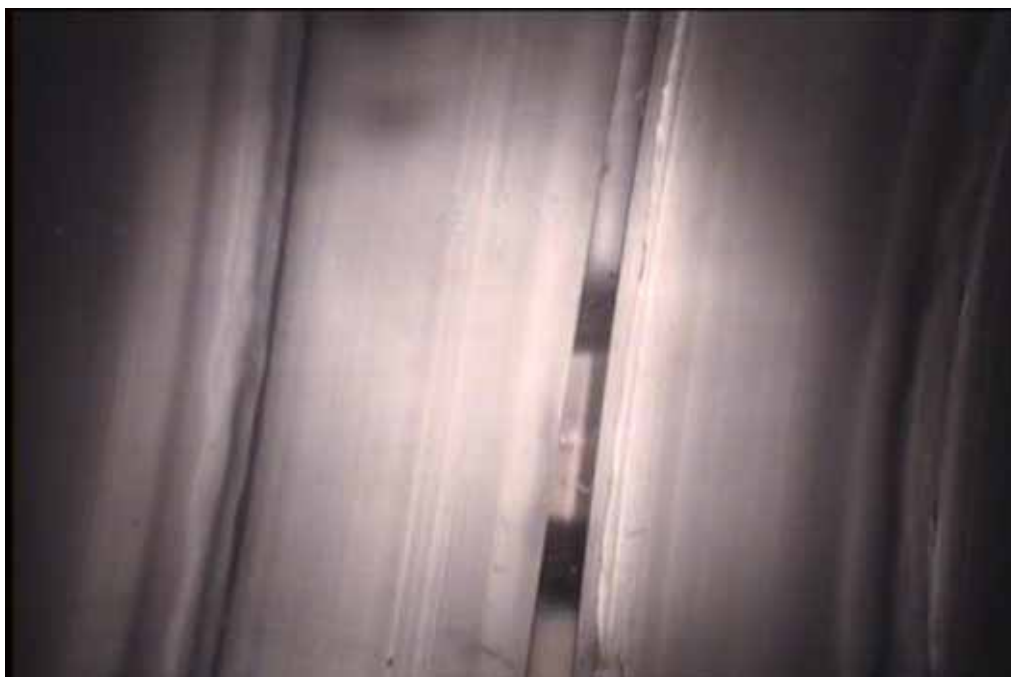
Figure 192 View of joint displacement failure for pipeline No. 27 (Site No. 8: Fairmont)

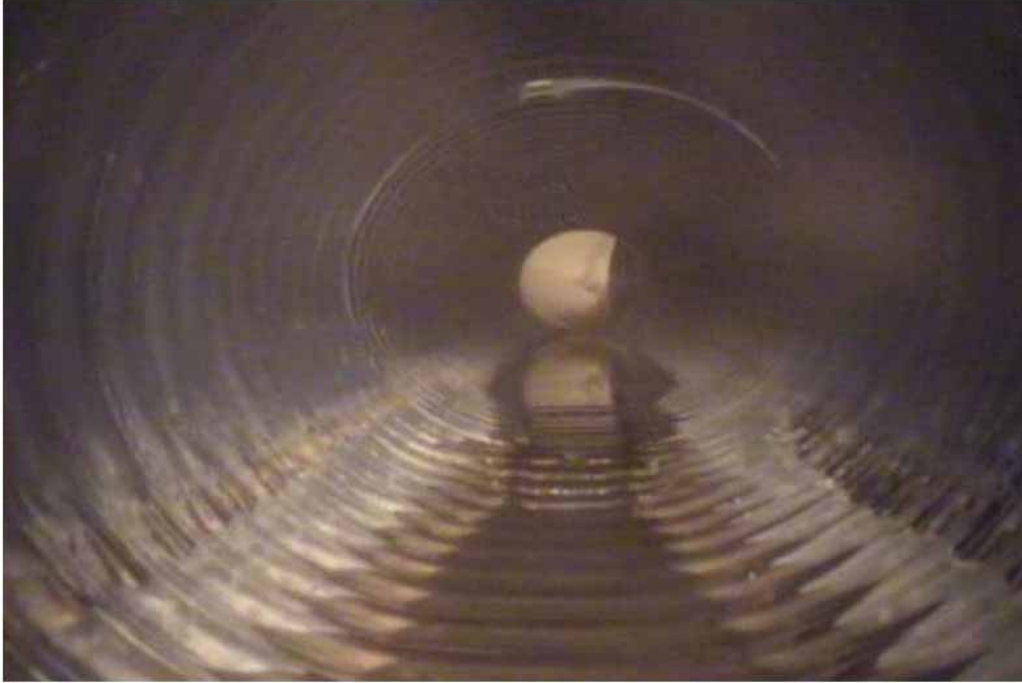
Figure 193 View of excessive deformation failure for pipeline No. 27 (Site No. 8: Fairmont)

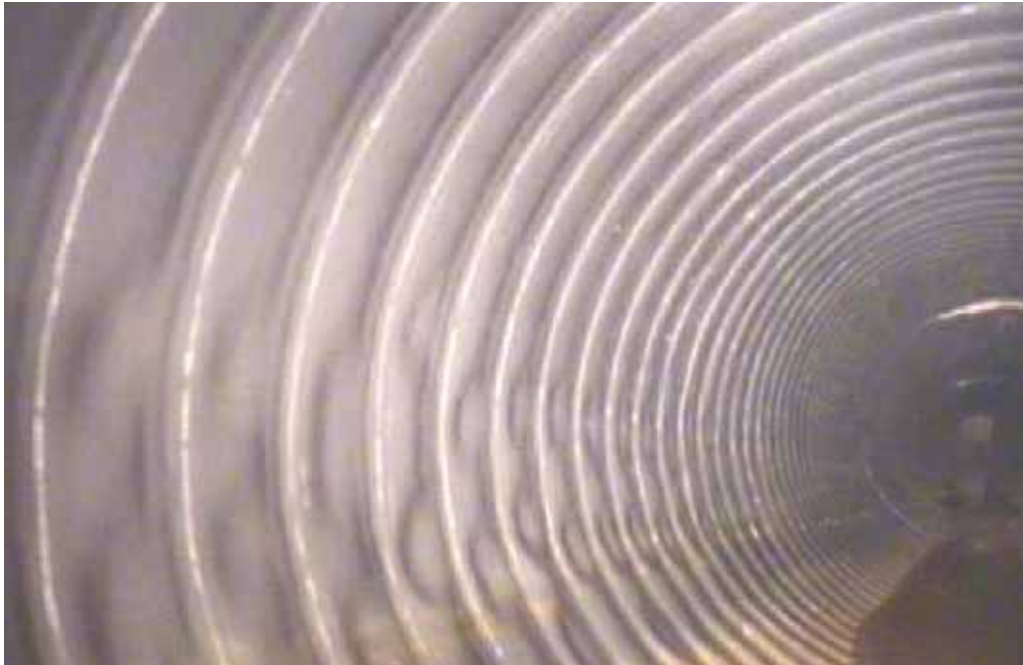
Figure 196 View of corrugation growth and buckling failure for pipeline No. 29 (Site No. 8: Fairmont)

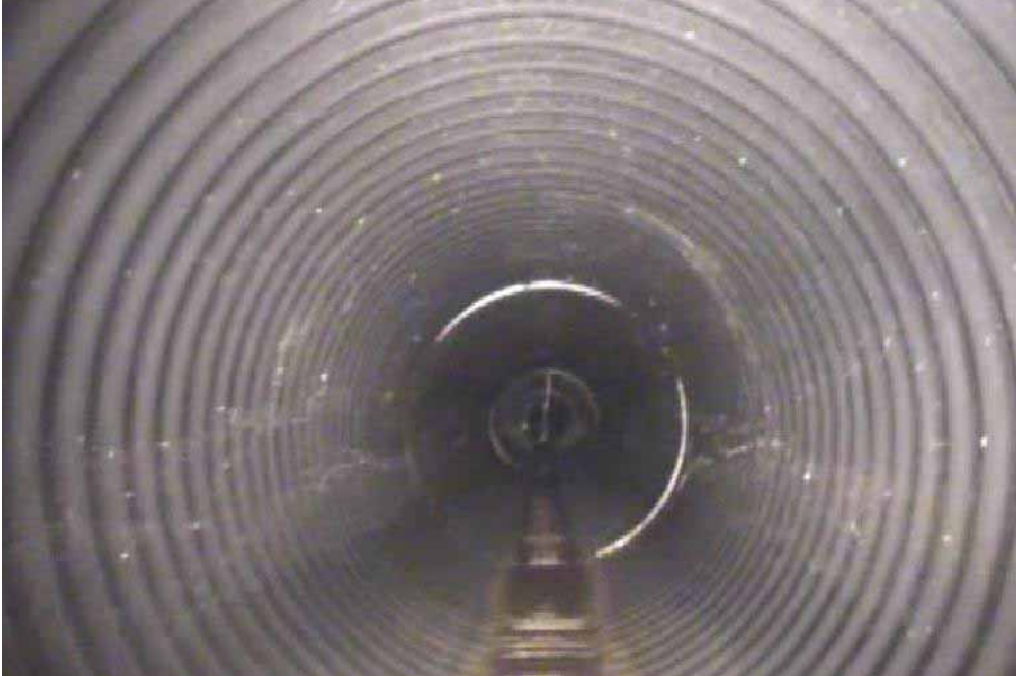
Figure 199 View of corrugation growth failure for pipeline No. 30 (Site No. 8: Fairmont)

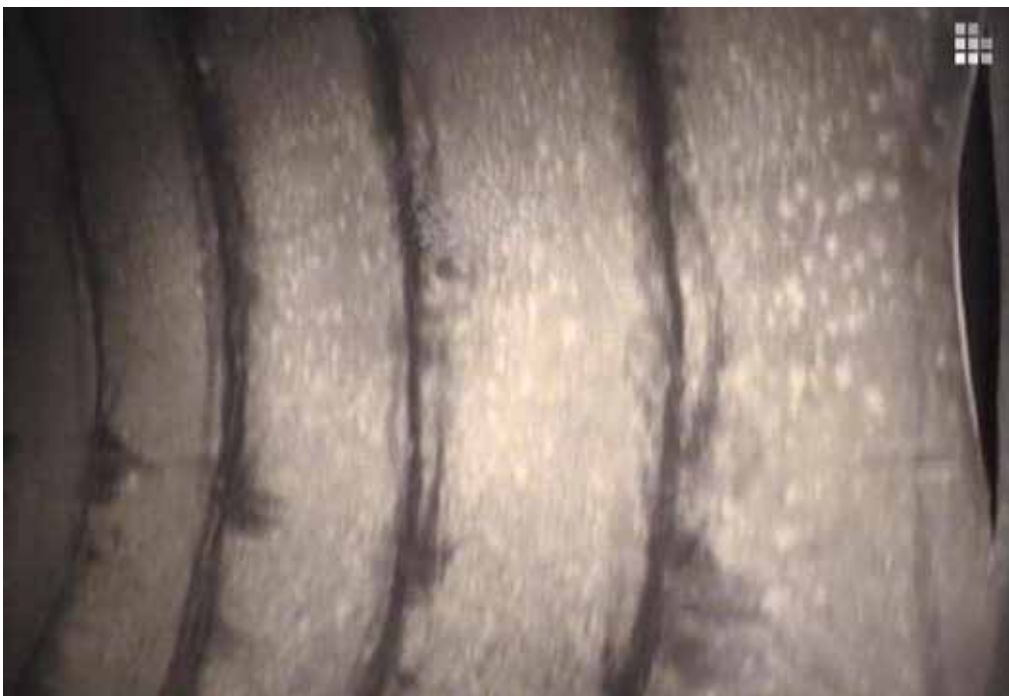
Figure 202 View of cracking/fracture failure for pipeline No. 31 (Site No. 9: Rochester)

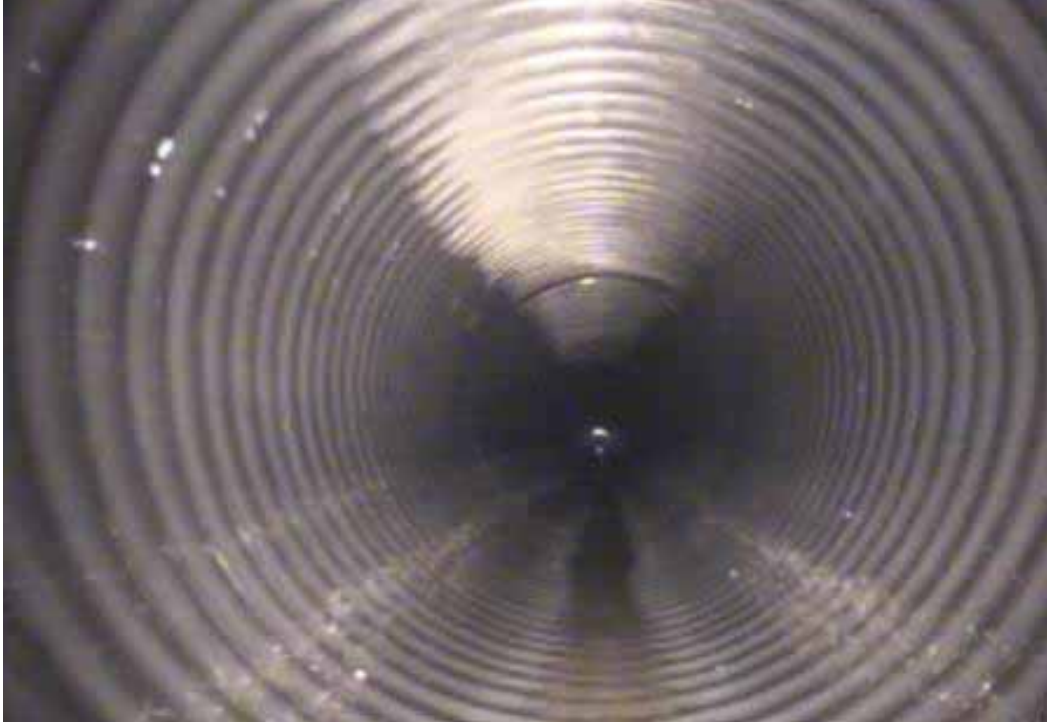
Figure 206 View of corrugation growth failure for pipeline No. 1 (Site No. 1: Lenexa)

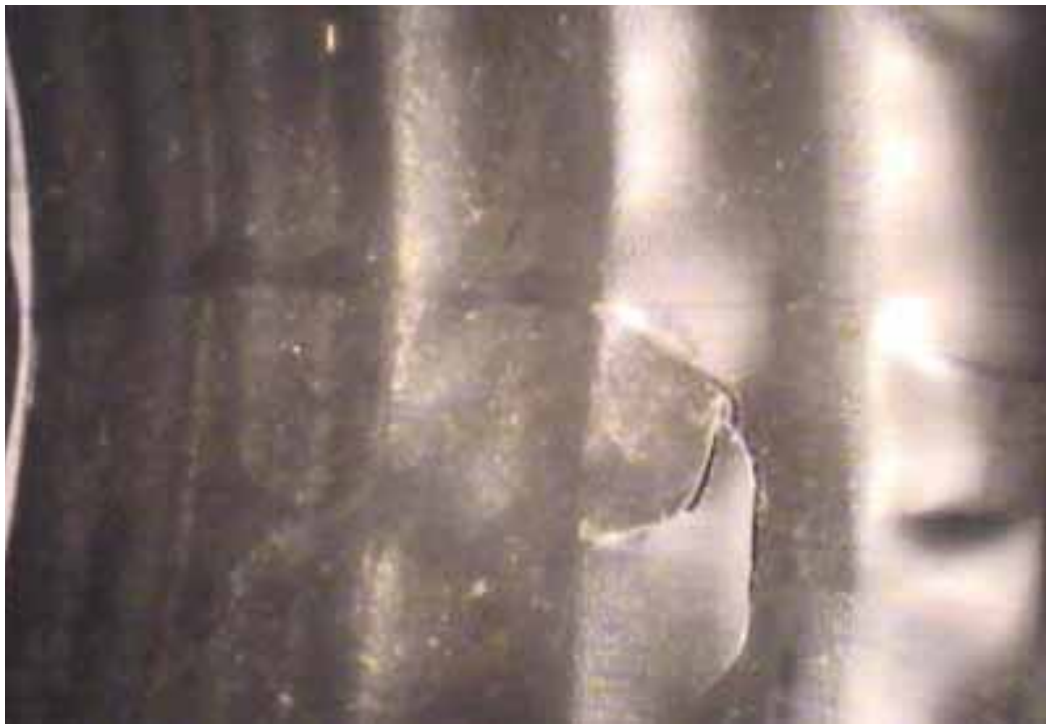
Figure 208 View of the cracking failure for pipeline No. 2 (Site No. 1: Lenexa)

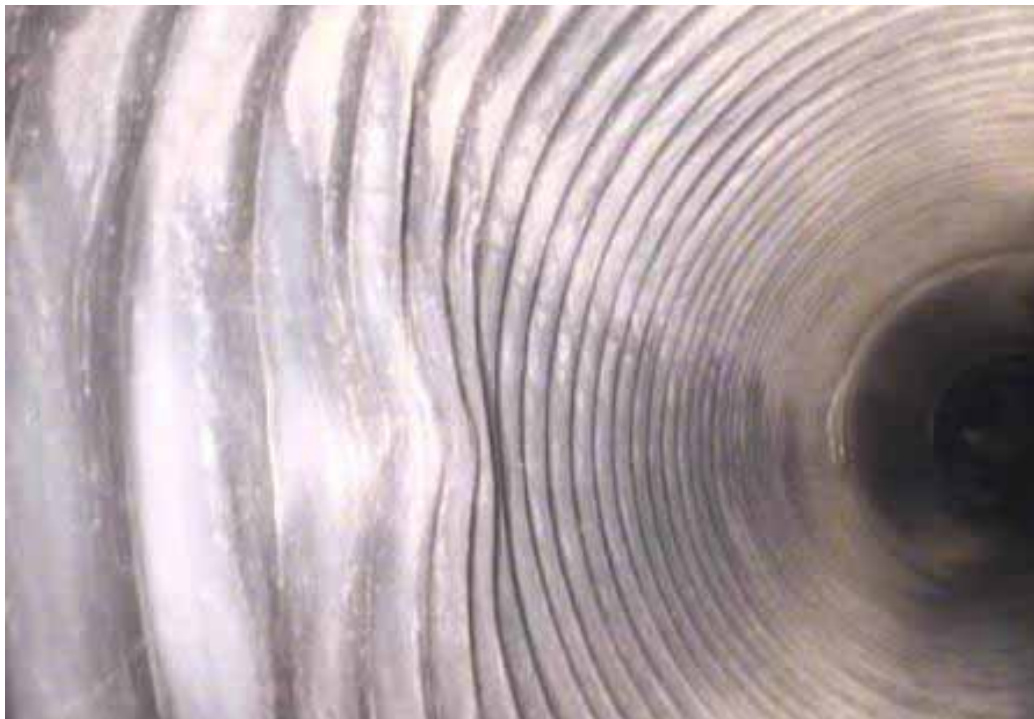
Figure 212 View of inverse curvature failure for pipeline No. 4 (Site No. 1: Lenexa)

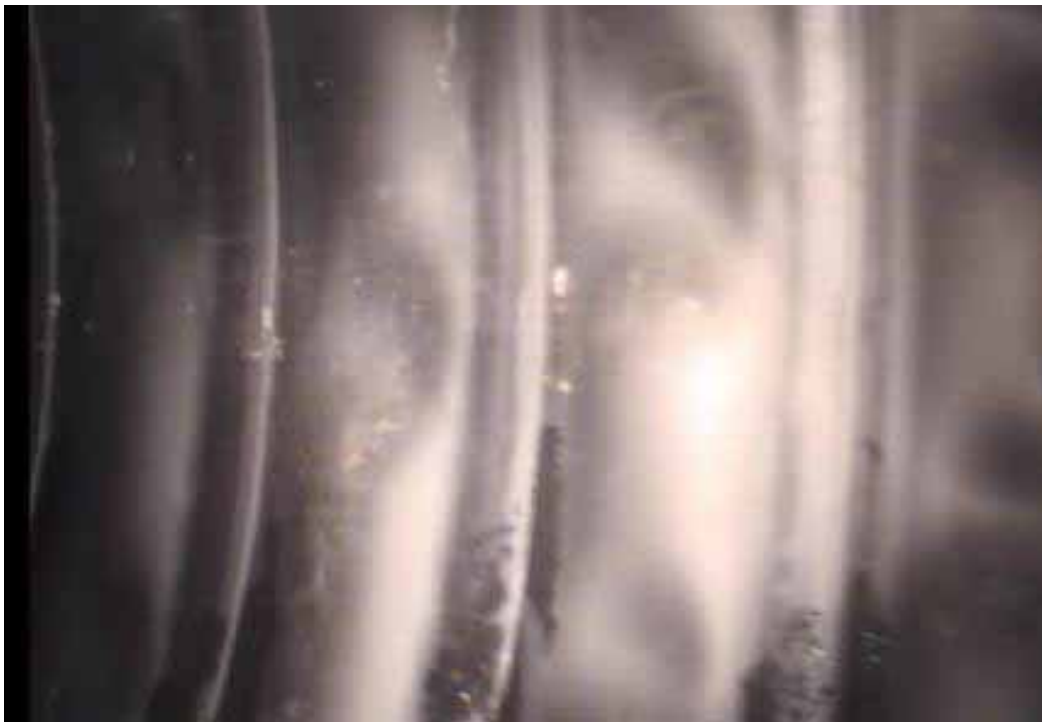
Figure 215 View of the buckling failure for pipeline No. 5 (Site No. 1: Lenexa)

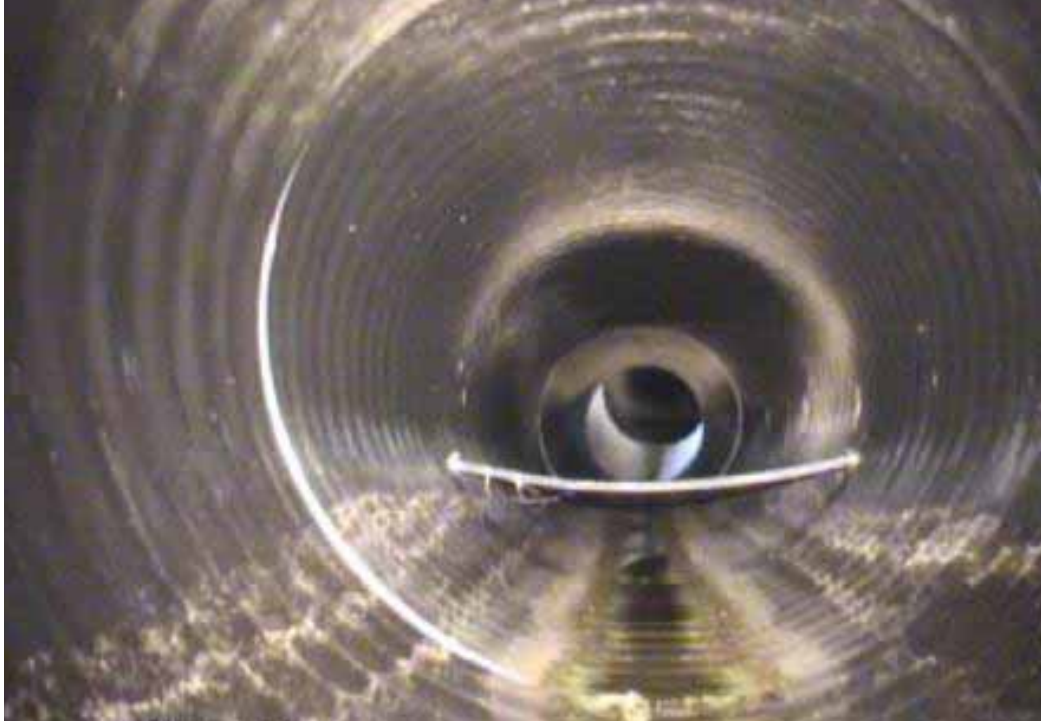
Figure 218 View of corrugation failure and pipe intrusion for pipeline No. 6 (Site No. 1: Lenexa)

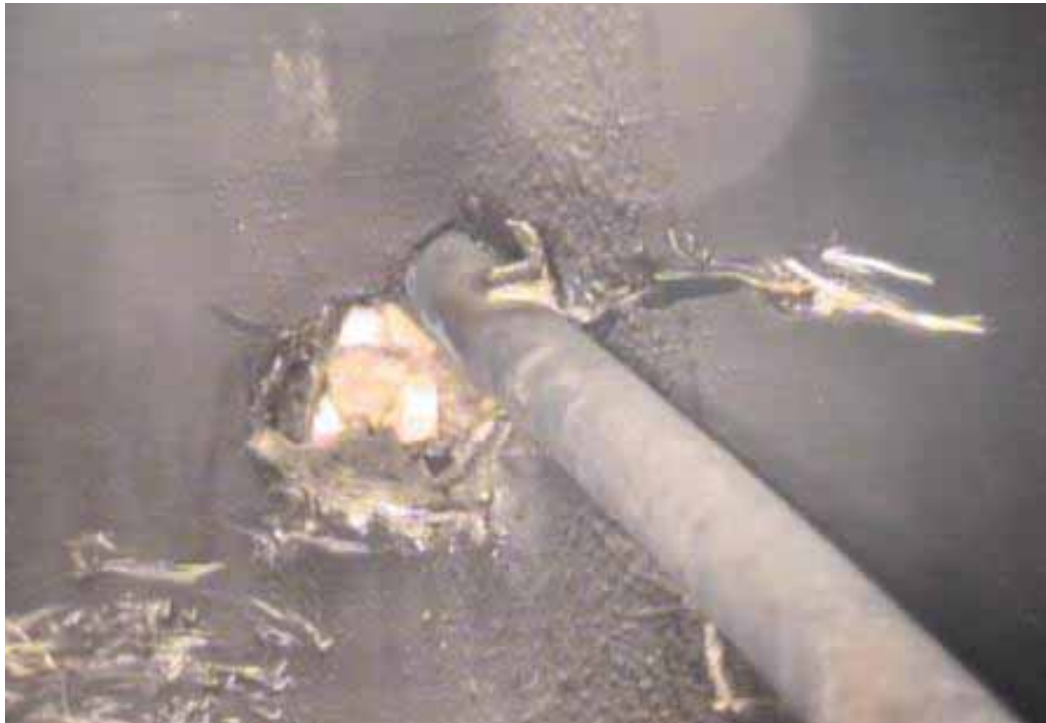
Figure 219 View of pipe intrusion for pipeline No. 6 (Site No. 1: Lenexa)

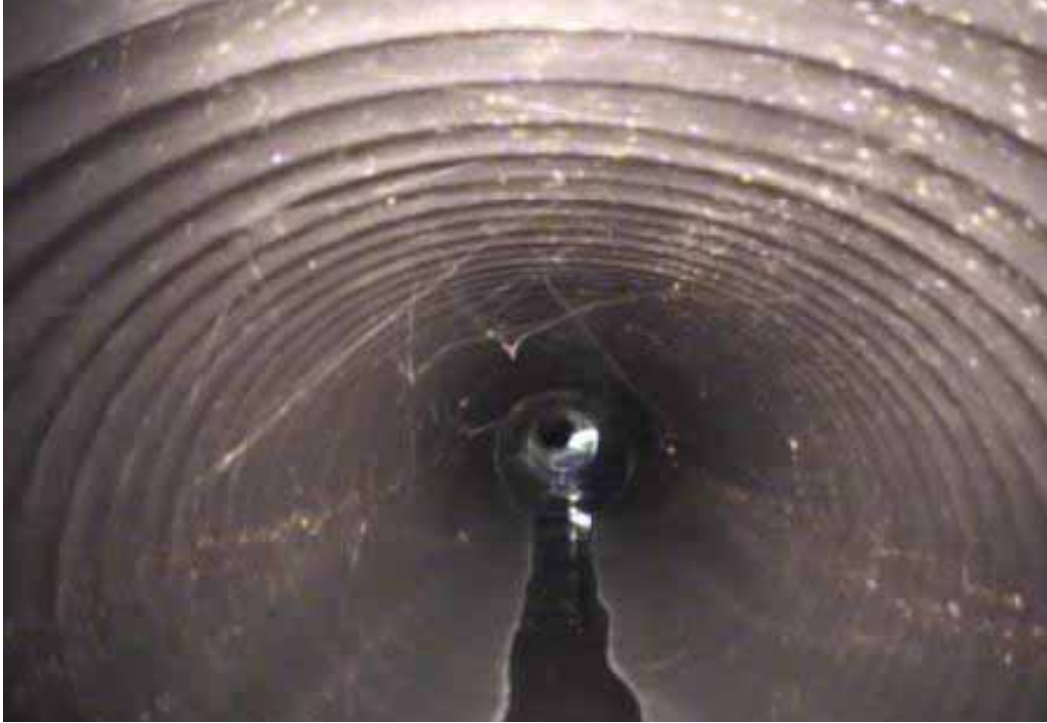
Figure 221 View of the corrugation growth failure for pipeline No. 7 (Site No. 2: Wichita)

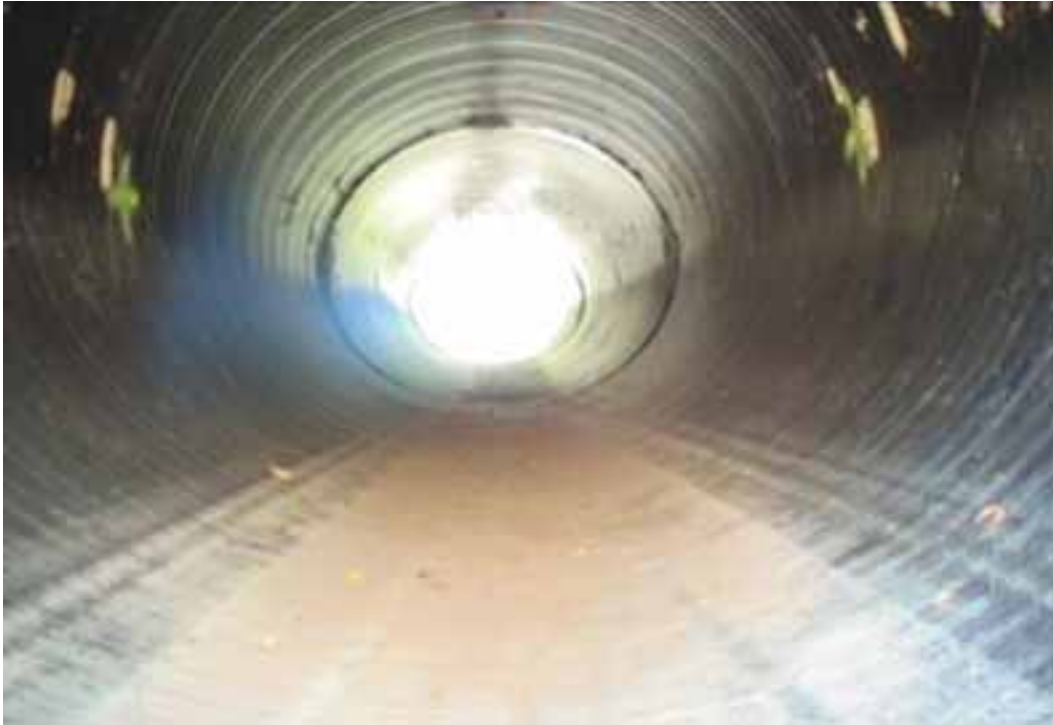
Figure 232 Corrugation growth for pipeline No. 4 (Site No. 2: St Claire County – Route B)
