Evaluation of HDPE Pipelines Structural Performance

UT Arlington Center for Structural Engineering Research

November 2010

**As a Part of the Initiative on the Underground Structural Health
Monitoring and Equipment Development**

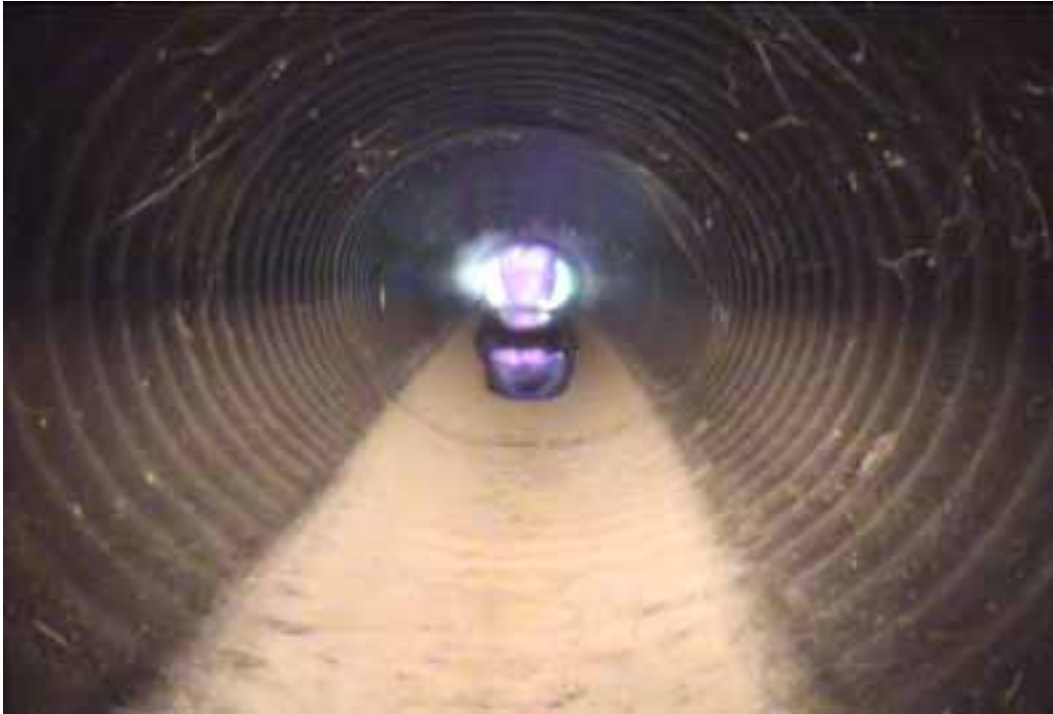
Figure 234 Corrugation growth for pipeline No. 5 (Site No. 3: Franklin County – Route FF)

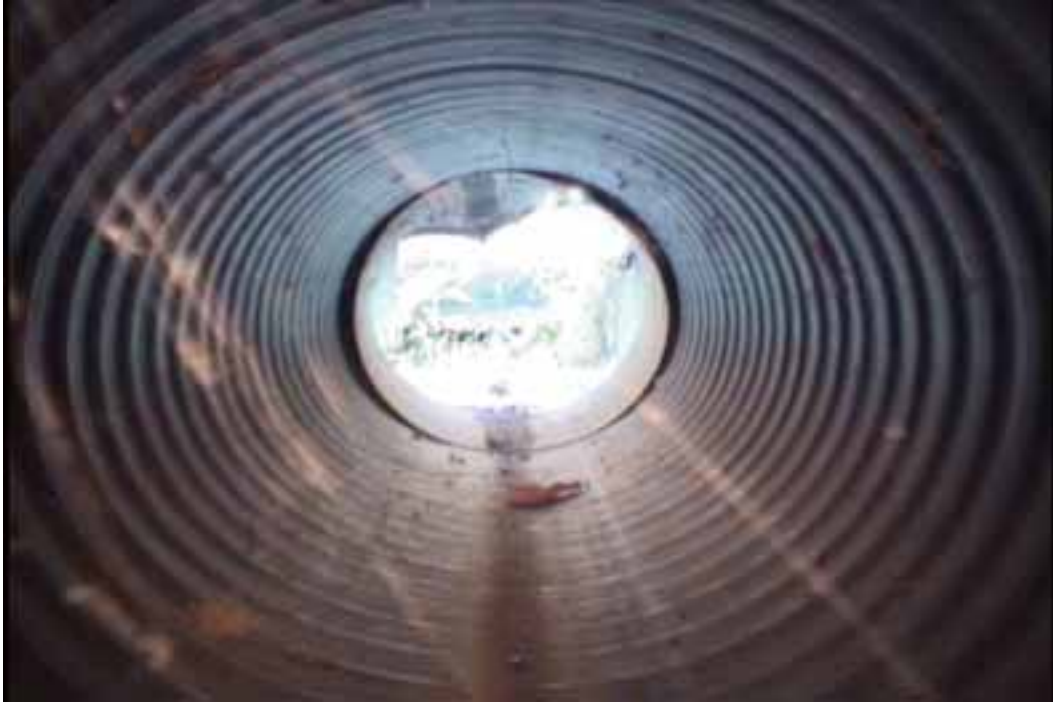
Figure 240 Corrugation growth for pipeline No. 9 (Site No. 3: Franklin County – Route FF)

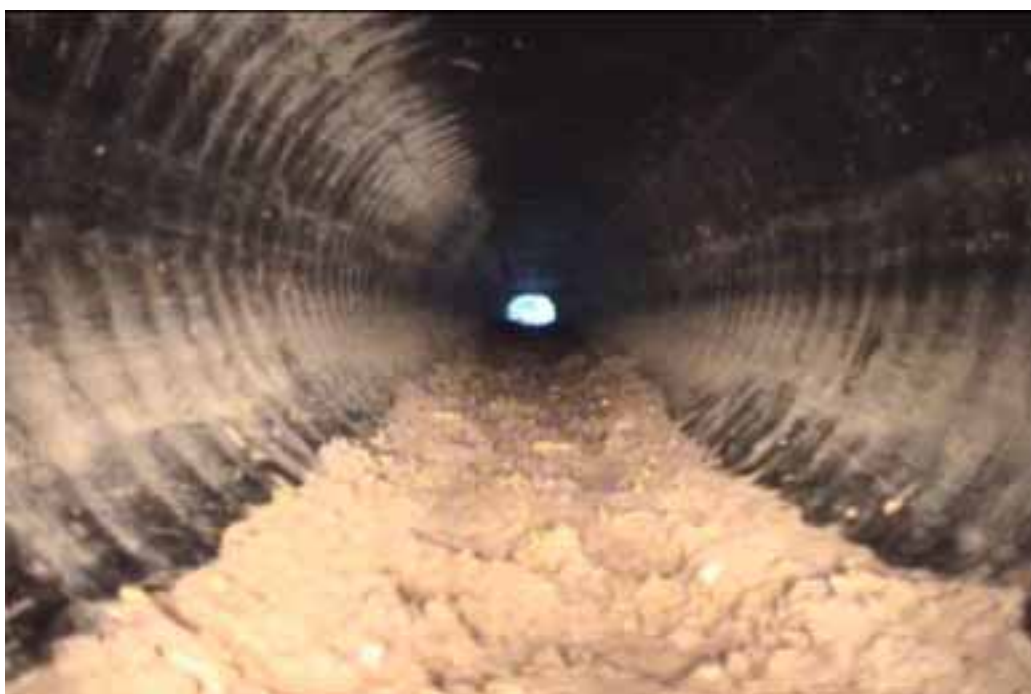
Figure 242 Corrugation growth for pipeline No. 10 (Site No. 3: Franklin County – Route FF)

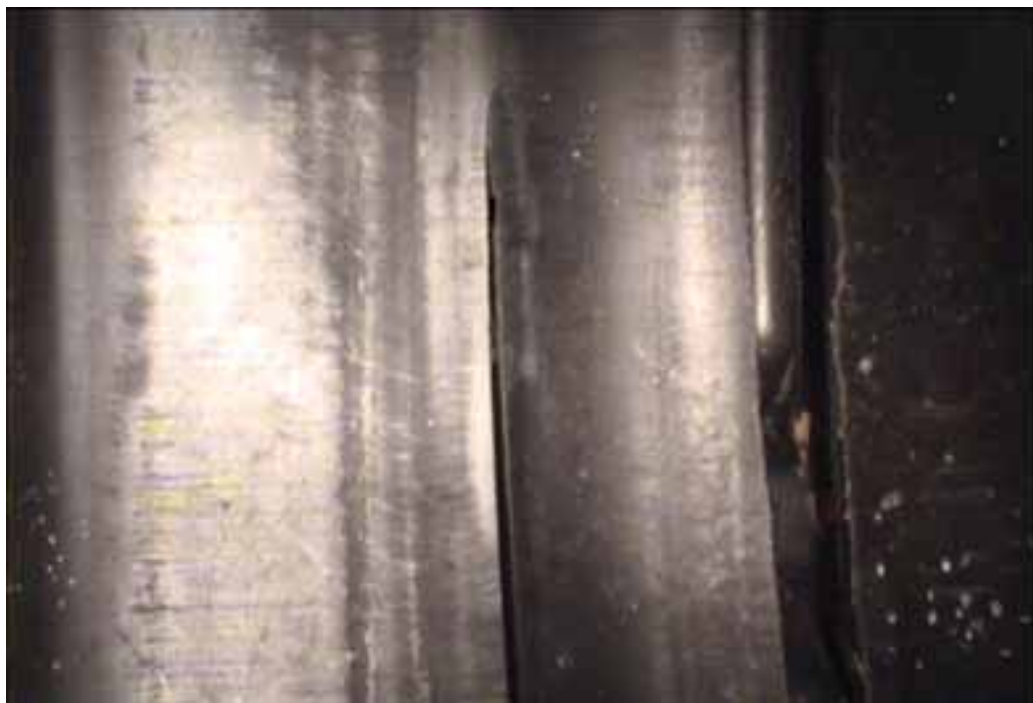
Figure 244 Cracking failure for pipeline No. 11 (Site No. 3: Franklin County – Route FF)

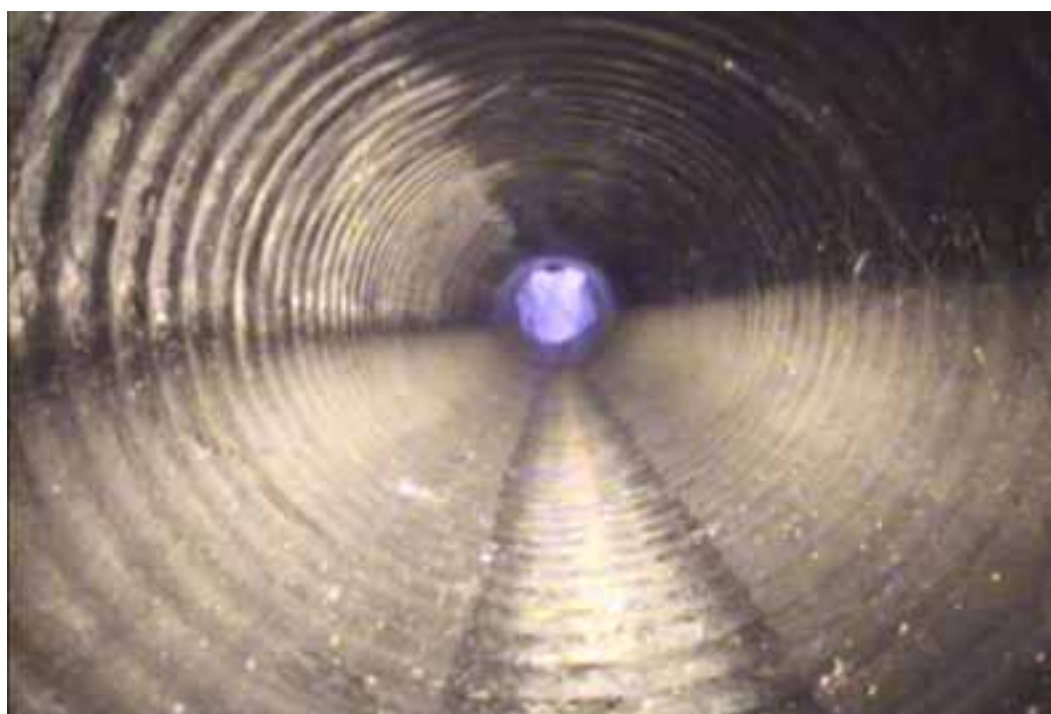
Figure 245 Corrugation growth failure for pipeline No. 11 (Site No. 3: Franklin County – Route FF)

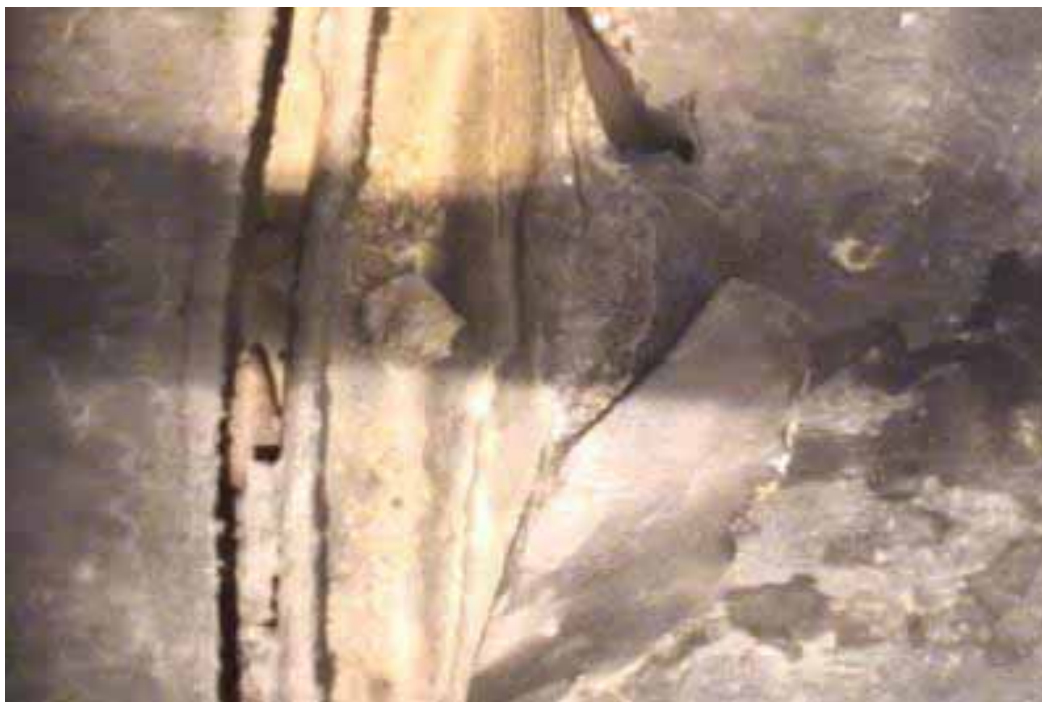
Figure 252 Cracking/fracture failure for Pipeline No. 1 (Site No. 1: Route 101)

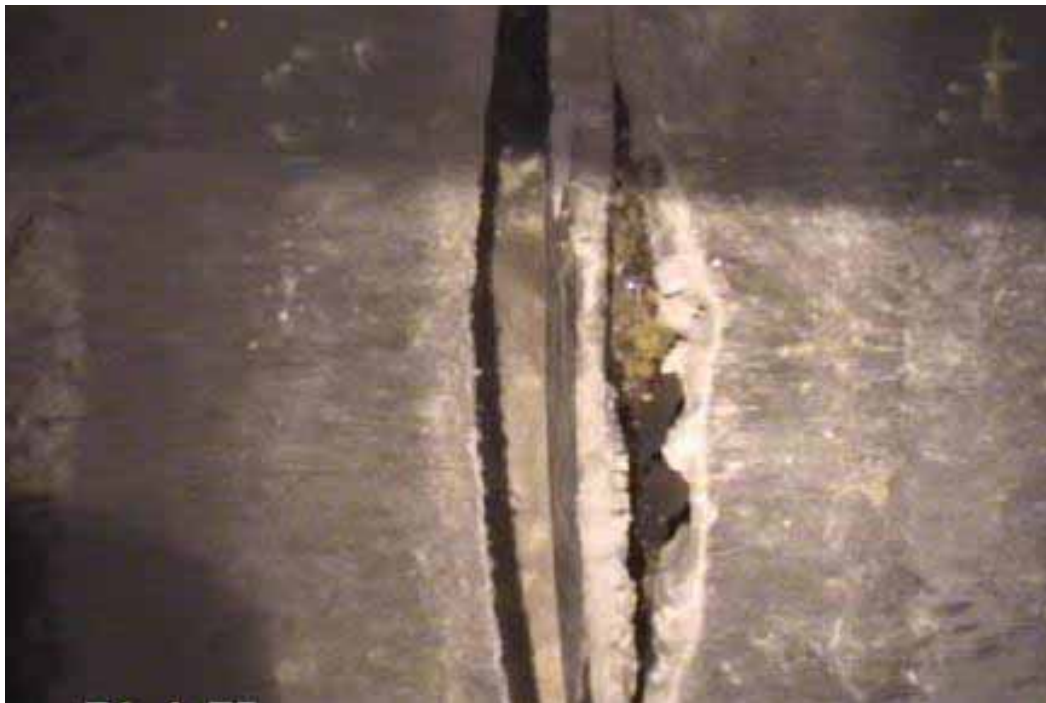
Figure 253 Cracking/fracture failure for Pipeline No. 1 (Site No. 1: Route 101)

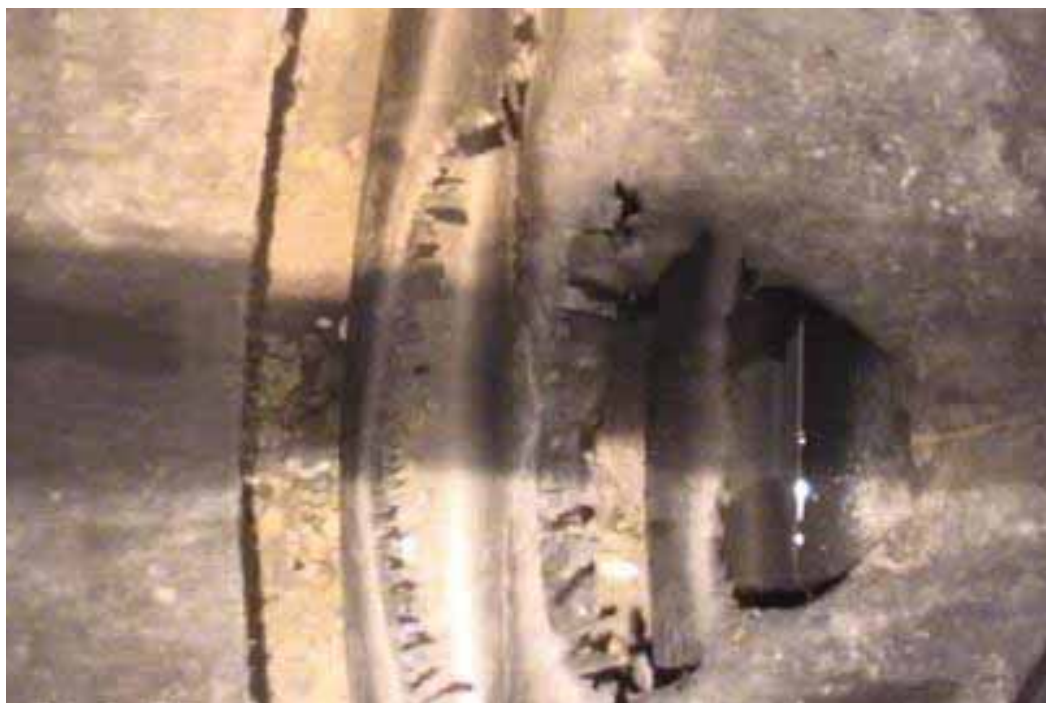
Figure 254 Cracking/fracture failure for Pipeline No. 1 (Site No. 1: Route 101)

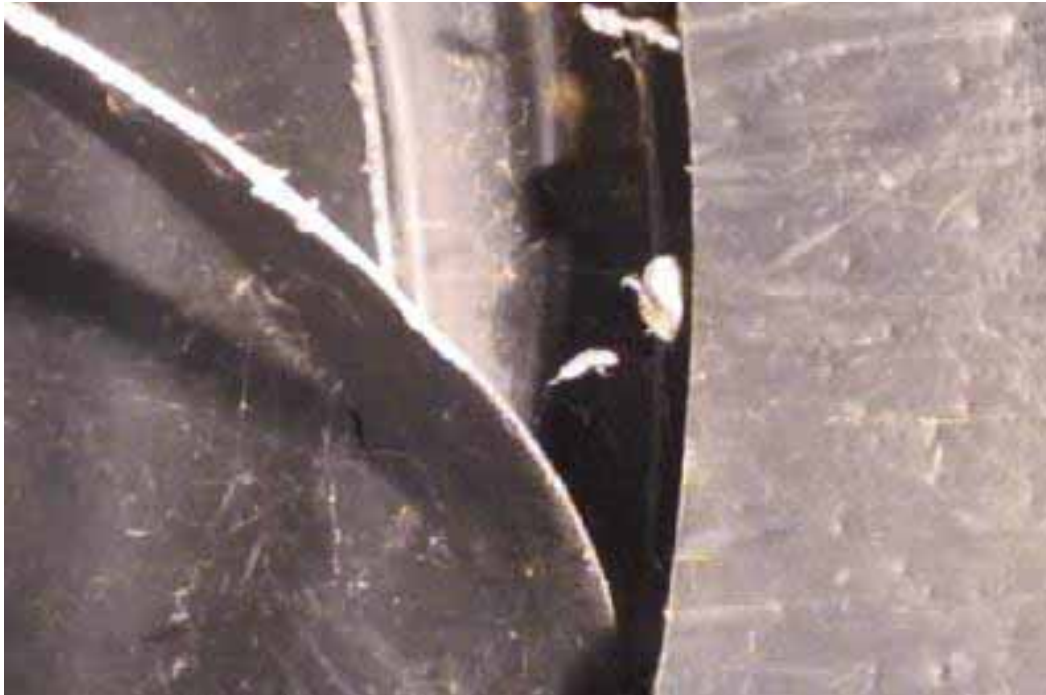
Figure 255 Cracking/fracture failure for Pipeline No. 1 (Site No. 1: Route 101)

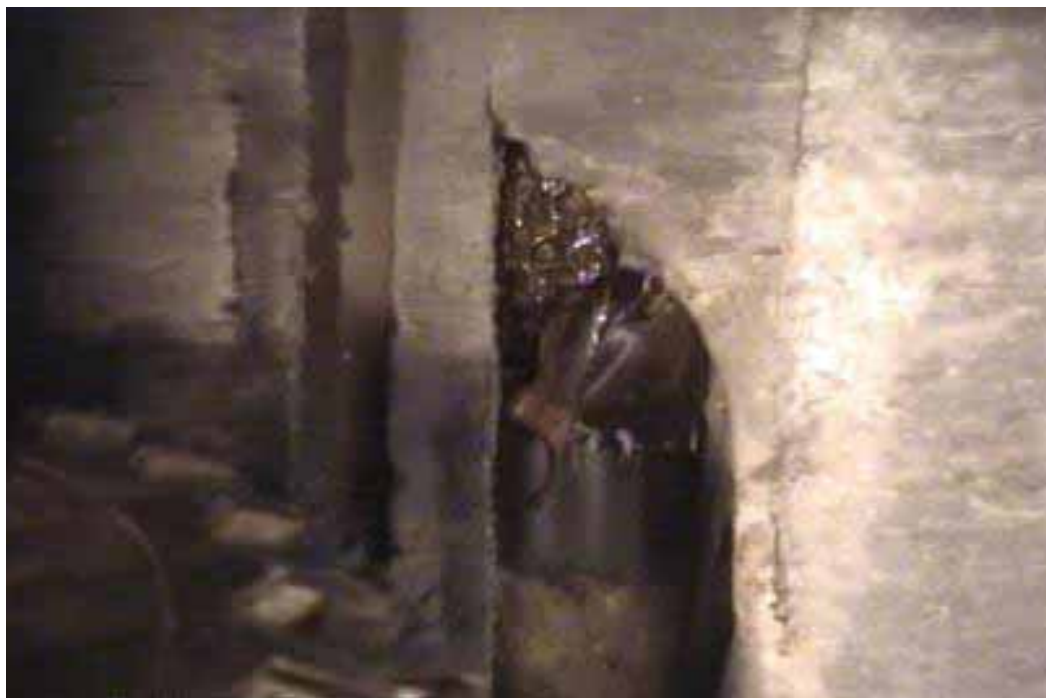
Figure 256 Cracking/fracture failure for Pipeline No. 1 (Site No. 1: Route 101)

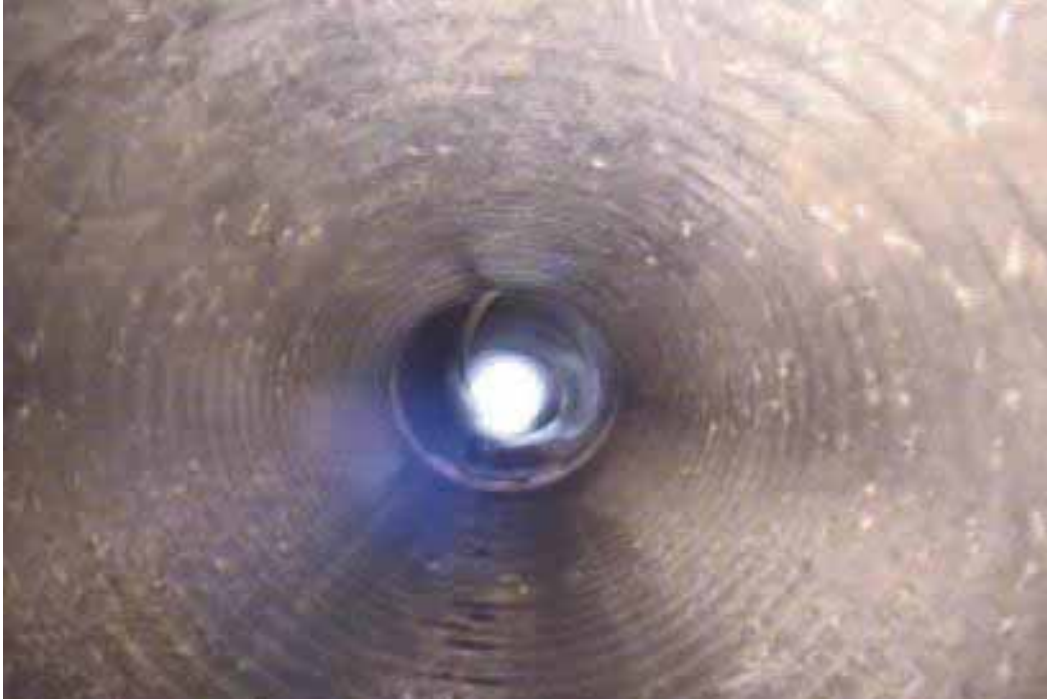
Figure 257 Corrugation growth failure for Pipeline No. 1 (Site No. 1: Route 101)

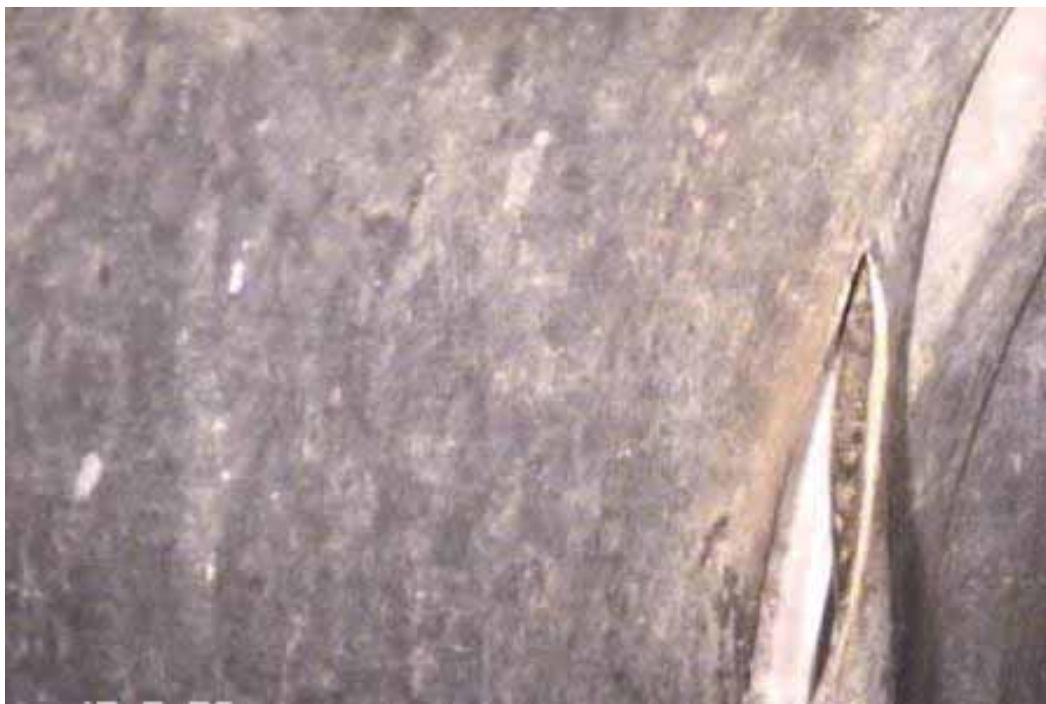
Figure 259 Cracking/fracture failure for Pipeline No. 2 (Site No. 1: Route 101)

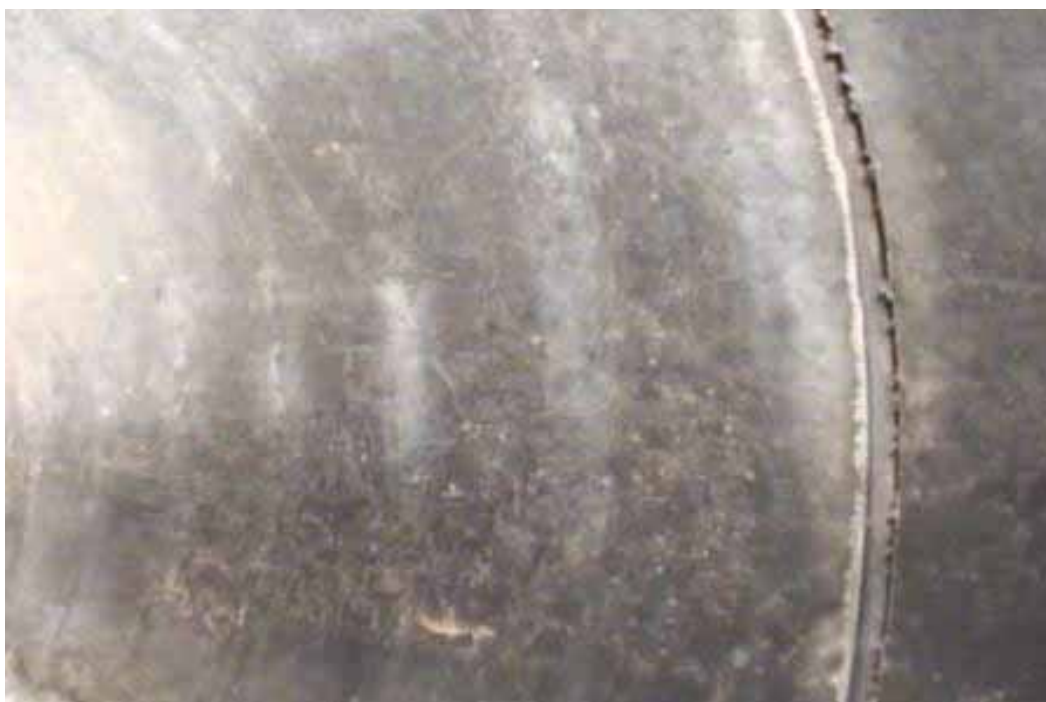
Figure 260 Cracking/fracture failure for Pipeline No. 2 (Site No. 1: Route 101)

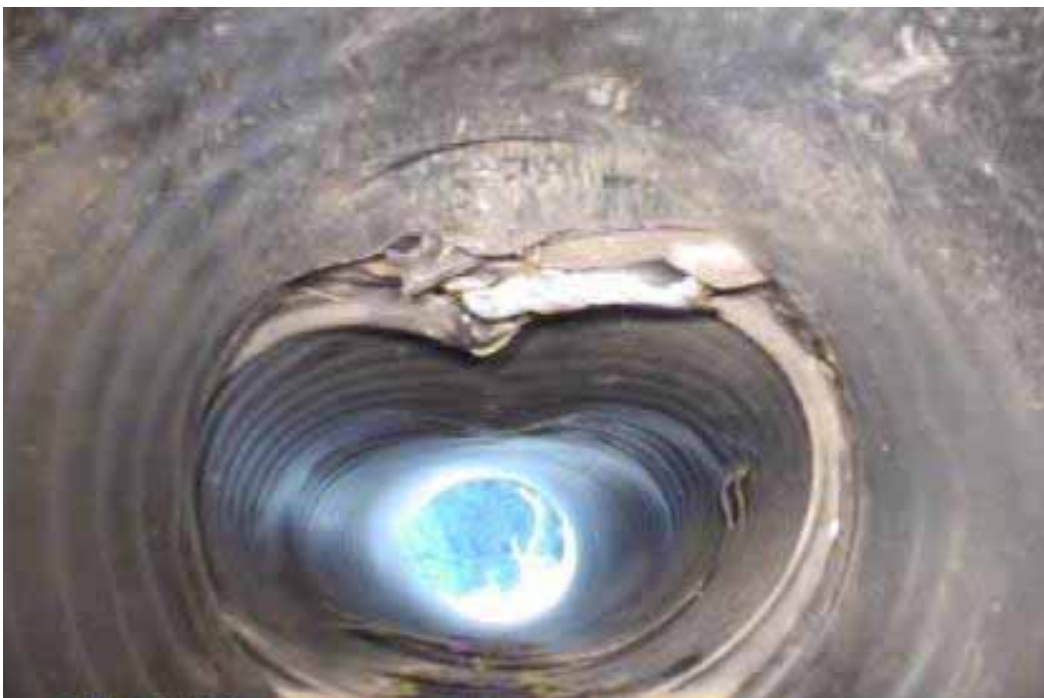
Figure 262 Cracking/fracture, inverse curvature, and excessive deformation failures for Pipeline No. 2 (Site No. 1: Route 101)

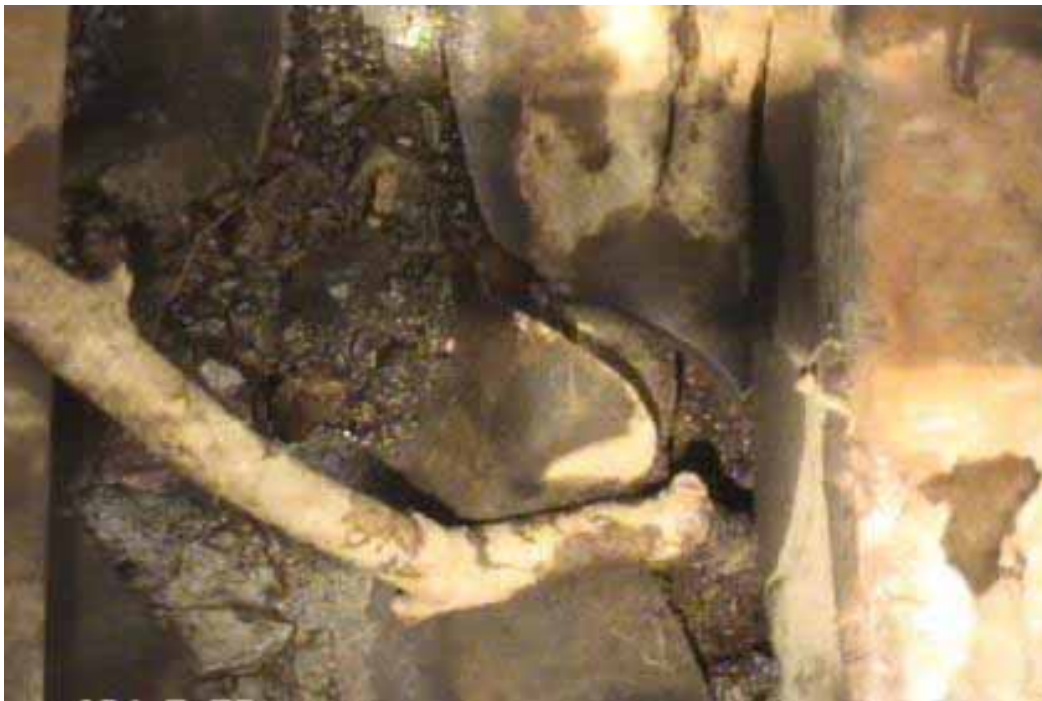
Figure 263 Cracking/fracture failure for Pipeline No. 2 (Site No. 1: Route 101)

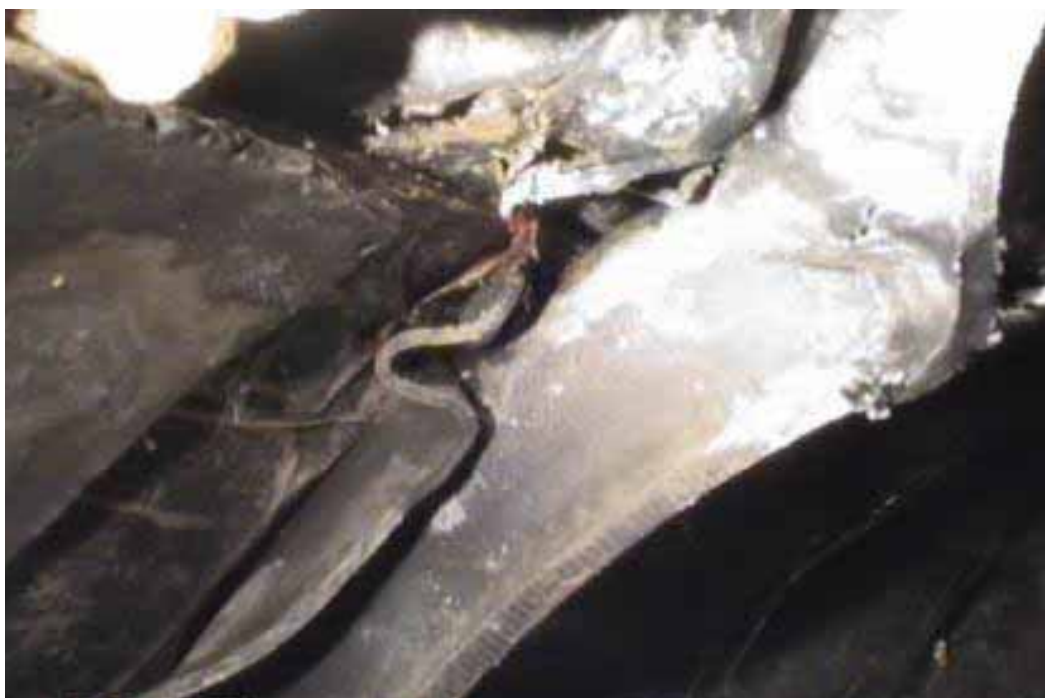
Figure 264 Cracking/fracture failures for Pipeline No. 2 (Site No. 1: Route 101)

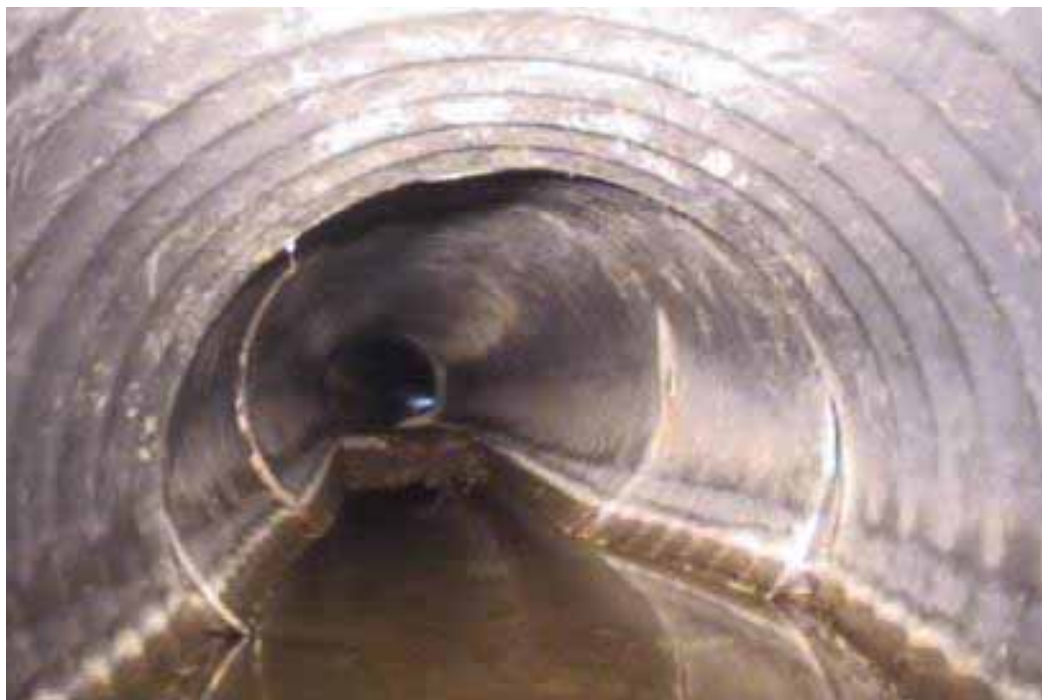
Figure 265 Corrugation growth and excessive deformation failures for Pipeline No. 2 (Site No. 1: Route 101)

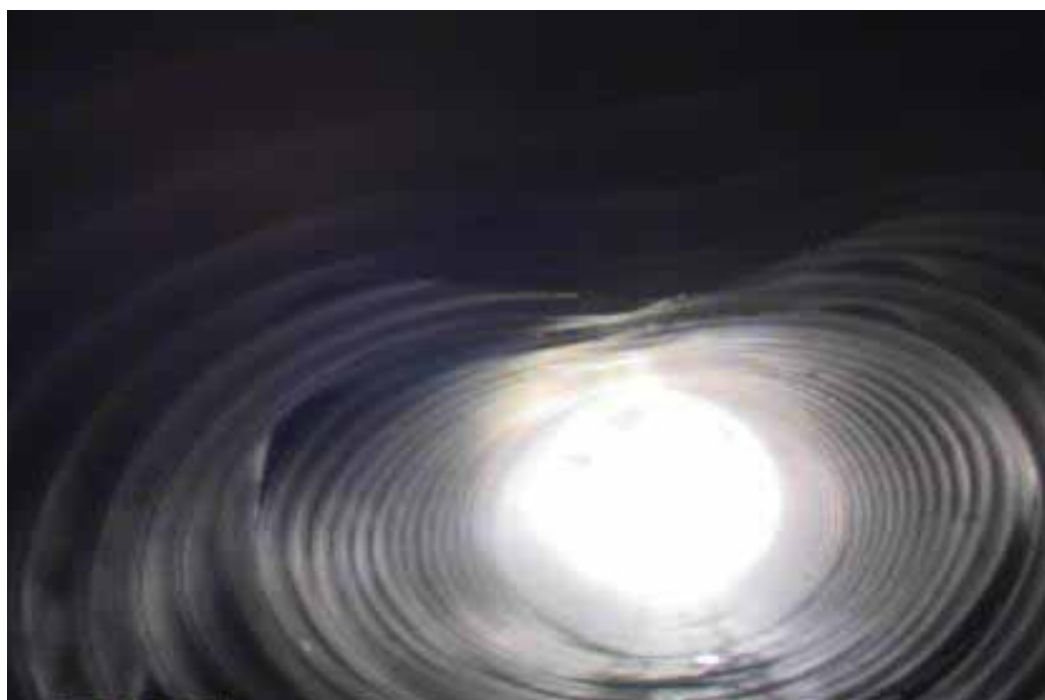
Figure 266 Corrugation growth, excessive deformation, cracking/fracture, and inverse curvature failures for Pipeline No. 2 (Site No. 1: Route 101)

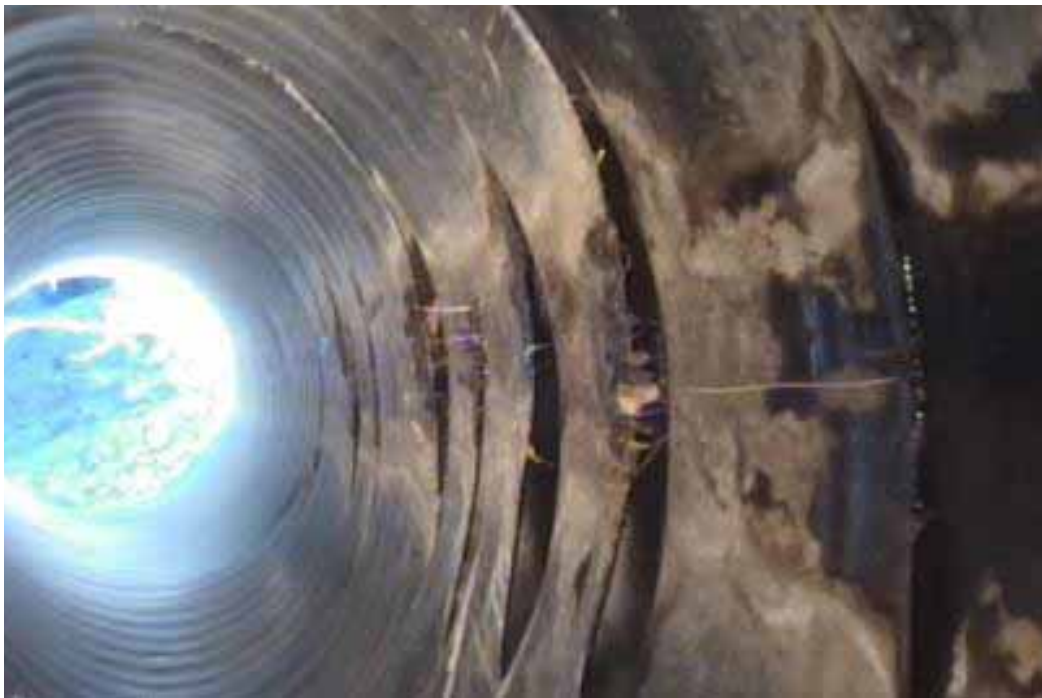
Figure 267 Corrugation growth and cracking/fracture failures for Pipeline No. 2 (Site No. 1: Route 101)

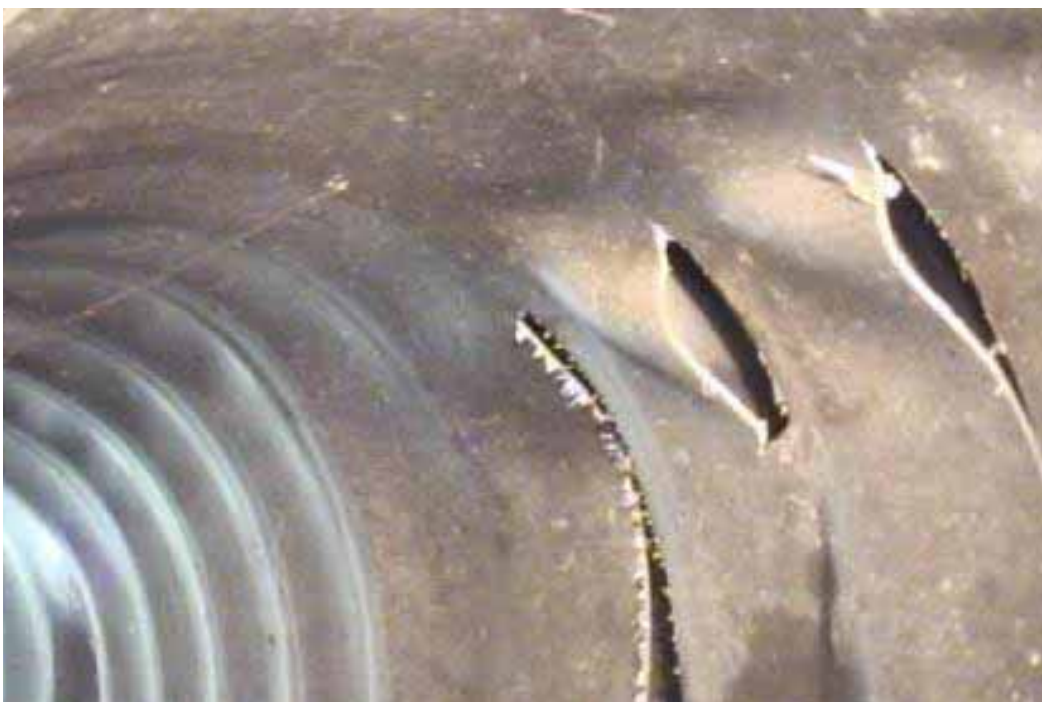
Figure 268 Corrugation growth and cracking/fracture failures for Pipeline No. 2 (Site No. 1: Route 101)

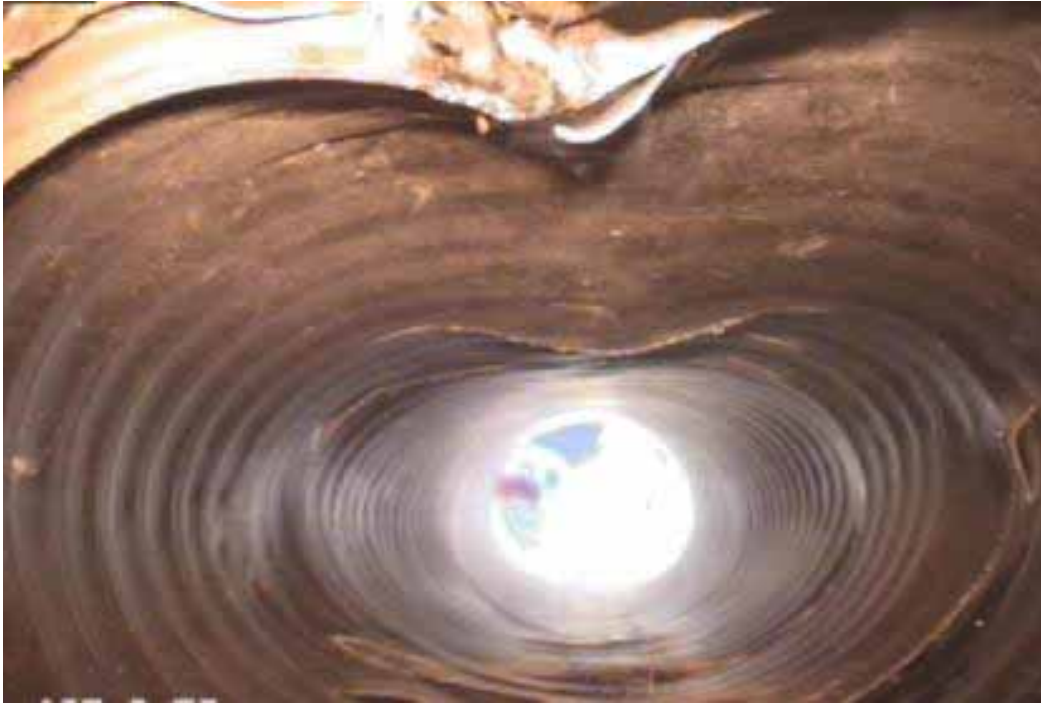
Figure 269 Inverse curvature, cracking/fracture, excessive deformation, and corrugation growth failures for Pipeline No. 2 (Site No. 1: Route 101)

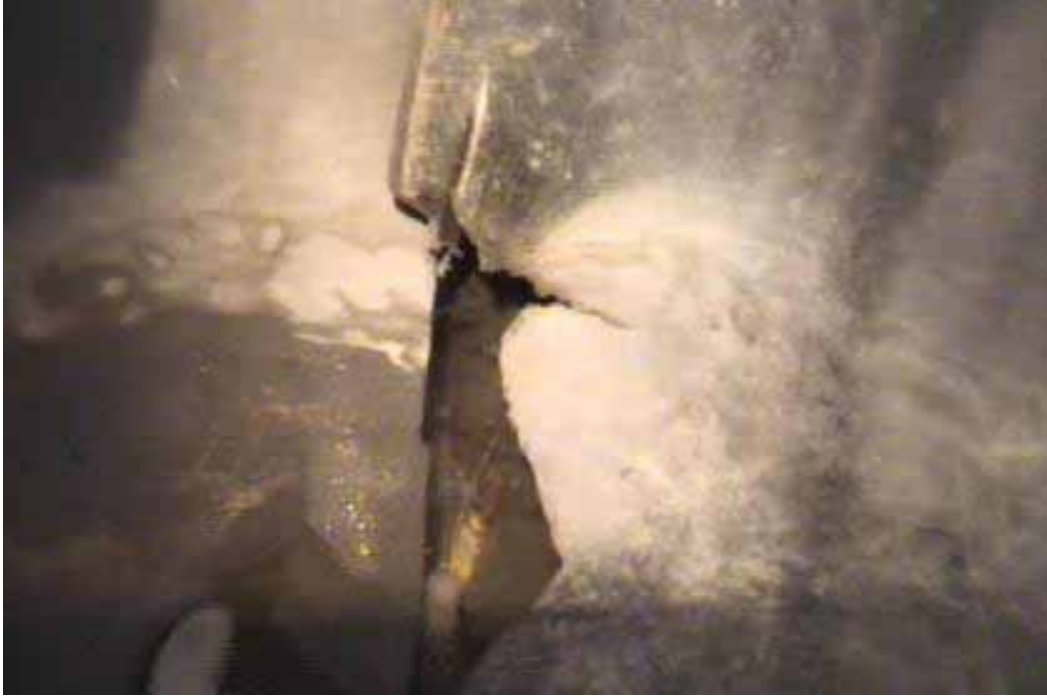
Figure 271 Cracking/fracture failure for Pipeline No. 3 (Site No. 1: Route 101)

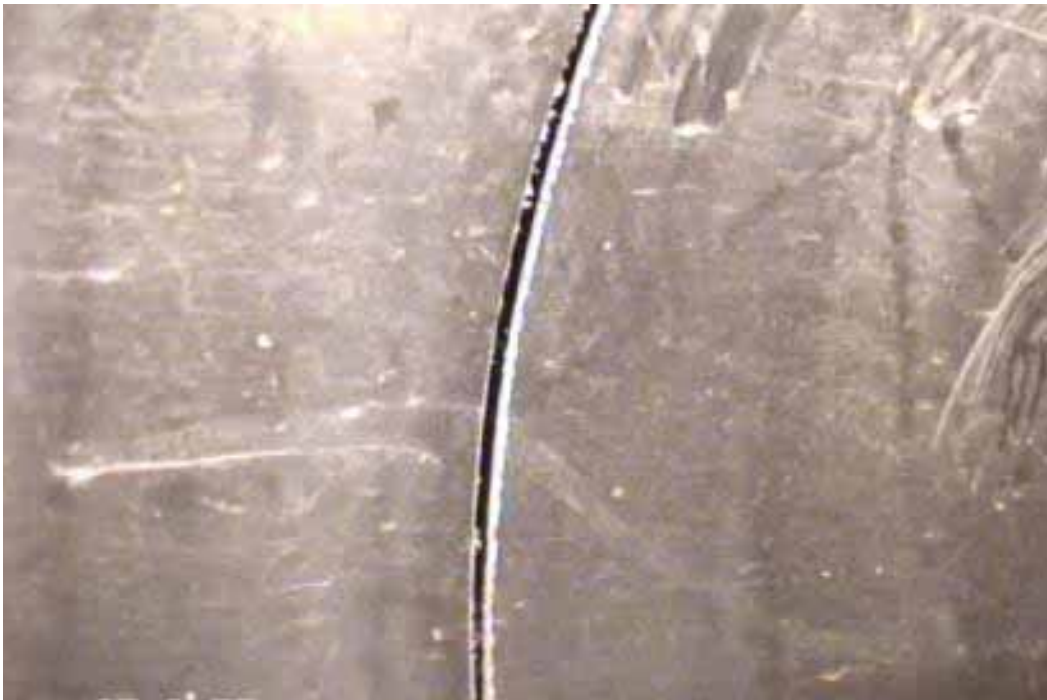
Figure 272 Cracking/fracture failure for Pipeline No. 3 (Site No. 1: Route 101)

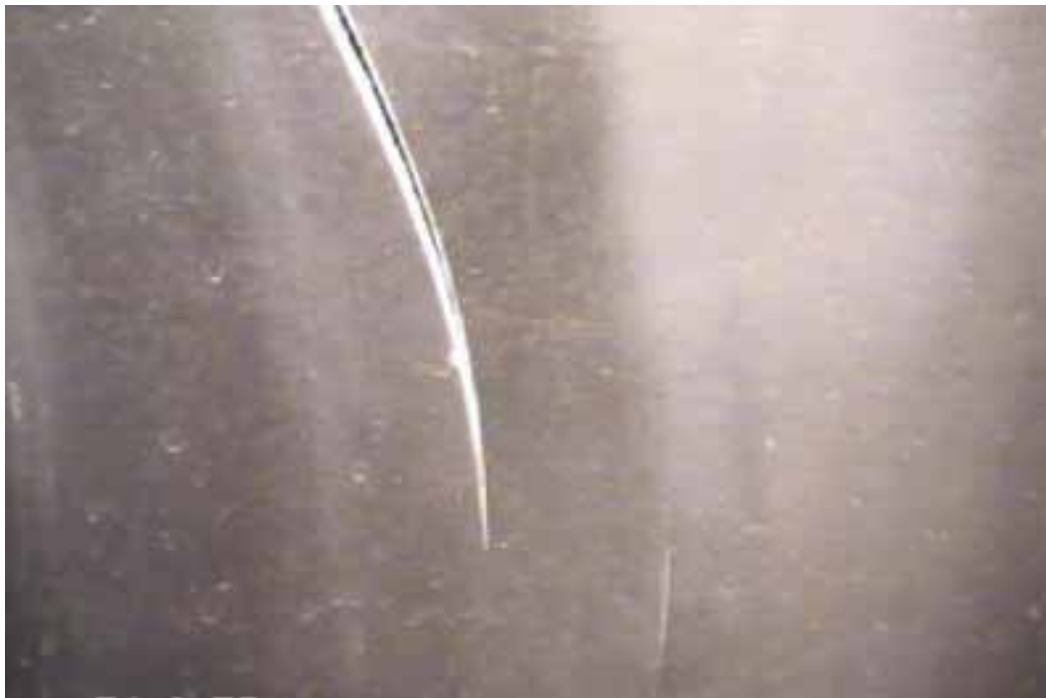
Figure 273 Cracking/fracture failure for Pipeline No. 3 (Site No. 1: Route 101)

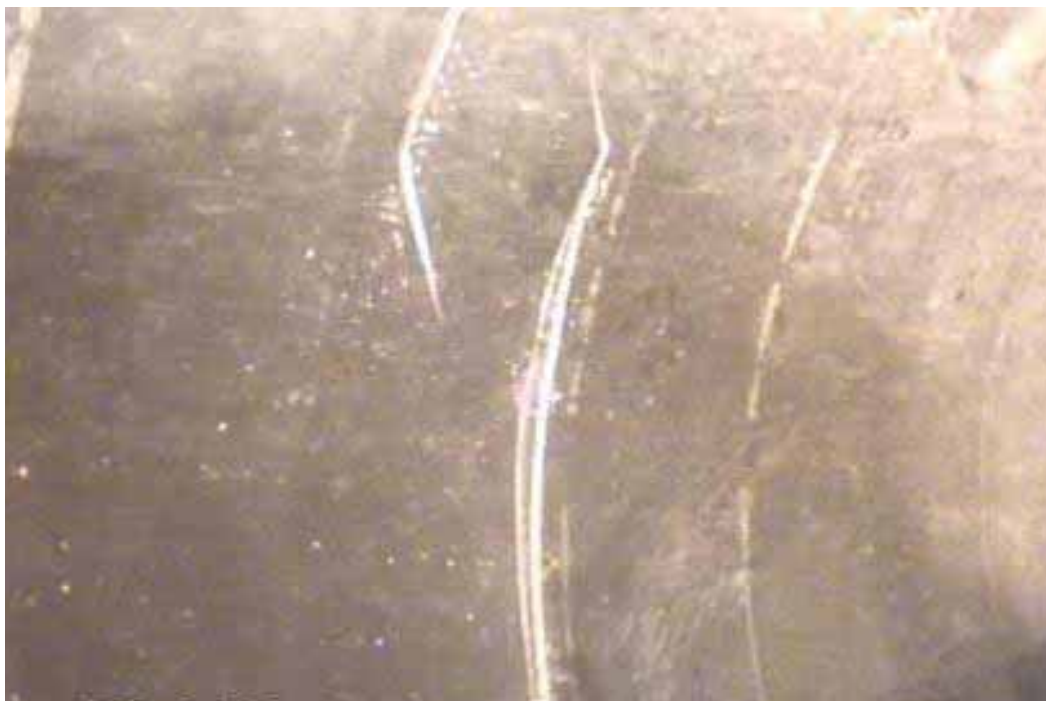
Figure 274 Cracking/fracture failure for Pipeline No. 3 (Site No. 1: Route 101)

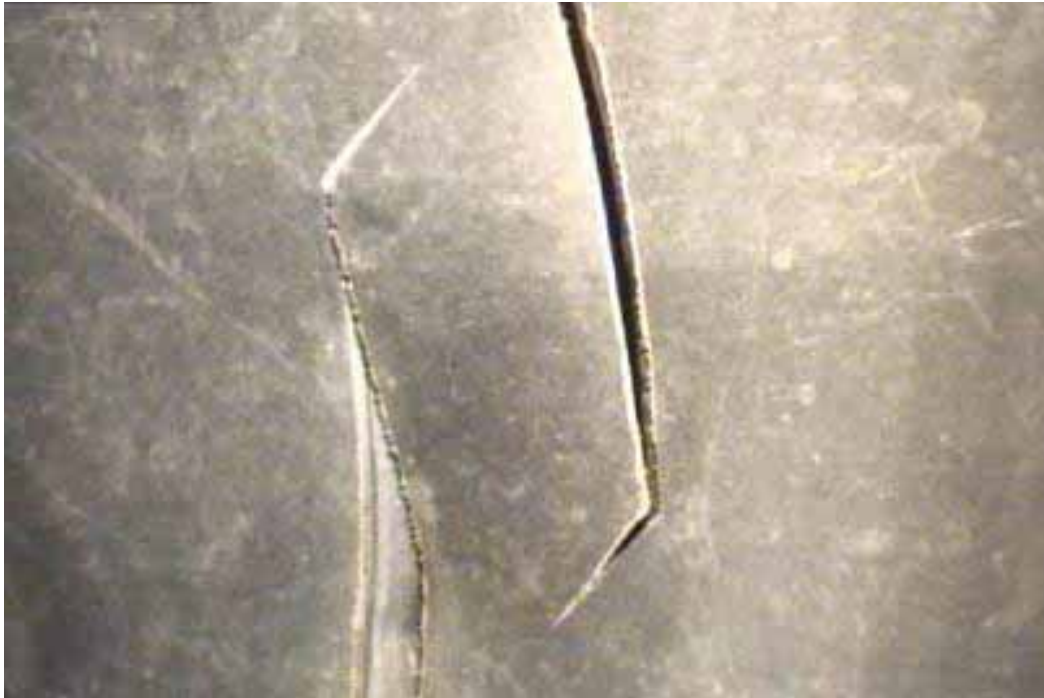
Figure 276 Cracking/fracture failure for Pipeline No. 4 (Site No. 1: Route 101)

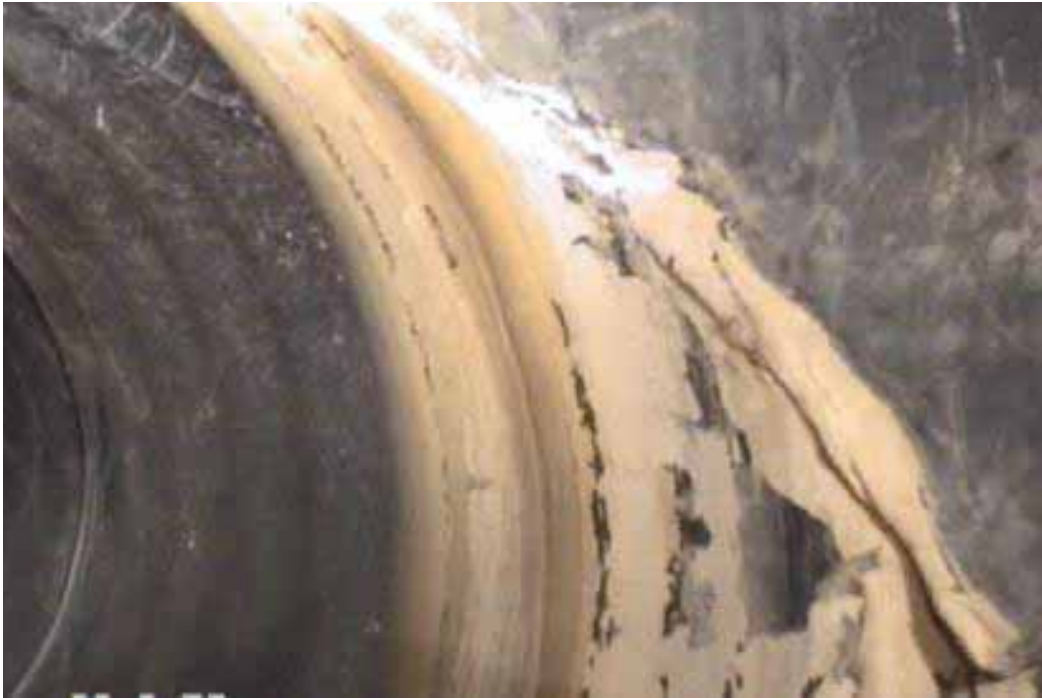
Figure 279 Cracking/fracture failure for Pipeline No. 5 (Site No. 1: Route 101)

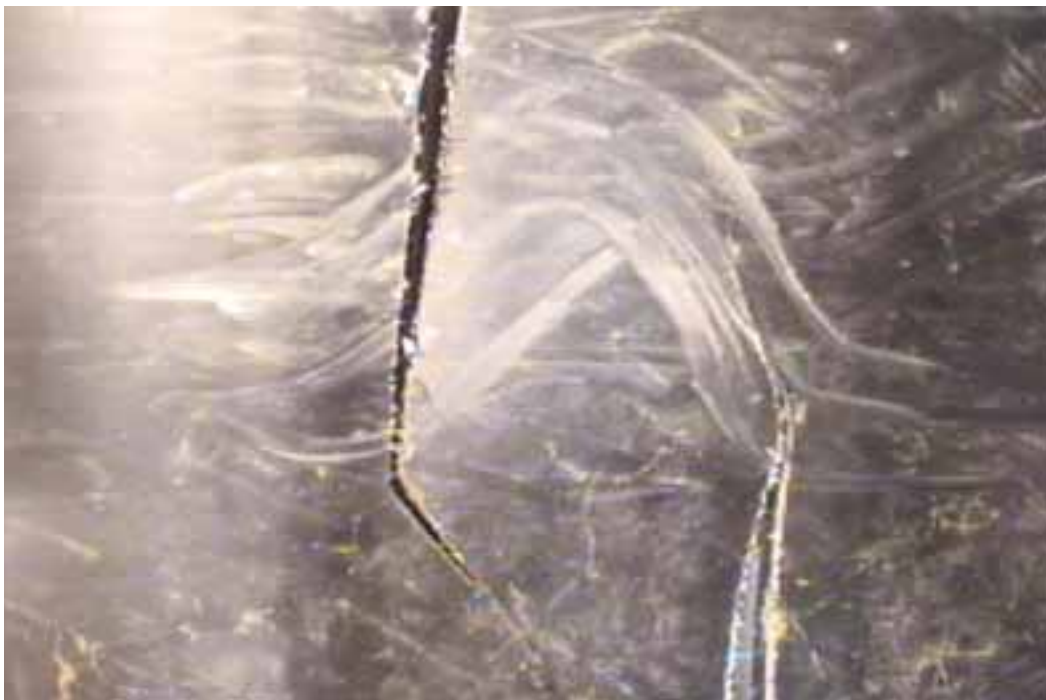
Figure 280 Cracking/fracture failure for Pipeline No. 5 (Site No. 1: Route 101)

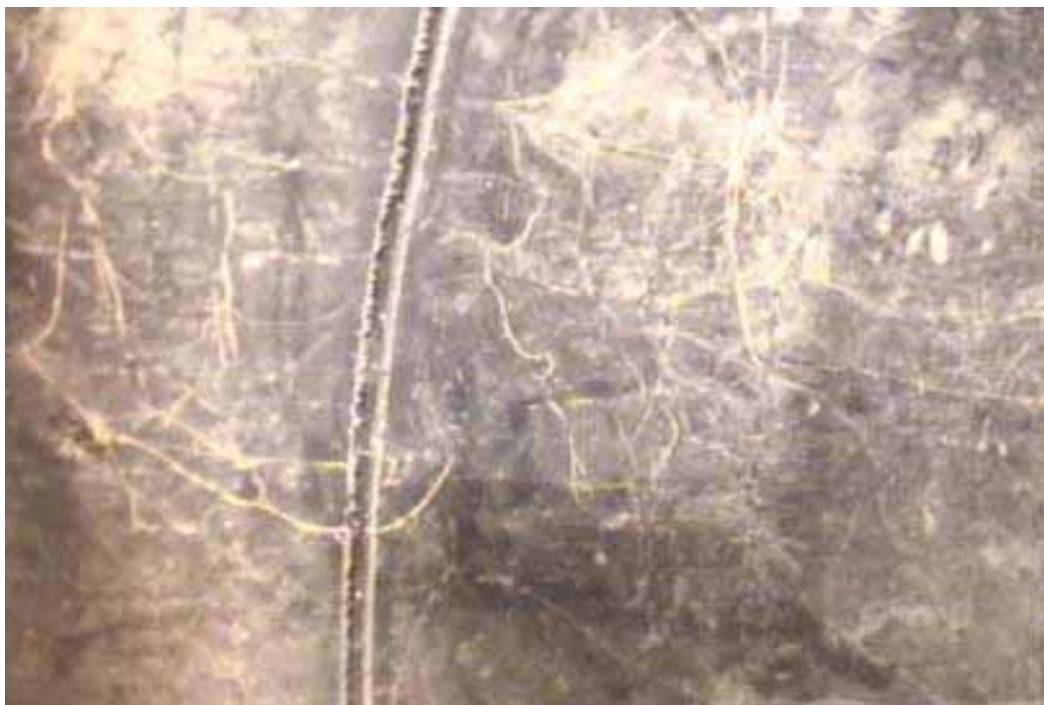
Figure 281 Cracking/fracture failure for Pipeline No. 5 (Site No. 1: Route 101)

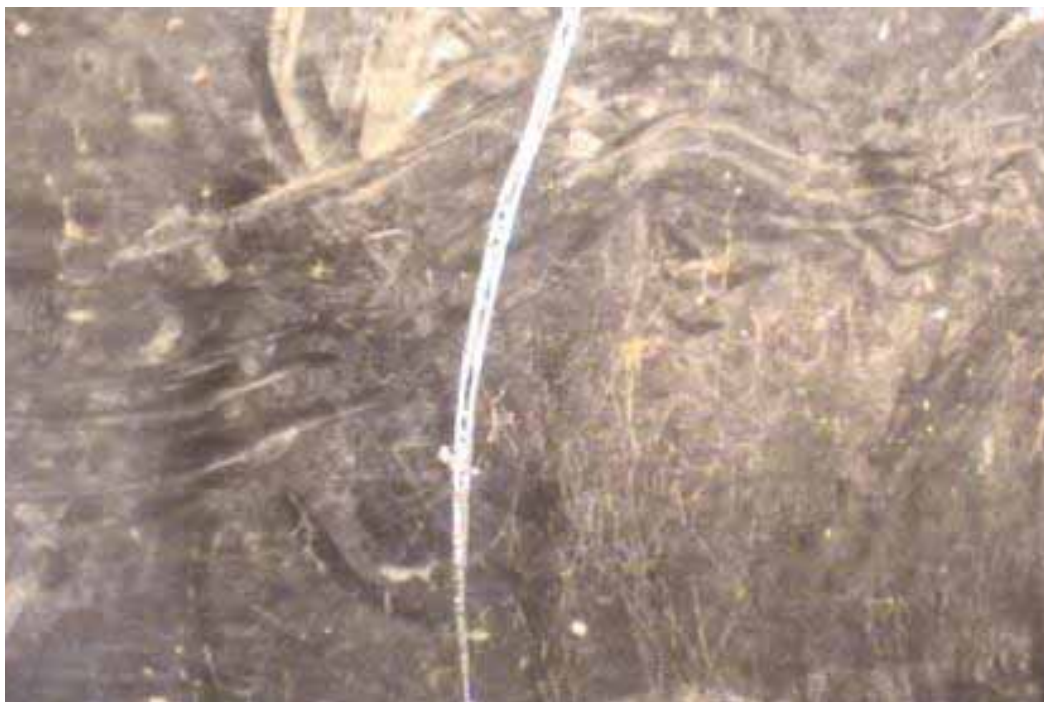
Figure 282 Cracking/fracture failure for Pipeline No. 5 (Site No. 1: Route 101)
