Evaluation of HDPE Pipelines Structural Performance

UT Arlington Center for Structural Engineering Research

November 2010

**As a Part of the Initiative on the Underground Structural Health
Monitoring and Equipment Development**

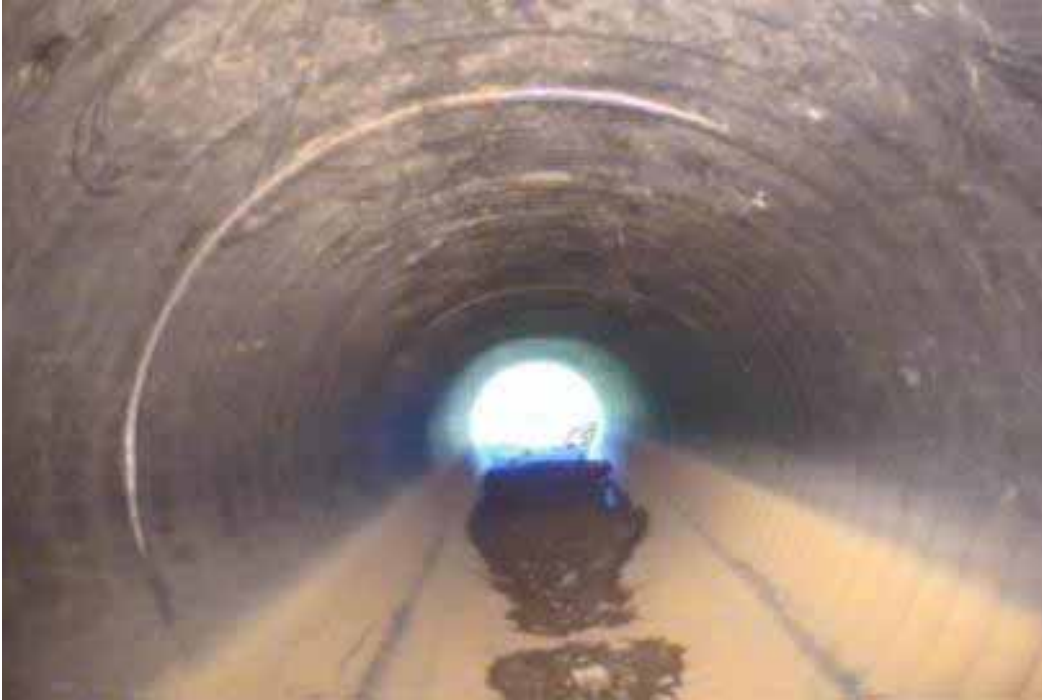
Figure 283 Cracking/fracture and corrugation growth failure for Pipeline No. 5 (Site No. 1: Route 101)

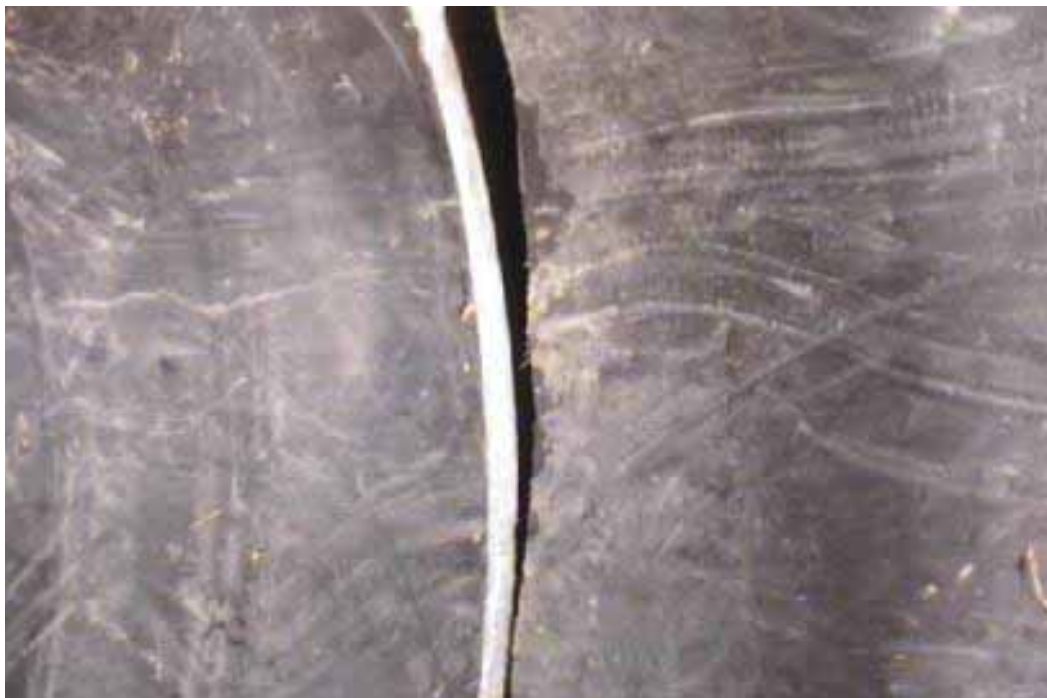
Figure 285 Cracking/fracture failure for Pipeline No. 6 (Site No. 1: Route 101)

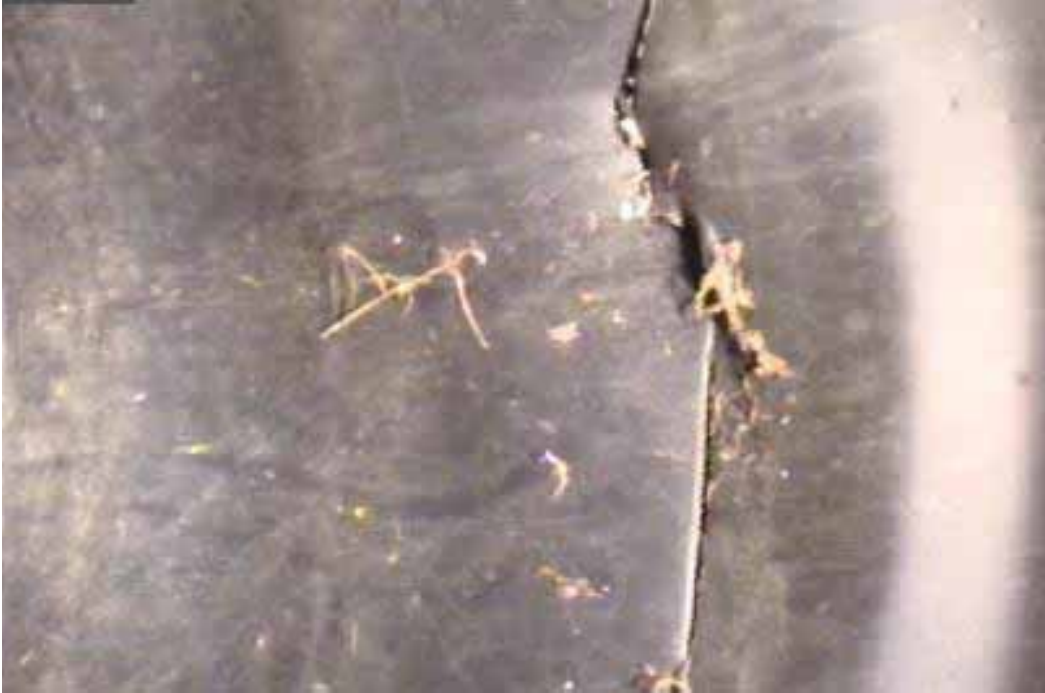
Figure 286 Cracking/fracture failure for Pipeline No. 6 (Site No. 1: Route 101)

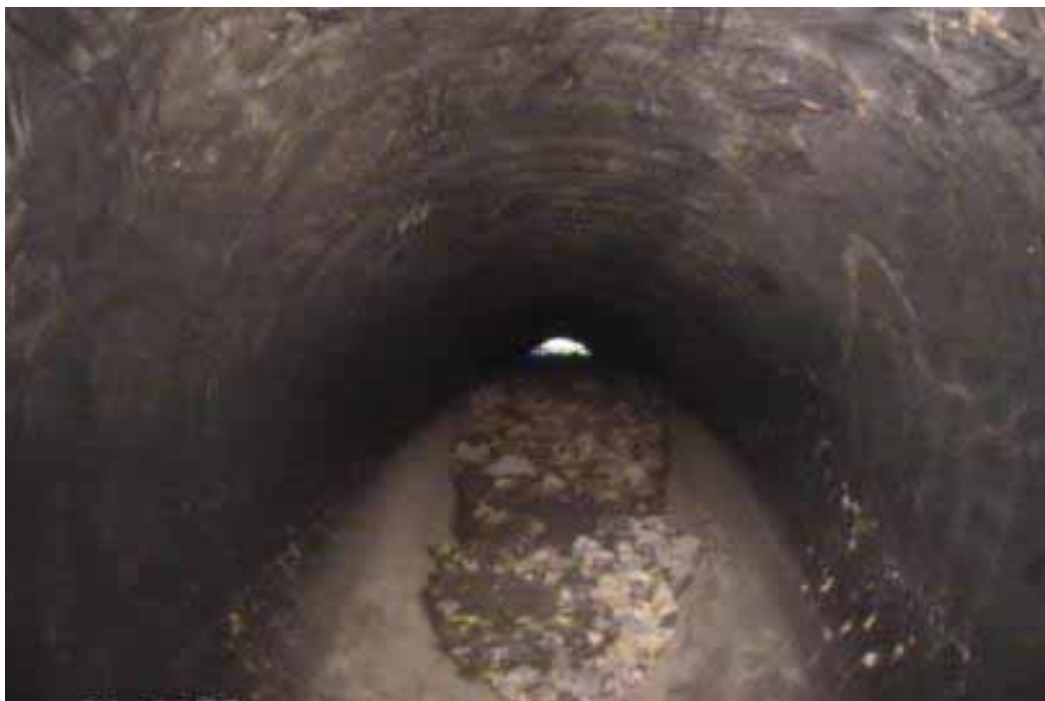
Figure 287 Debris blockage for Pipeline No. 6 (Site No. 1: Route 101)

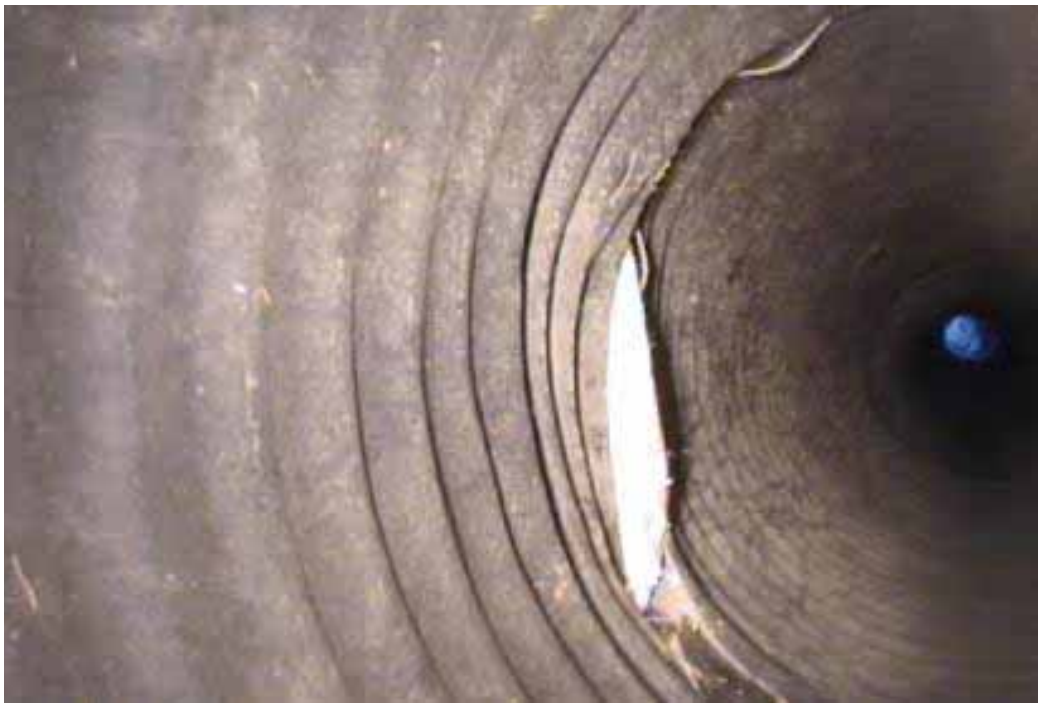
Figure 289 Cracking/fracture and corrugation growth failures for Pipeline No. 7 (Site No. 1: Route 101)

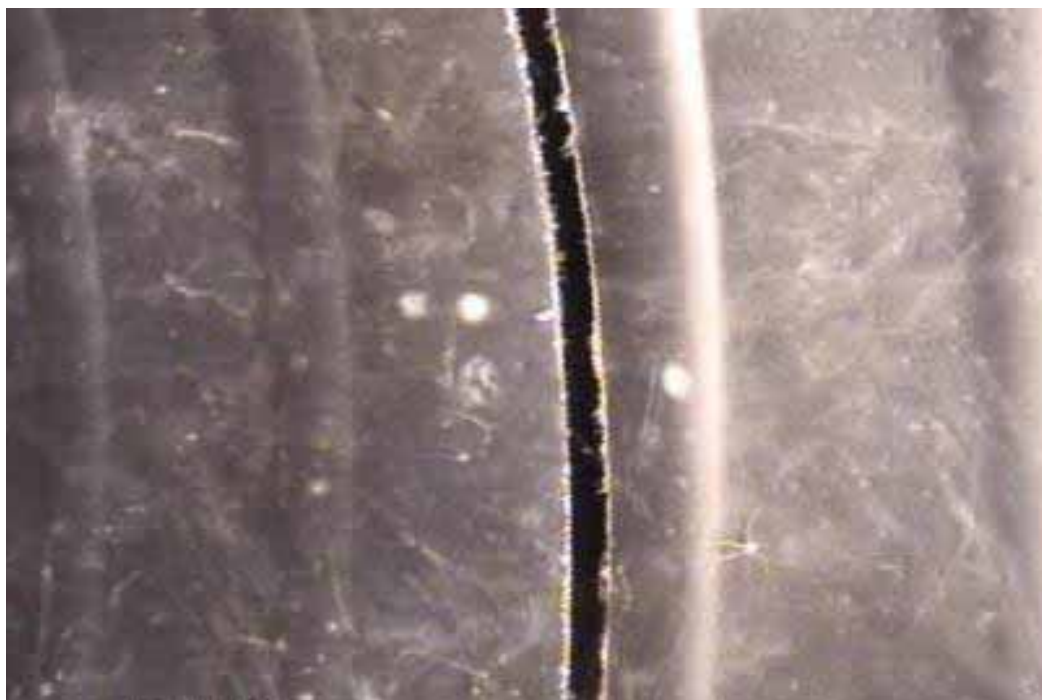
Figure 290 Cracking/fracture failure for Pipeline No. 7 (Site No. 1: Route 101)

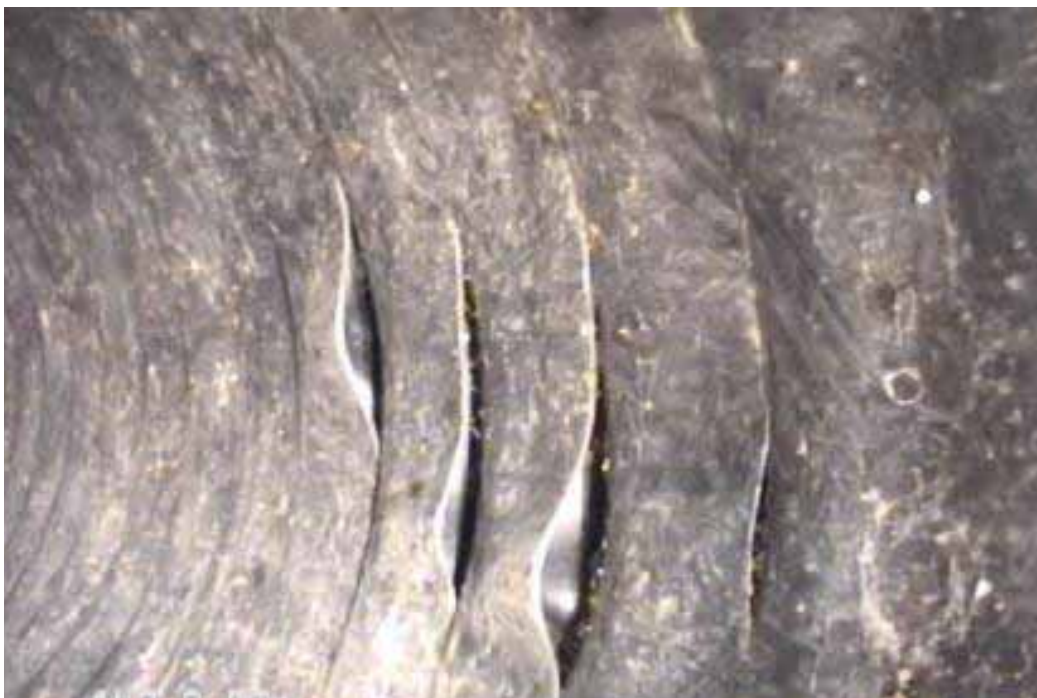
Figure 291 Cracking/fracture failure for Pipeline No. 7 (Site No. 1: Route 101)

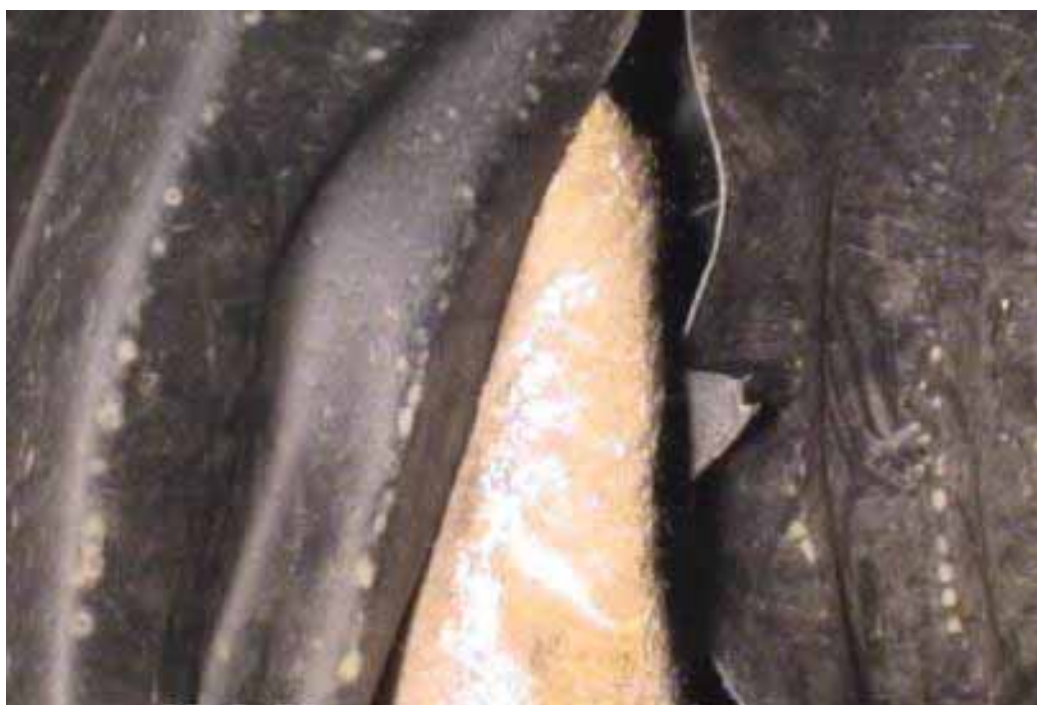
Figure 292 Cracking/fracture failure for Pipeline No. 7 (Site No. 1: Route 101)

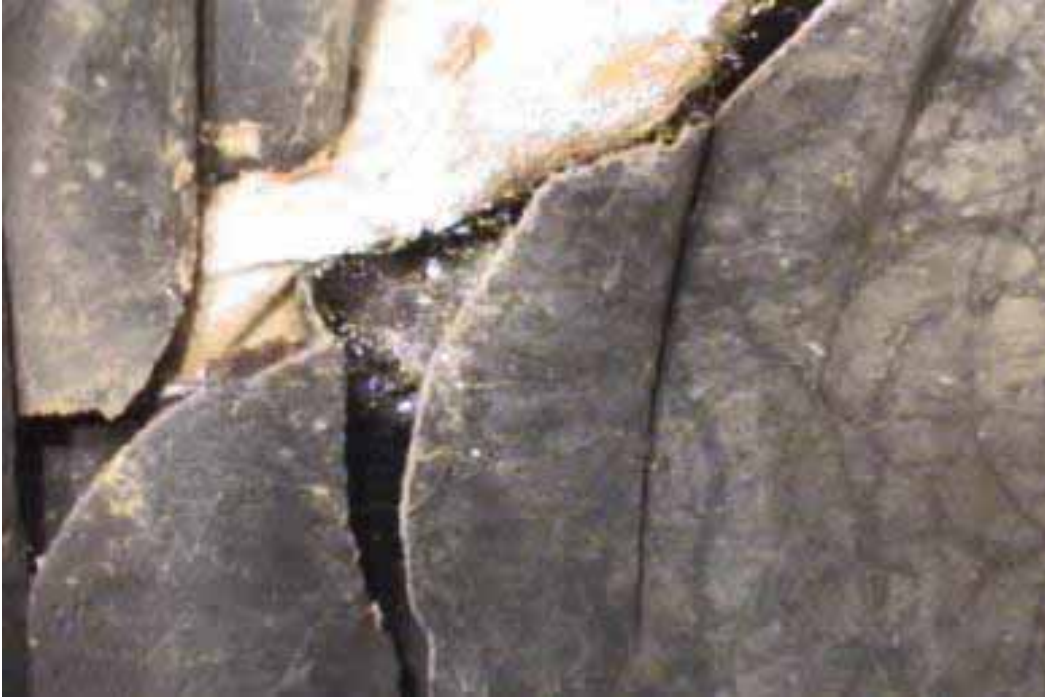
Figure 293 Cracking/fracture for Pipeline No. 7 (Site No. 1: Route 101)

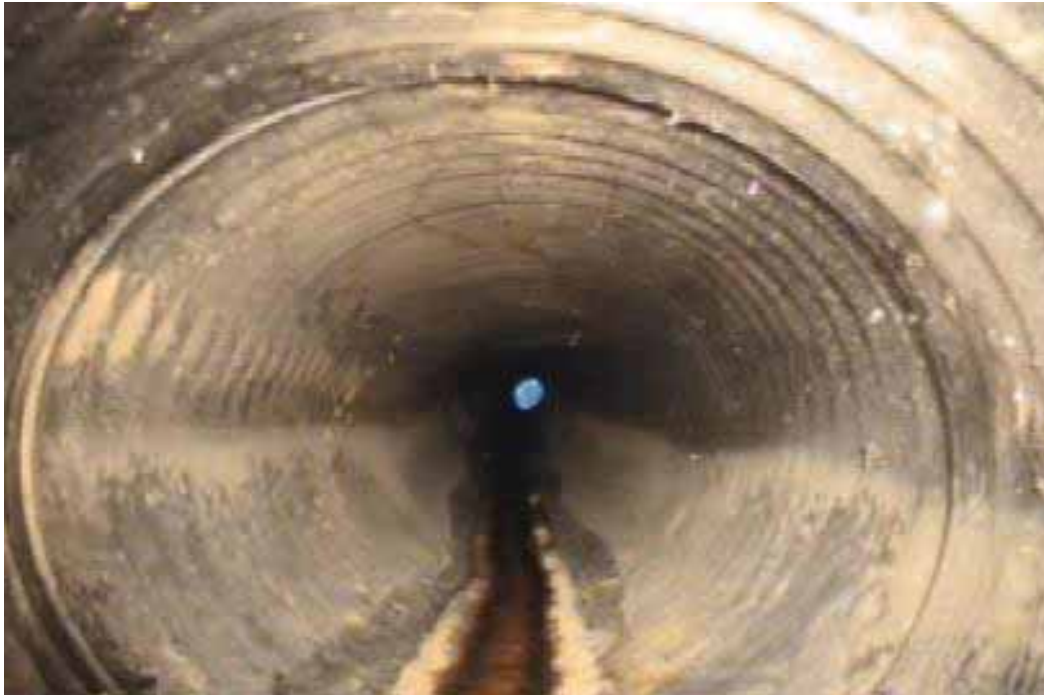
Figure 295 Corrugation growth failure for Pipeline No. 8 (Site No. 1: Route 101)

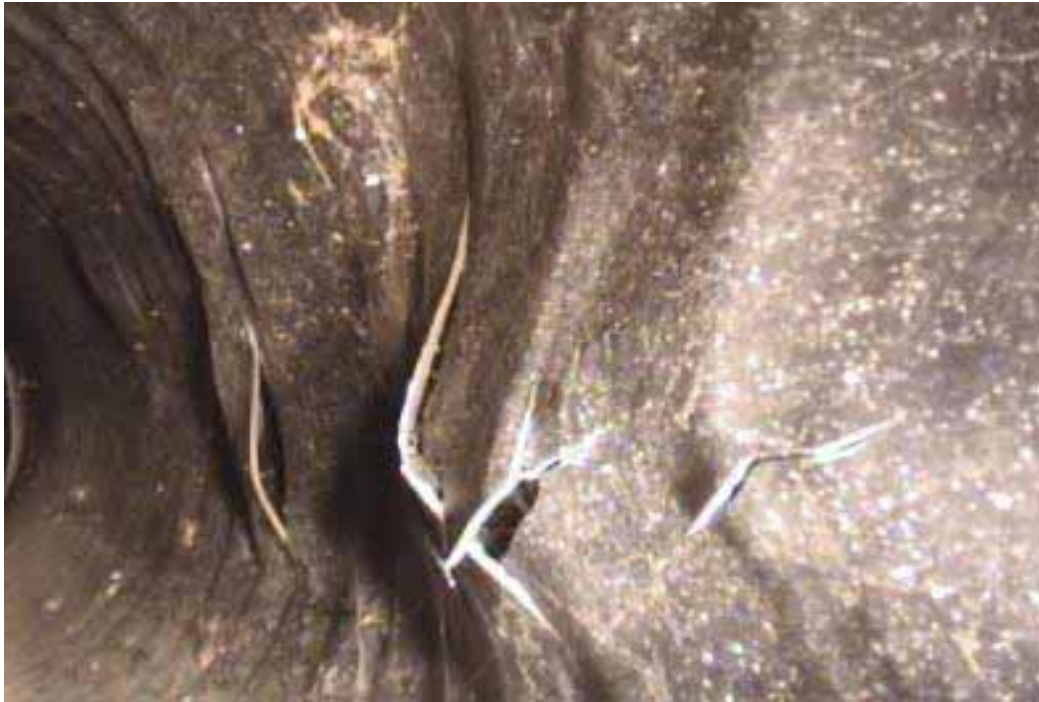
Figure 299 Cracking/fracture, inverse curvature, and corrugation growth failure for Pipeline No. 8 (Site No. 1: Route 101)

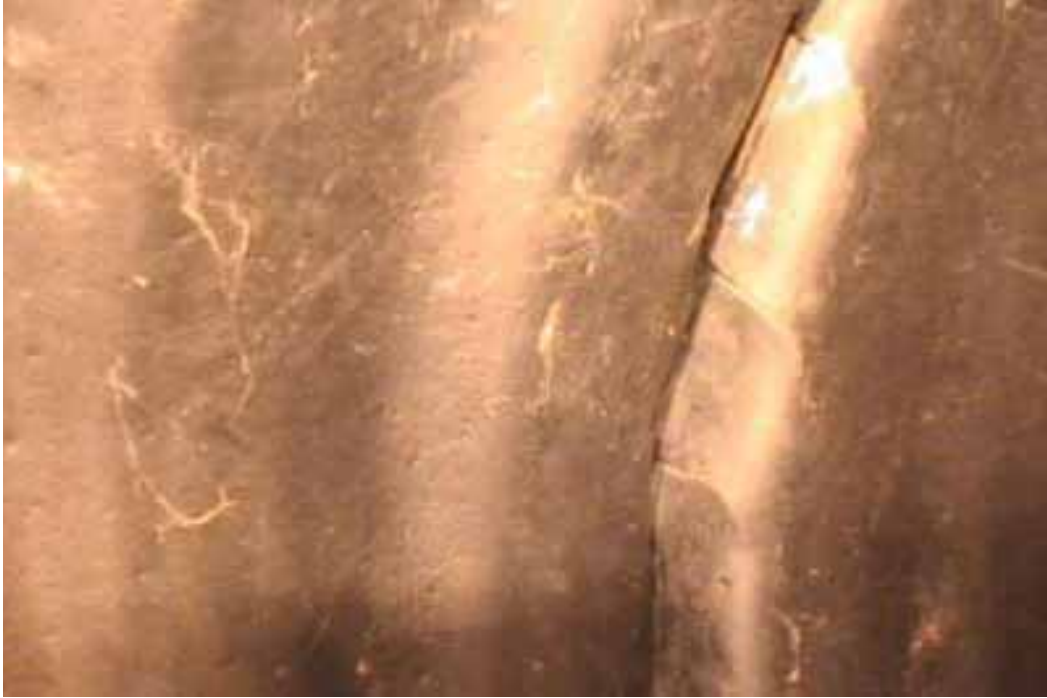
Figure 302 Cracking/fracture failure for Pipeline No. 9 (Site No. 1: Route 101)

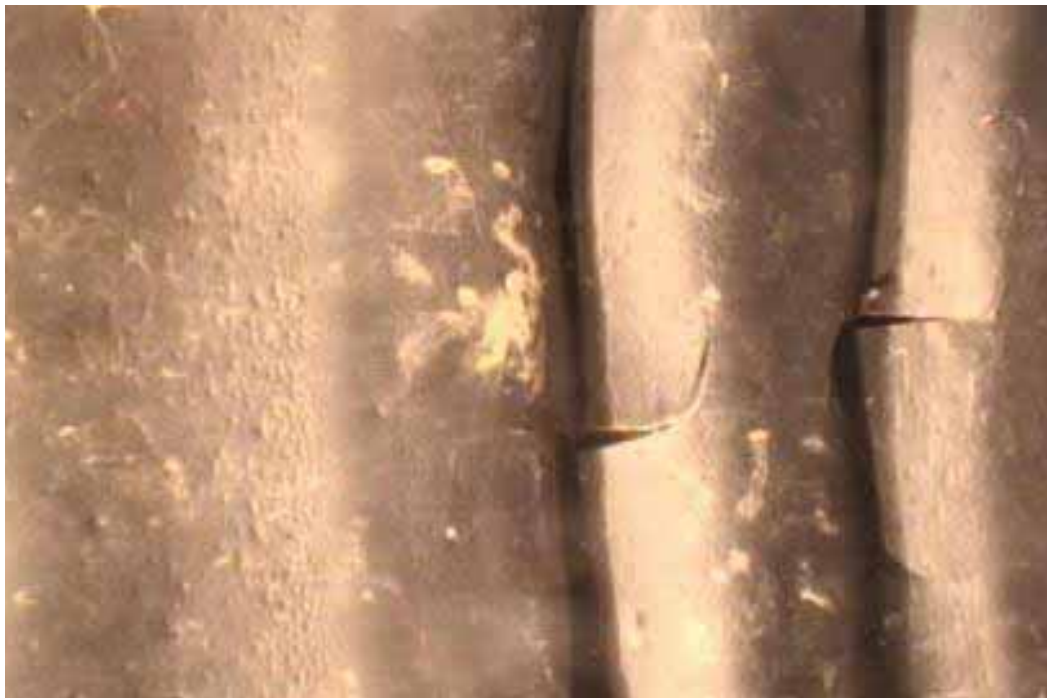
Figure 303 Cracking/fracture failure for Pipeline No. 9 (Site No. 1: Route 101)

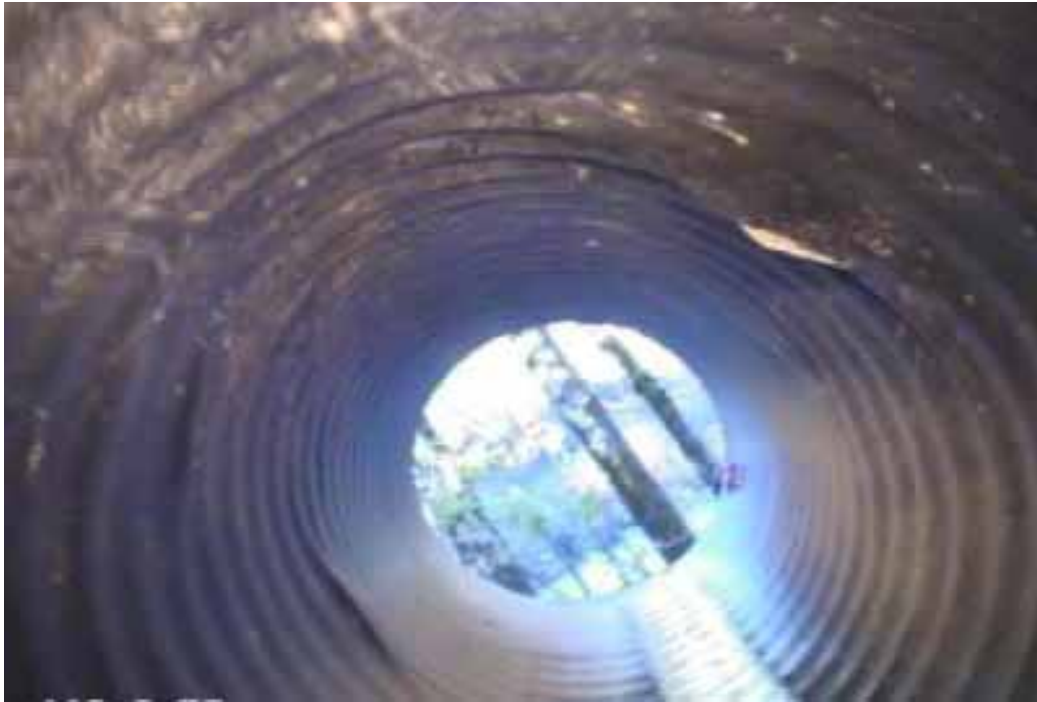
Figure 304 Cracking/fracture, inverse curvature, and corrugation growth failure for Pipeline No. 9 (Site No. 1: Route 101)

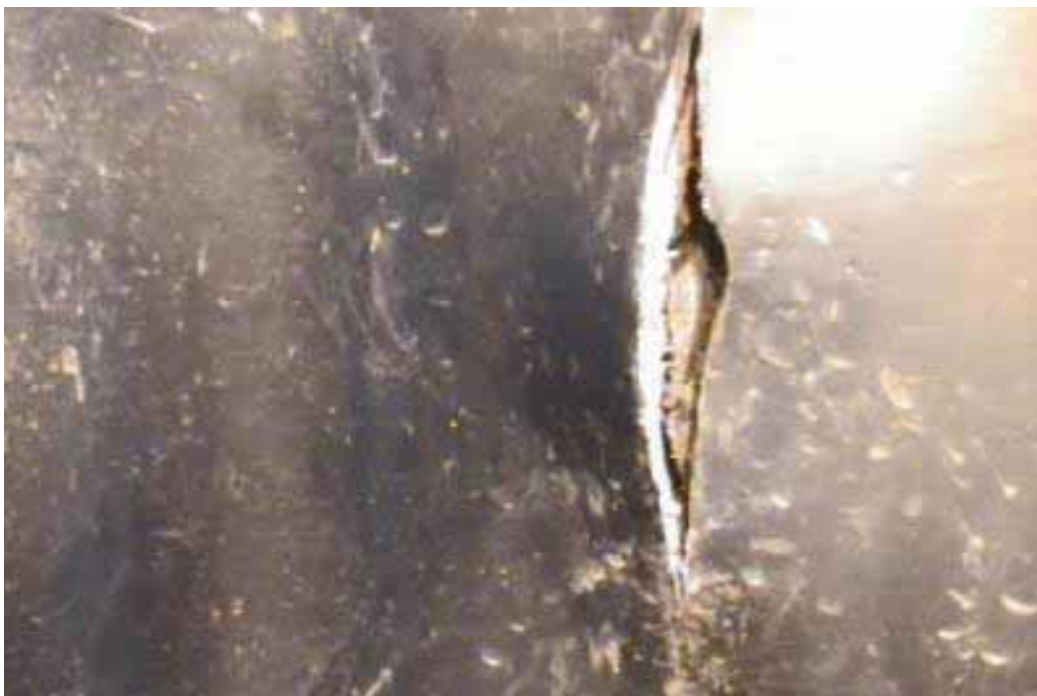
Figure 305 Cracking/fracture and inverse curvature failure for Pipeline No. 9 (Site No. 1: Route 101)

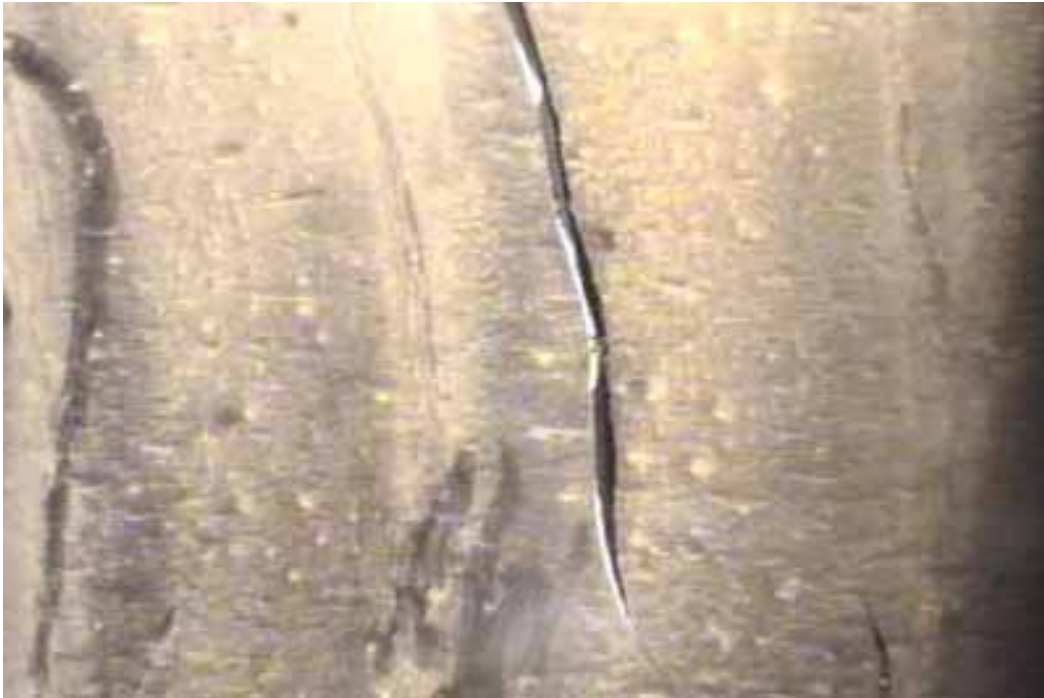
Figure 307 Cracking/fracture failure for Pipeline No. 10 (Site No. 1: Route 101)

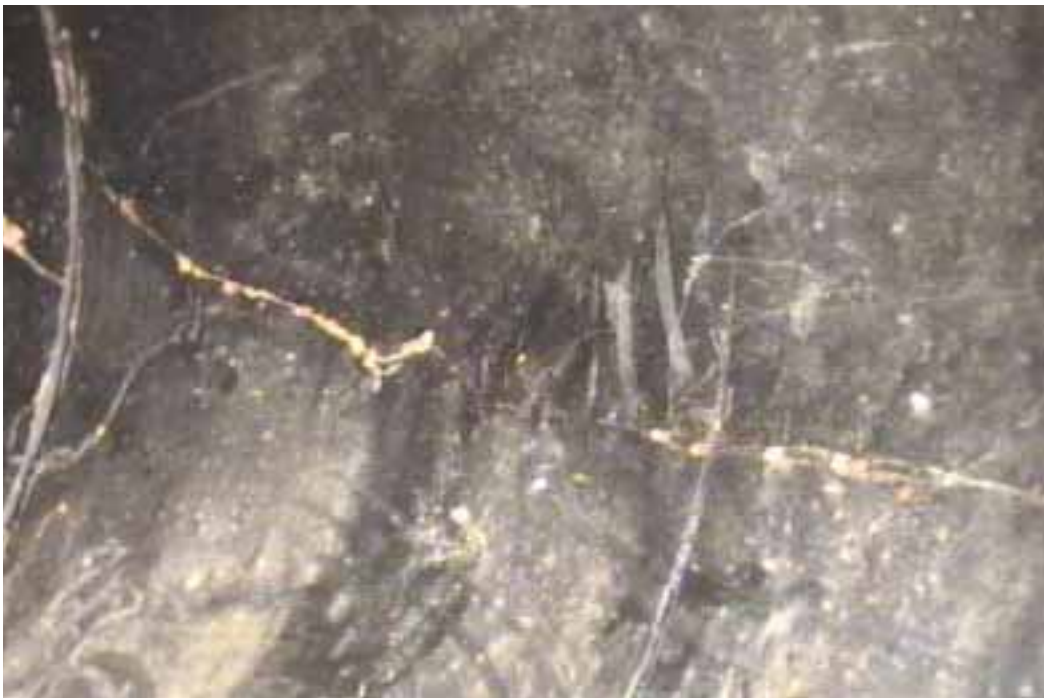
Figure 308 Cracking/fracture failure for Pipeline No. 10 (Site No. 1: Route 101)

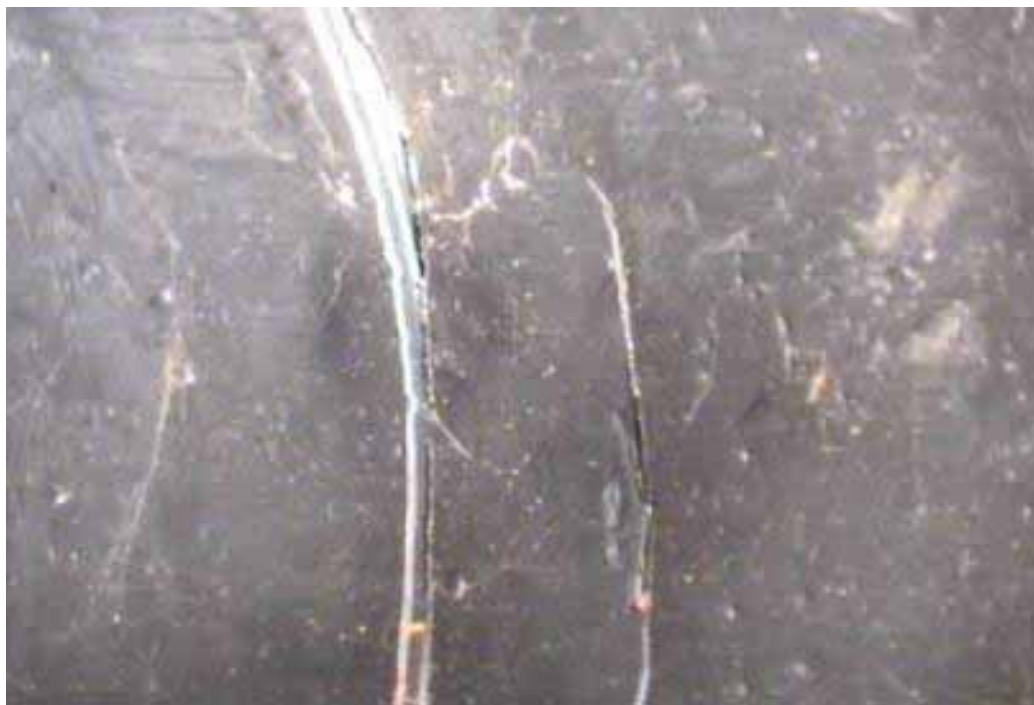
Figure 309 Cracking/fracture failure for Pipeline No. 10 (Site No. 1: Route 101)

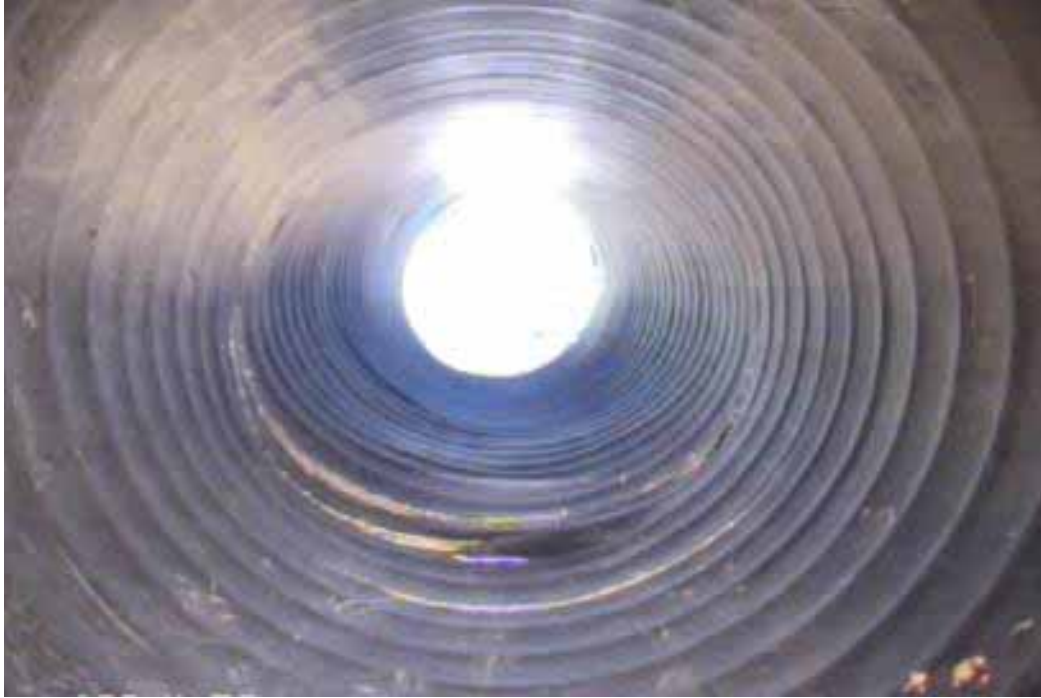
Figure 311 Cracking/fracture and corrugation growth failure for Pipeline No. 10 (Site No. 1: Route 101)

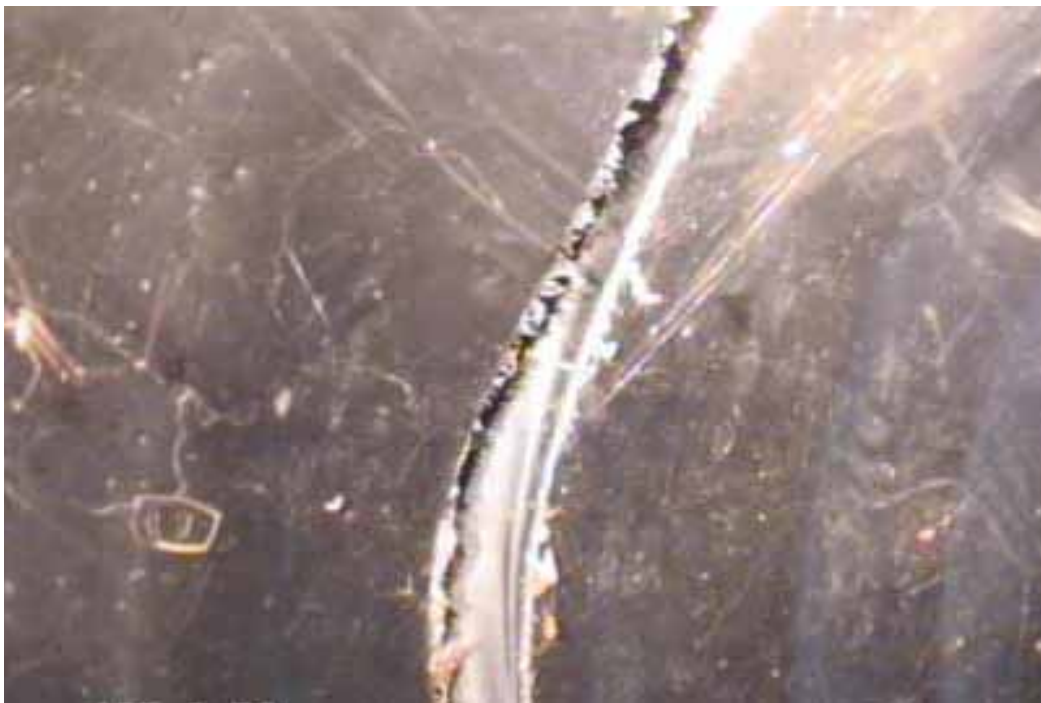
Figure 312 Cracking/fracture failure for Pipeline No. 10 (Site No. 1: Route 101)

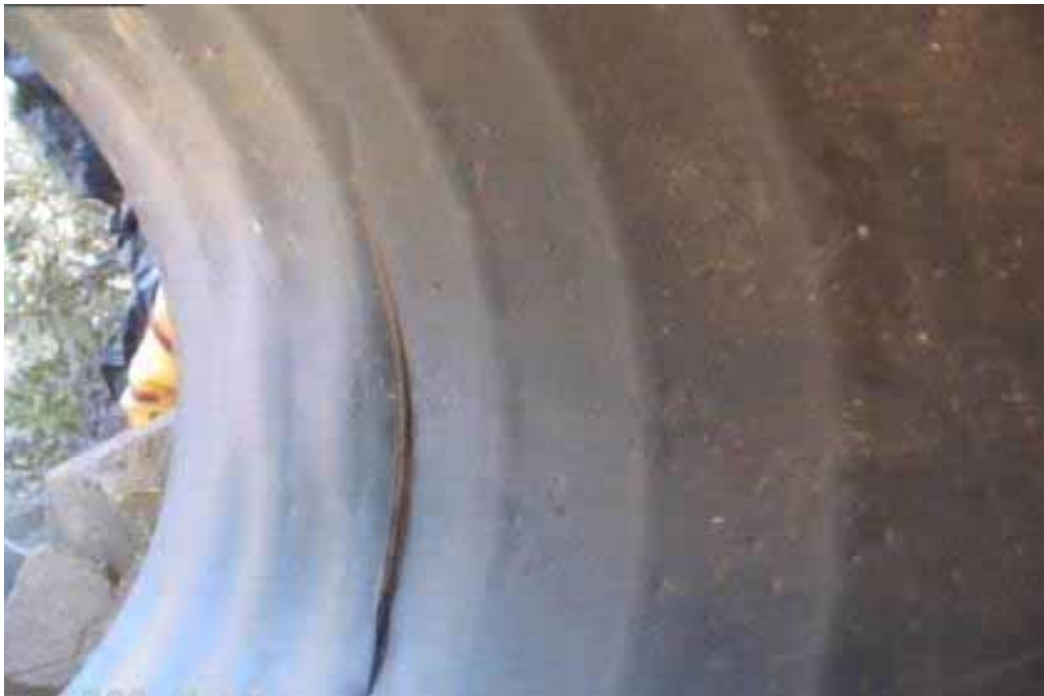
Figure 314 Cracking/fracture failure for Pipeline No. 10 (Site No. 1: Route 101)

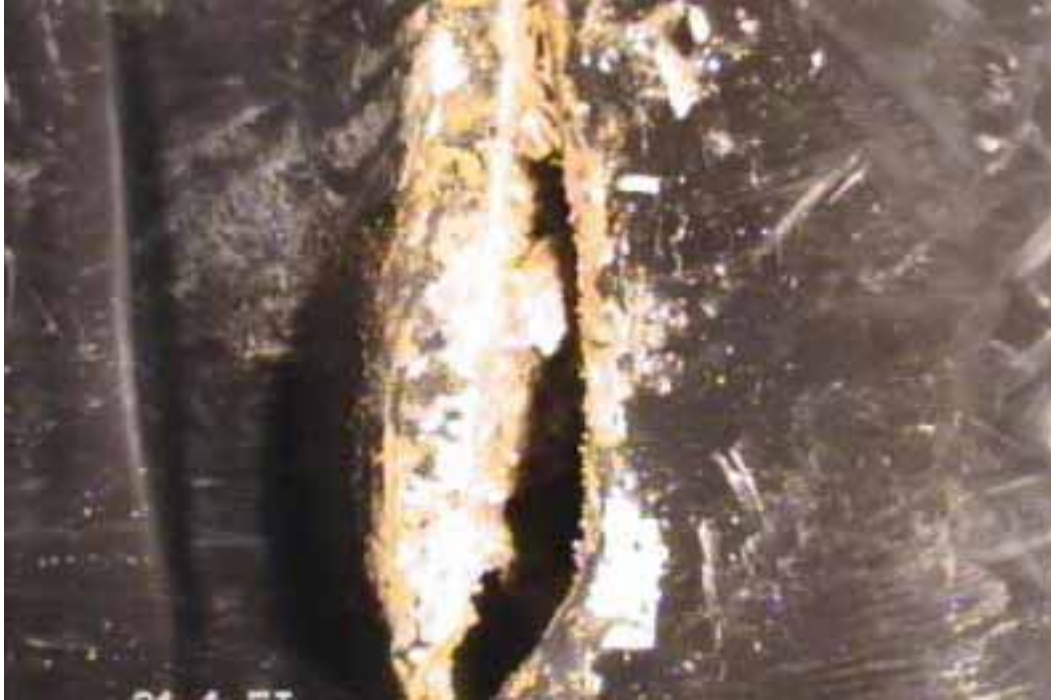
Figure 317 Cracking/fracture failure for Pipeline No. 12 (Site No. 1: Route 101)

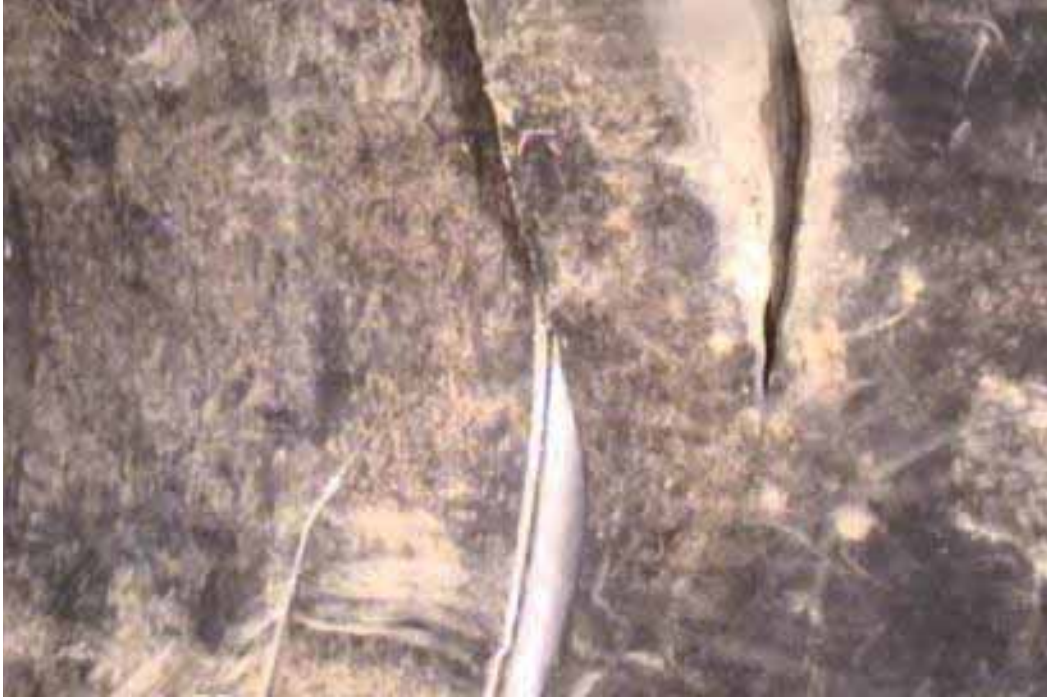
Figure 322 Cracking/fracture failure for Pipeline No. 16 (Site No. 2: Route 36)

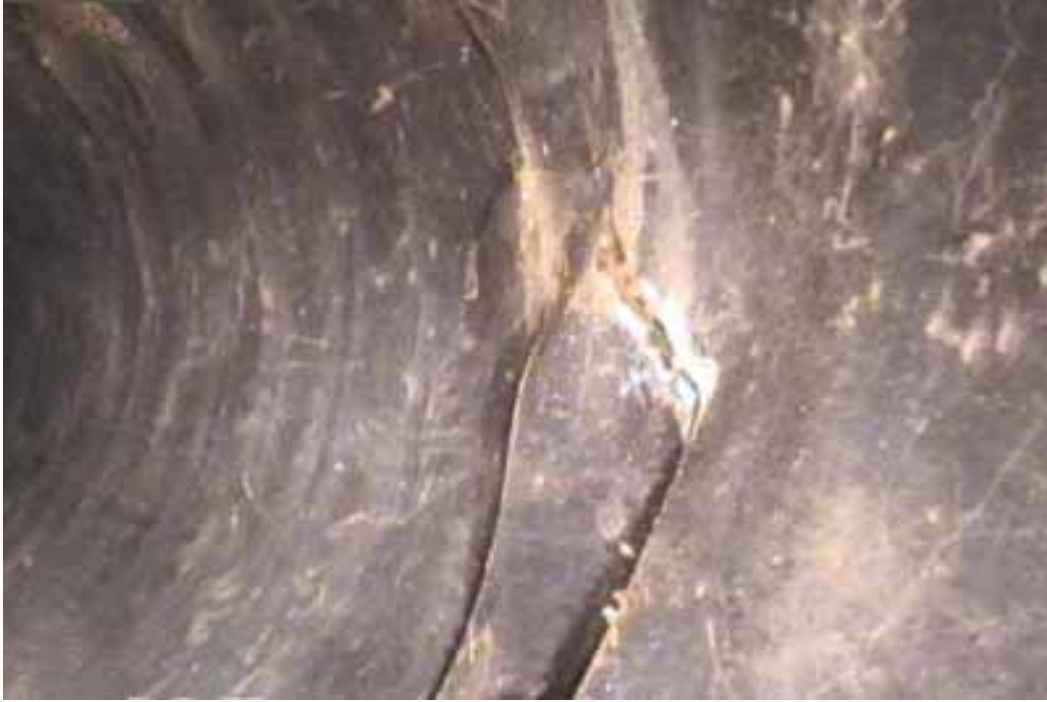
Figure 324 Cracking/fracture failure for Pipeline No. 17 (Site No. 2: Route 36)

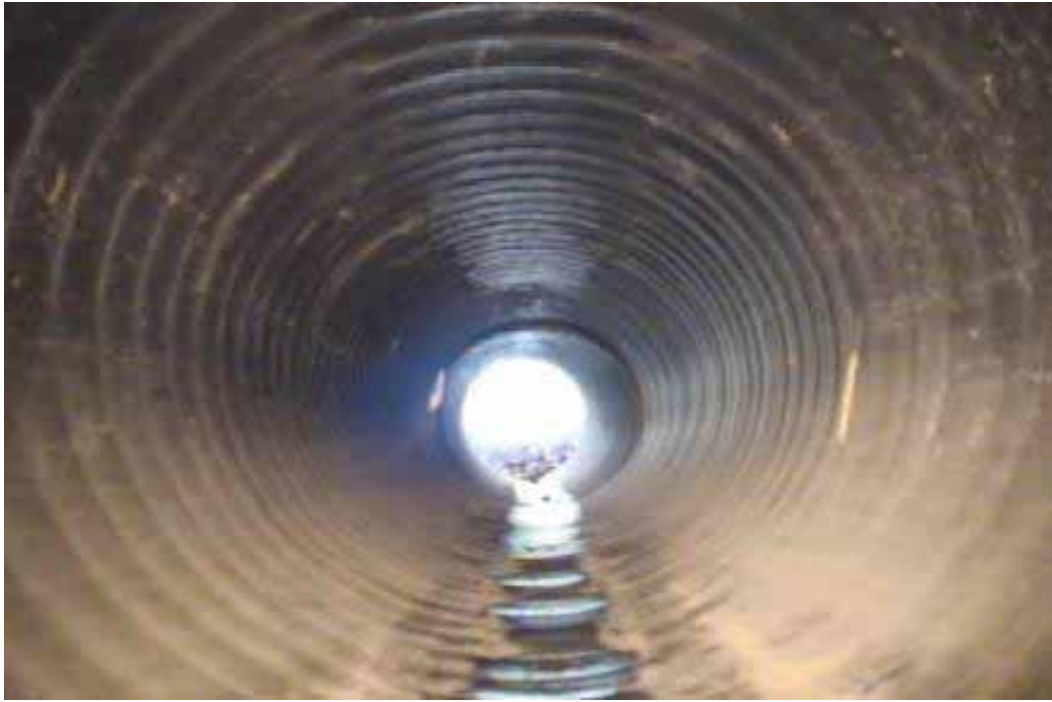
Figure 325 Corrugation growth failure for Pipeline No. 18 (Site No. 2: Route 36)

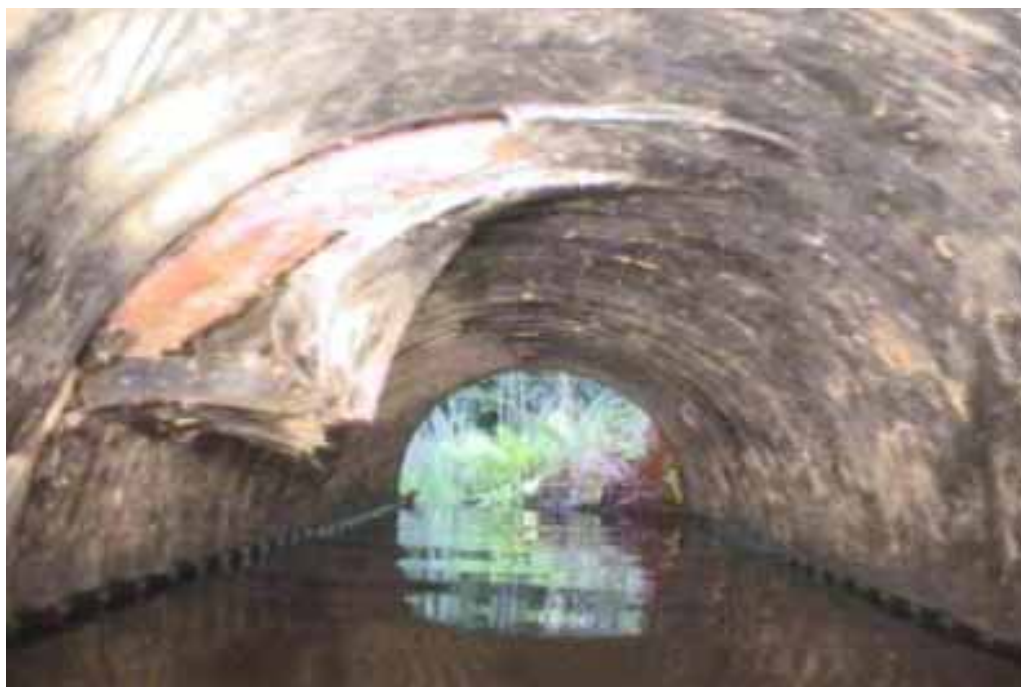
Figure 328 Cracking/fracture and corrugation growth failure for Pipeline No. 20 (Site No. 2: Route 36)

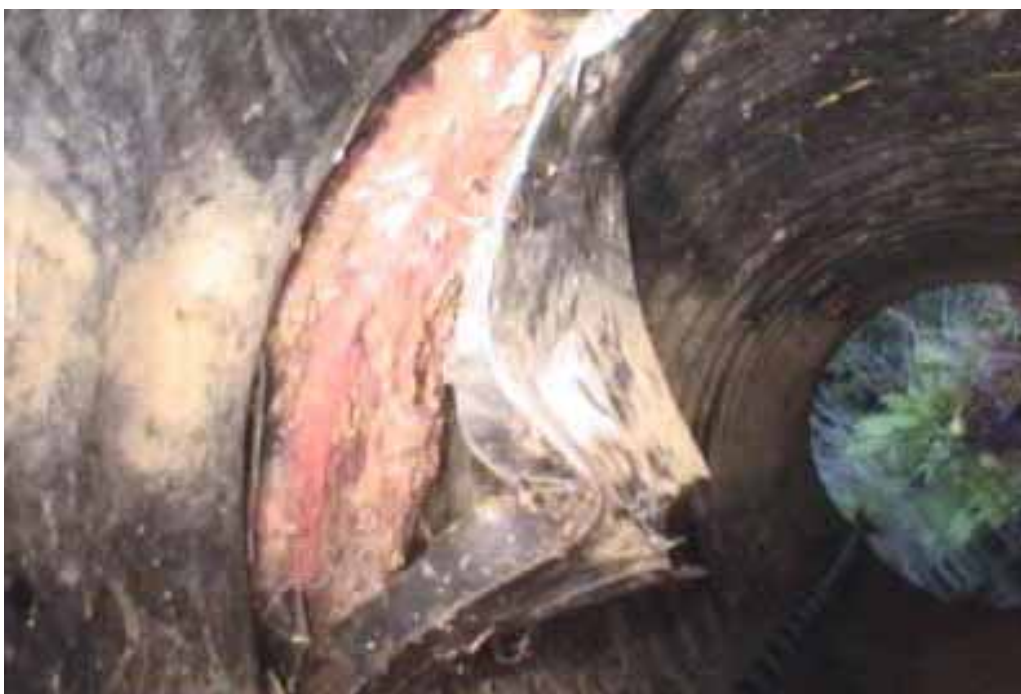
Figure 329 Cracking/fracture failure for Pipeline No. 20 (Site No. 2: Route 36)

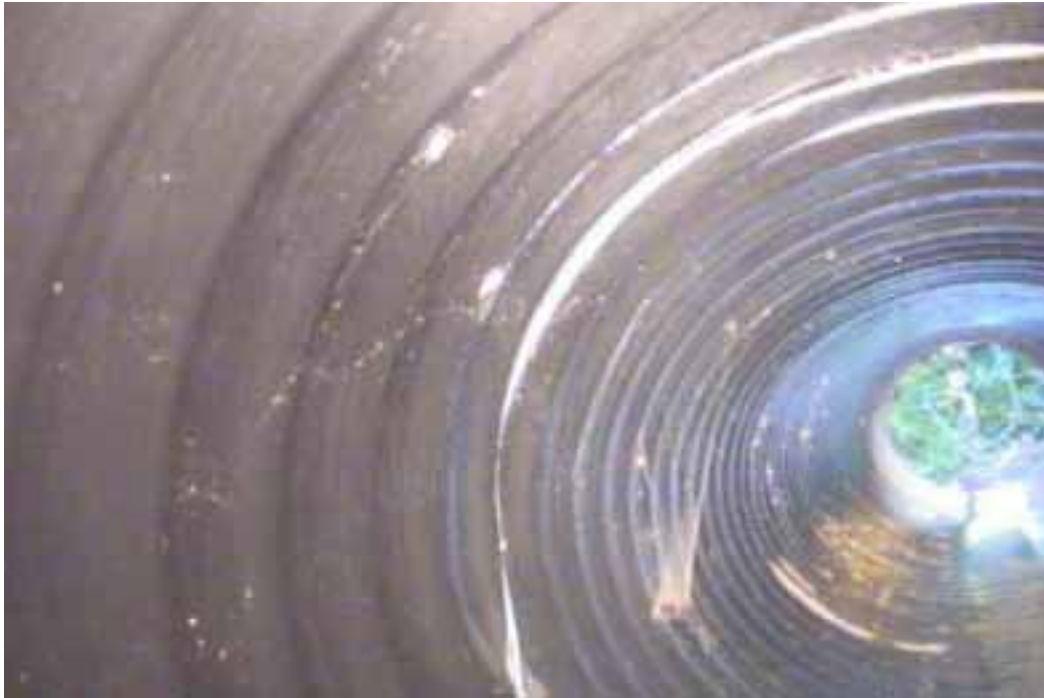
Figure 334 Cracking/fracture and corrugation growth failure for Pipeline No. 22 (Site No. 2: Route 36)

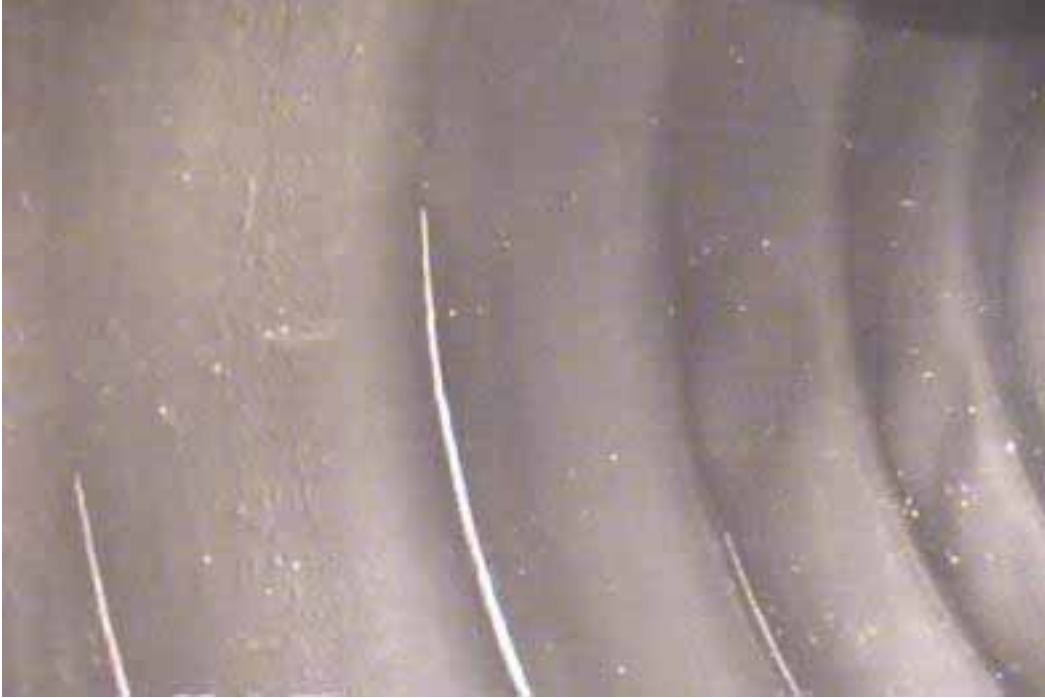
Figure 336 Cracking/fracture and corrugation growth failure for Pipeline No. 22 (Site No. 2: Route 36)

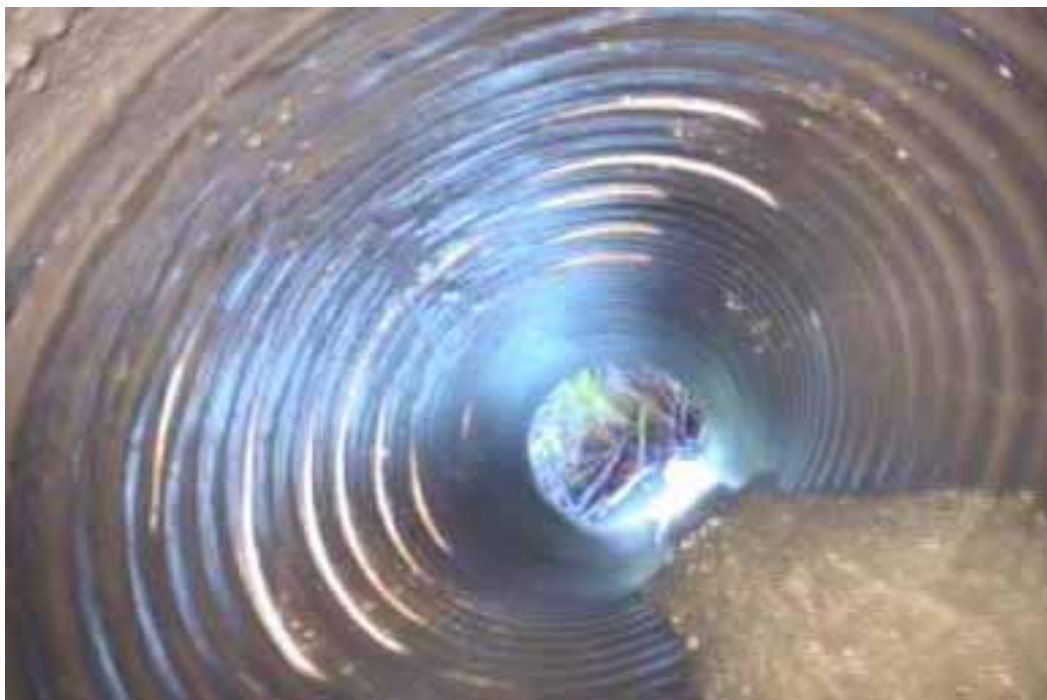
Figure 338 Cracking/fracture and corrugation growth failure for Pipeline No. 23 (Site No. 2: Route 36)
