Evaluation of HDPE Pipelines Structural Performance

UT Arlington Center for Structural Engineering Research

November 2010

**As a Part of the Initiative on the Underground Structural Health
Monitoring and Equipment Development**

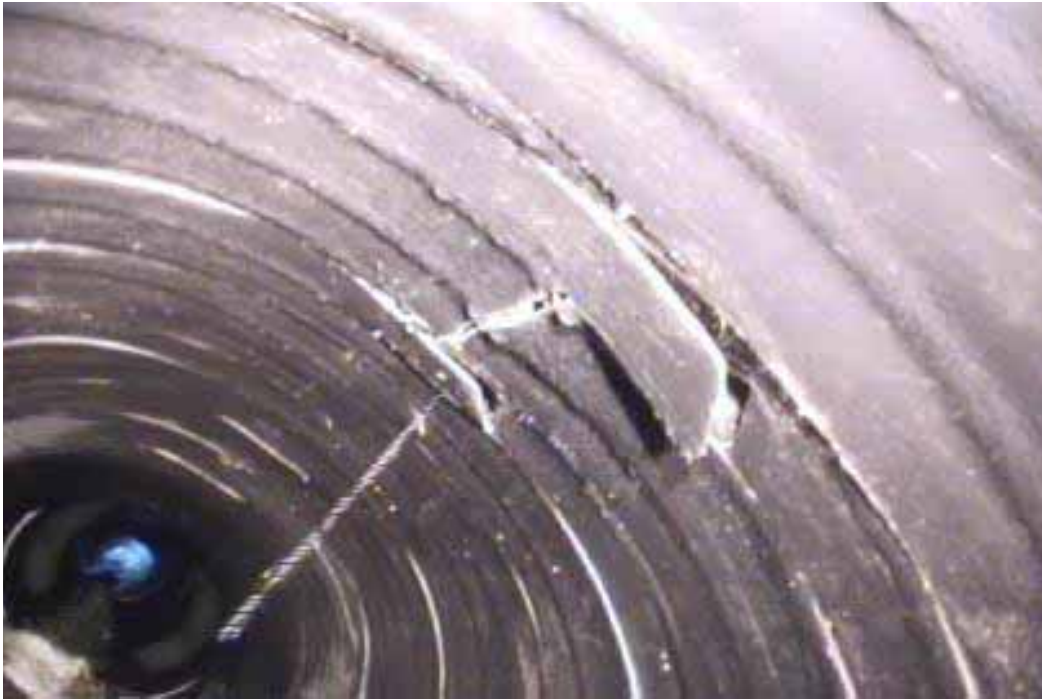
Figure 340 Cracking/fracture and corrugation growth failure for Pipeline No. 23 (Site No. 2: Route 36)

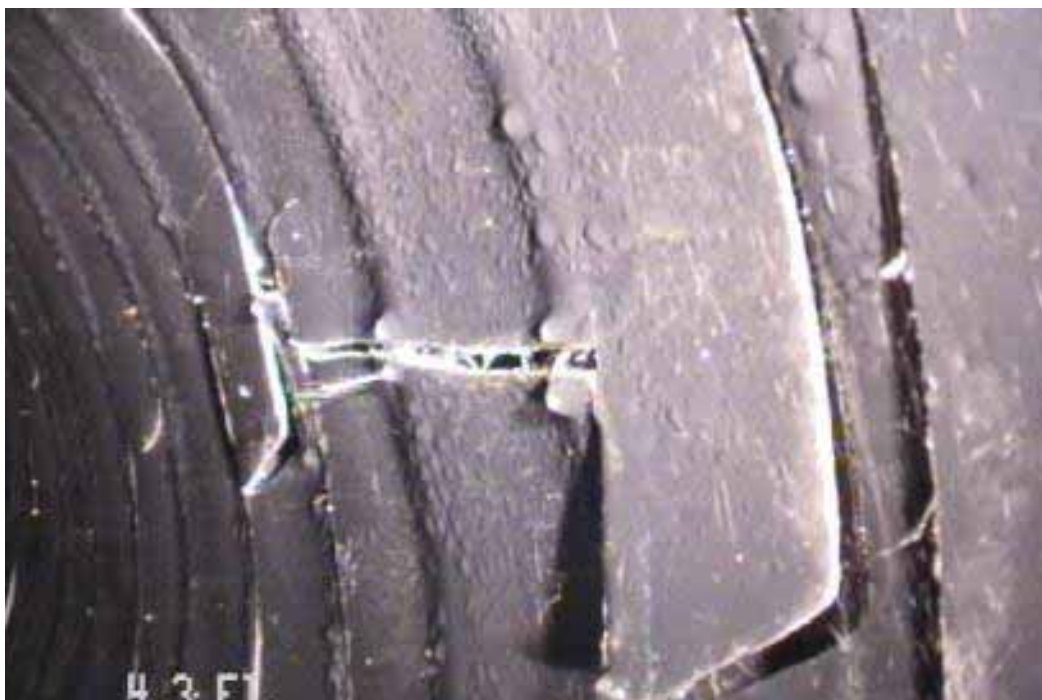
Figure 341 Cracking/fracture and corrugation growth failure for Pipeline No. 23 (Site No. 2: Route 36)

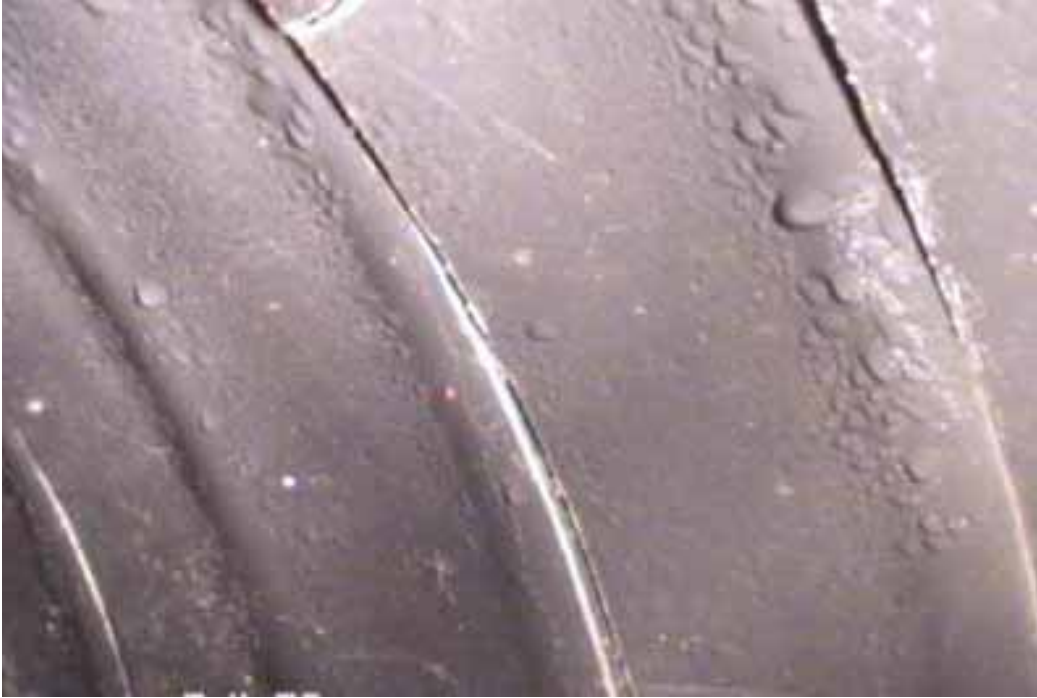
Figure 342 Cracking/fracture failure for Pipeline No. 23 (Site No. 2: Route 36)

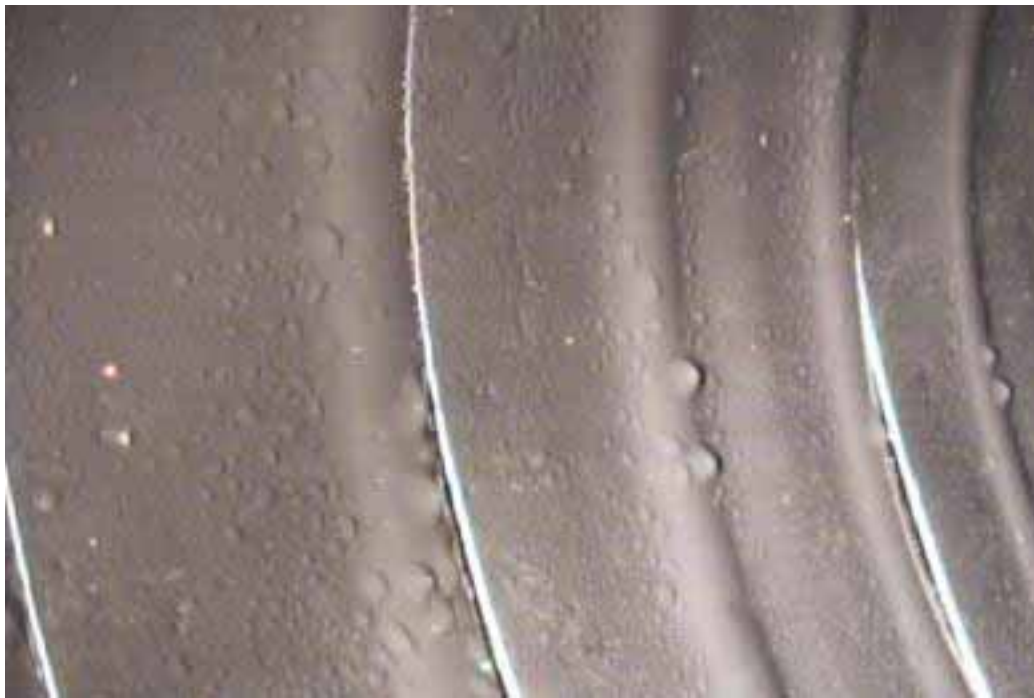
Figure 346 Cracking/fracture failure for Pipeline No. 23 (Site No. 2: Route 36)

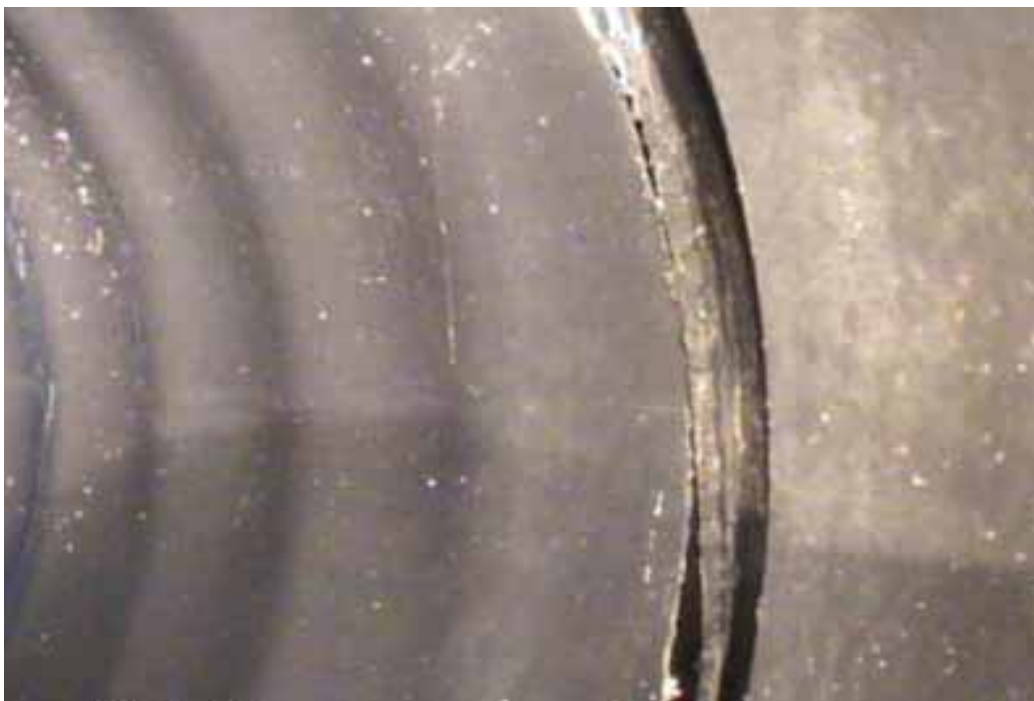
Figure 347 Cracking/fracture and corrugation growth failure for Pipeline No. 23 (Site No. 2: Route 36)

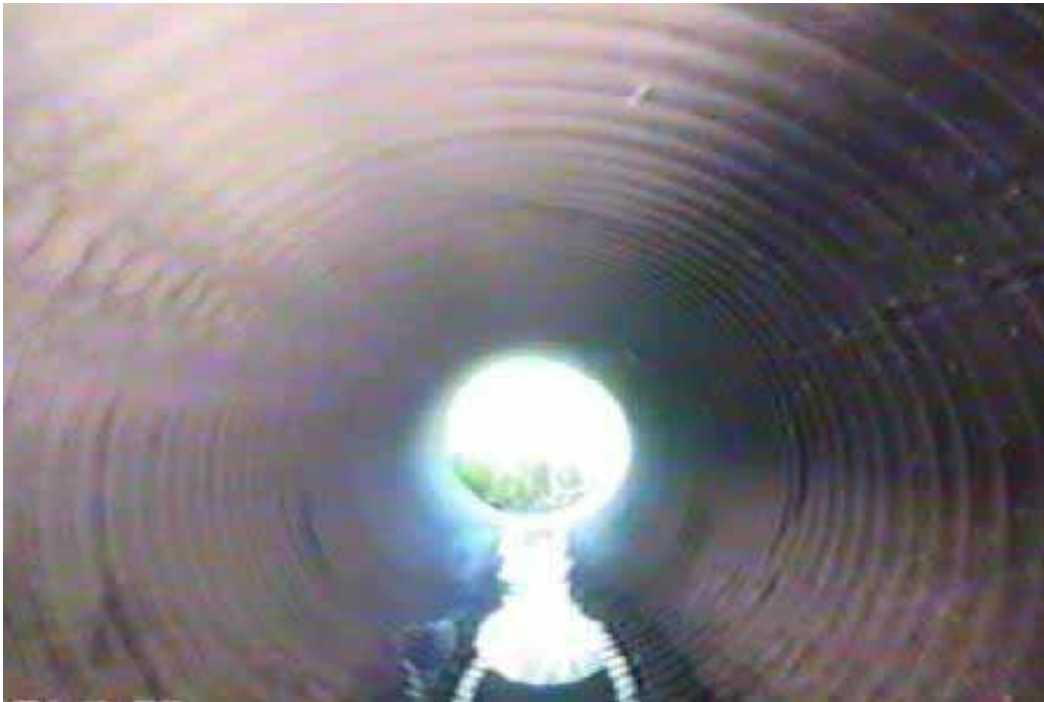
Figure 358 Corrugation growth and excessive deformation (refer to Figure 357-d) failure for Pipeline No. 1 (Site No. 1: Legacy Parkway)

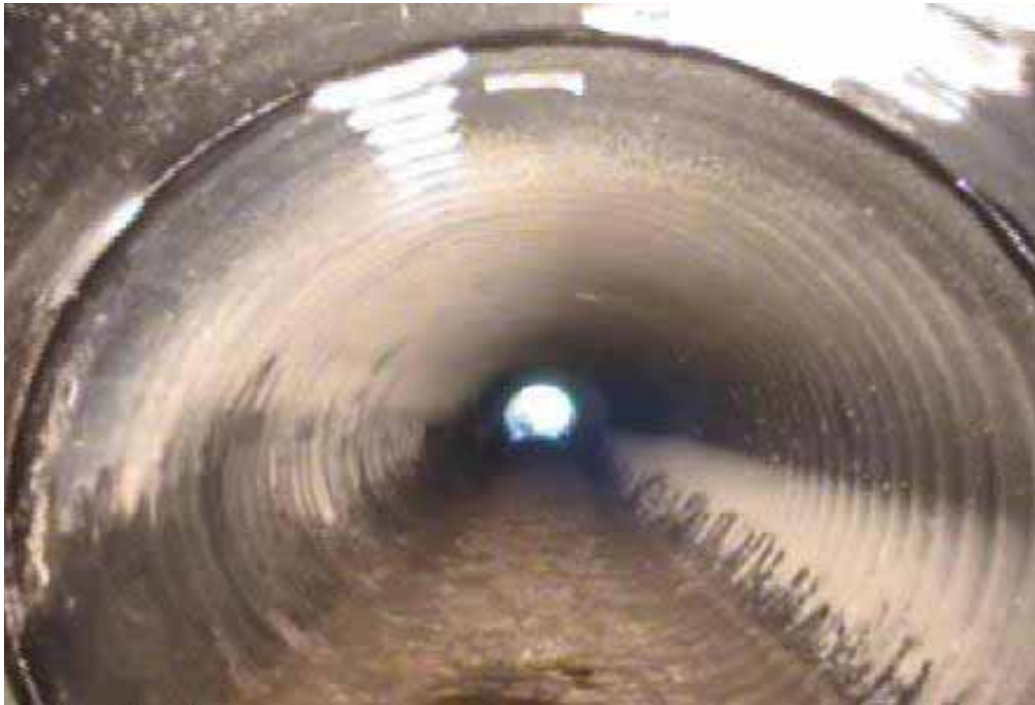
Figure 363 Excessive deformation failure (refer to Figure 362-d) for Pipeline No. 3 (Site No. 1: Legacy Parkway)

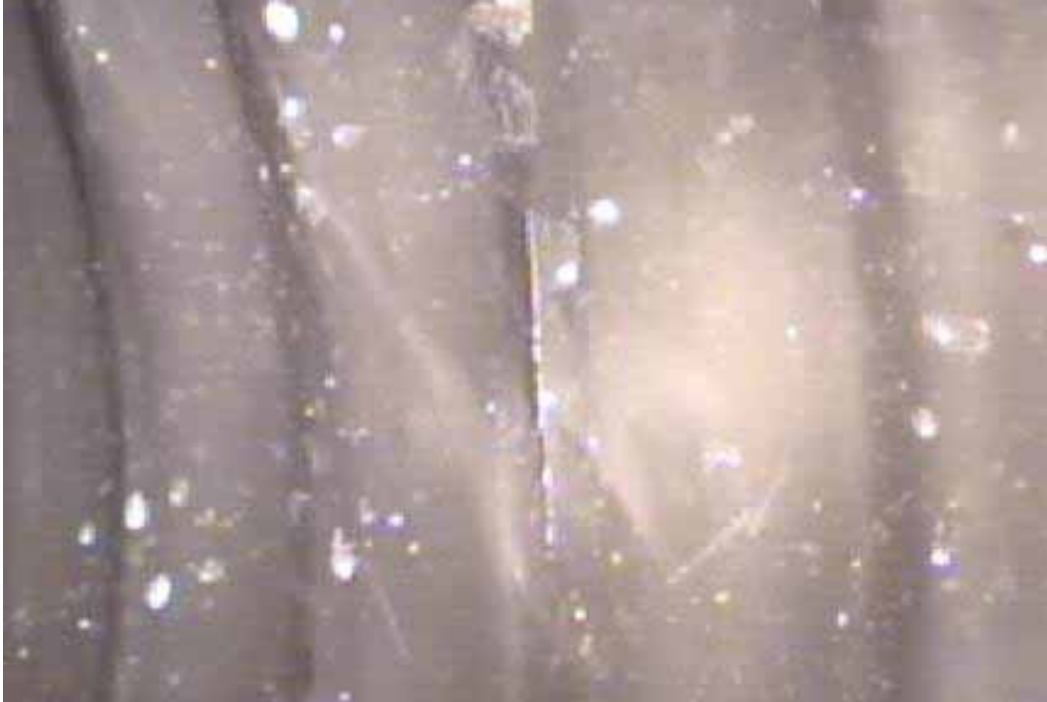
Figure 365 Cracking/fracture failure for Pipeline No. 4 (Site No. 1: Legacy Parkway)

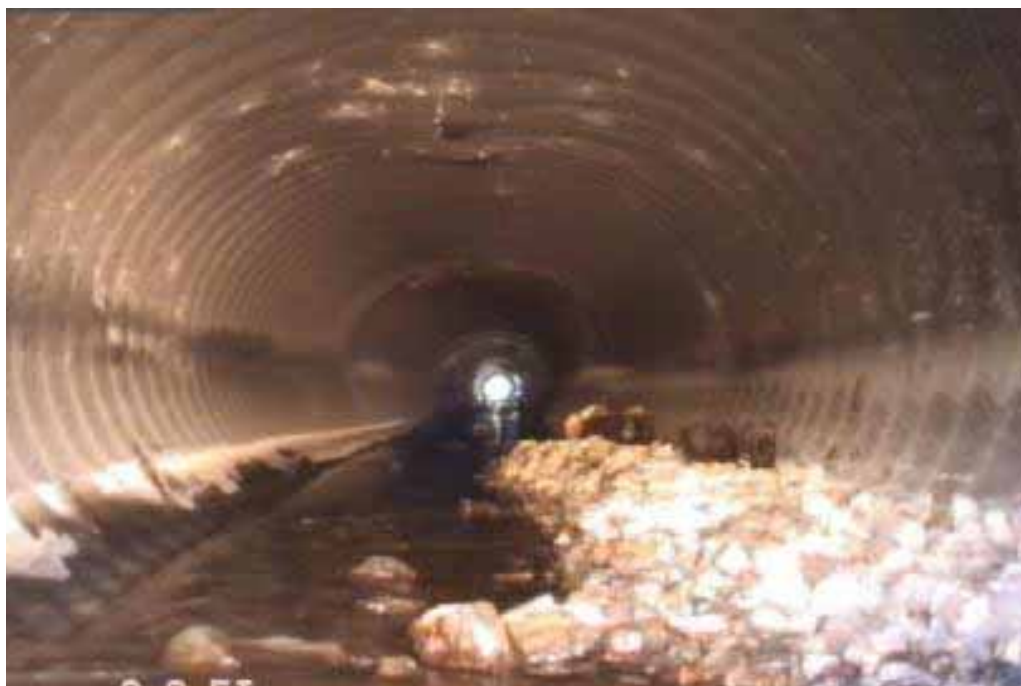
Figure 368 Corrugation growth, cracking/fracture, and inverse curvature failure and debris for Pipeline No. 6 (Site No. 1: Legacy Parkway)

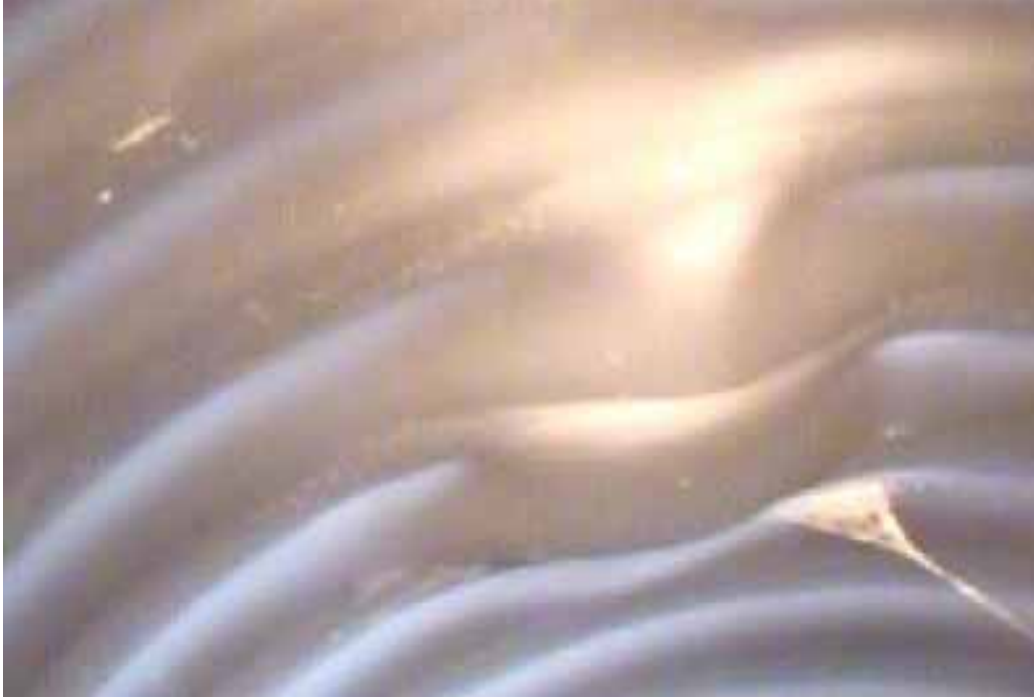
Figure 372 Cracking/fracture, corrugation growth, and inverse curvature failure for Pipeline No. 6 (Site No. 1: Legacy Parkway)

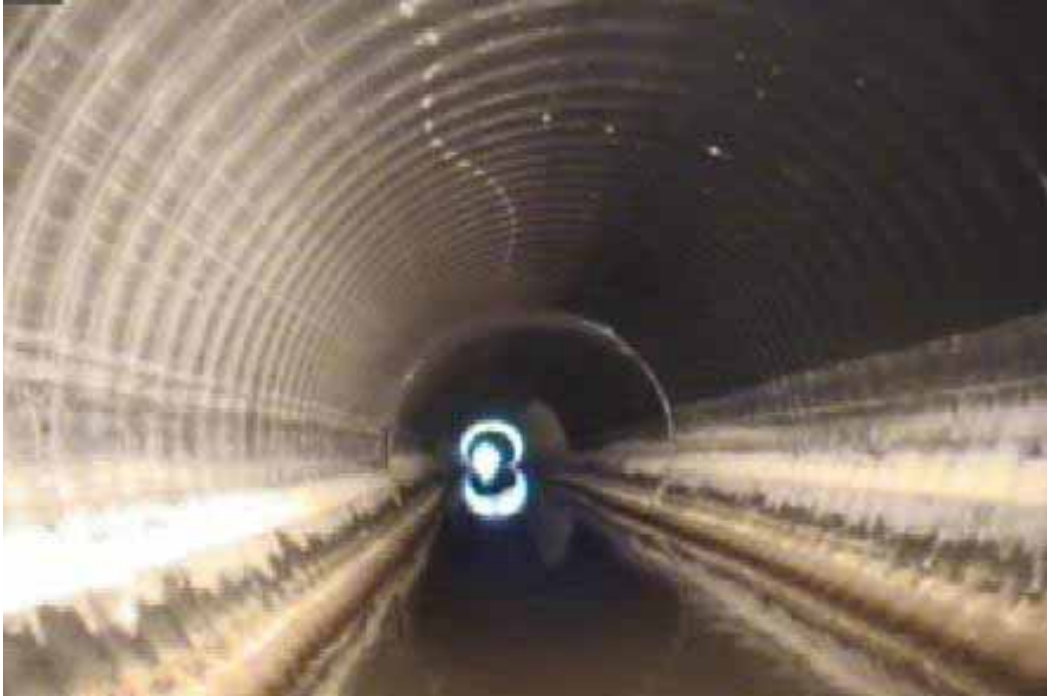
Figure 375 Excessive deformation failure (refer to Figure 374-d) for Pipeline No. 8 (Site No. 1: Legacy Parkway)

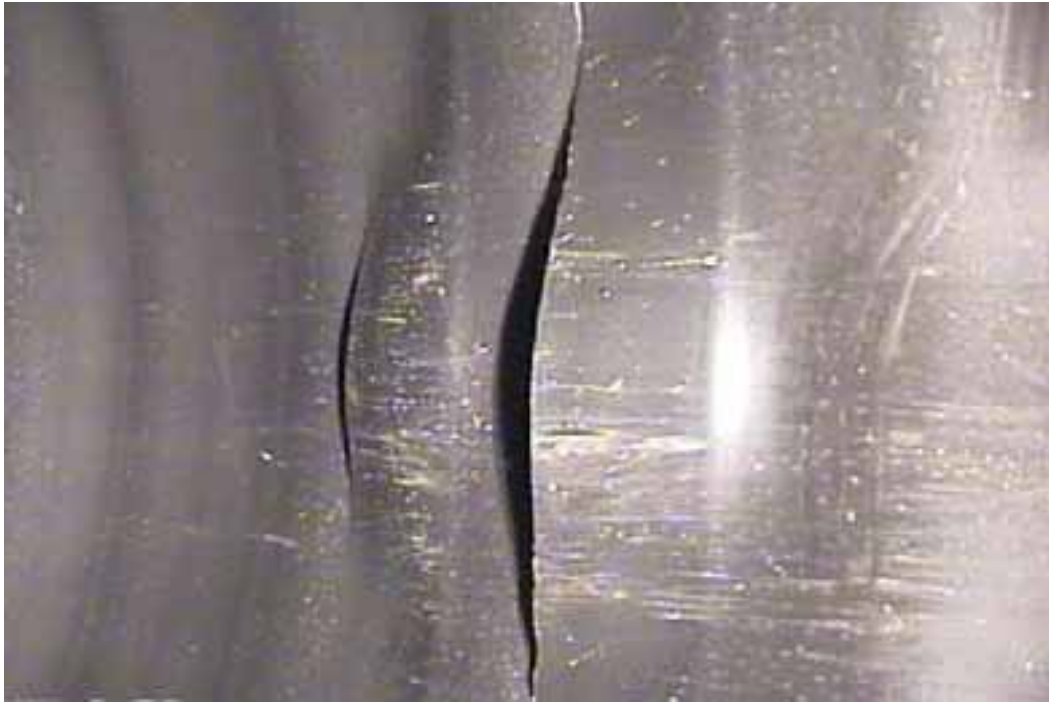
Figure 377 Cracking/fracture failure for Pipeline No. 9 (Site No. 2: Silver Creek Parkway)

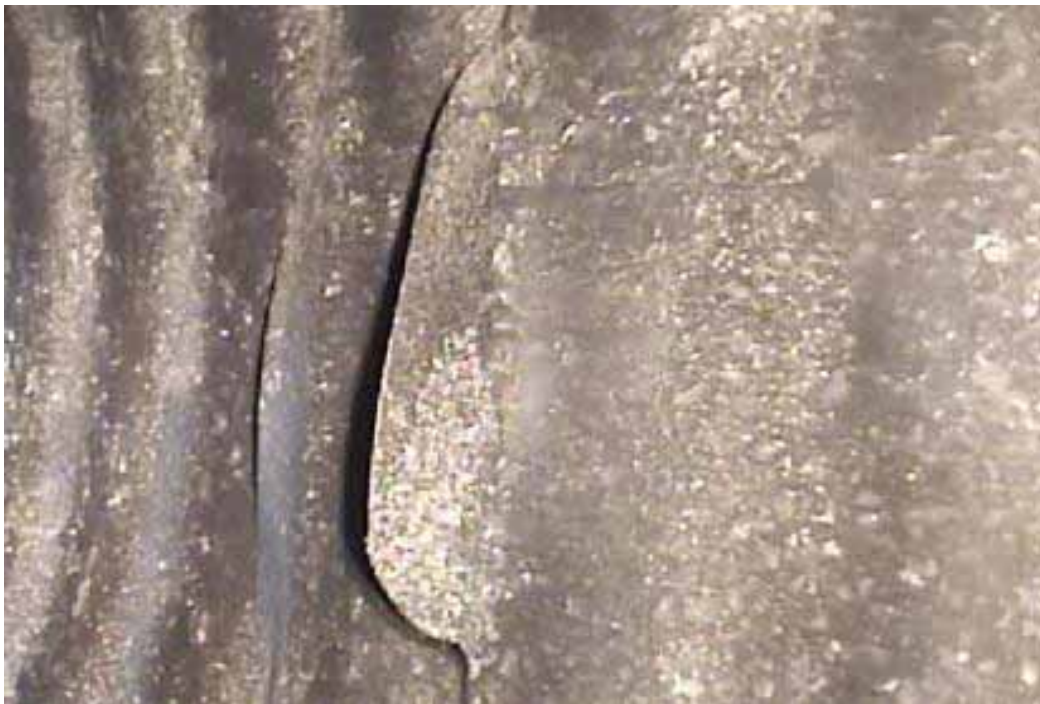
Figure 378 Cracking/fracture failure for Pipeline No. 9 (Site No. 2: Silver Creek Parkway)

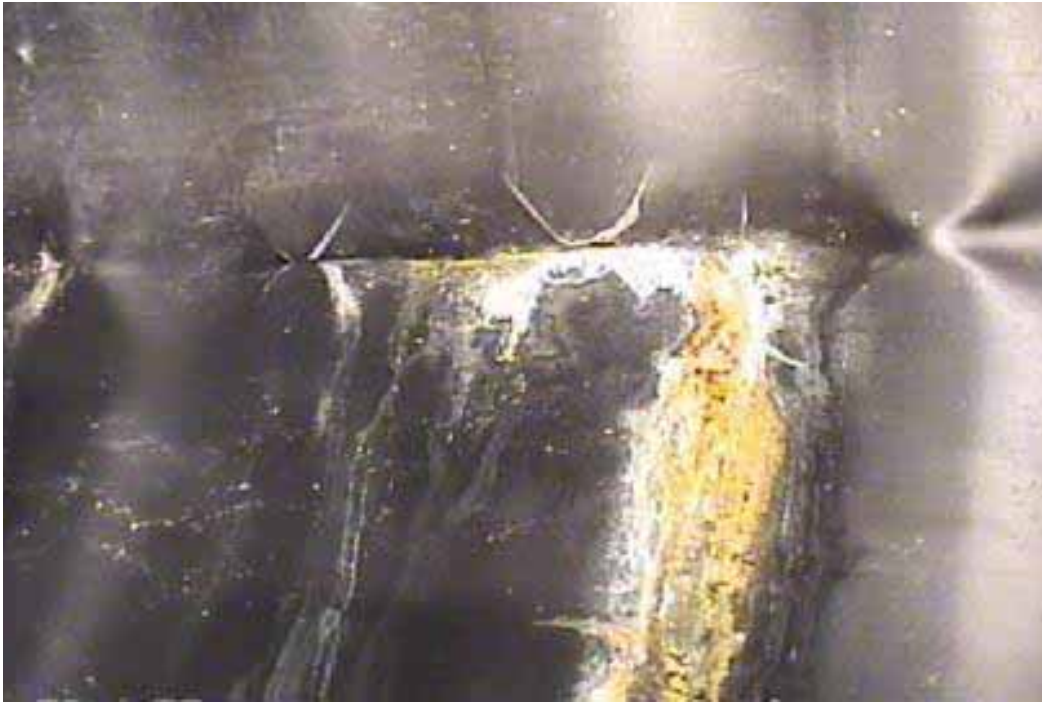
Figure 379 Cracking/fracture and buckling failure for Pipeline No. 9 (Site No. 2: Silver Creek Parkway)

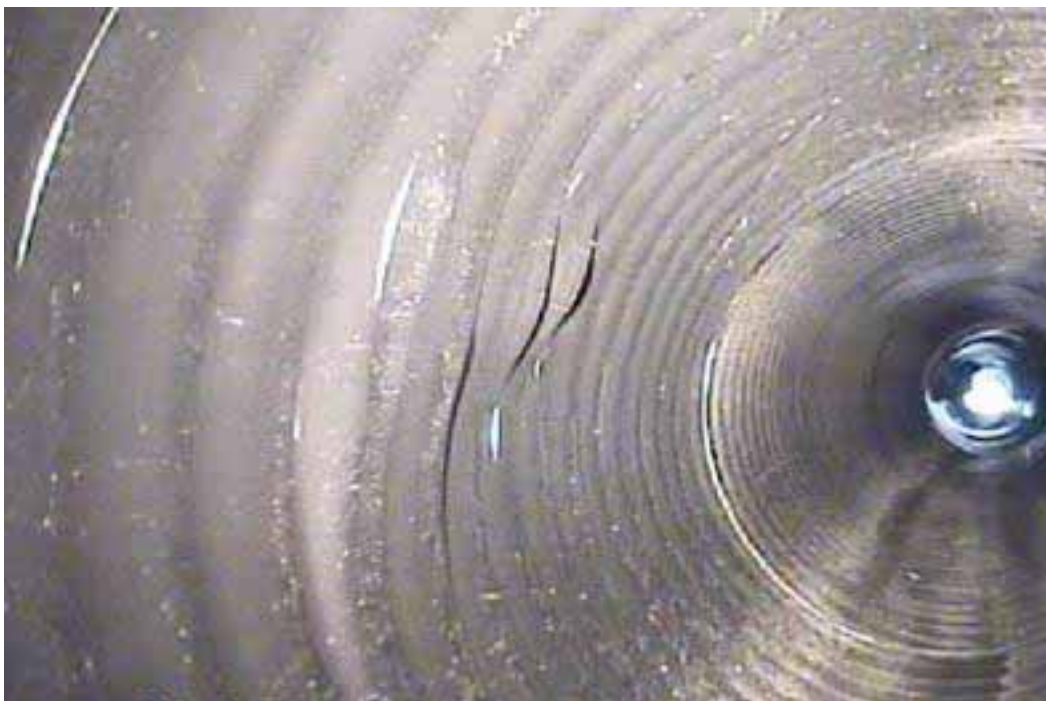
Figure 380 Cracking/fracture failure for Pipeline No. 9 (Site No. 2: Silver Creek Parkway)

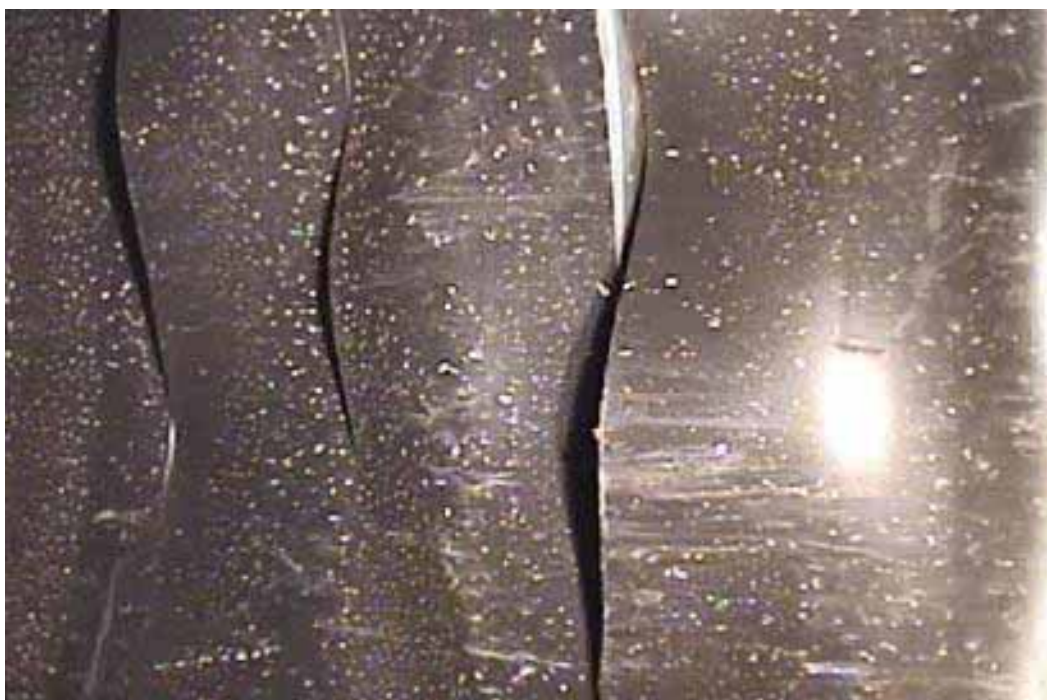
Figure 382 Cracking/fracture failure for Pipeline No. 9 (Site No. 2: Silver Creek Parkway)

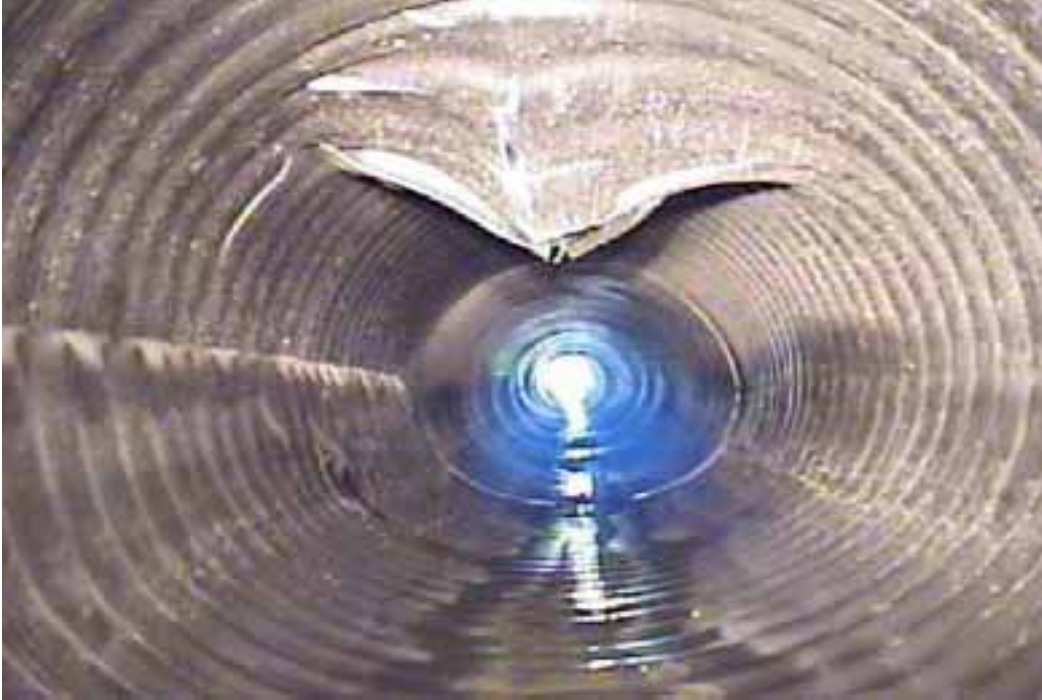
Figure 383 Cracking/fracture, inverse curvature, buckling, and excessive deformation (refer to Figure 376-c), and corrugation growth failure for Pipeline No. 9 (Site No. 2: Silver Creek Parkway)

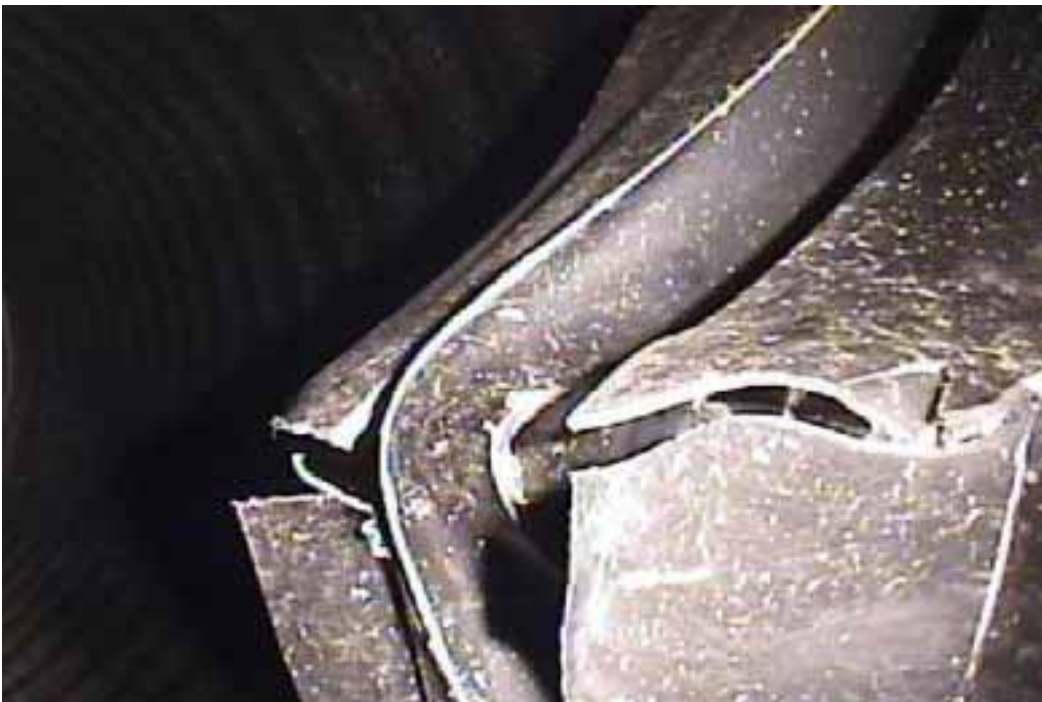
Figure 384 Cracking/fracture and inverse curvature failure from Figure 383 above for Pipeline No. 9 (Site No. 2: Silver Creek Parkway)

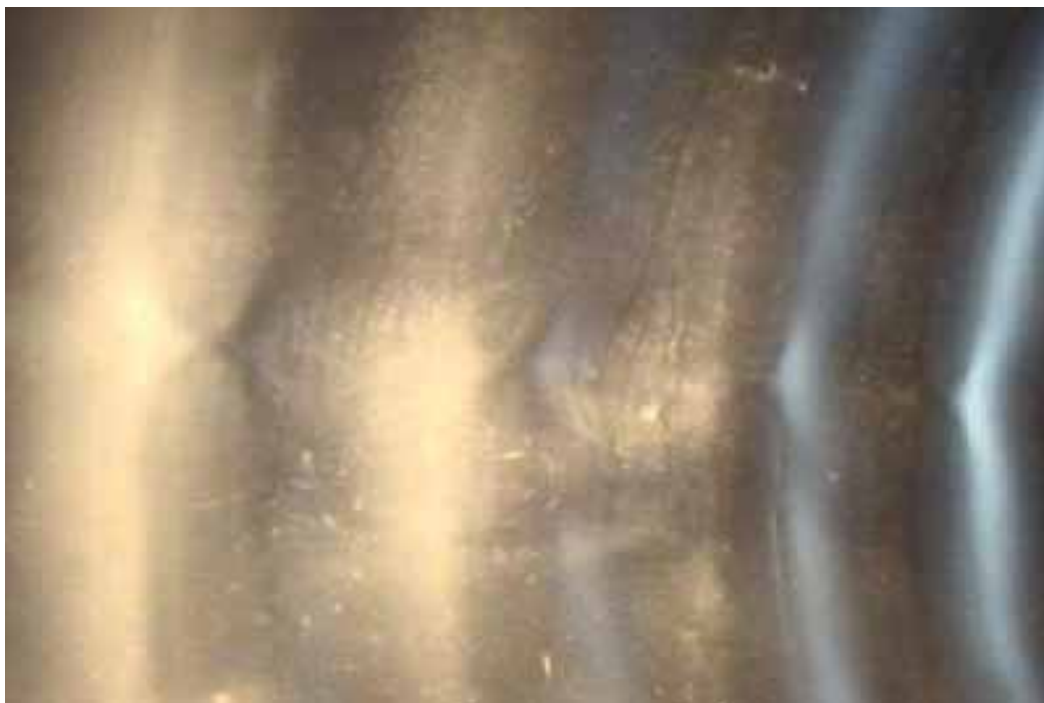
Figure 386 Buckling and corrugation growth failure for Pipeline No. 10 (Site No. 2: Silver Creek Parkway)

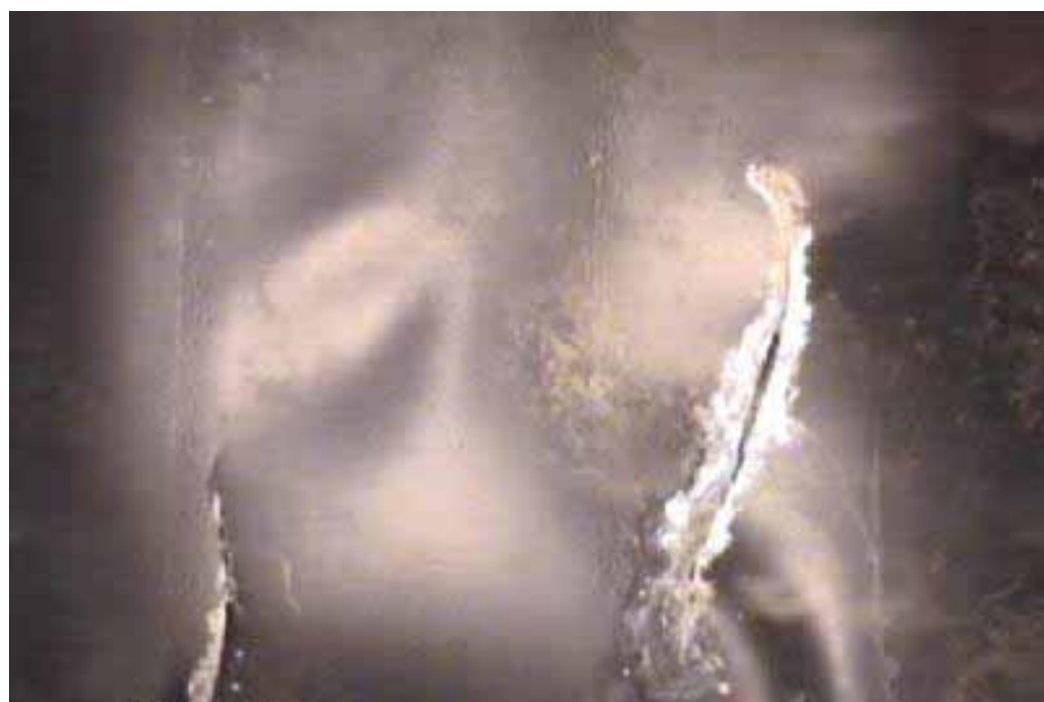
Figure 387 Cracking/fracture and buckling failure for Pipeline No. 10 (Site No. 2: Silver Creek Parkway)

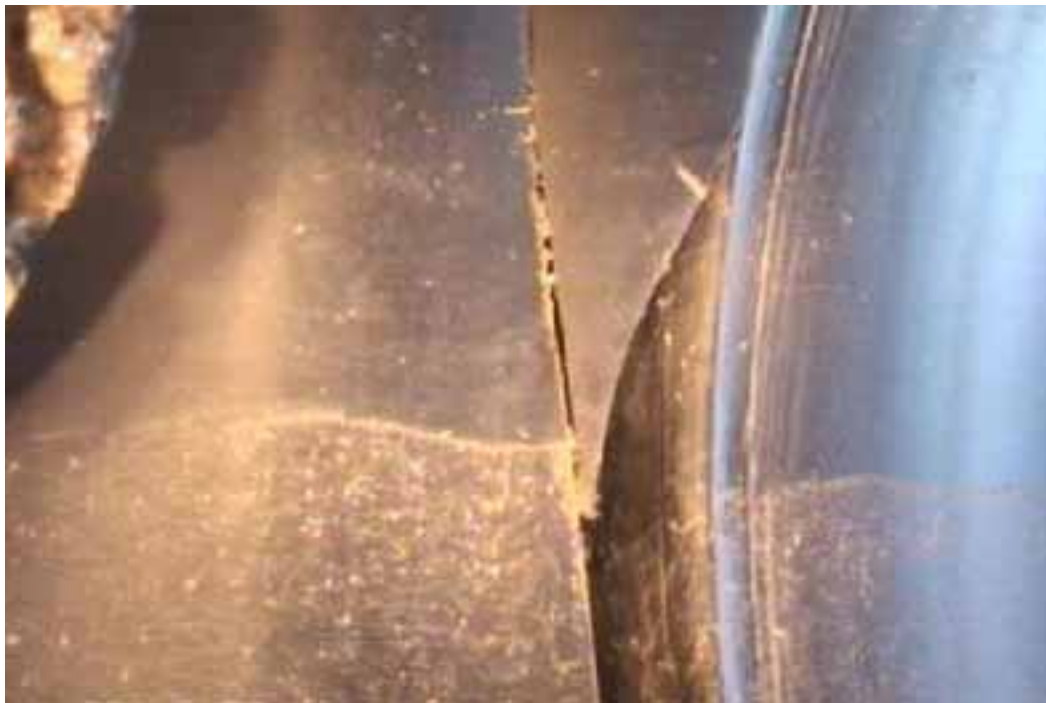
Figure 388 Cracking/fracture and joint displacement failure for Pipeline No. 10 (Site No. 2: Silver Creek Parkway)

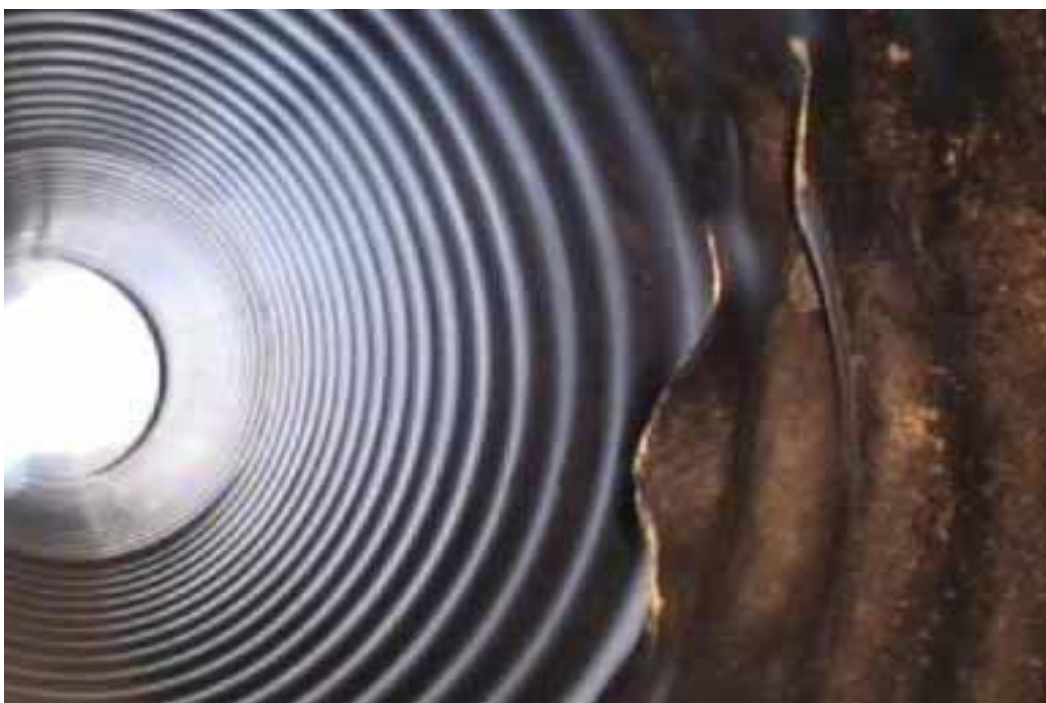
Figure 389 Cracking/fracture, corrugation growth, and inverse curvature failure for Pipeline No. 10 (Site No. 2: Silver Creek Parkway)

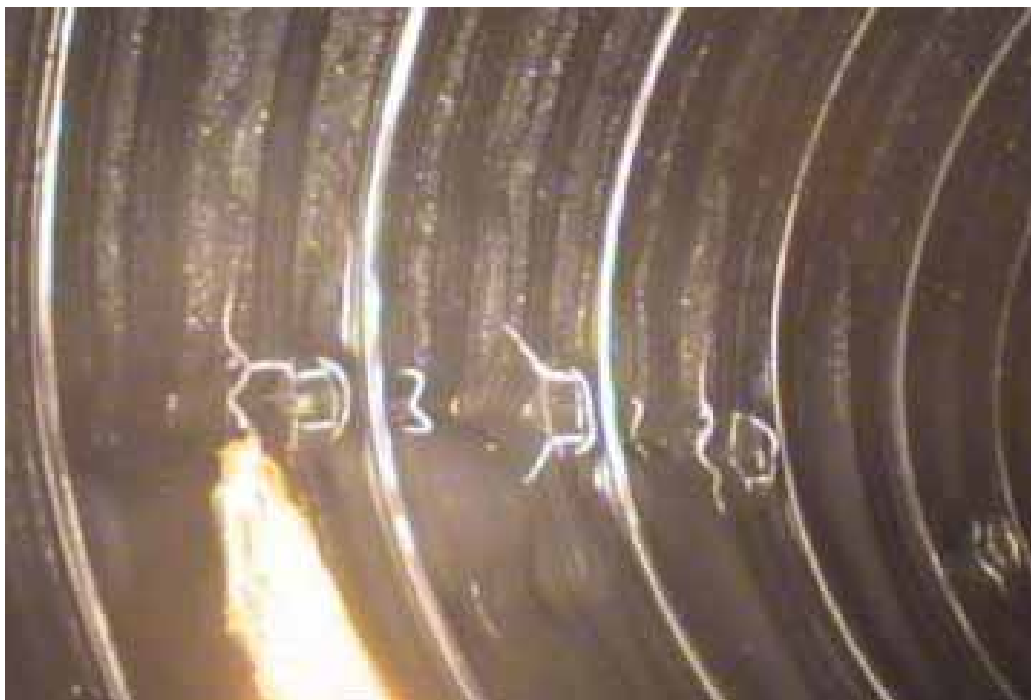
Figure 396 Cracking/fracture, corrugation growth, and buckling failure for Pipeline No. 4 (Site No. 4: Horton)

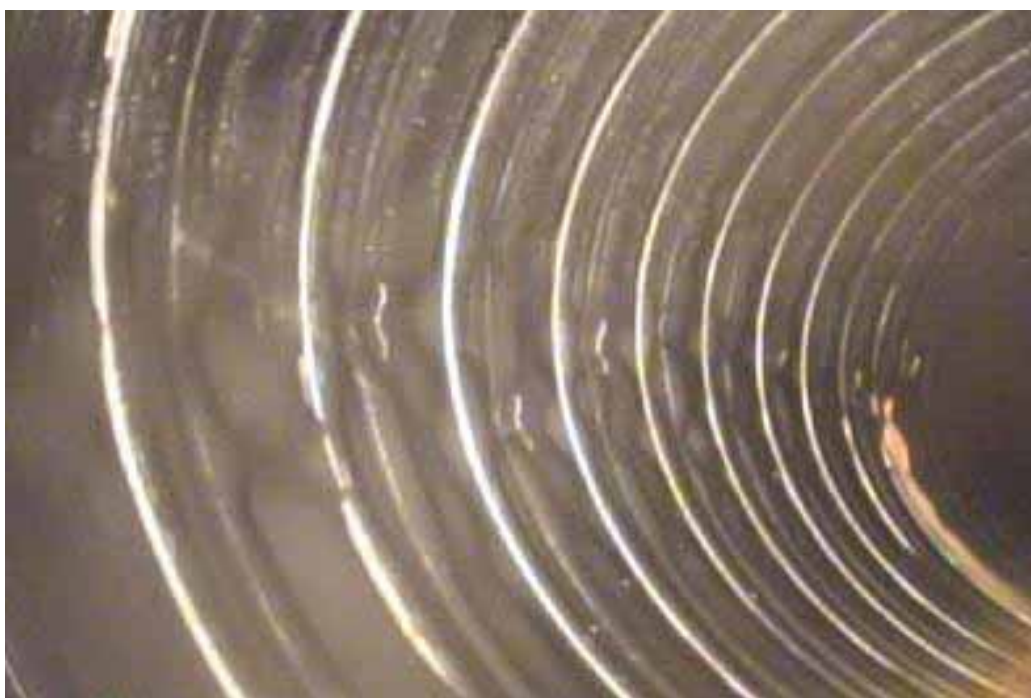
Figure 397 Corrugation growth and buckling failure for Pipeline No. 4 (Site No. 4: Horton Parkway)

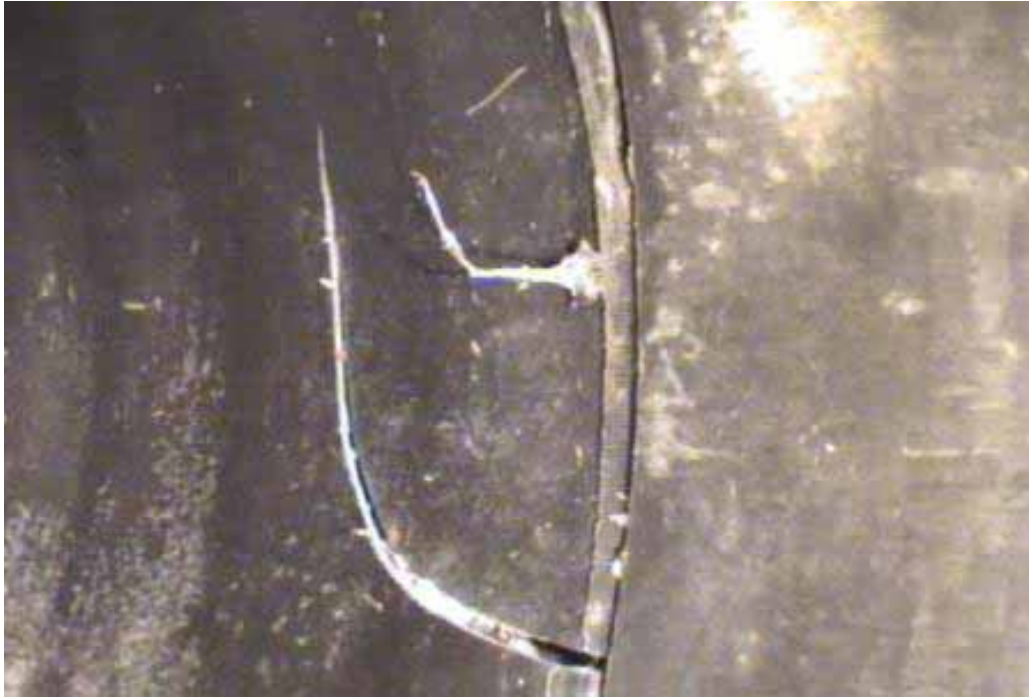
Figure 401 Cracking/fracture and major joint failure for Pipeline No. 5 (Site No. 5: Bad Axe)

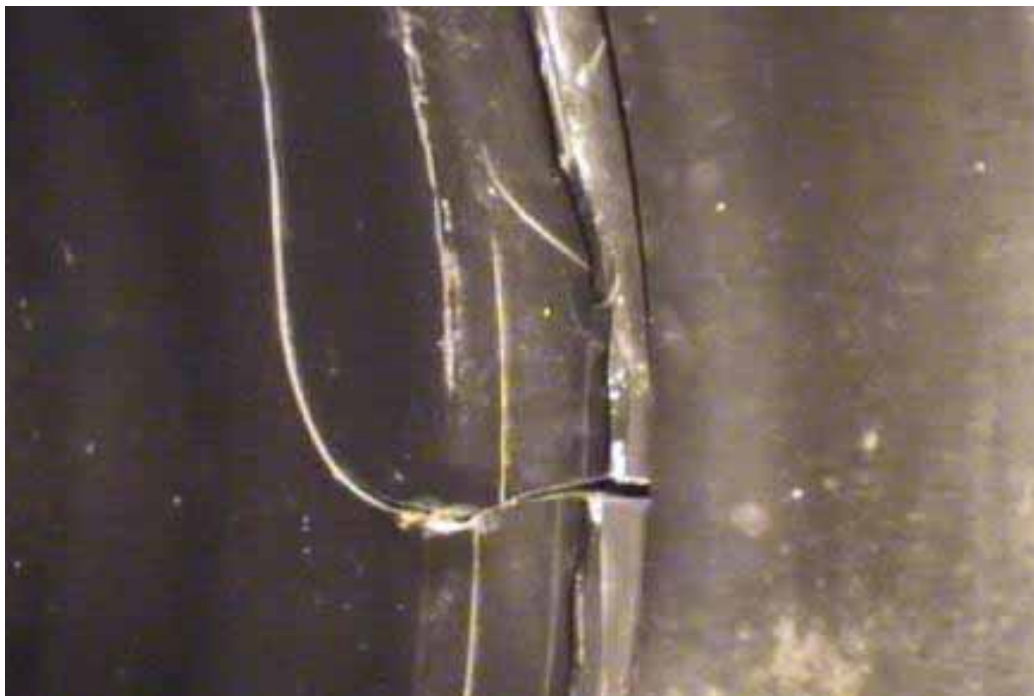
Figure 402 Cracking/fracture and major joint failure for Pipeline No. 5 (Site No. 5: Bad Axe)

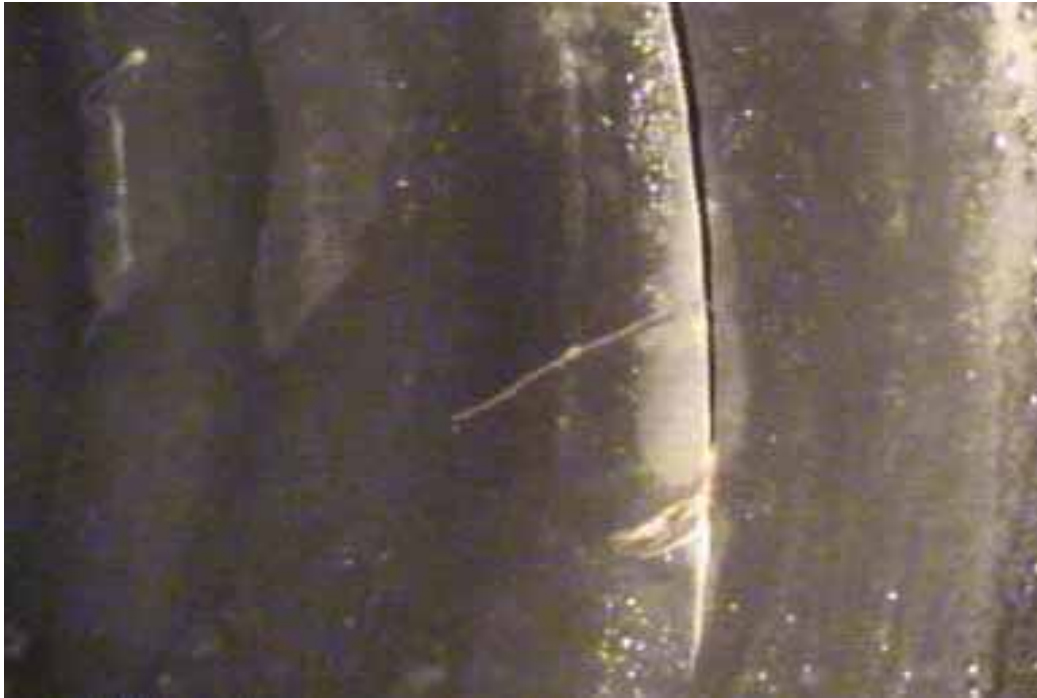
Figure 403 Cracking/fracture and major joint failure for Pipeline No. 5 (Site No. 5: Bad Axe)

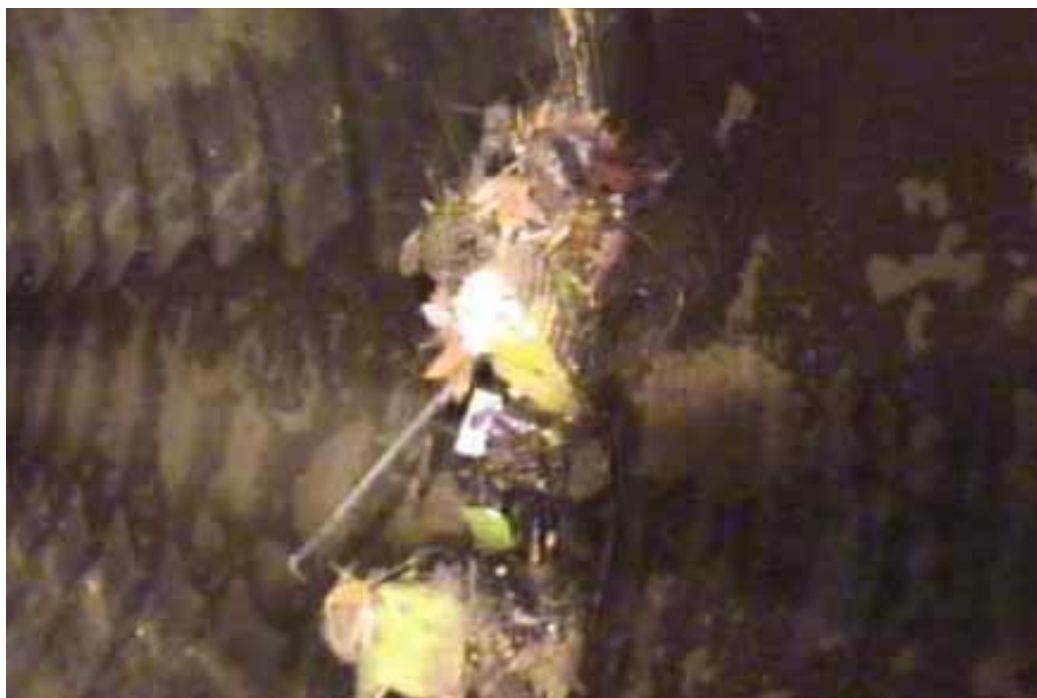
Figure 404 Corrugation growth and major joint displacement failure for Pipeline No. 5 (Site No. 5: Bad Axe)

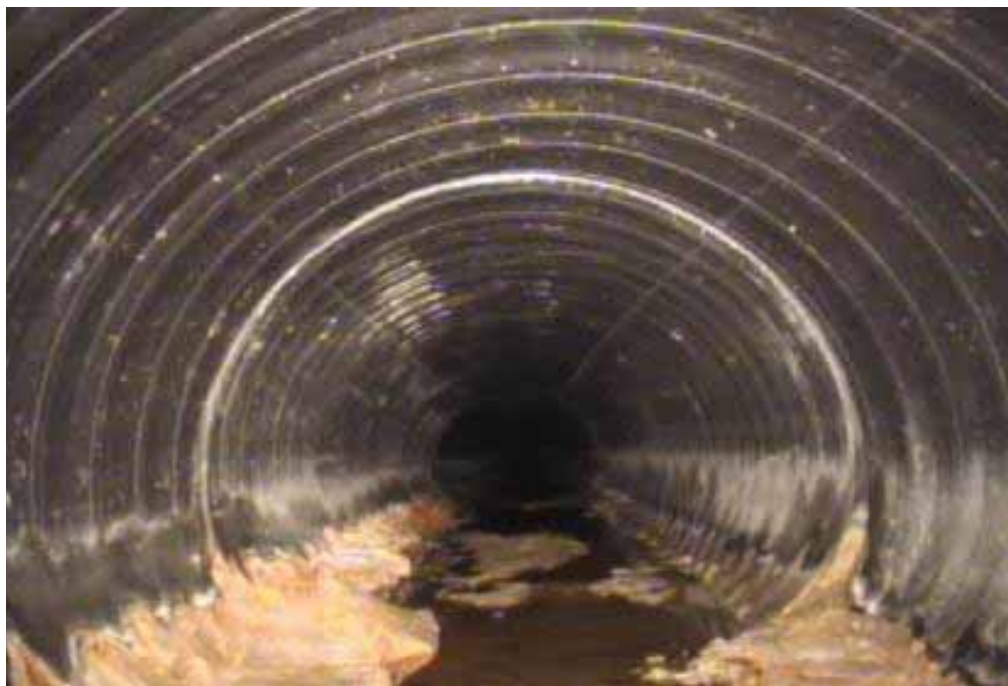
Pipeline No. 6a (Site No. 6 Houghton County M92)

Figure 405 Corrugation growth failure and debris for Pipeline No. 6a (Site No. 6: Houghton County M92)

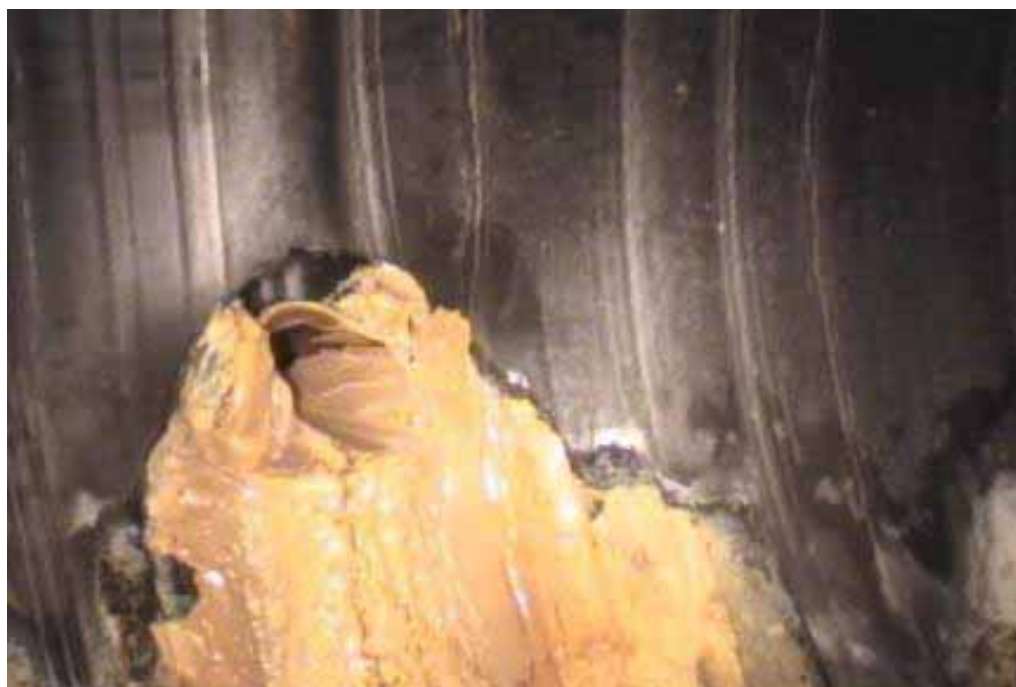
Figure 406 Corrugation growth failure with inlet added after installation for Pipeline No. 6a (Site No. 6: Houghton County M92)
