Evaluation of HDPE Pipelines Structural Performance

UT Arlington Center for Structural Engineering Research

November 2010

**As a Part of the Initiative on the Underground Structural Health
Monitoring and Equipment Development**

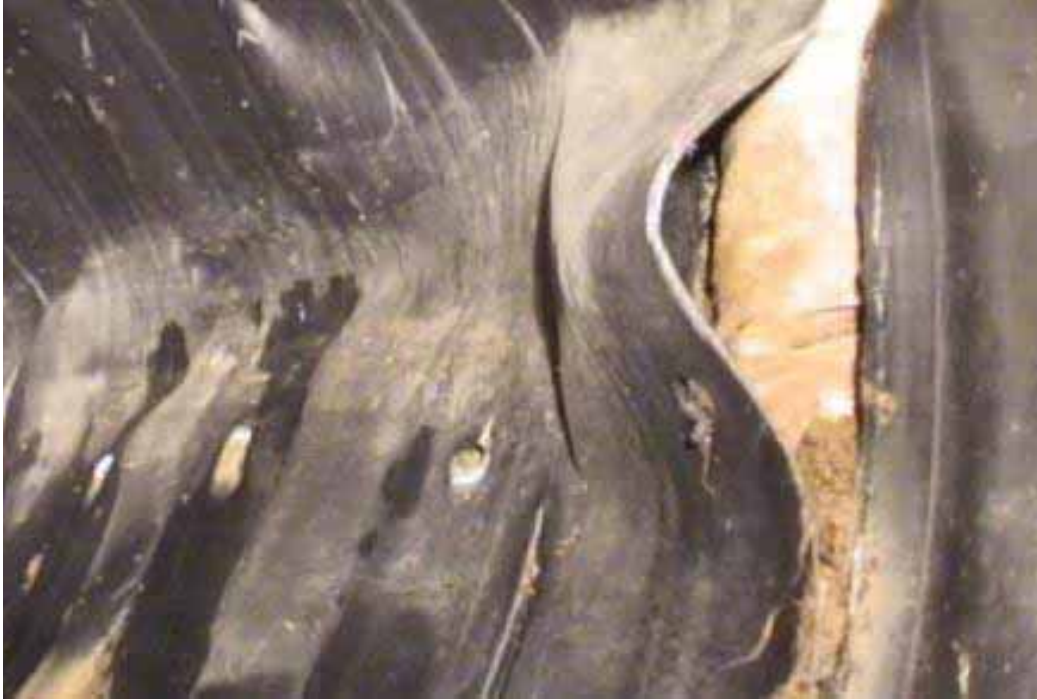
Figure 409 Cracking/fracture failure for Pipeline No. 6a (Site No. 6: Houghton County M92)

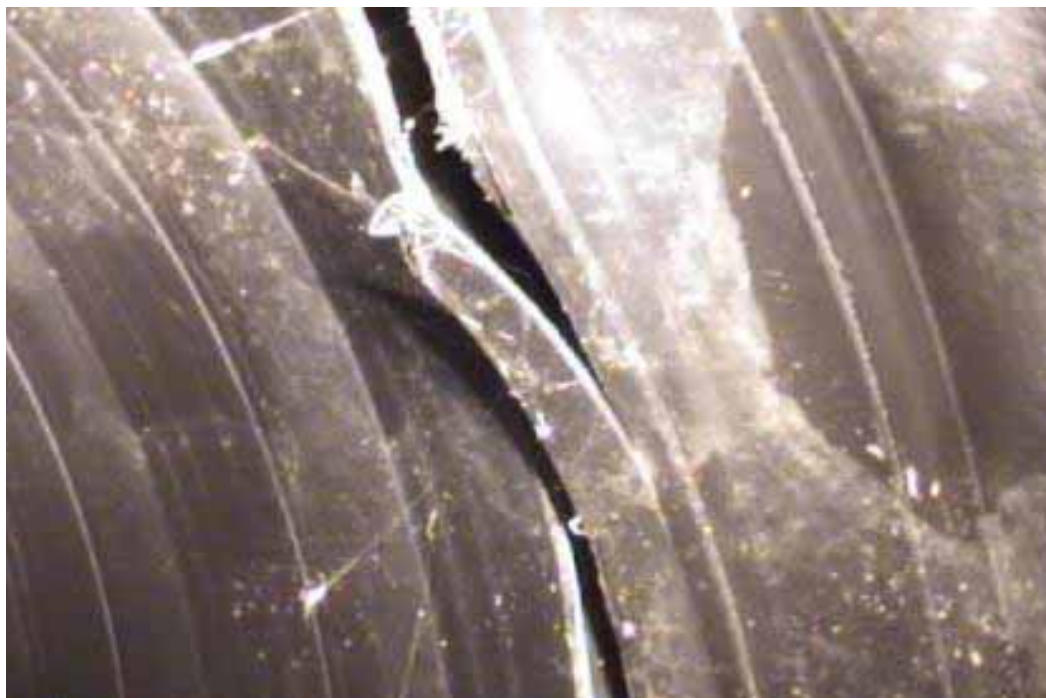
Figure 414 Cracking/fracture and inverse curvature failure for Pipeline No. 6b (Site No. 6: Houghton County M92)

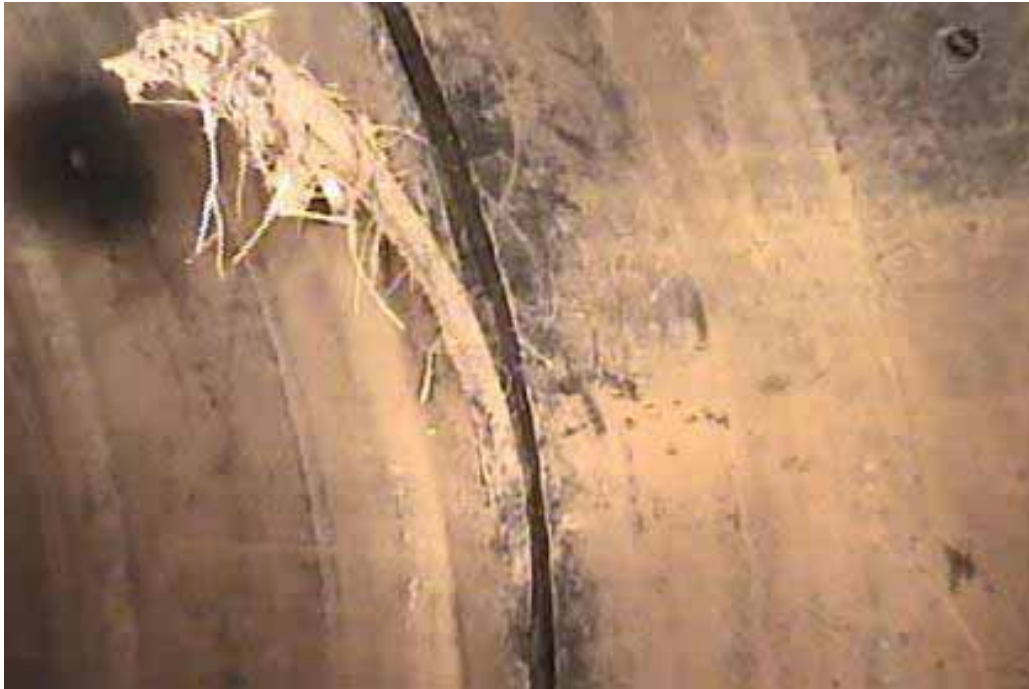
Pipeline No. 7 (Site No. 7 West Island Road)

Figure 415 Cracking/fracture and major joint displacement failure for Pipeline No. 7 (Site No. 7: West Island Road)

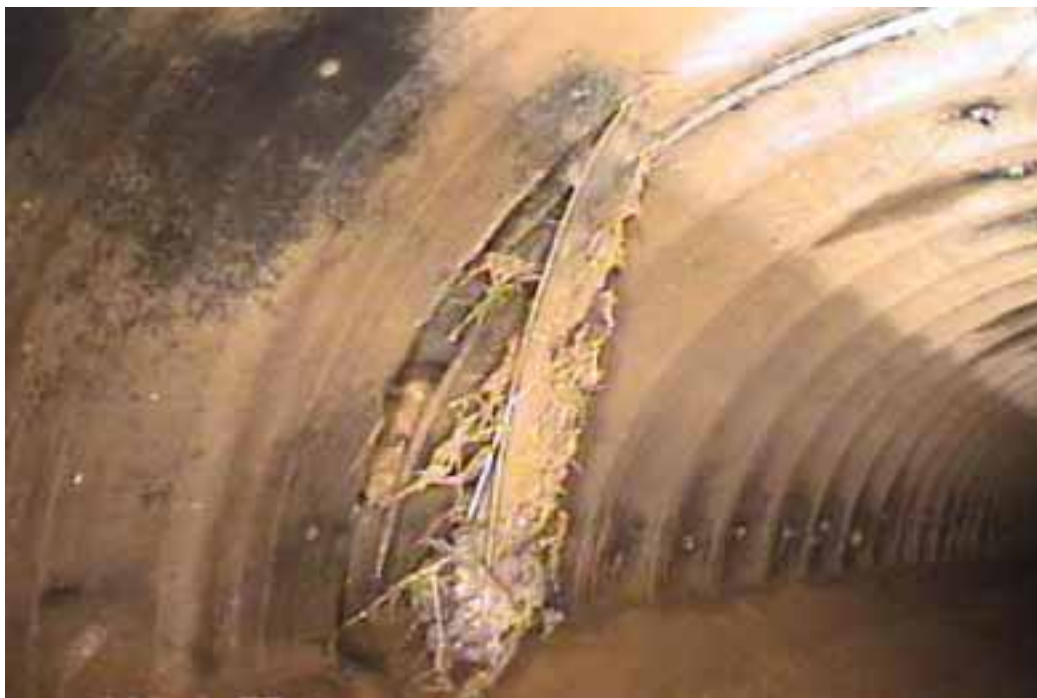
Figure 416 Cracking/fracture, major joint displacement, and corrugation growth failure for Pipeline No. 7 (Site No. 7: West Island Road)

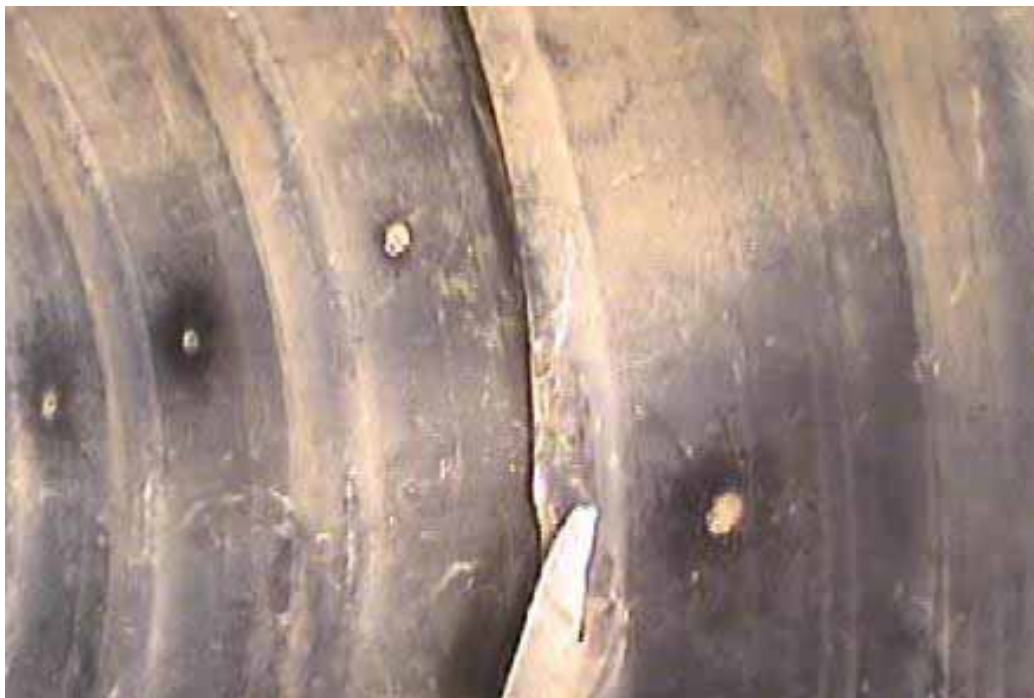
Figure 417 Cracking/fracture failure for Pipeline No. 7 (Site No. 7: West Island Road)

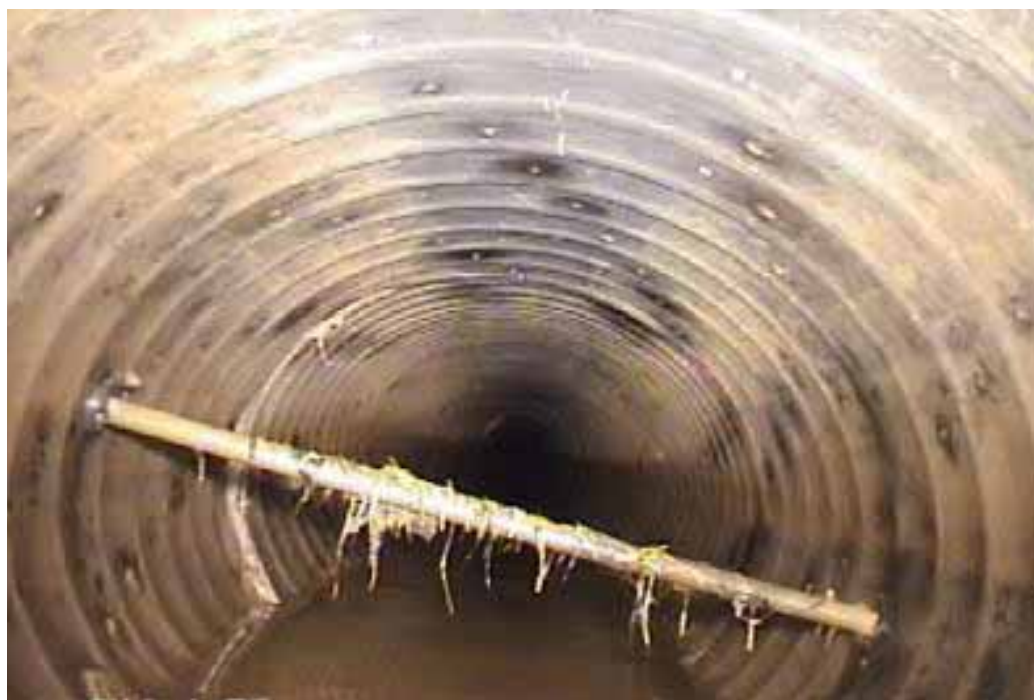
Figure 418 Cracking/fracture and corrugation growth failure for Pipeline No. 7 (Site No. 7: West Island Road)

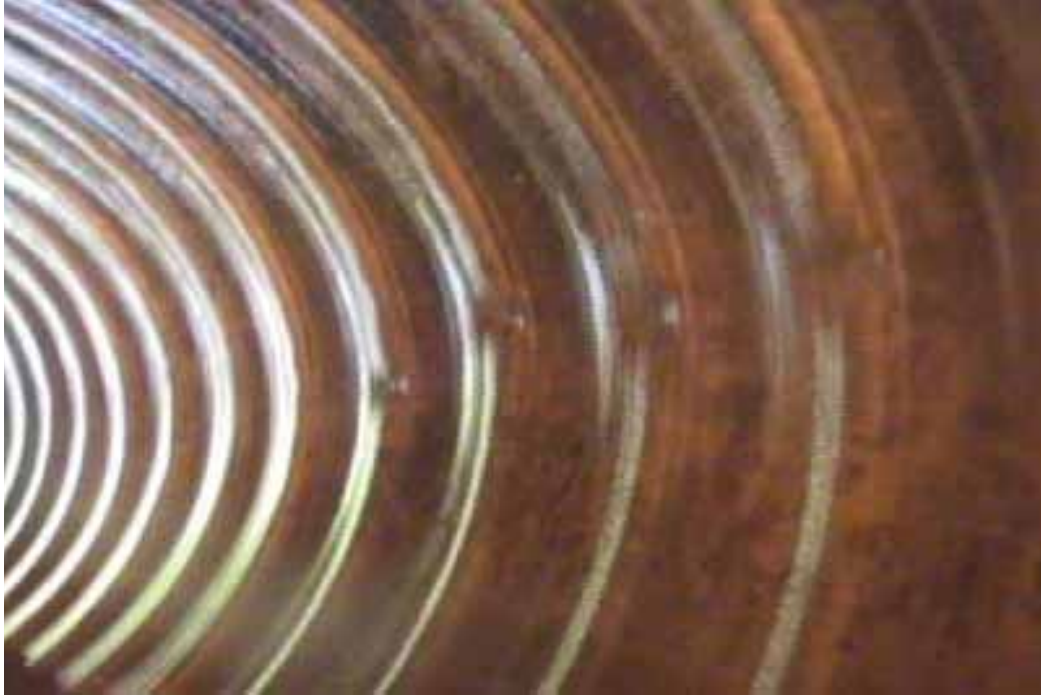
Figure 420 Corrugation growth and buckling failure for Pipeline No. 8 (Site No. 7: West Island Road)

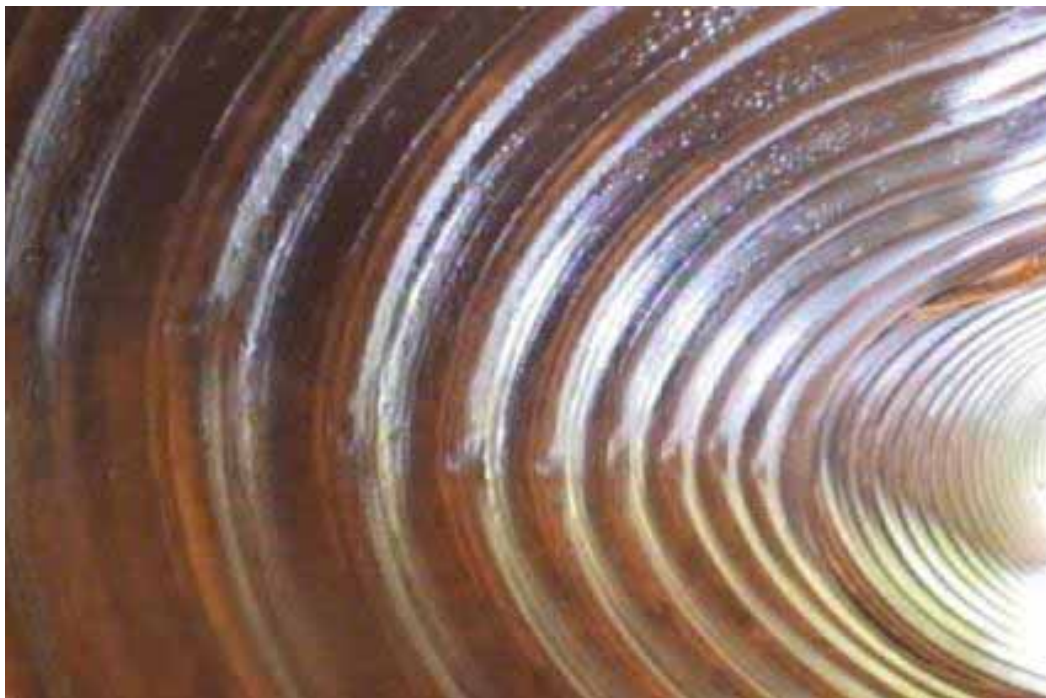
Figure 421 Corrugation growth, excessive deformation, and buckling failure for Pipeline No. 8 (Site No. 7: West Island Road)

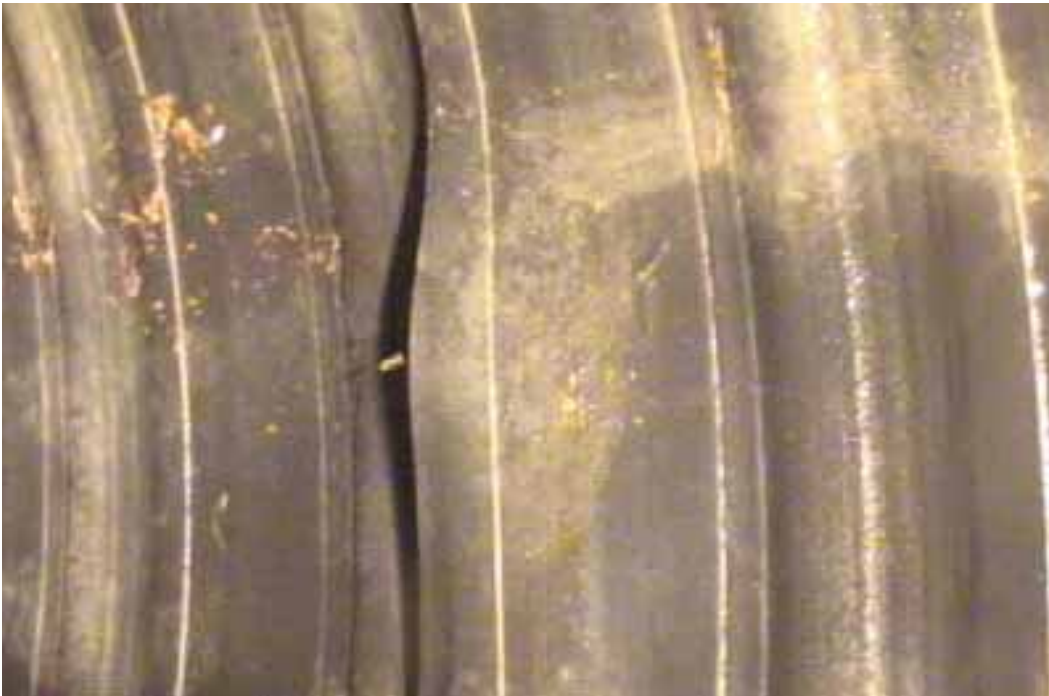
Figure 423 Cracking/fracture failure for Pipeline No. 8 (Site No. 7: West Island Road)

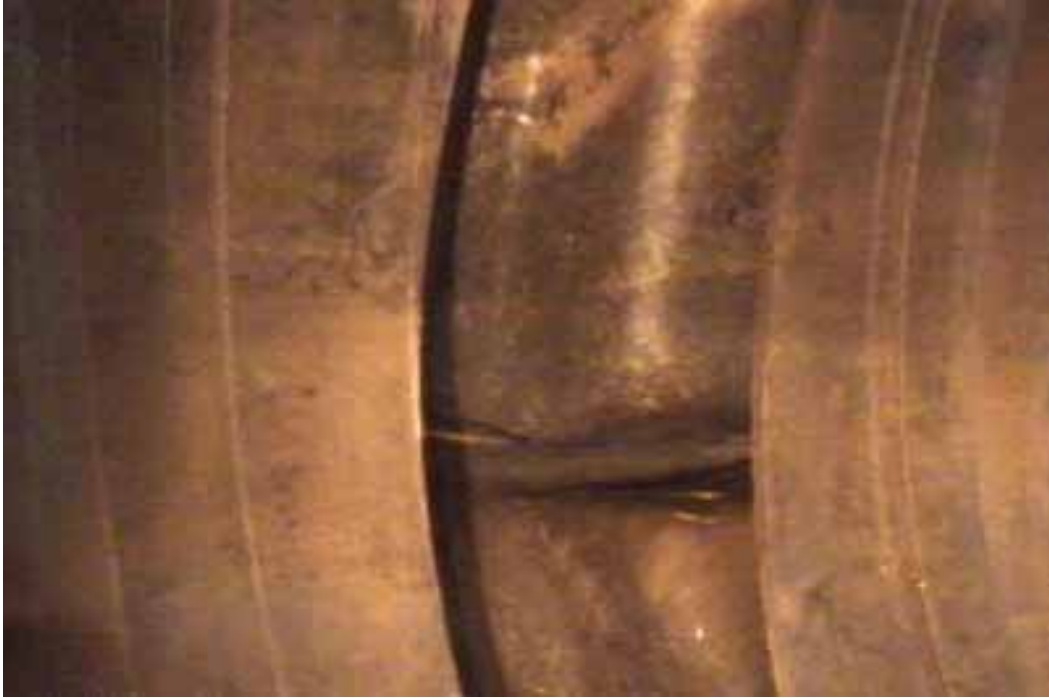
Figure 424 Joint displacement failure for Pipeline No. 8 (Site No. 7: West Island Road)

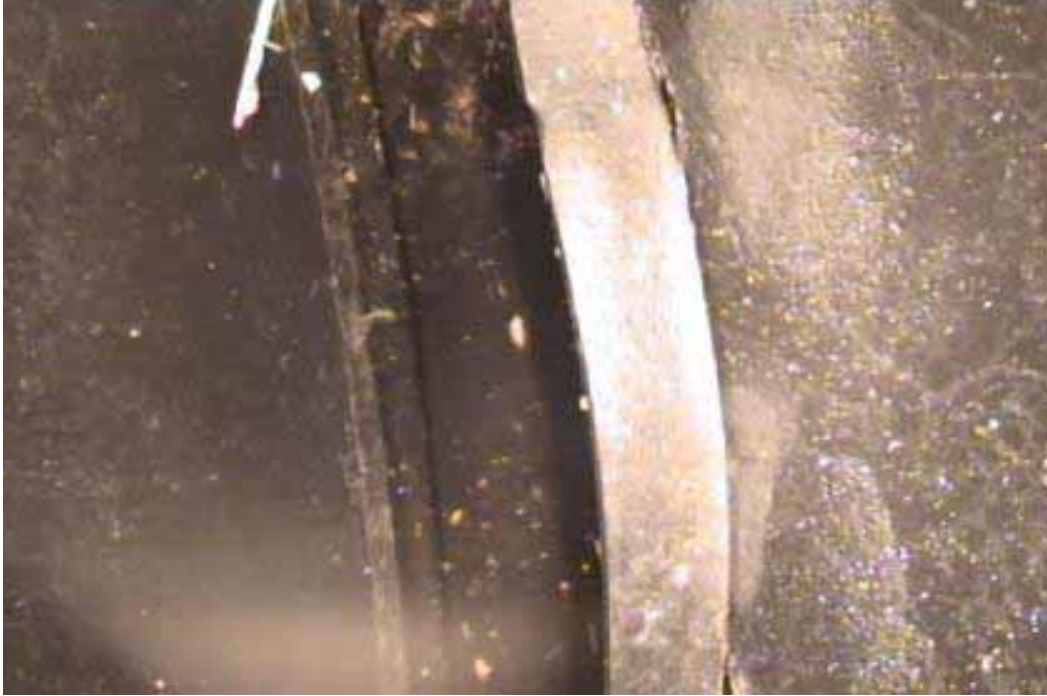
Figure 426 Cracking/fracture failure for Pipeline No. 9 (Site No. 8: Kinross Road)

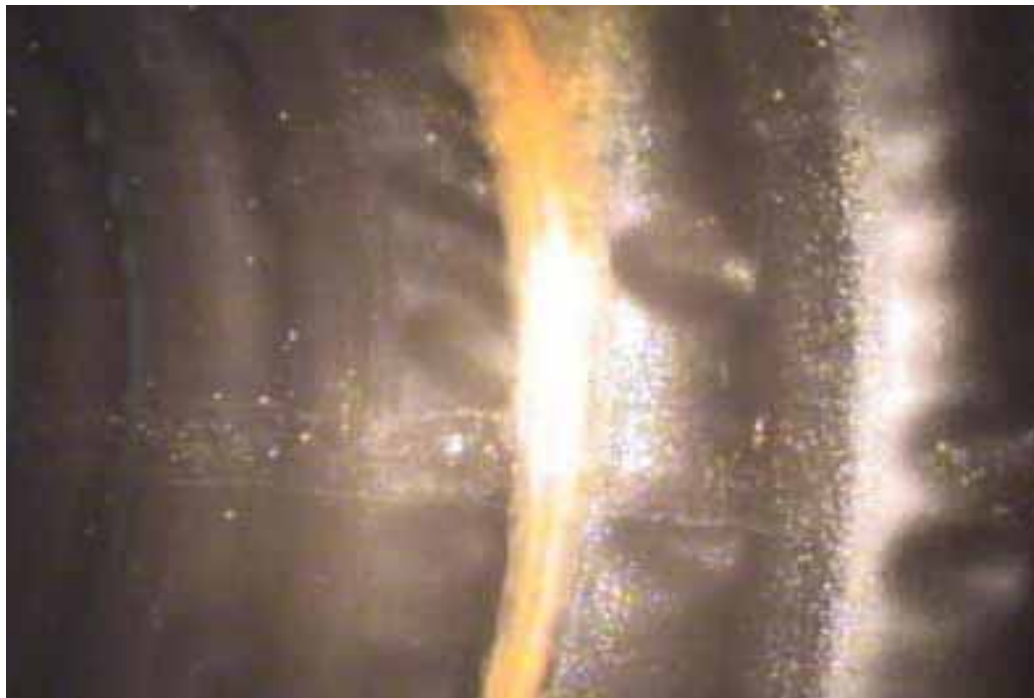
Figure 432 Buckling and corrugation growth failure for Pipeline No. 13 (Site No. 8: Kinross Road)

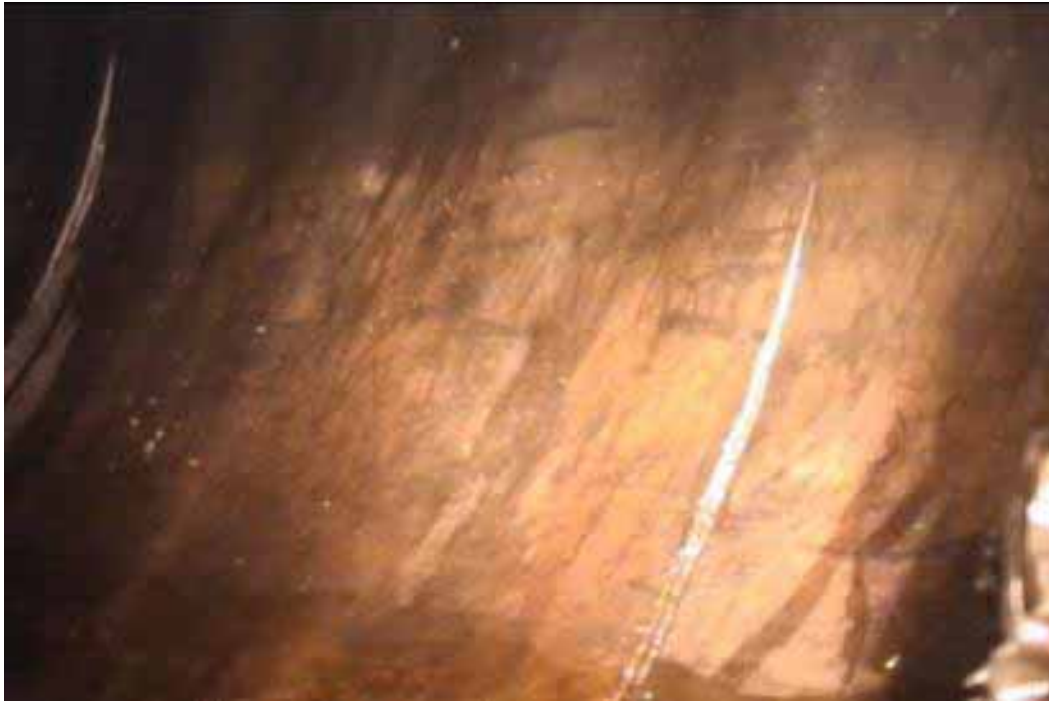
Figure 435 Cracking/fracture failure for Pipeline No. 13 (Site No. 8: Kinross Road)

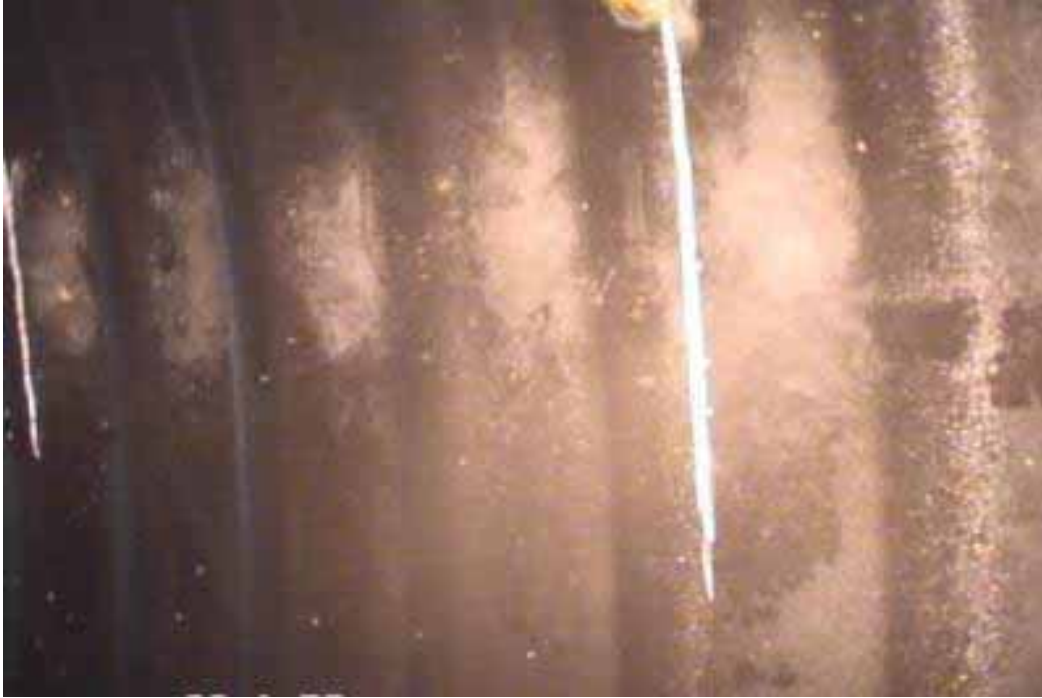
Figure 437 Cracking/fracture and corrugation growth failure for Pipeline No. 13 (Site No. 8: Kinross Road)

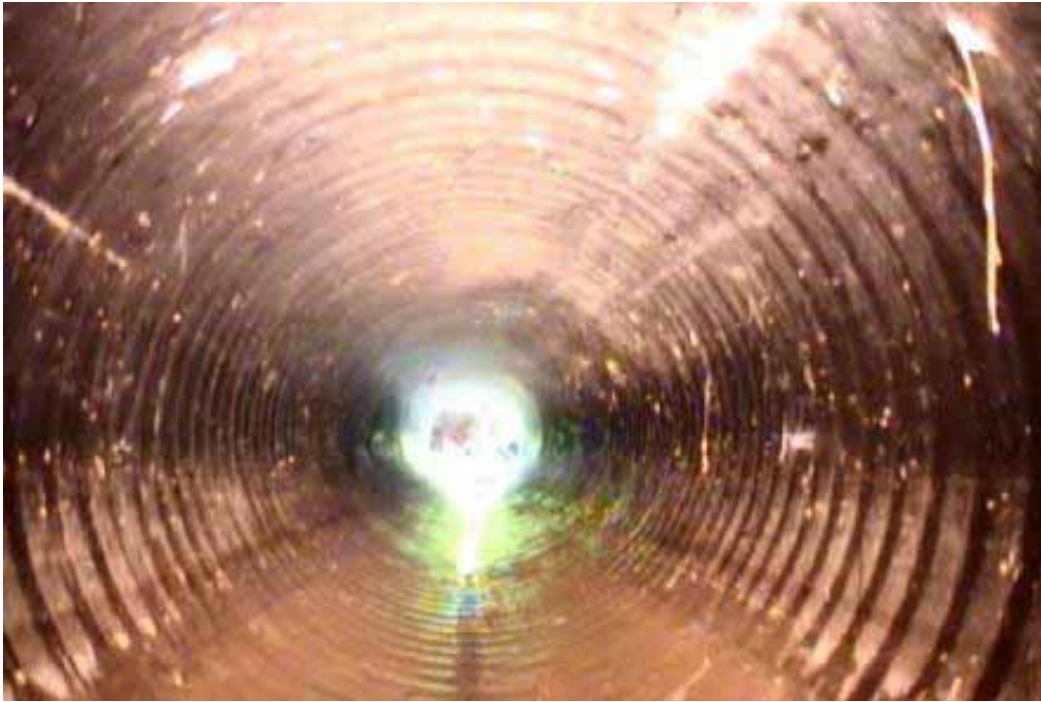
Pipeline No. 16 (Site No. 9 Driveway off Main Street L’Anse)

Figure 441 Corrugation growth failure for Pipeline No. 16 (Site No. 9: Driveway off Main St. L’Anse)

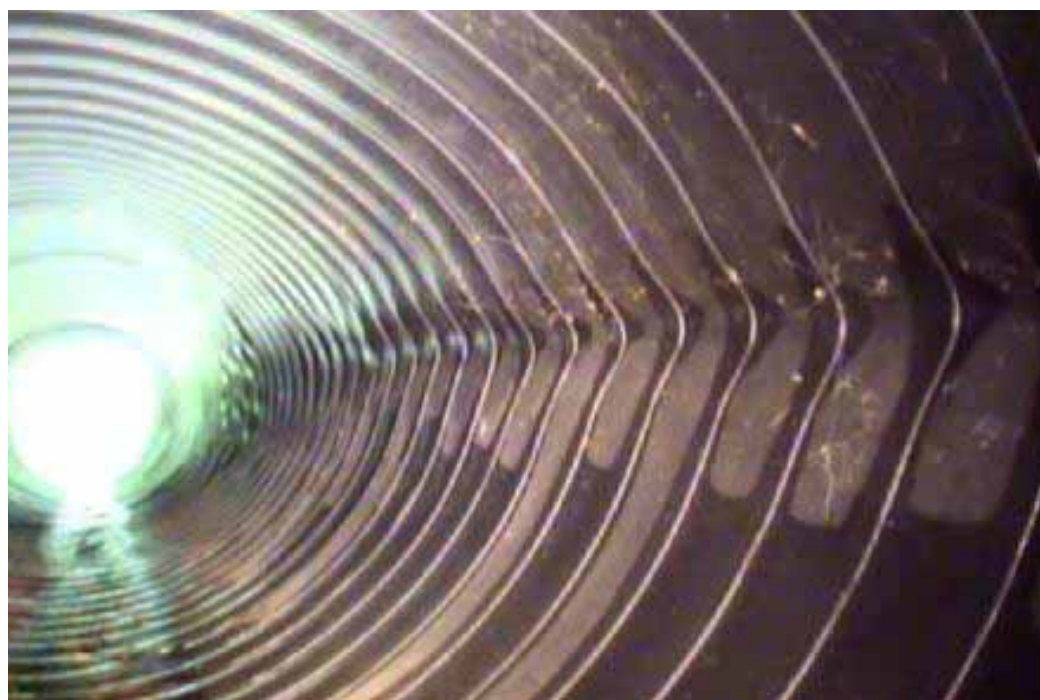
Figure 448 Buckling and corrugation growth failure for Pipeline No. 21 (Site No. 11: Houghton County-North Laird Heights)

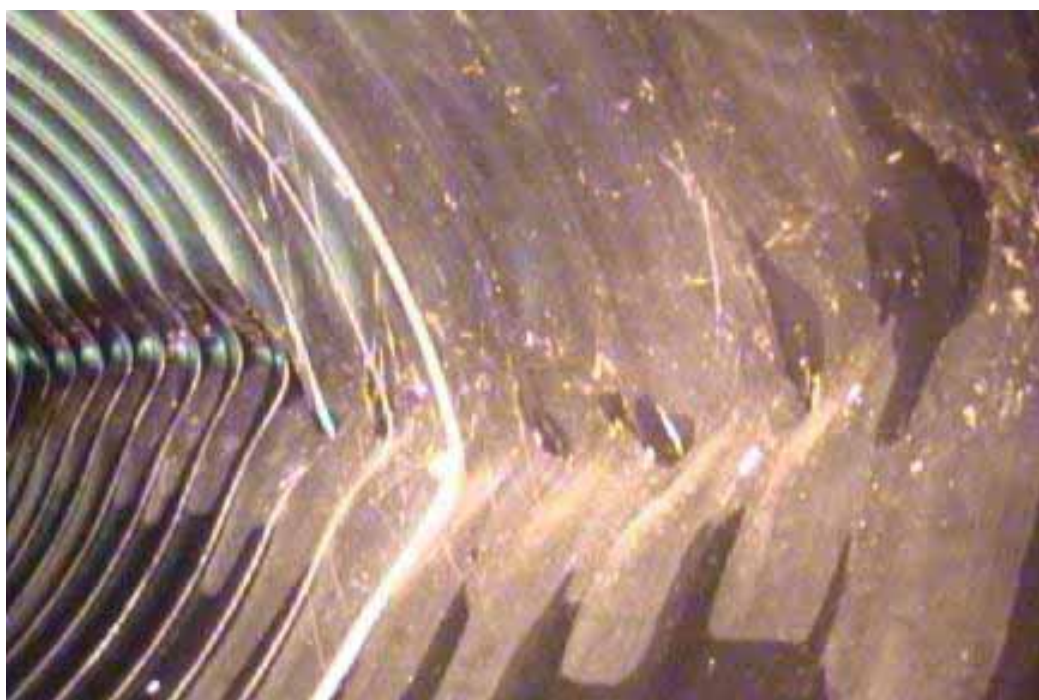
Figure 450 Buckling and corrugation growth failure for Pipeline No. 21 (Site No. 11: Houghton County-North Laird Heights)

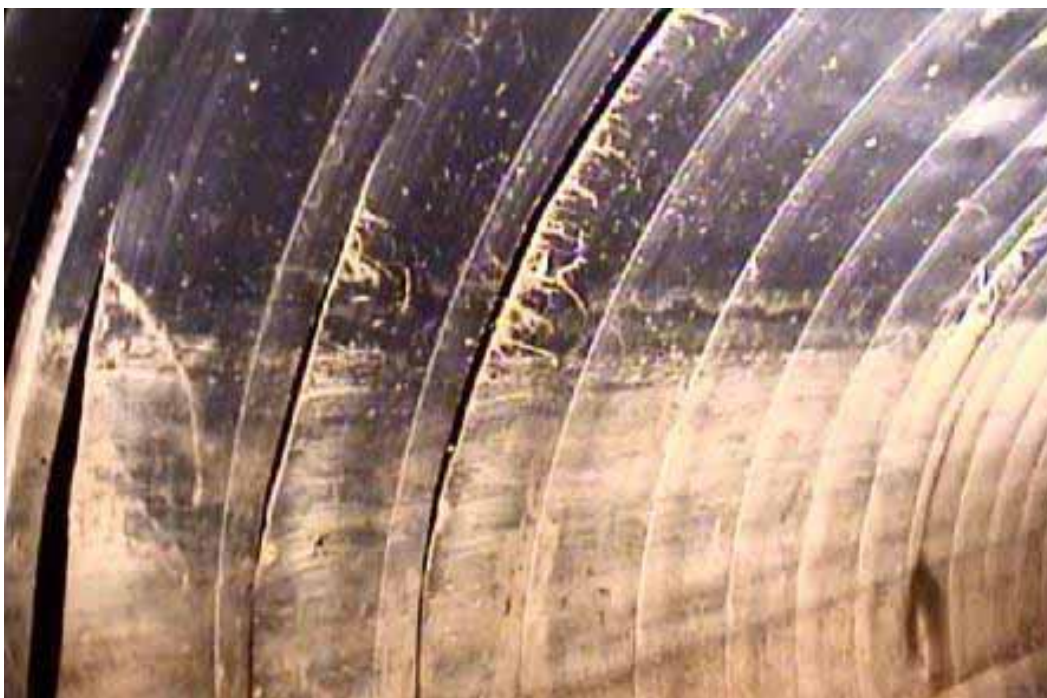
Figure 455 Buckling and corrugation growth failure for Pipeline No. 23 (Site No. 12: 48th Avenue)

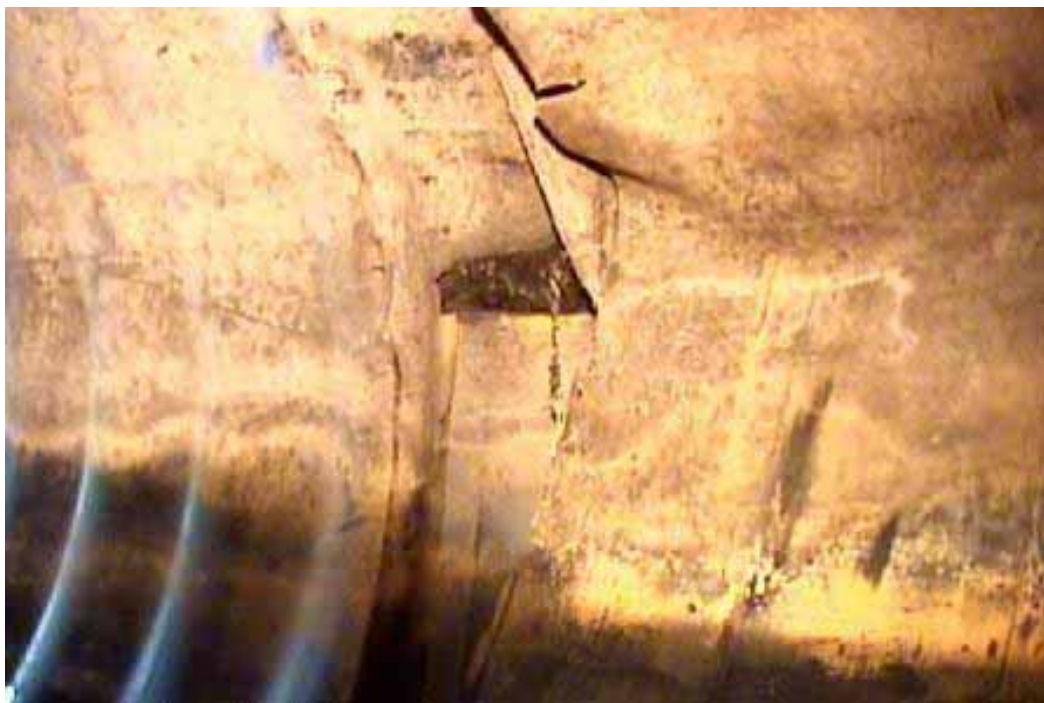
Figure 456 Buckling, cracking/fracture, joint displacement, and corrugation growth failure for Pipeline No. 23 (Site No. 12: 48th Avenue)

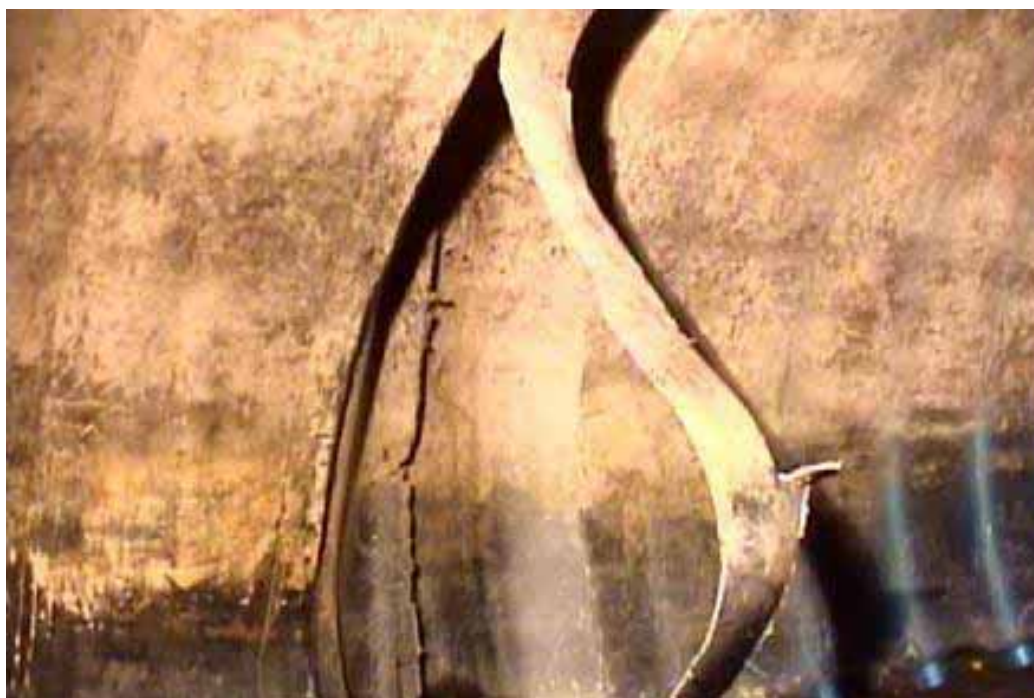
Figure 457 Cracking/fracture, major joint displacement, and corrugation growth failure for Pipeline No. 23 (Site No. 12: 48th Avenue)

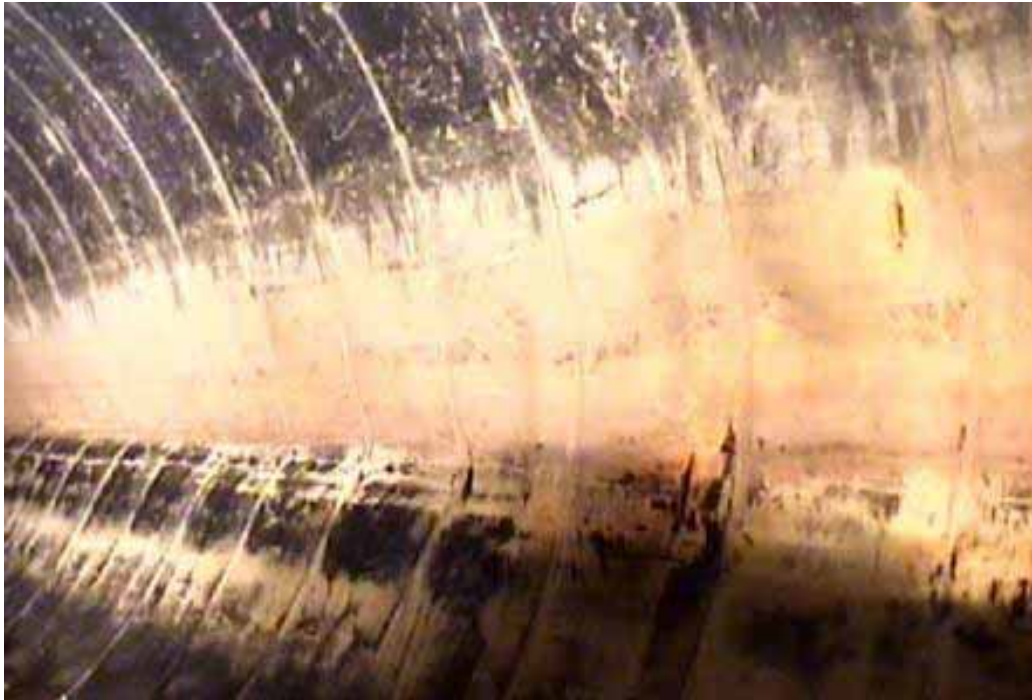
Figure 458 Buckling and corrugation growth failure for Pipeline No. 23 (Site No. 12: 48th Avenue)

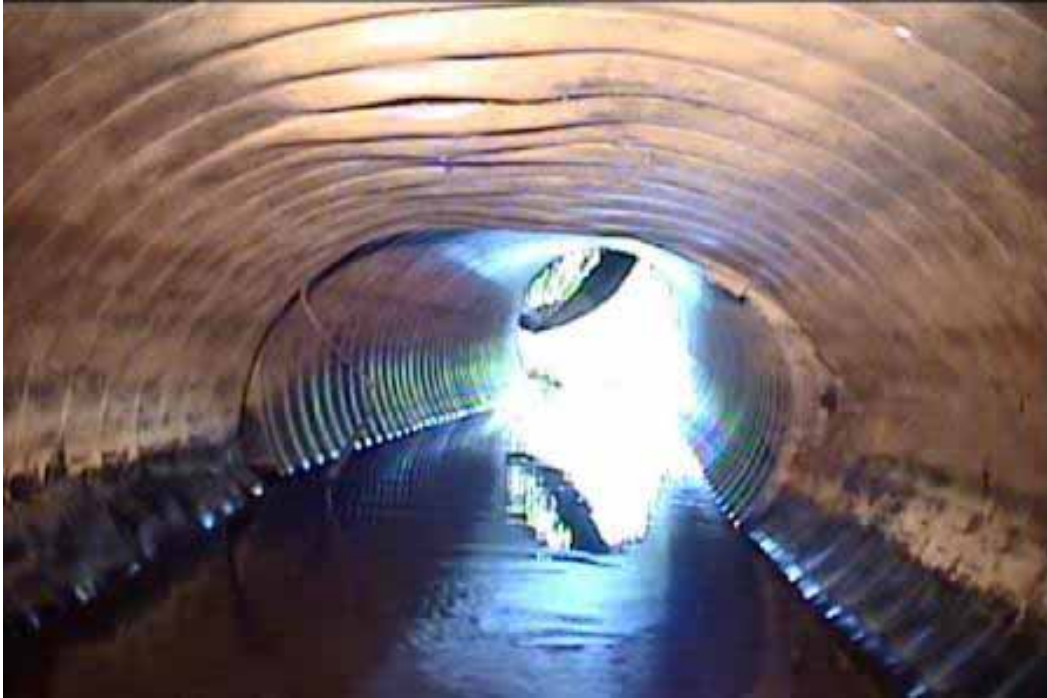
Figure 460 Excessive deformation, inverse curvature, and corrugation growth failure for Pipeline No. 23 (Site No. 12: 48th Avenue)

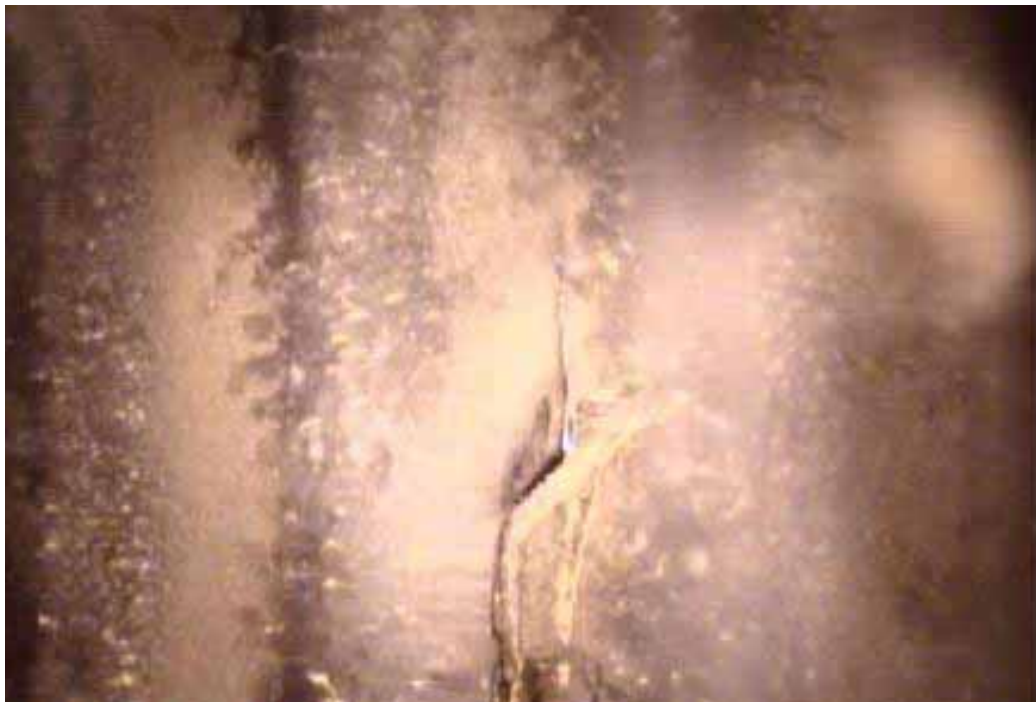
Figure 463 Cracking/fracture failure for Pipeline No. 24b (Site No. 13: Burlinghame Avenue)

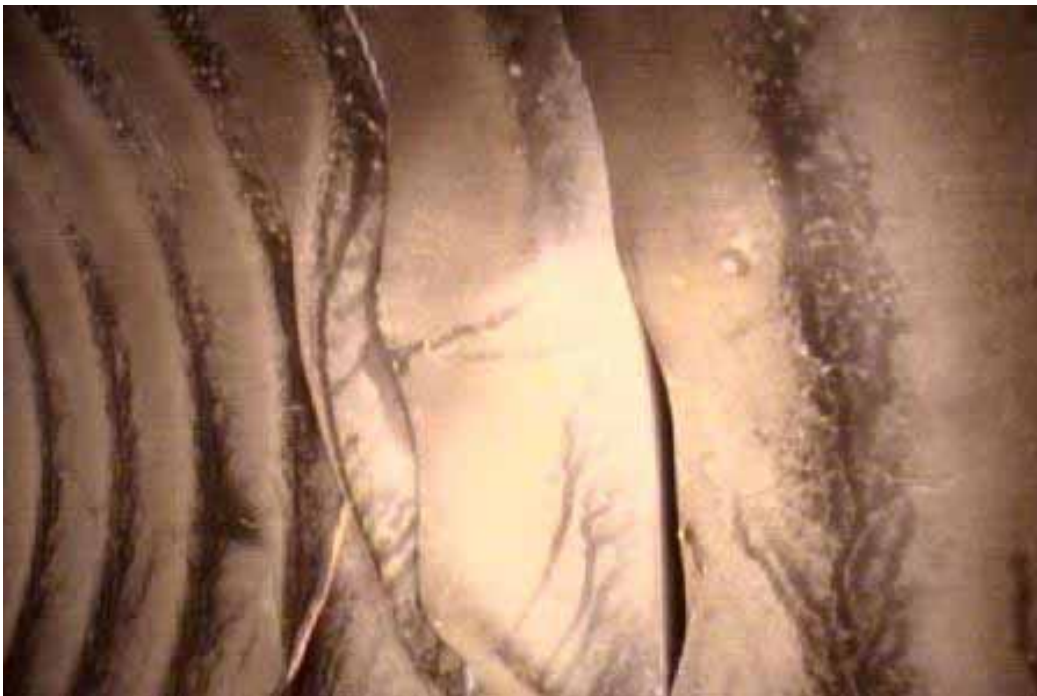
Figure 466 Cracking/fracture, buckling, and corrugation growth failure for Pipeline No. 24b (Site No. 13: Burlinghame Avenue)

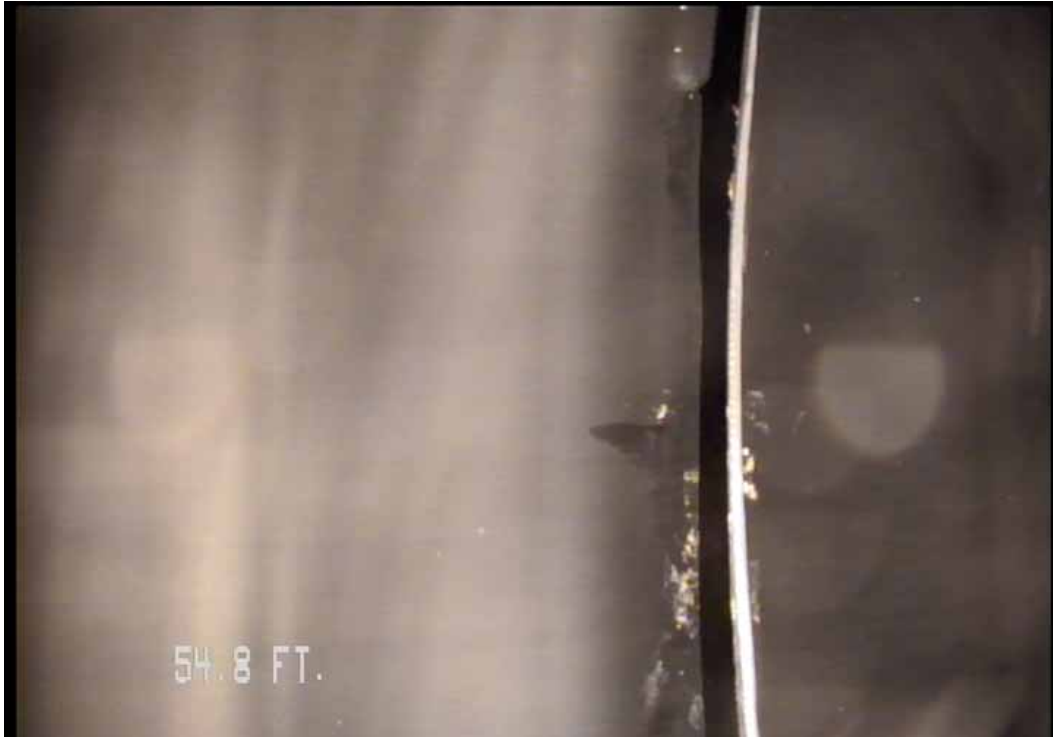
Figure 478 View of the major joint displacement failure for pipeline No. 1 (Site No. 1: Orlando)

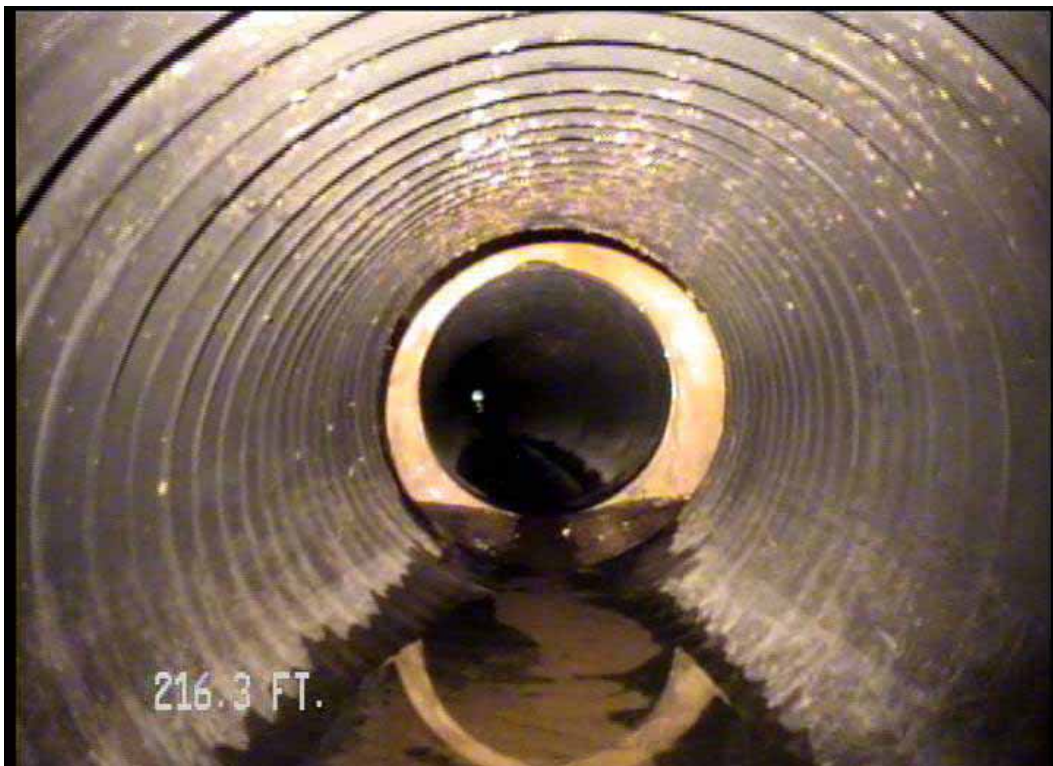
Figure 479 View of excessive deformation and corrugation growth failures for pipeline No. 1 (Site No. 1: Orlando)

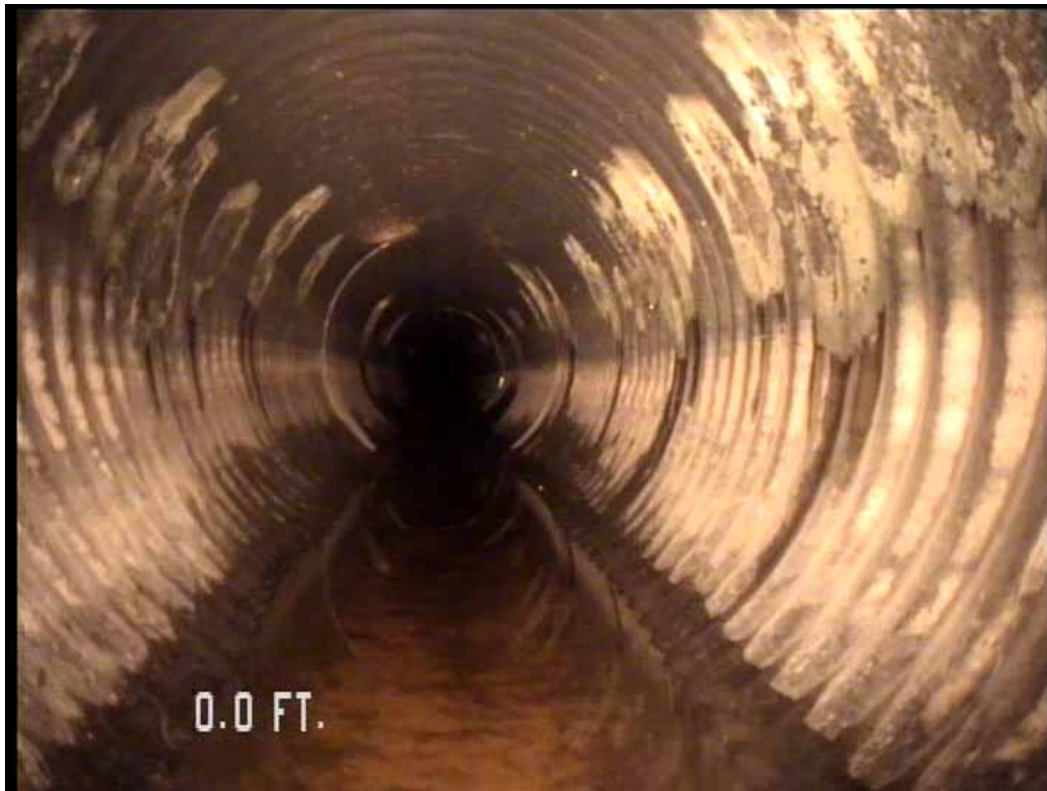
Figure 482 View of the corrugation growth failure for pipeline No. 2 (Site No. 1: Orlando)

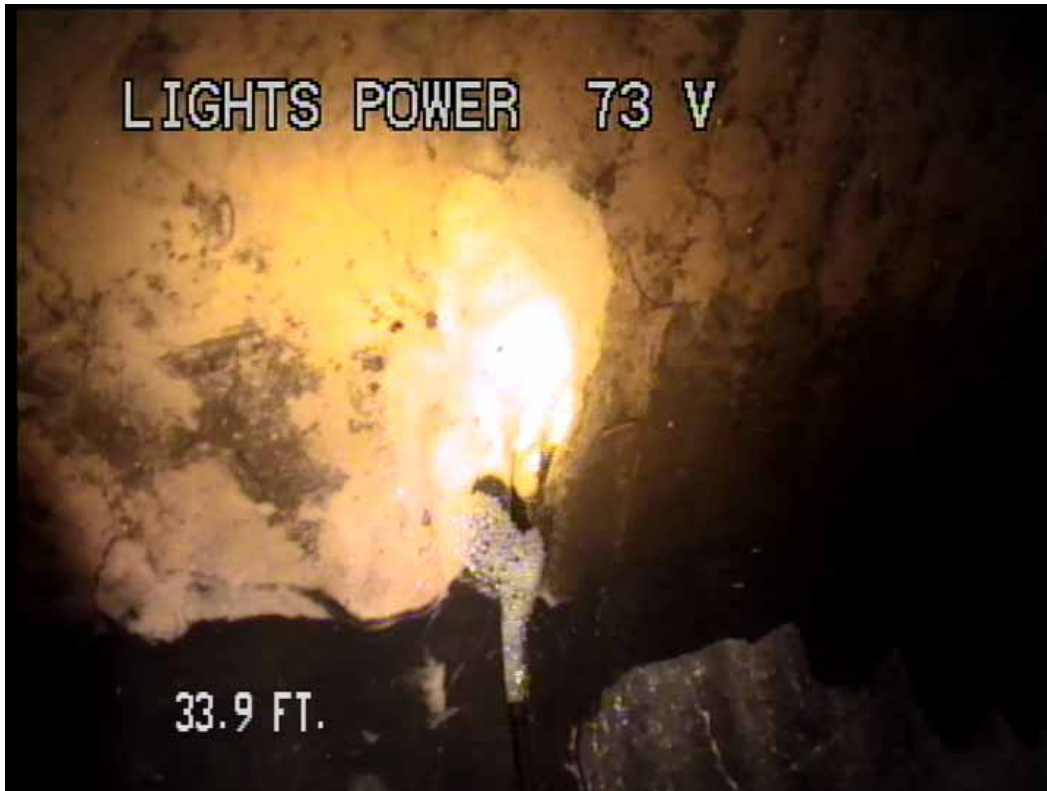
Figure 484 View of the leaking at the joint for pipeline No. 2 (Site No. 1: Orlando)

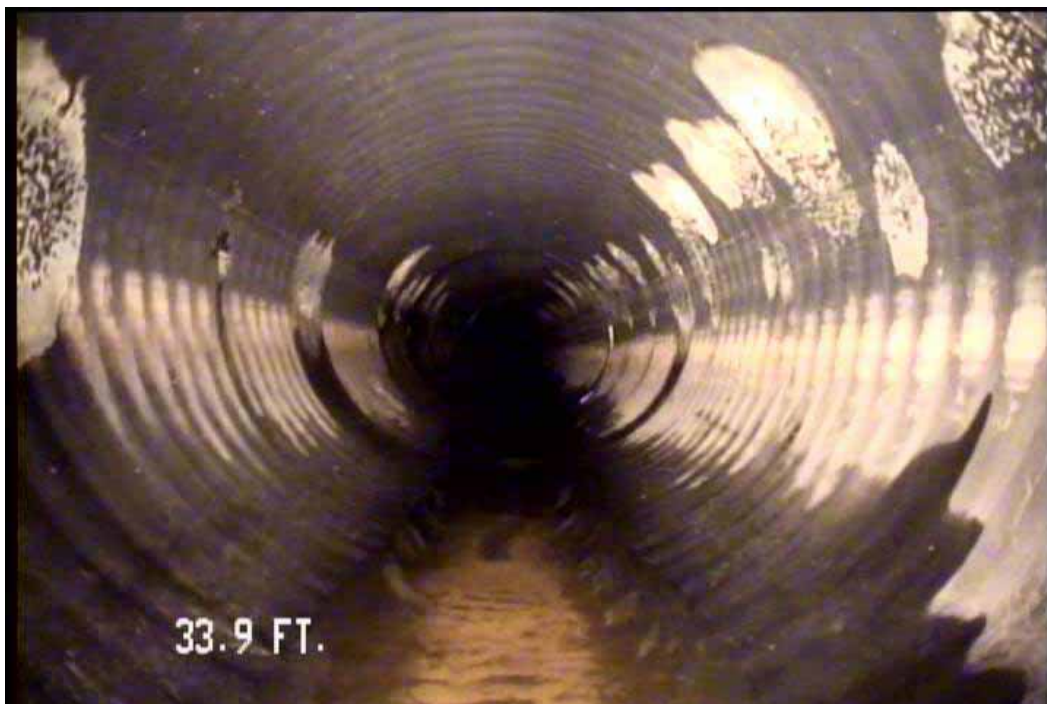
Figure 485 View of the corrugation growth failure for pipeline No. 2 (Site No. 1: Orlando)

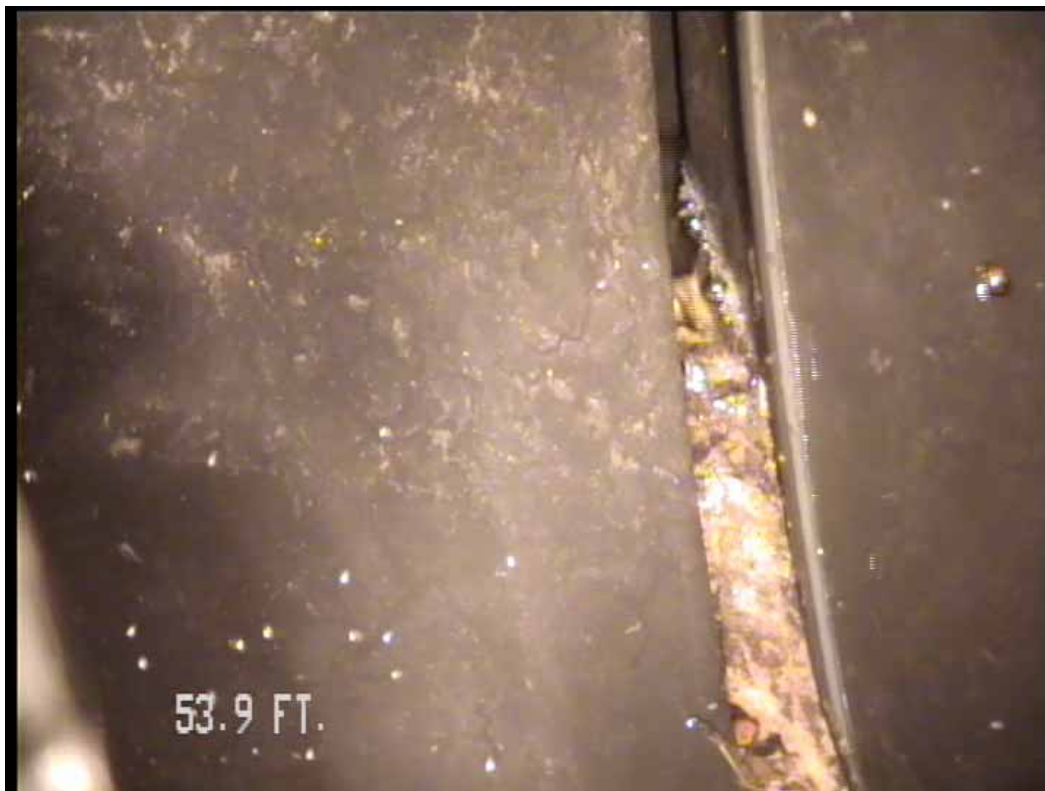
**Figure 486 View of the major joint displacement failure for pipeline No. 2
(Site No. 1: Orlando)**
