Evaluation of HDPE Pipelines Structural Performance

UT Arlington Center for Structural Engineering Research

November 2010

**As a Part of the Initiative on the Underground Structural Health
Monitoring and Equipment Development**

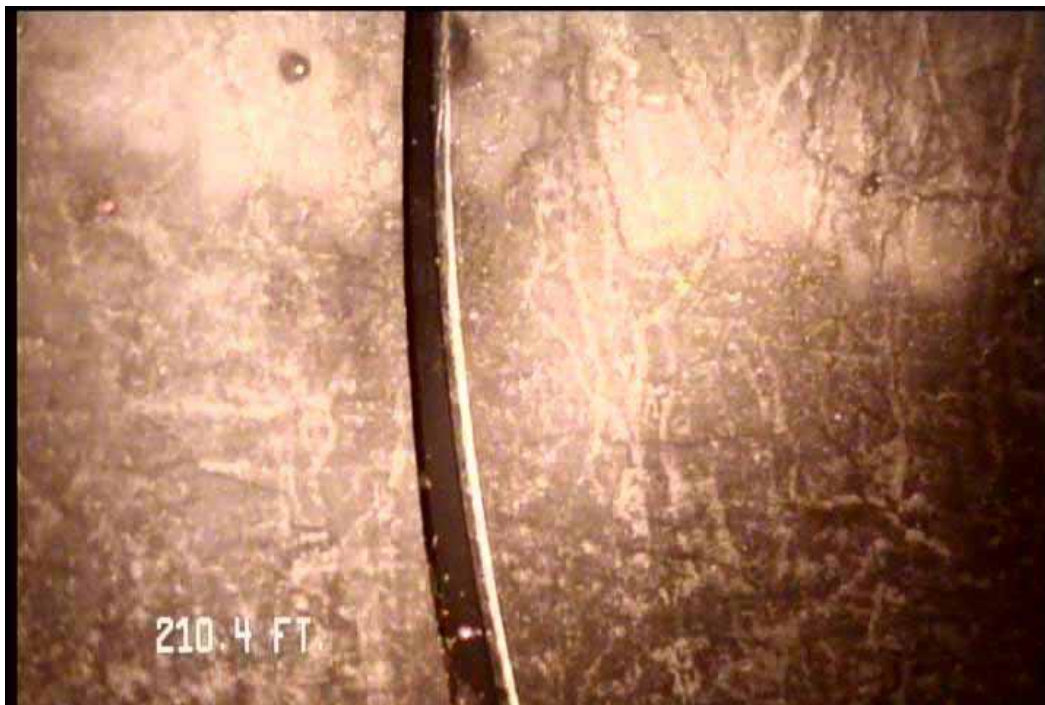
Figure 488 View of major joint displacement failure for pipeline No. 2 (Site No. 1: Orlando)

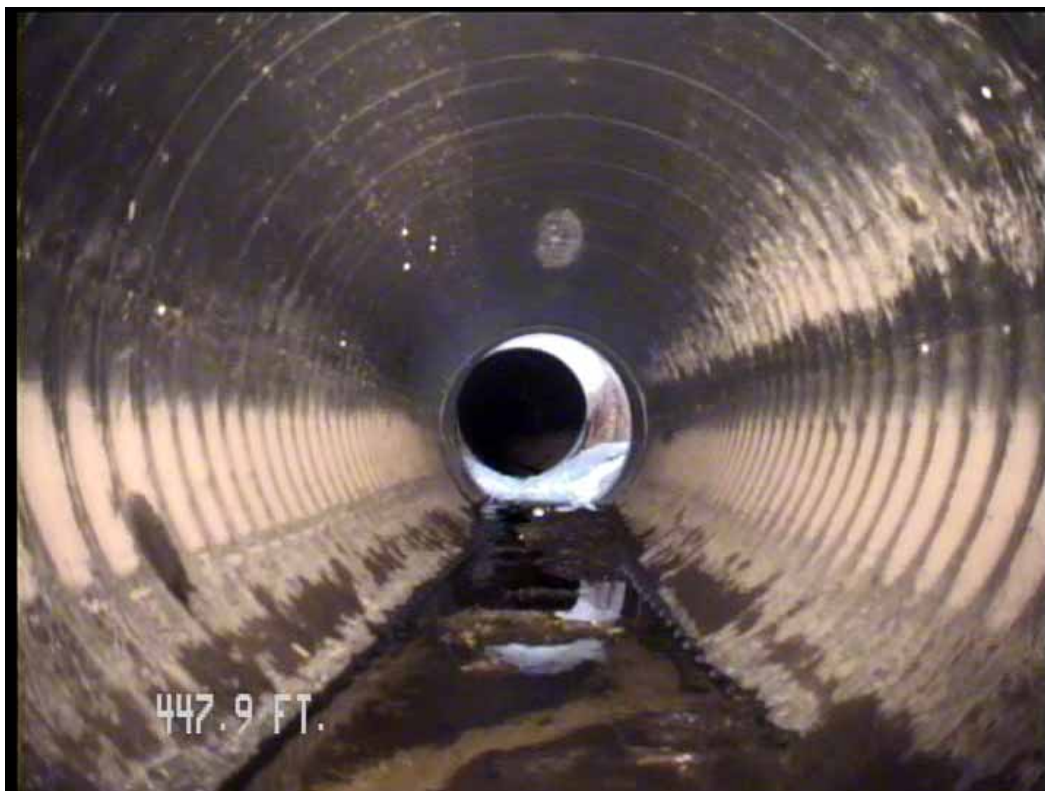
Figure 489 View of the corrugation growth failure for pipeline No. 2 (Site No. 1: Orlando)

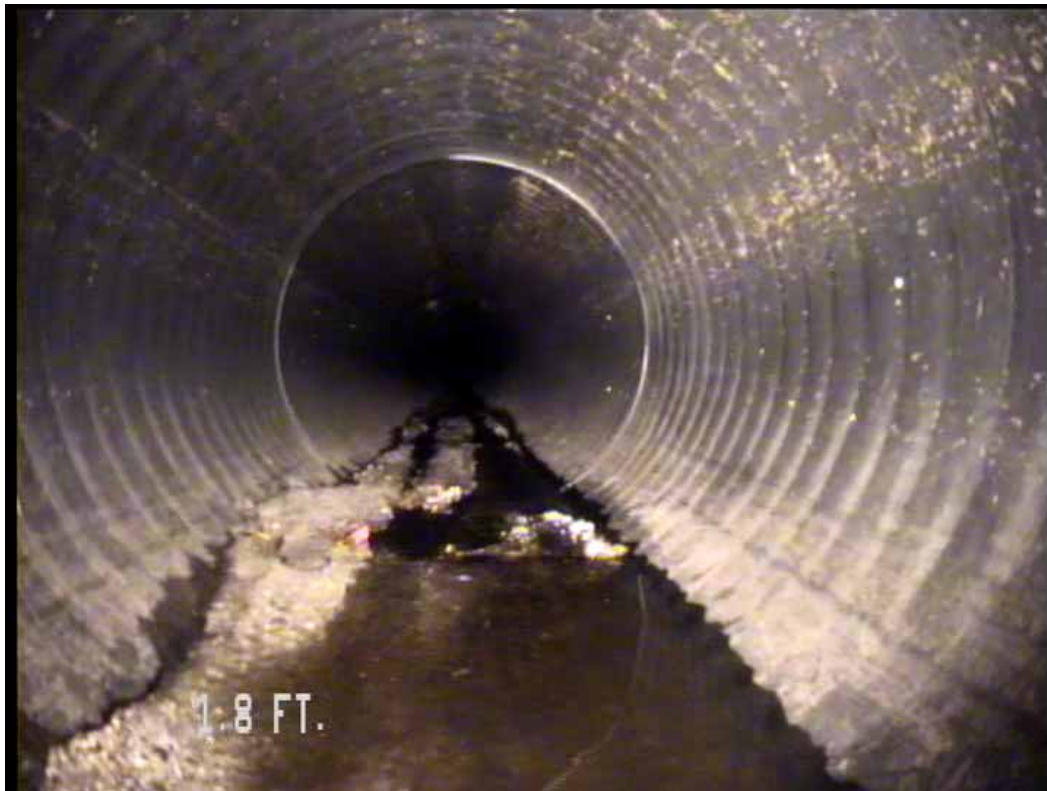
Figure 491 View of the corrugation growth failure for pipeline No. 3 (Site No. 1: Orlando)

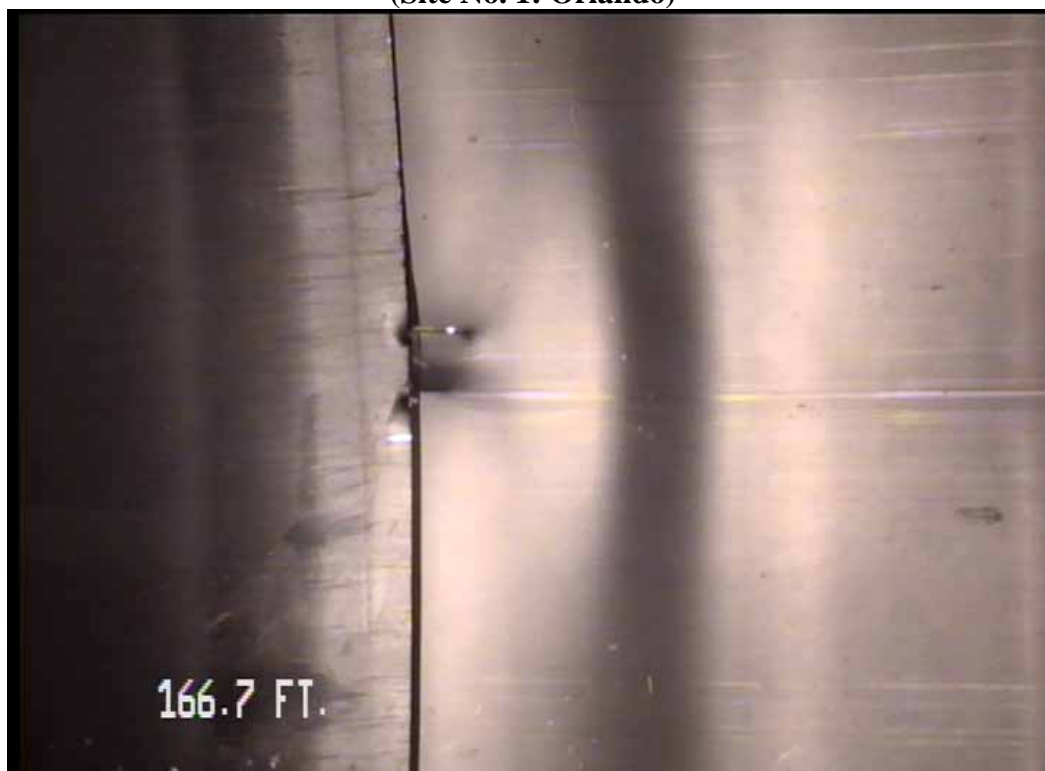
**Figure 493 View of the cracking and buckling failures for pipeline No. 3
(Site No. 1: Orlando)**

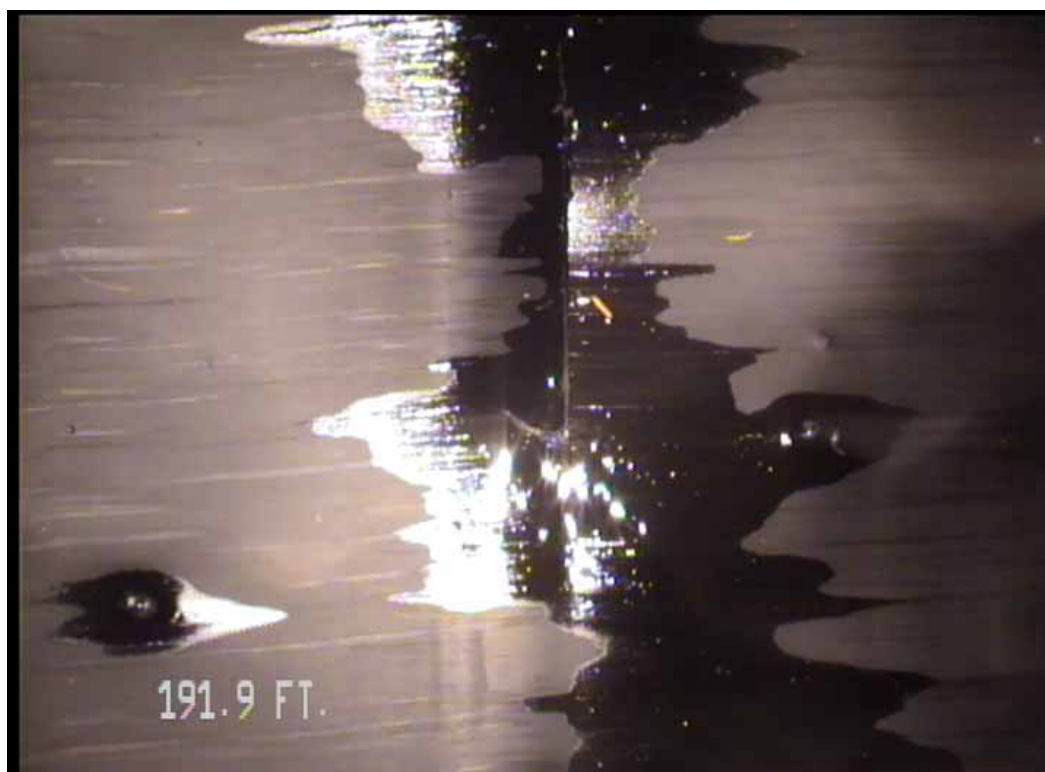
Figure 494 View of the cracking/leaking failures for pipeline No. 3

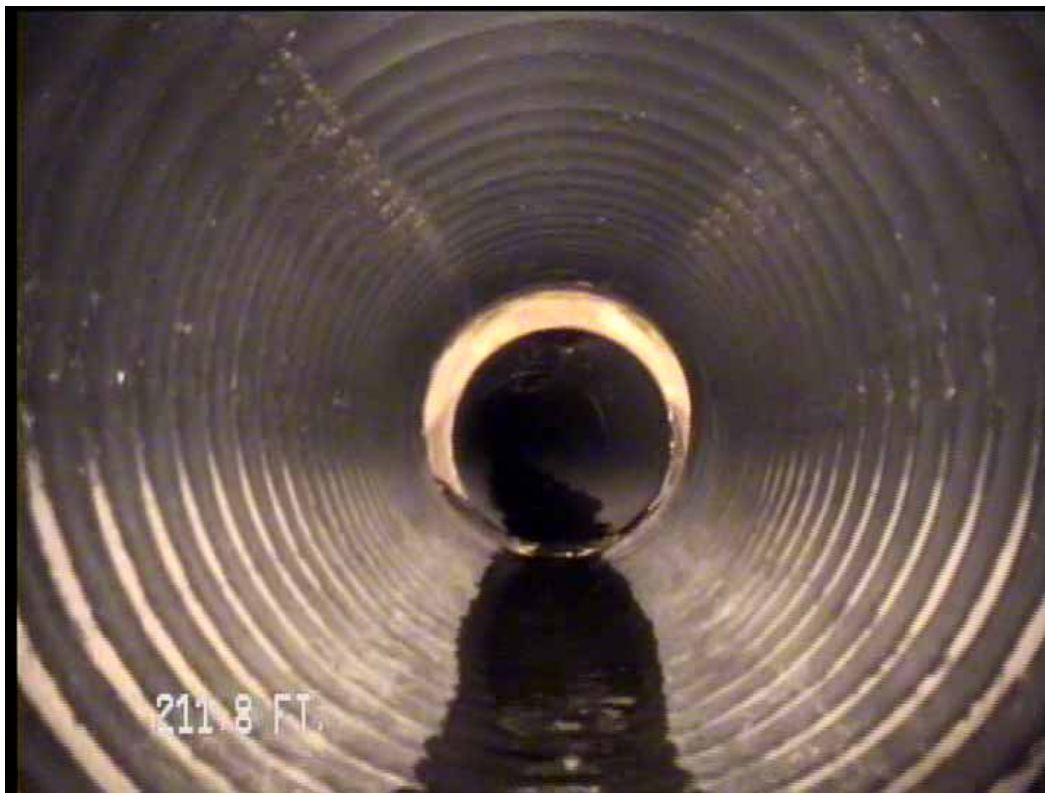
Figure 497 View of the corrugation growth failure for pipeline No. 3 (Site No. 1: Orlando)

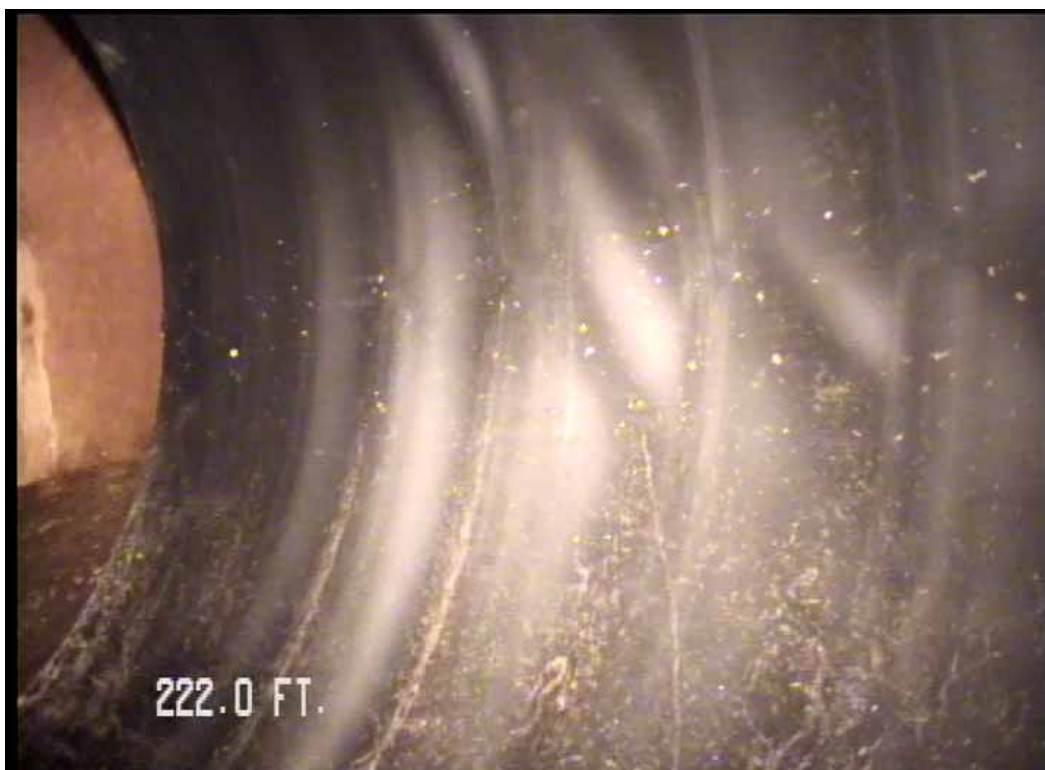
Figure 498 View of the buckling failure for pipeline No. 3 (Site No. 1: Orlando)

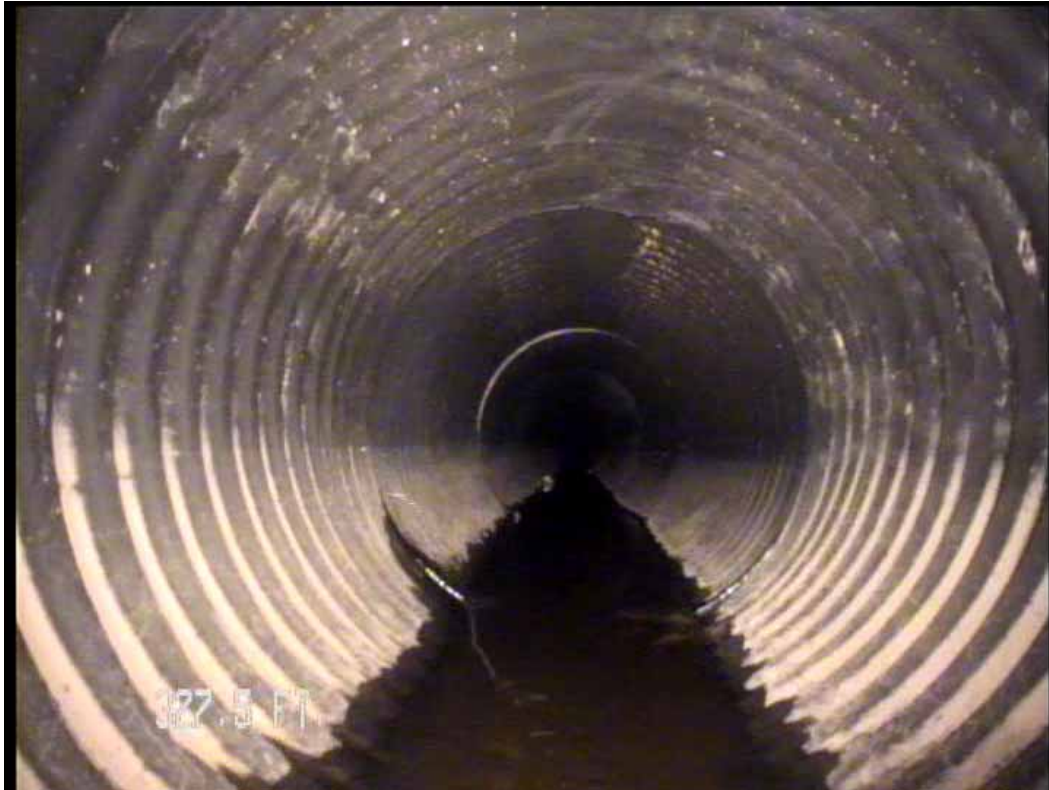
Figure 499 View of the corrugation growth failure for pipeline No. 3 (Site No. 1: Orlando)

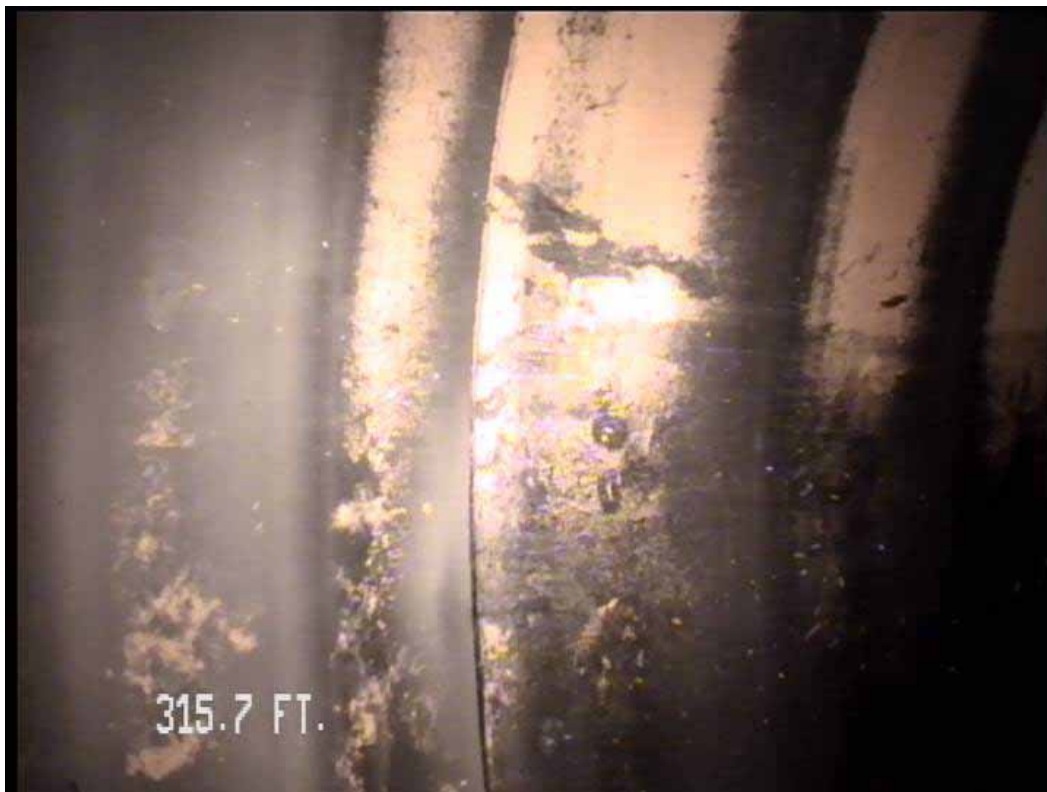
Figure 501 View of the joint for pipeline No. 3 (Site No. 1: Orlando)

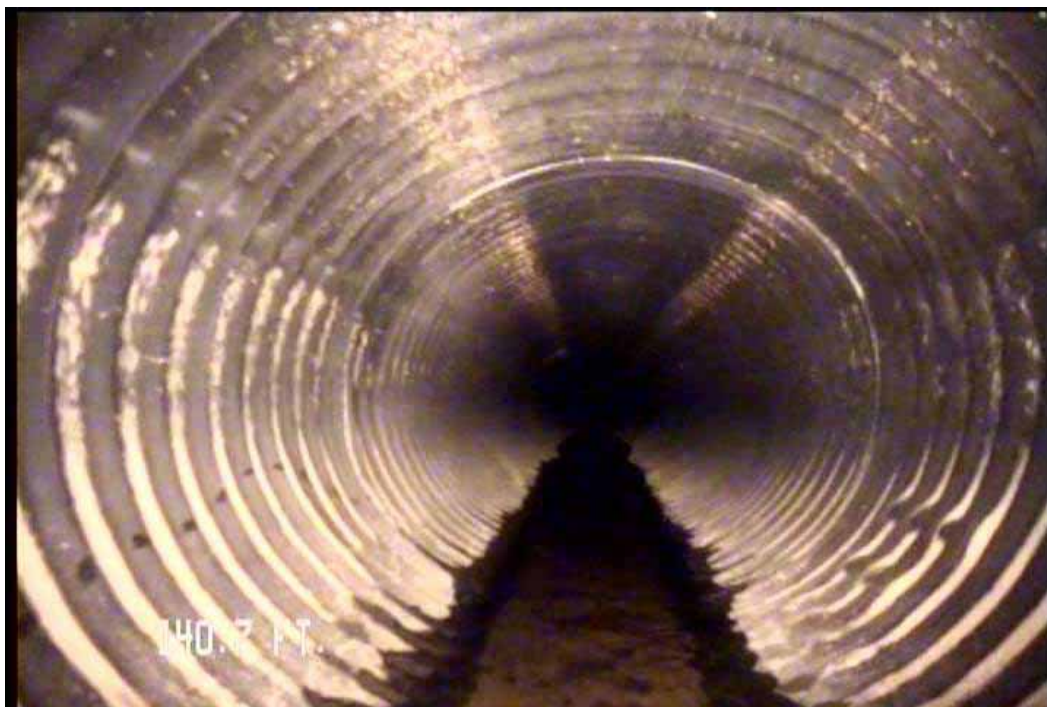
Figure 502 View of the excessive deformation, corrugation growth and buckling failures for pipeline No. 3 (Site No. 1: Orlando)

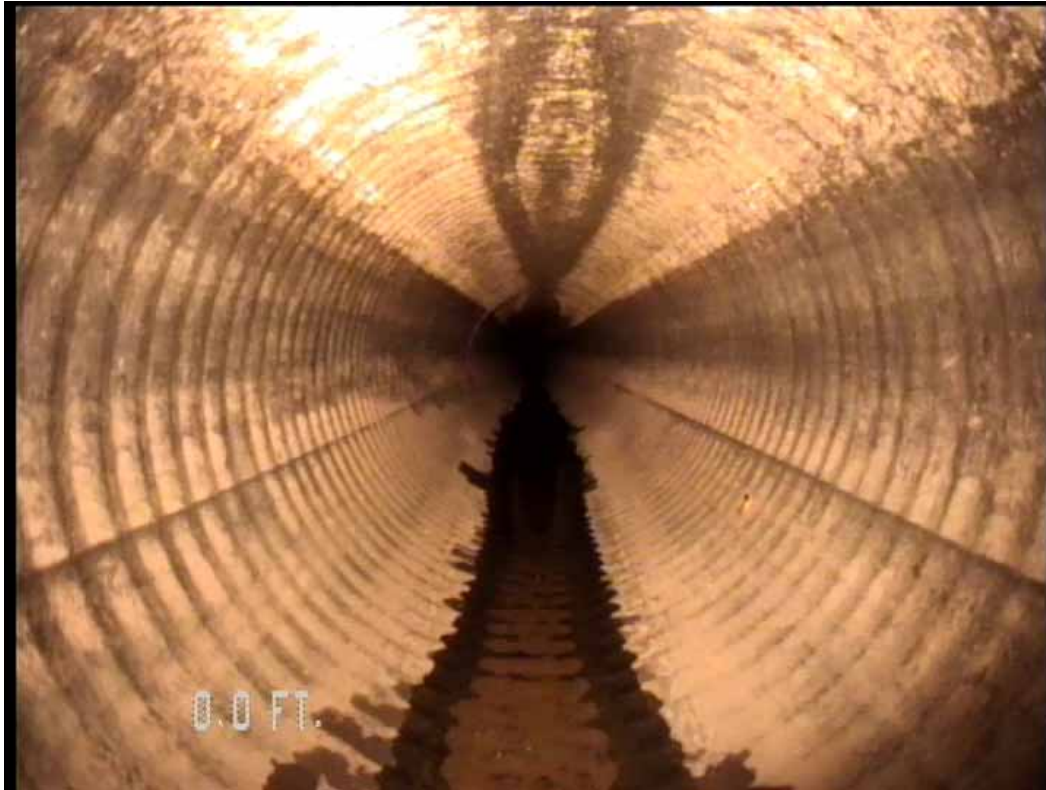
Figure 504 View of the corrugation growth failure for pipeline No. 6 (Site No. 1: Orlando)

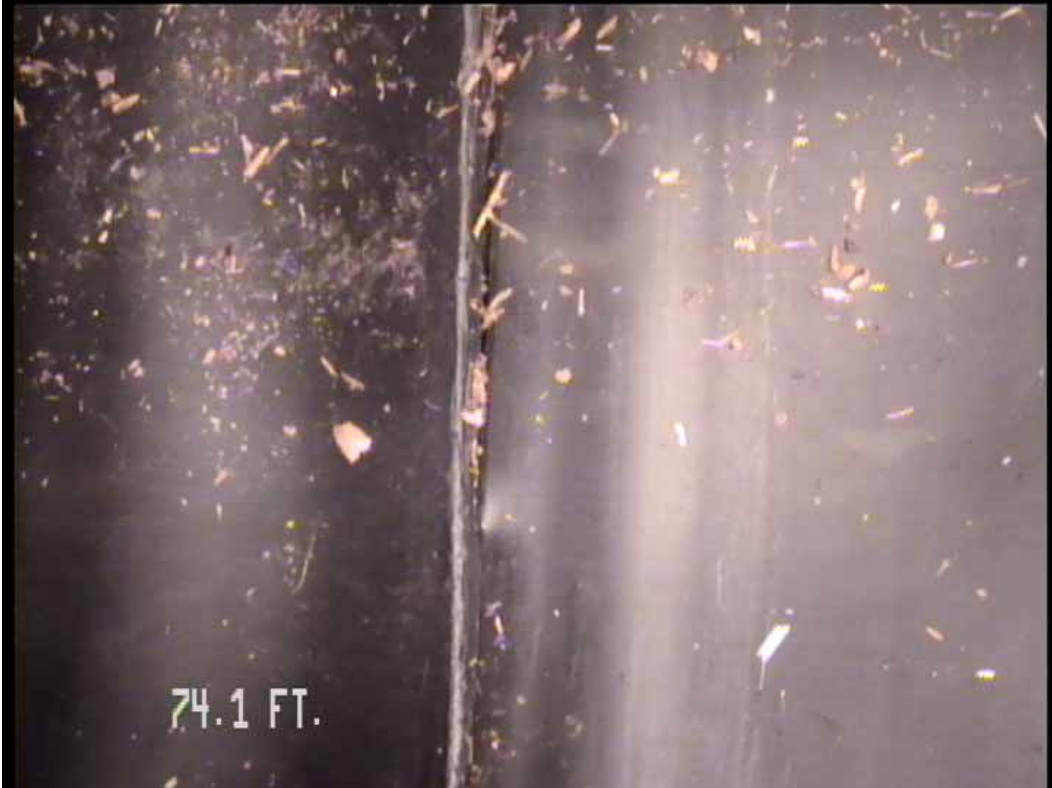
Figure 506 View of the minor joint displacement failure for pipeline No. 6 (Site No. 1: Orlando)

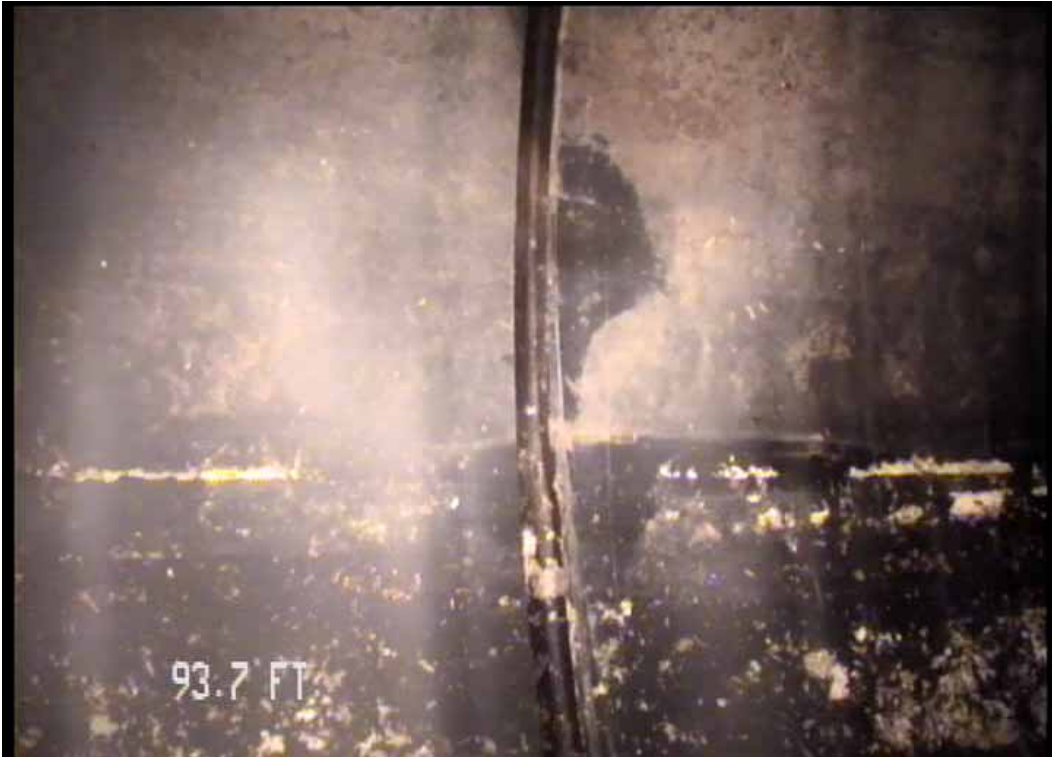
Figure 507 View of the major joint displacement failure for pipeline No. 6

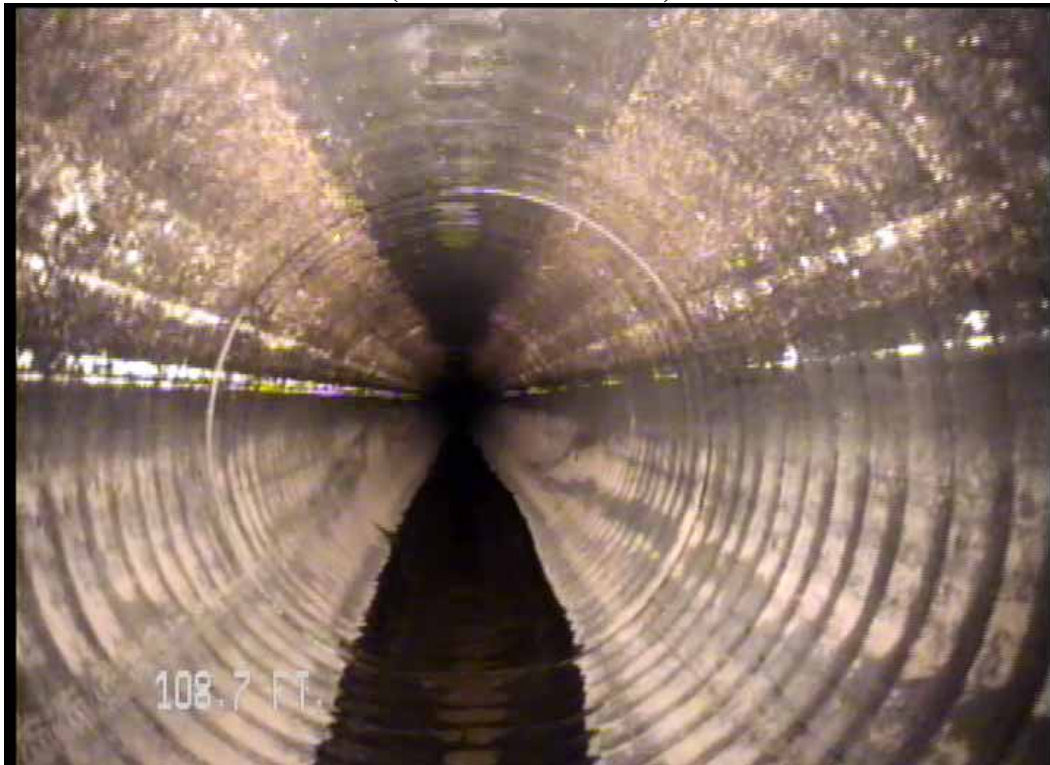
Figure 508 View of the corrugation growth failure for pipeline No. 6 (Site No. 1: Orlando)

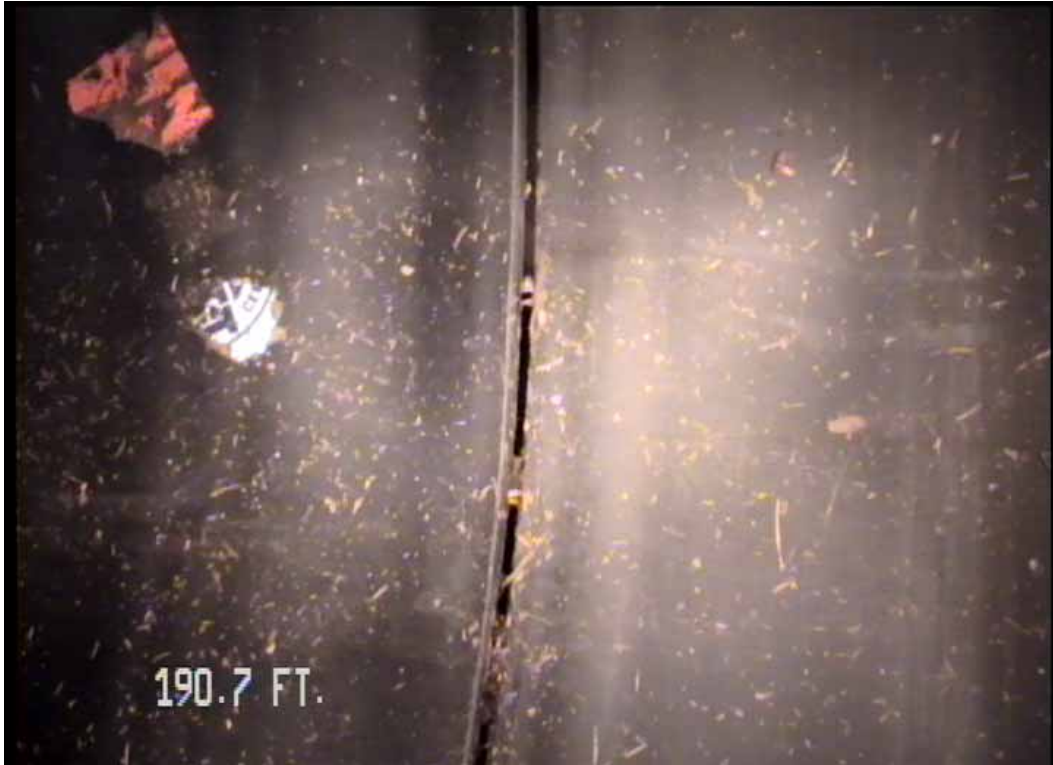
Figure 510 View of the minor joint displacement failure for pipeline No. 6 (Site No. 1: Orlando)

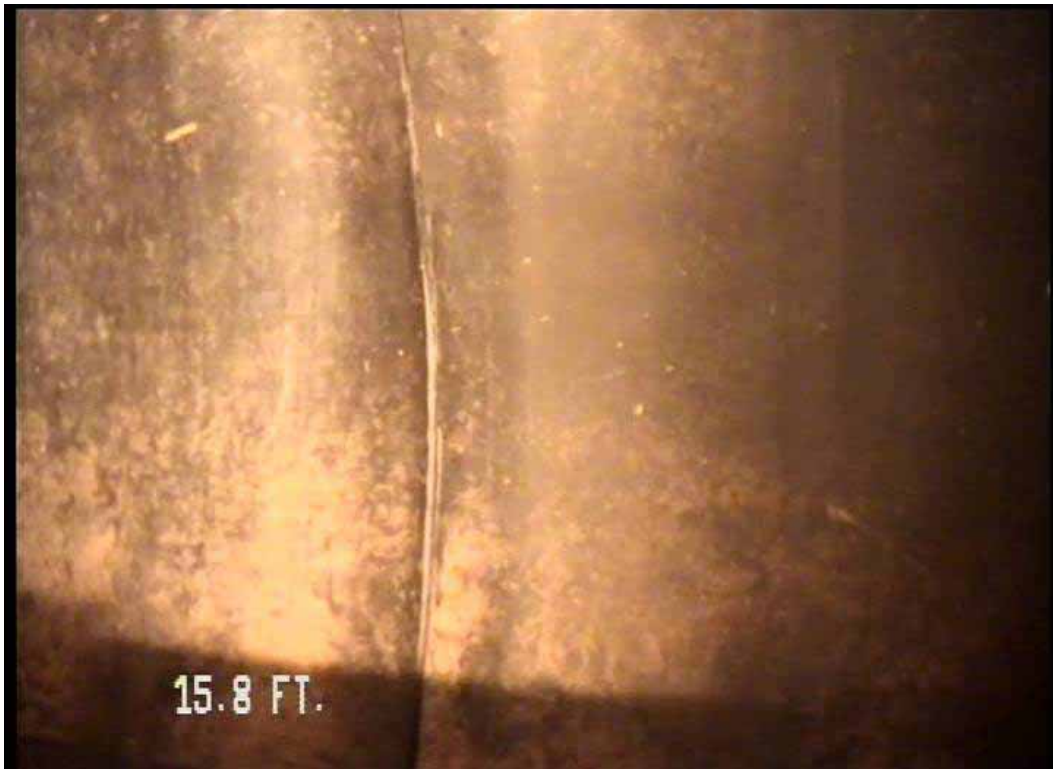
Figure 511 View of the joint for pipeline No. 6 (Site No. 1: Orlando)

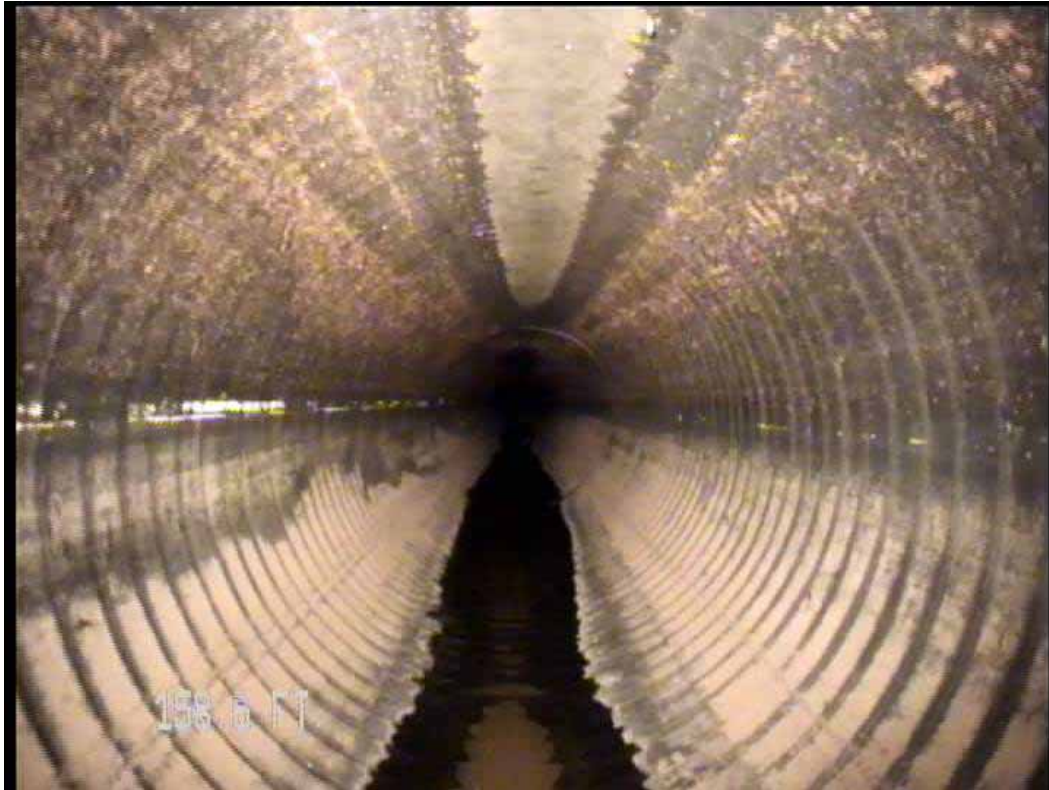
Figure 512 View of the corrugation growth failure for pipeline No. 6 (Site No. 1: Orlando)

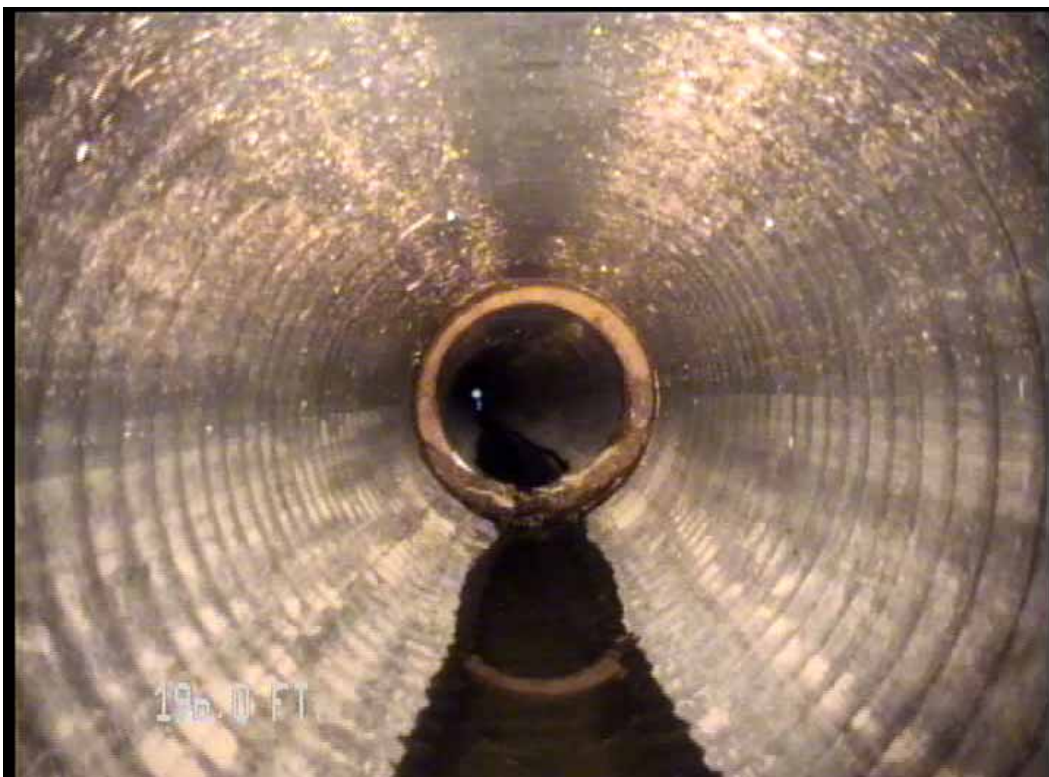
Figure 513 View of the corrugation growth failure for pipeline No. 6 (Site No. 1: Orlando)

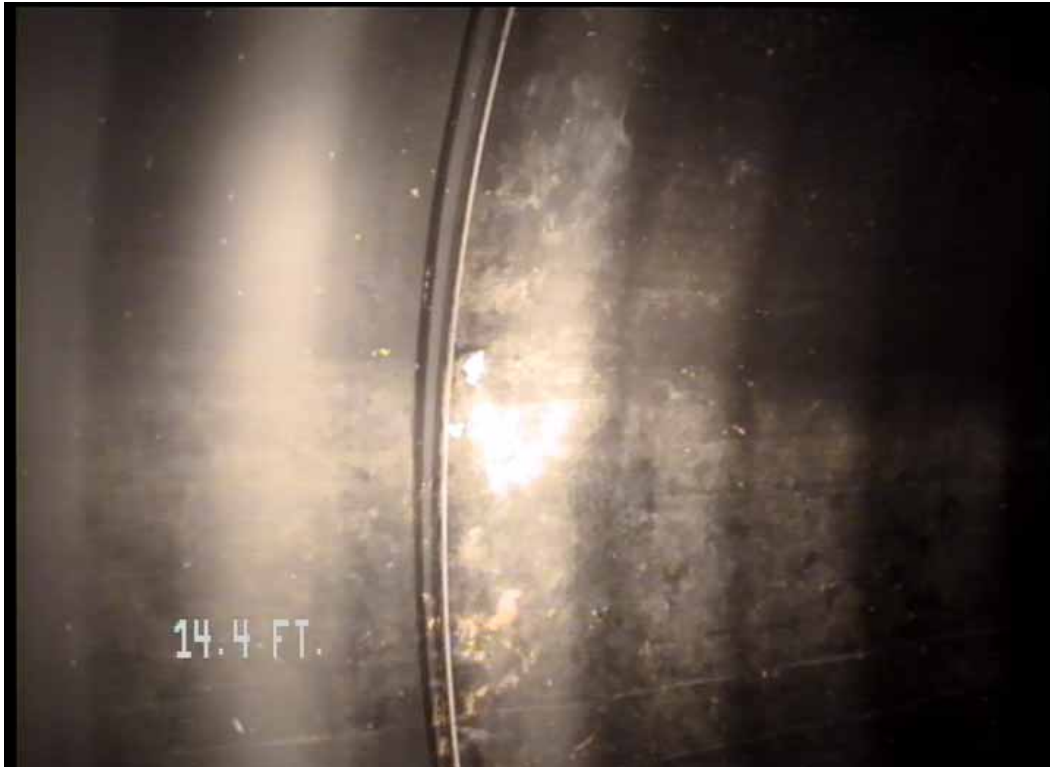
Figure 515 View of the minor joint displacement failure for pipeline No. 7 (Site No. 1: Orlando)

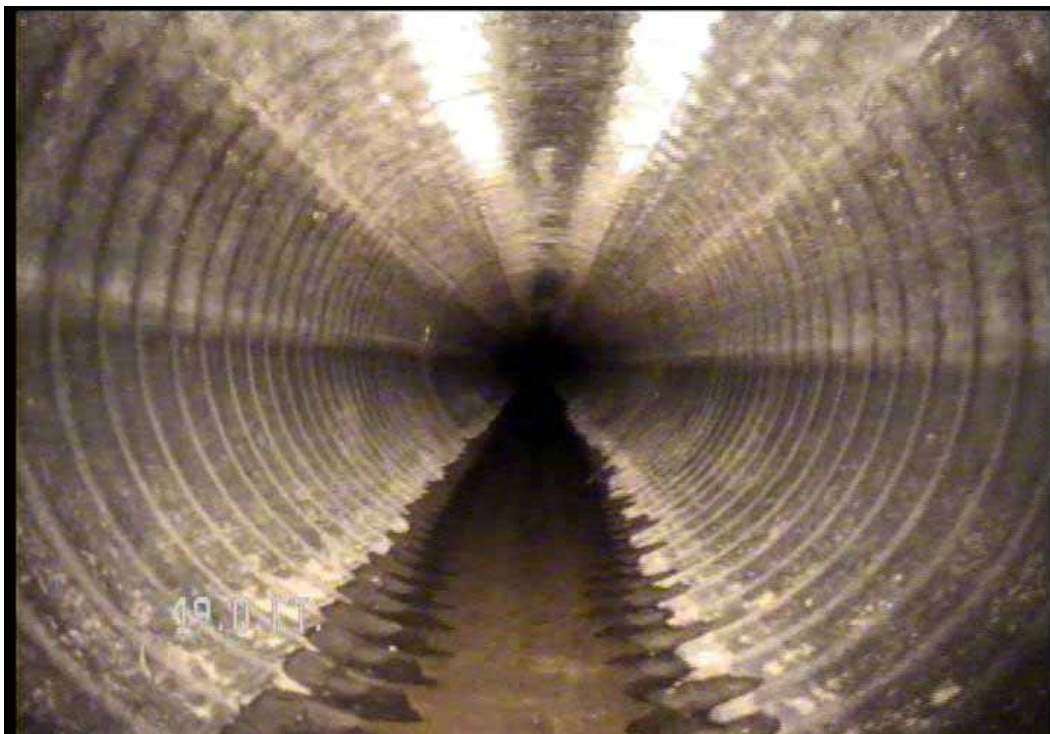
Figure 516 View of corrugation growth failure for pipeline No. 7 (Site No. 1: Orlando)

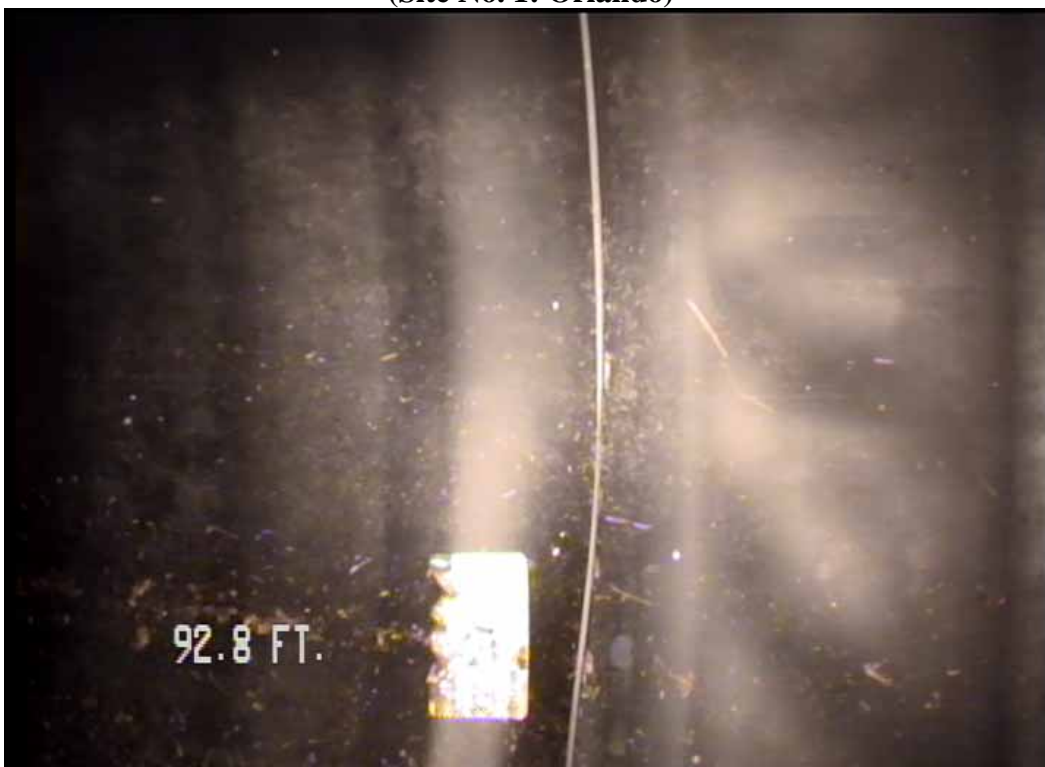
Figure 518 View of the buckling failures for pipeline No. 7 (Site No. 1: Orlando)

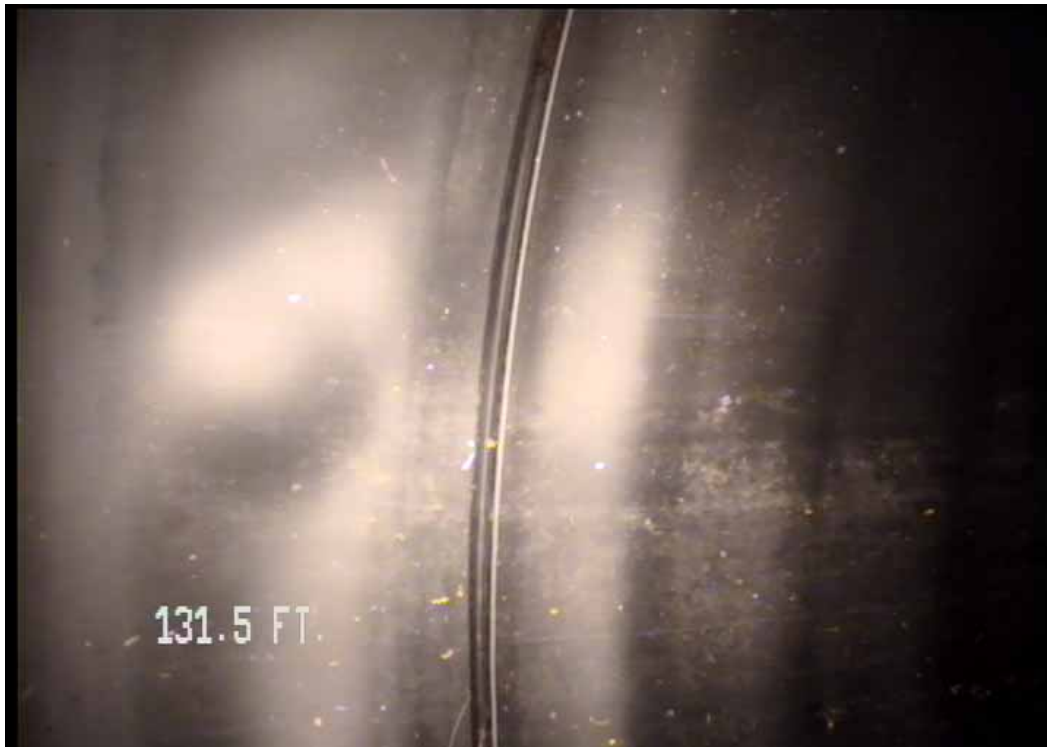
Figure 519 View of the minor joint displacement and buckling failures for pipeline No. 7 (Site No. 1: Orlando)

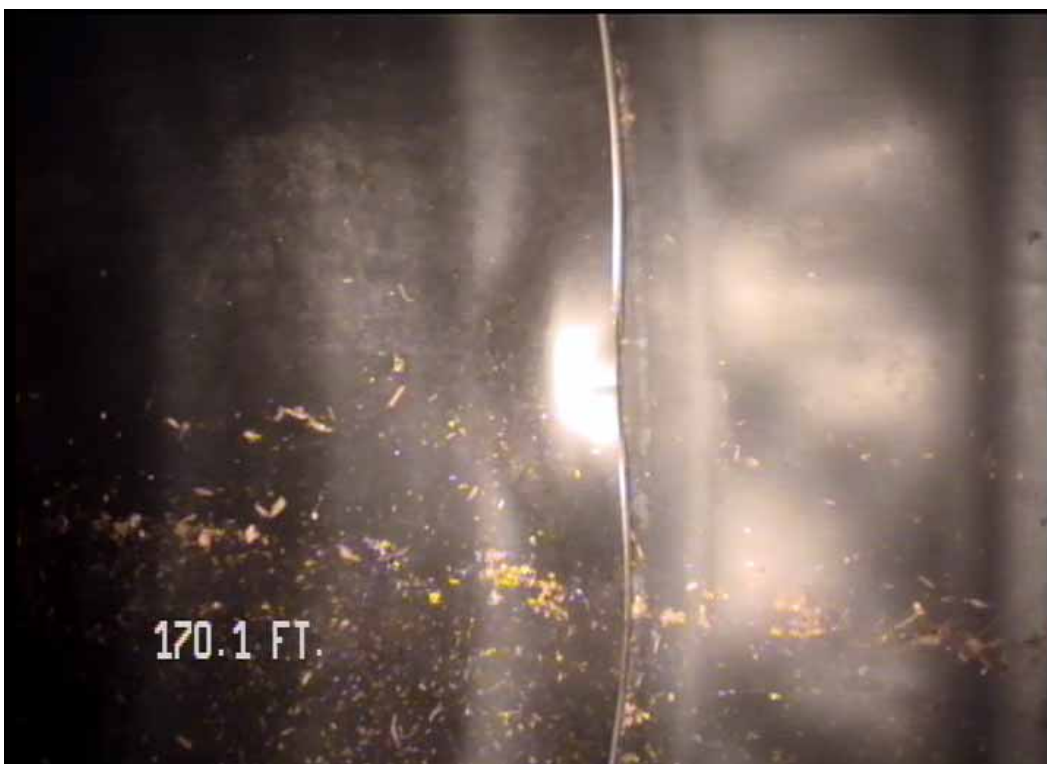
Figure 520 View of the buckling failure at the joint for pipeline No. 7 (Site No. 1: Orlando)

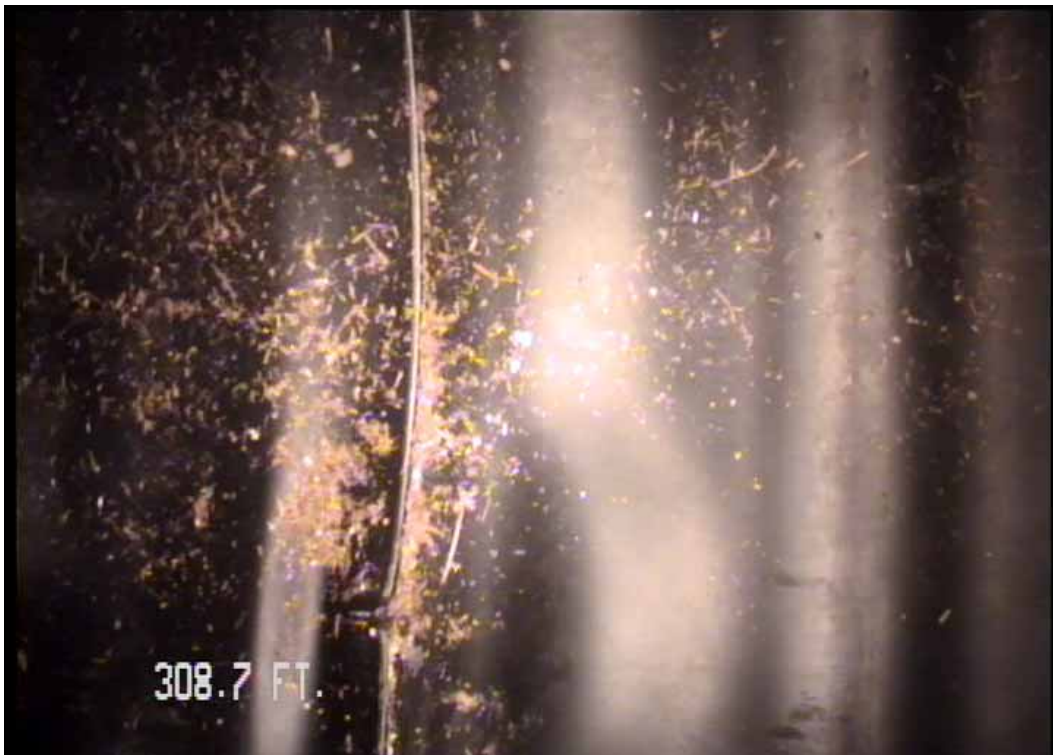
**Figure 522 View of the buckling/cracking failures at the joint for pipeline No. 7
(Site No. 1: Orlando)**

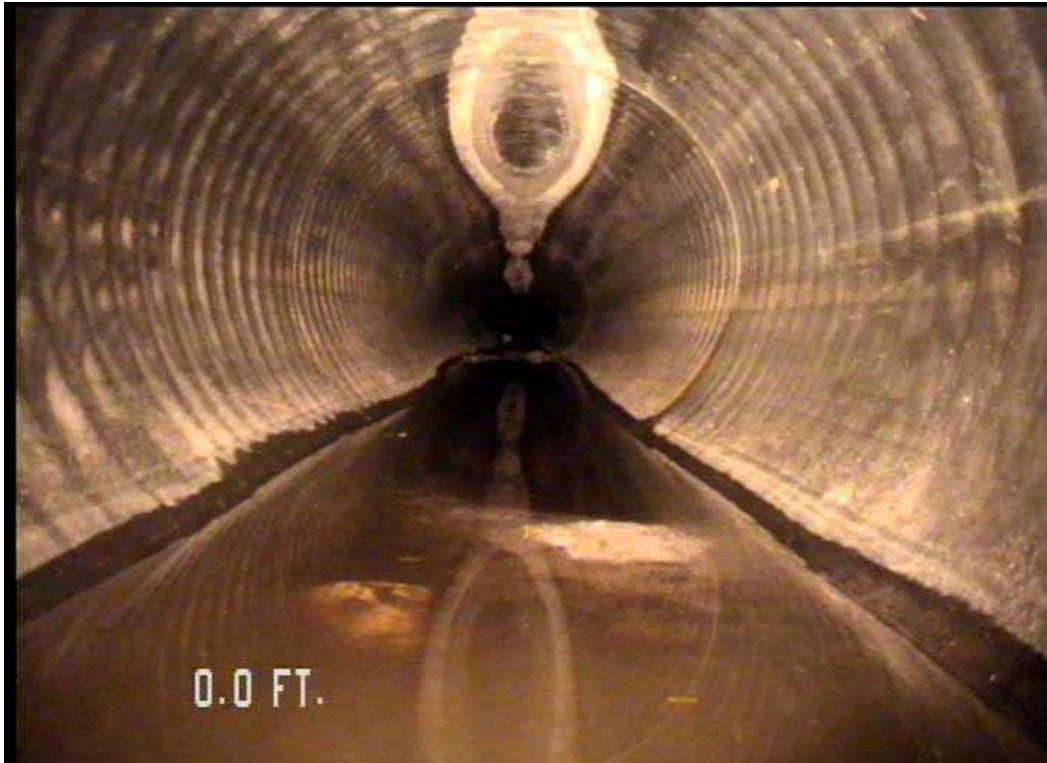
Figure 524 View of corrugation growth failure at the opening of pipeline No. 8 (Site No. 1: Orlando)

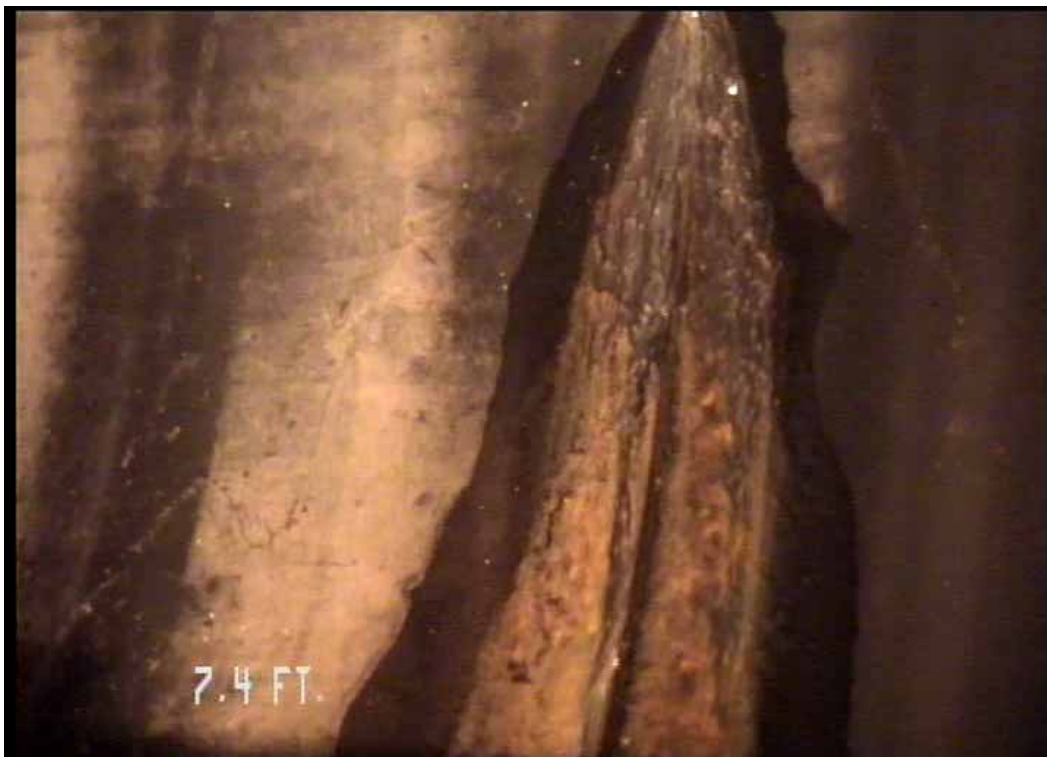
Figure 525 View of cracking/leaking failures for pipeline No. 8 (Site No. 1: Orlando)

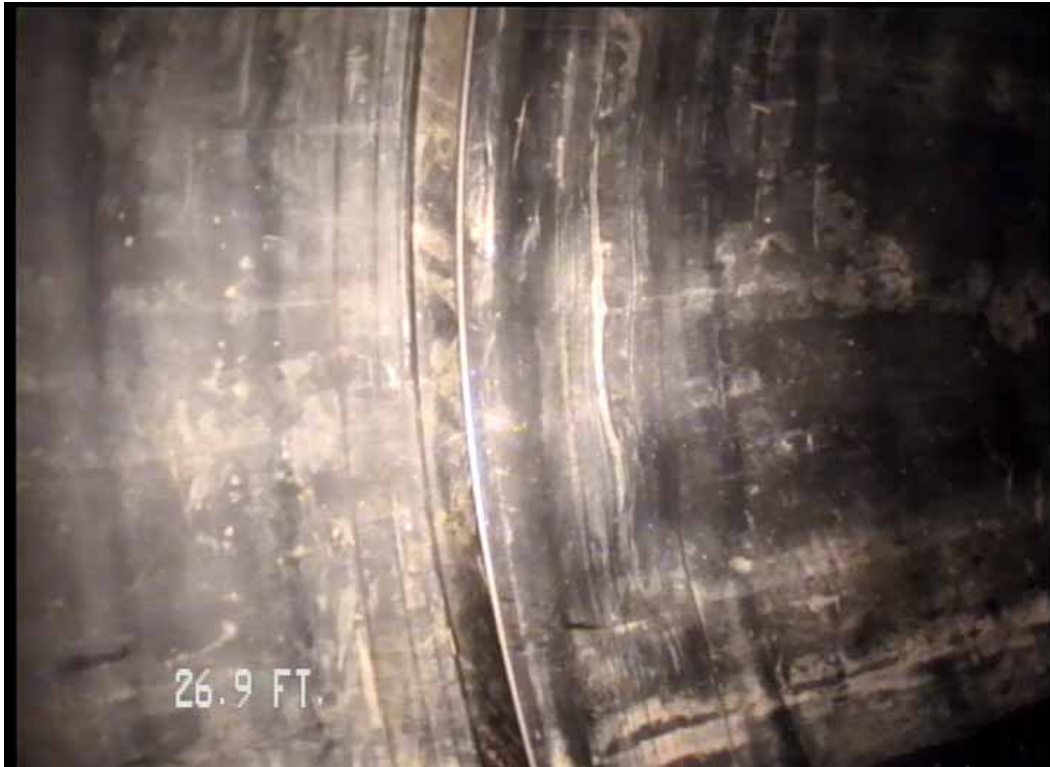
Figure 526 View of major joint displacement and buckling failures for pipeline No. 8 (Site No. 1: Orlando)

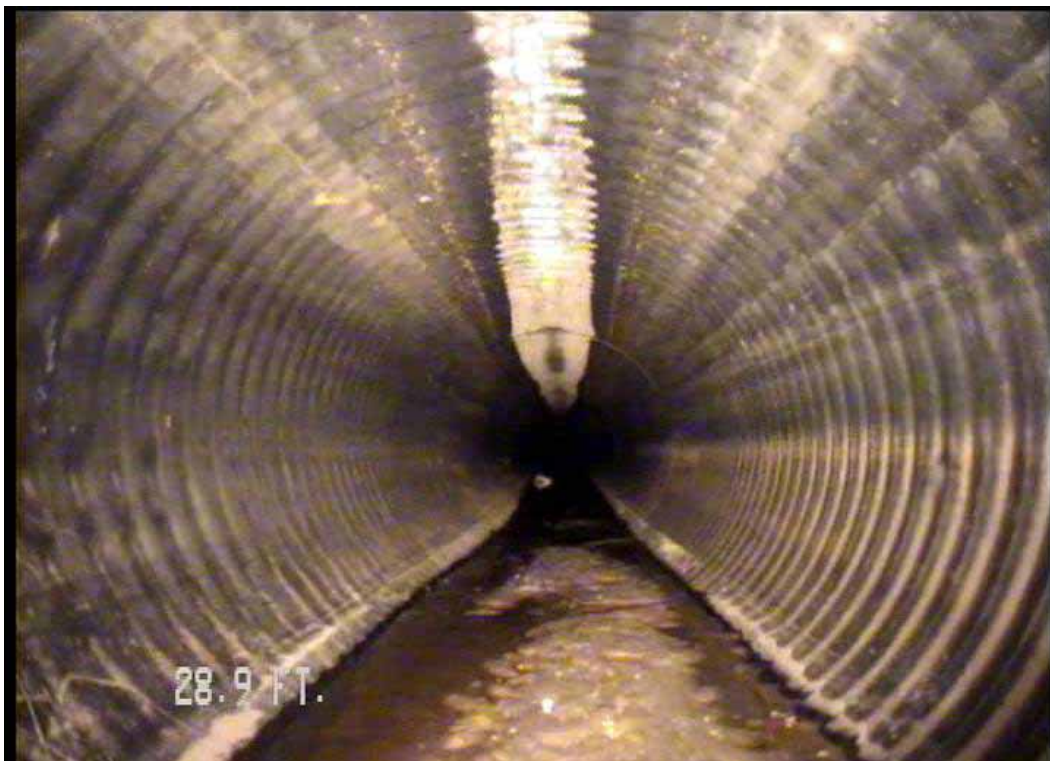
Figure 527 View of corrugation growth failure for pipeline No. 8 (Site No. 1: Orlando)
