Evaluation of HDPE Pipelines Structural Performance

UT Arlington Center for Structural Engineering Research

November 2010

**As a Part of the Initiative on the Underground Structural Health
Monitoring and Equipment Development**

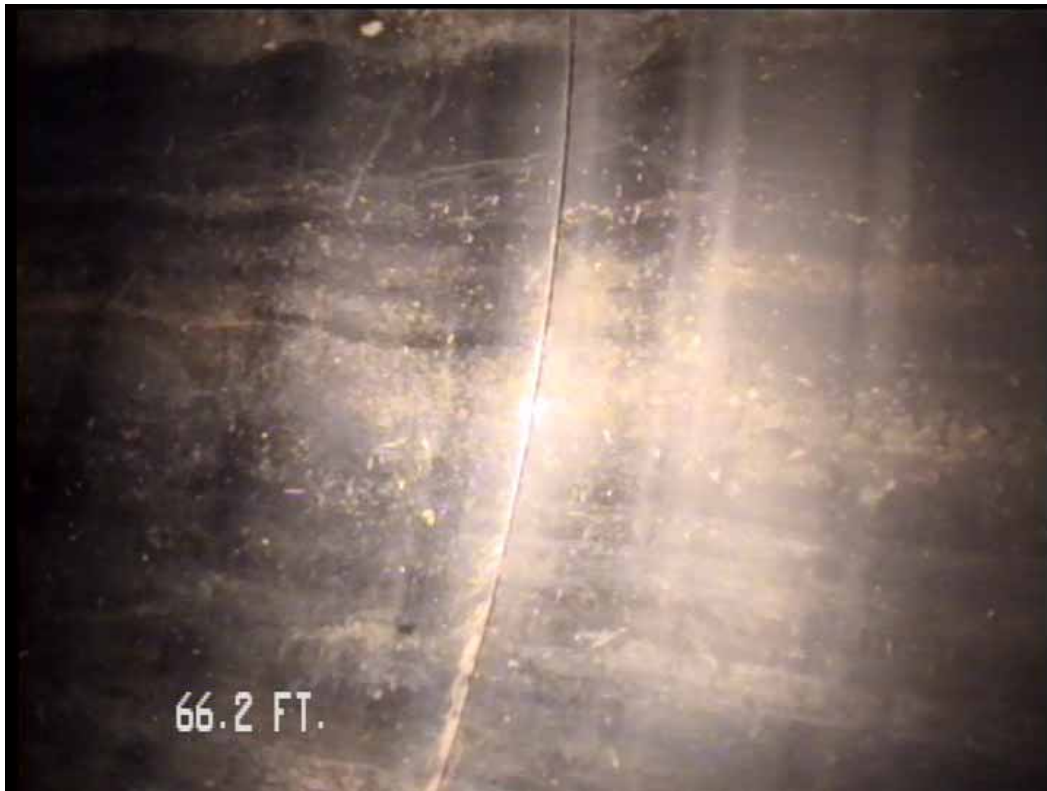
Figure 528 View of joint for pipeline No. 8 (Site No. 1: Orlando)

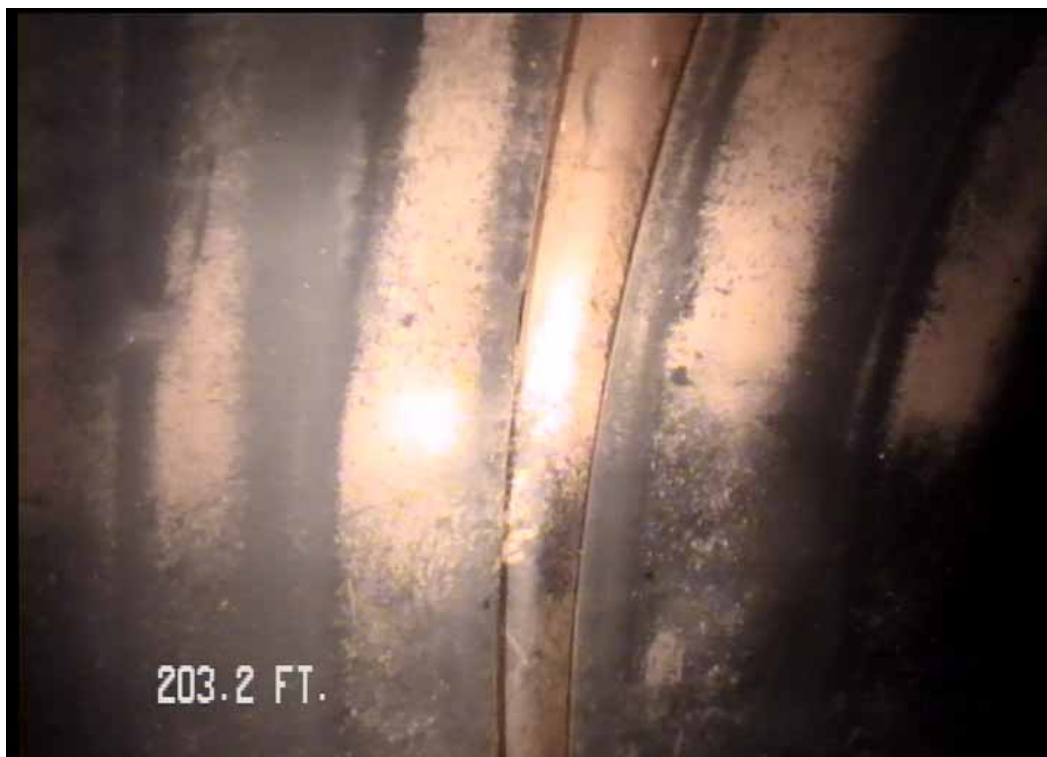
Figure 530 View of major joint displacement for pipeline No. 8 (Site No. 1: Orlando)

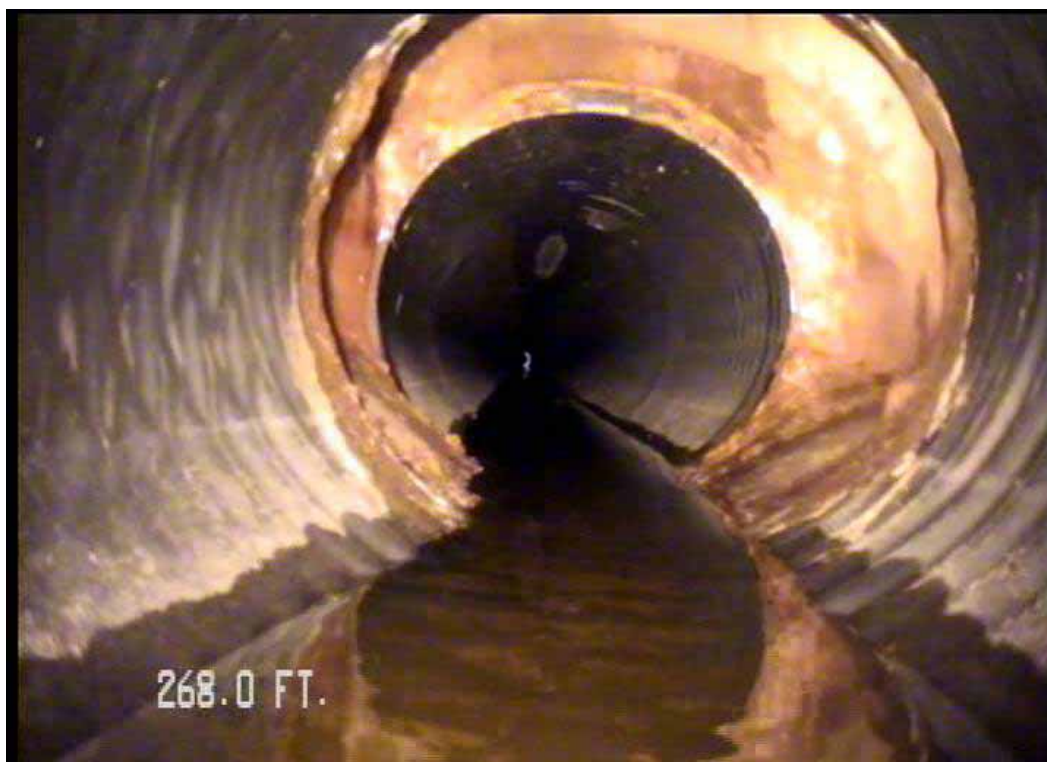
Figure 531 View of the buckling, corrugation growth failures and dip in line and grade for pipeline No. 8 (Site No. 1: Orlando)

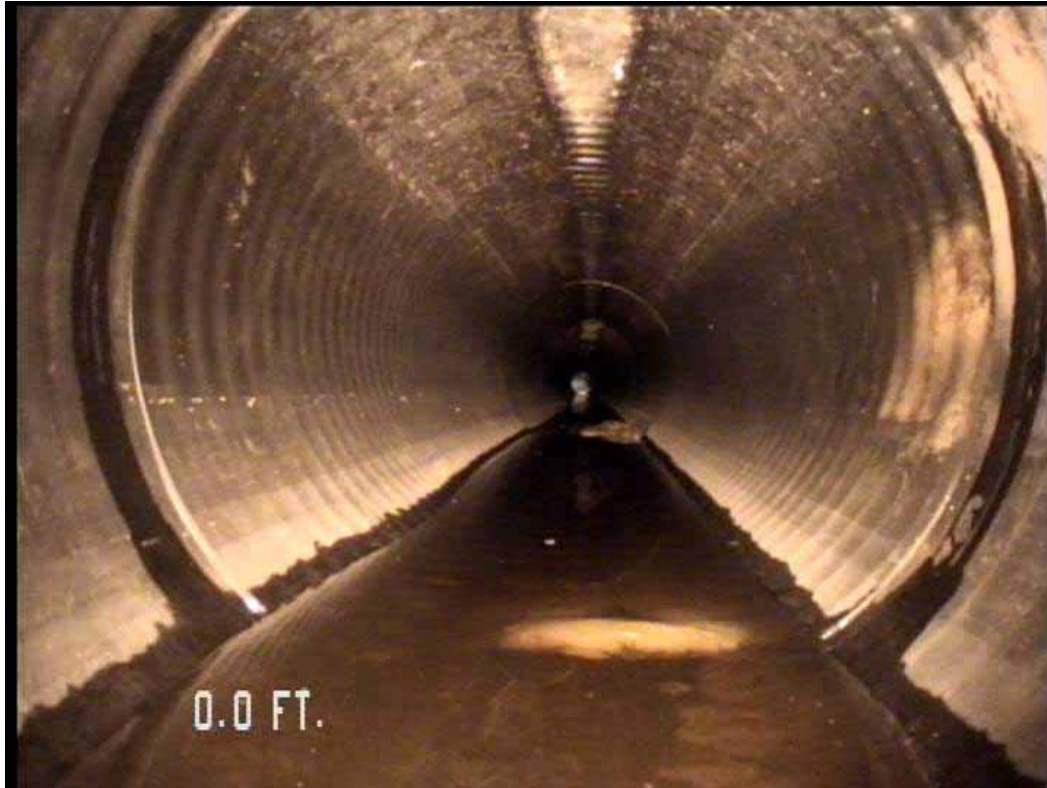
Figure 533 View of the corrugation growth failure at the opening of pipeline No. 9 (Site No. 1: Orlando)

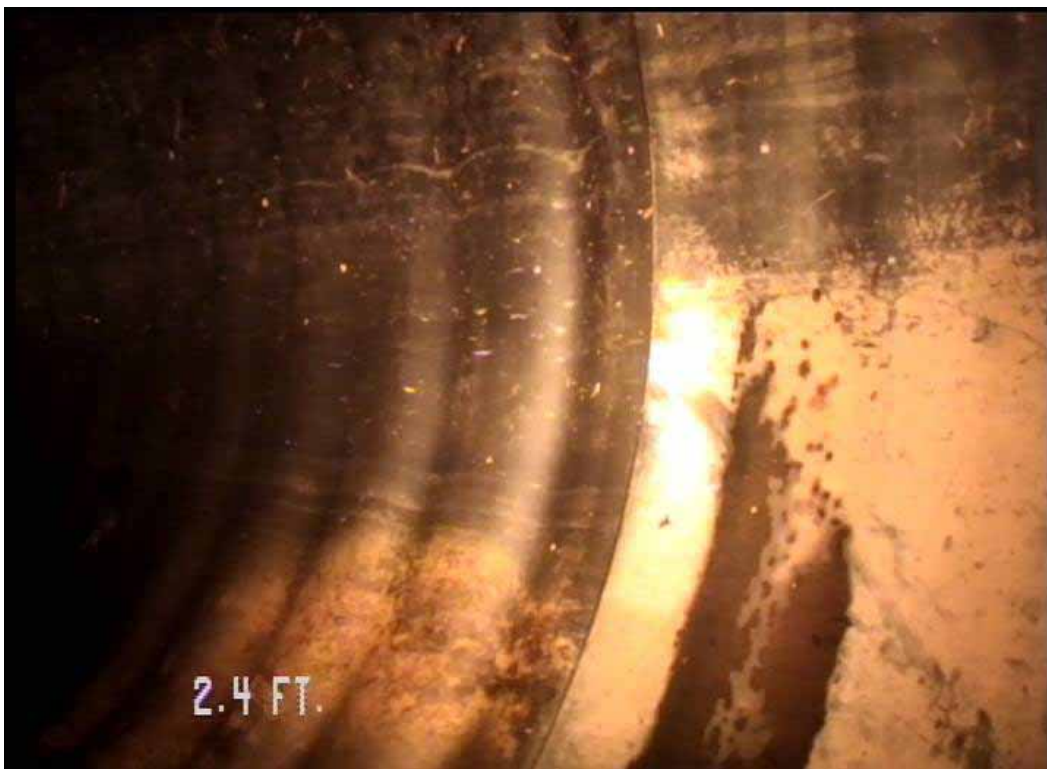
Figure 534 View of the joint for pipeline No. 9 (Site No. 1: Orlando)

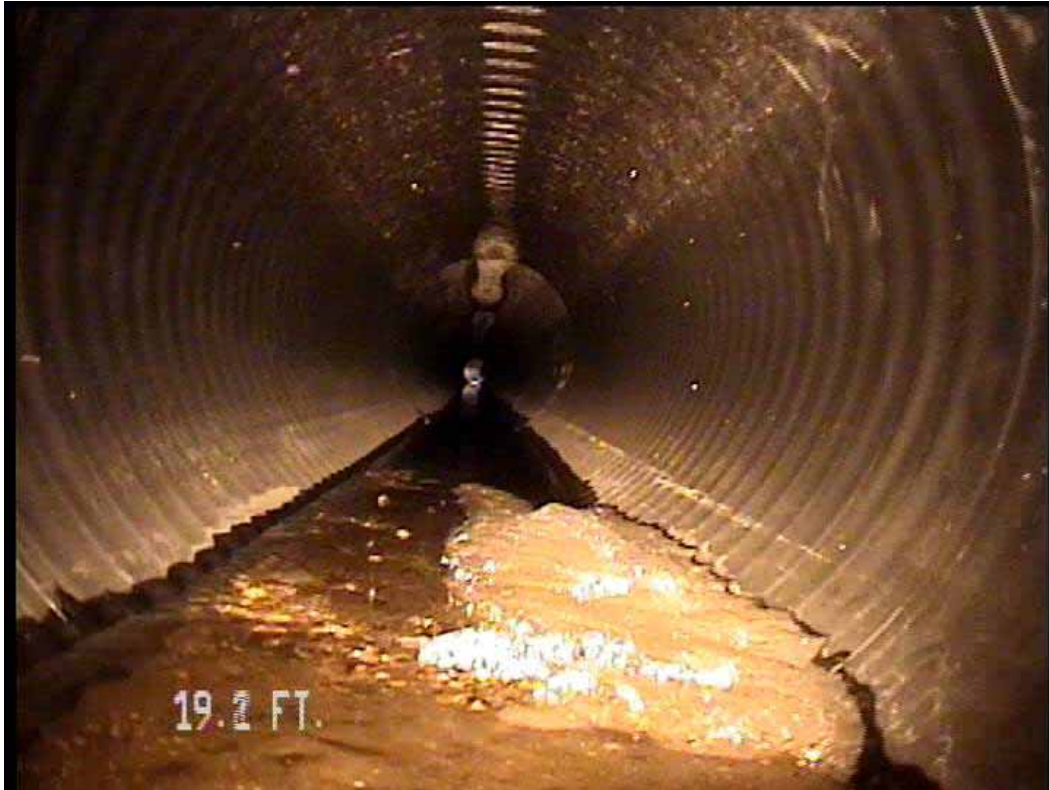
Figure 535 View of the corrugation growth for pipeline No. 9 (Site No. 1: Orlando)

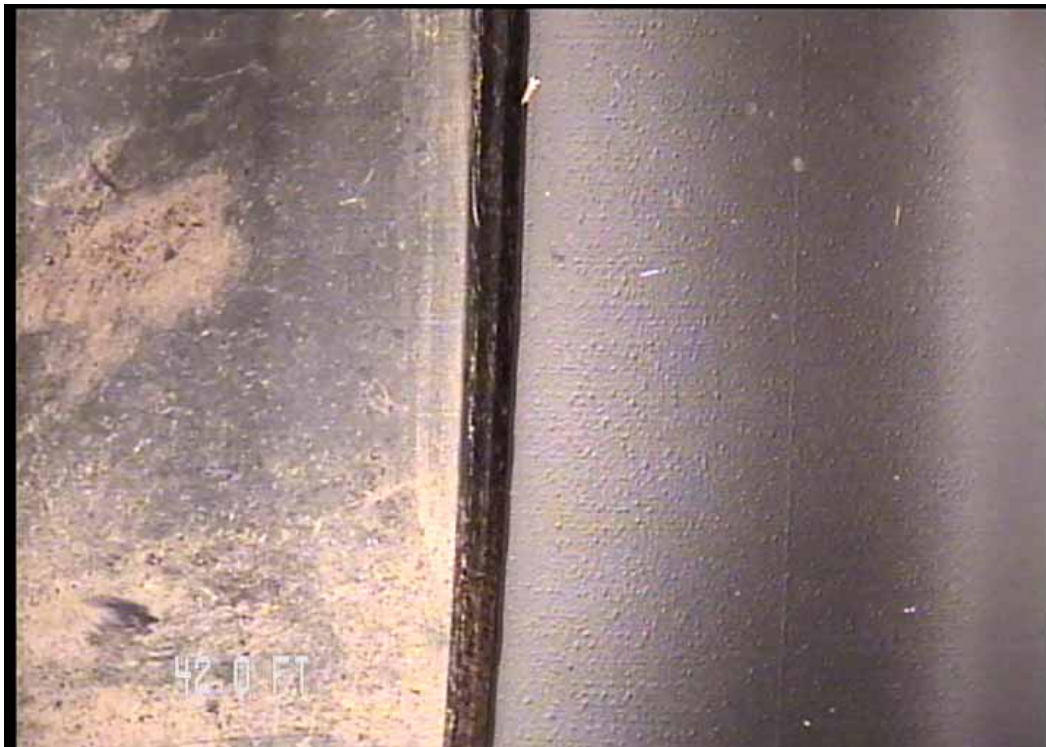
Figure 537 View of the major joint displacement failure for pipeline No. 9 (Site No. 1: Orlando)

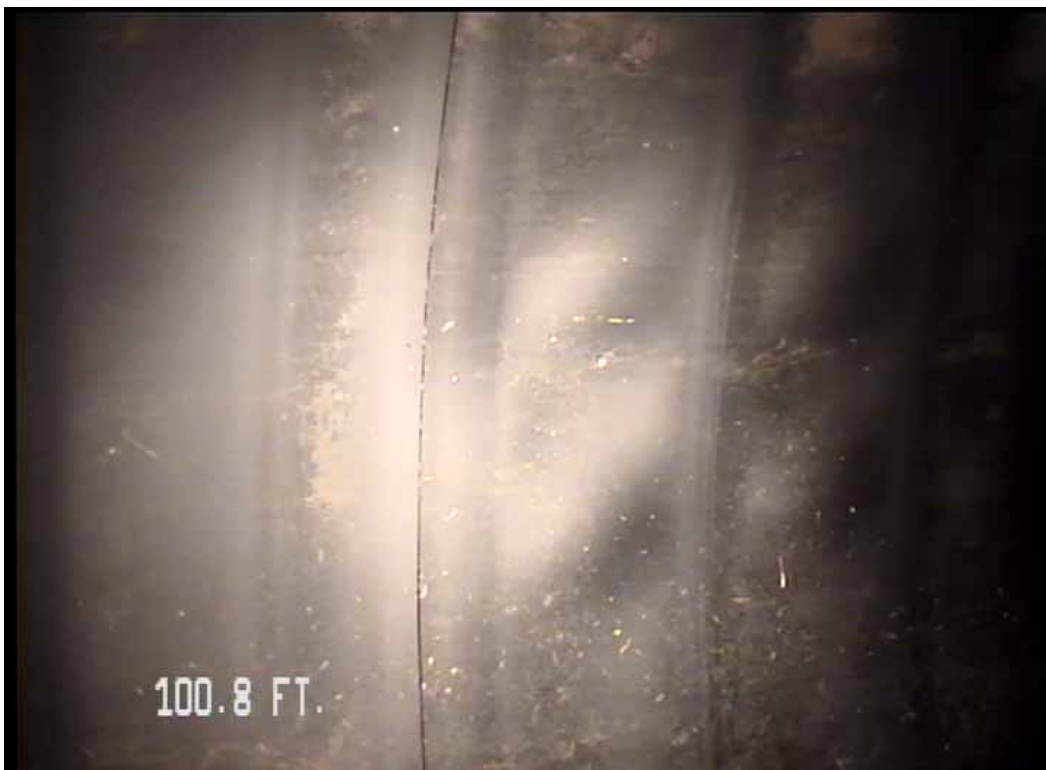
Figure 538 View of the buckling failure for pipeline No. 9 (Site No. 1: Orlando)

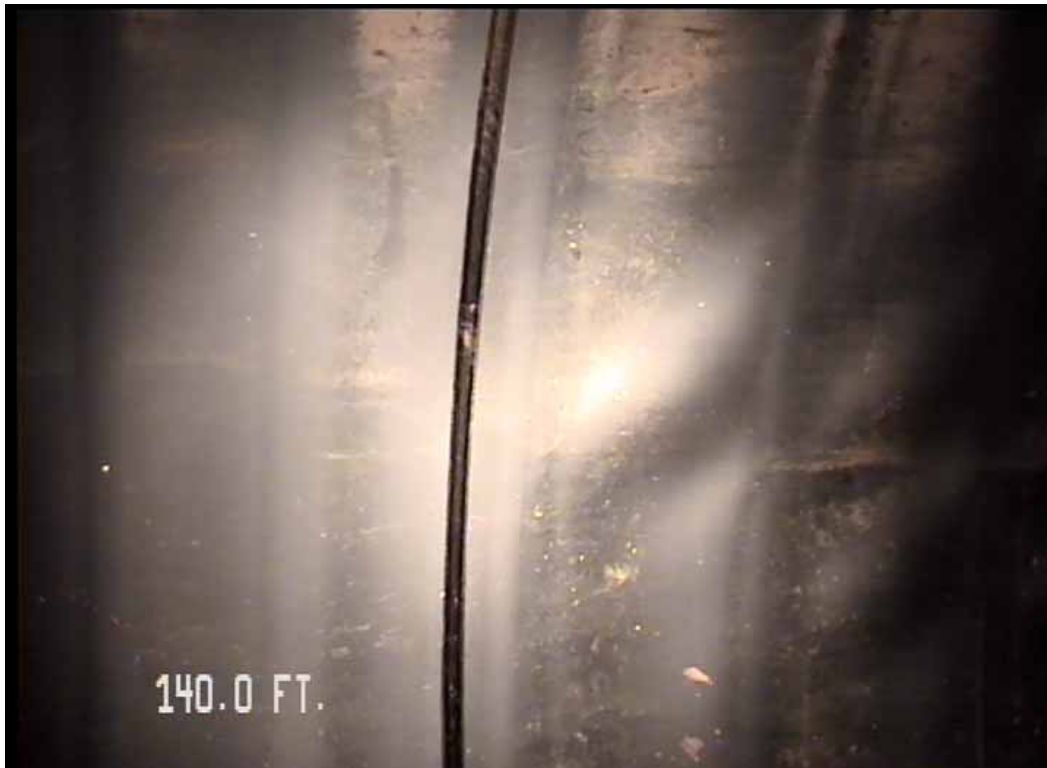
Figure 539 View of the minor joint displacement and buckling failures for pipeline No. 9 (Site No. 1: Orlando)

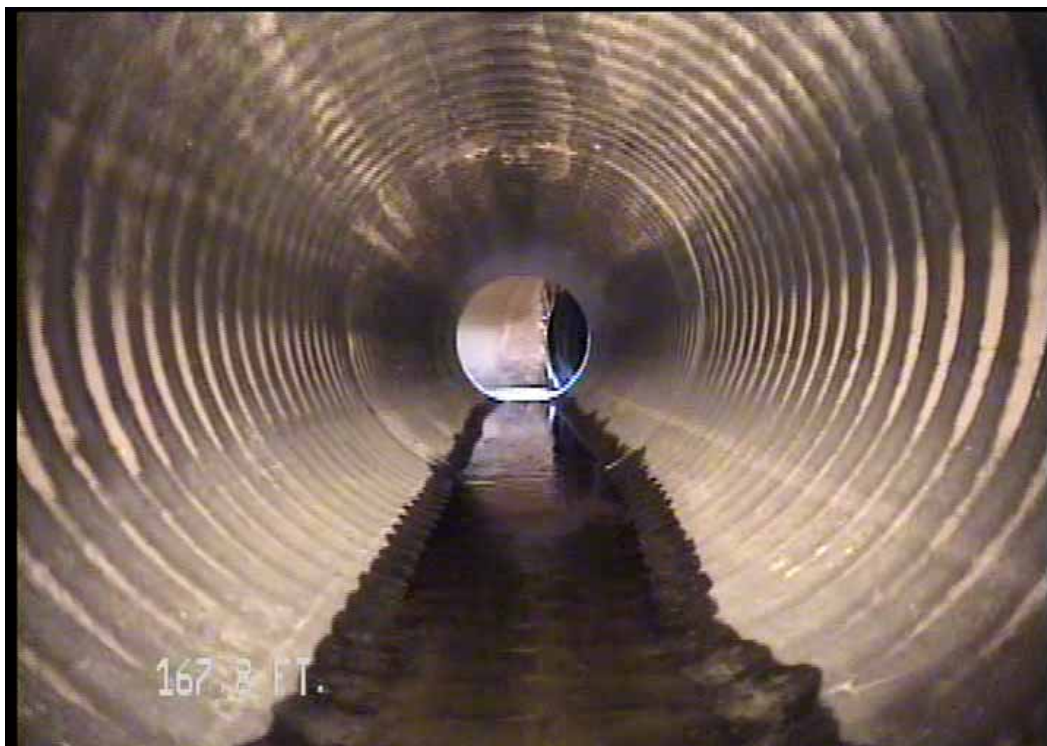
Figure 540 View of corrugation growth failure for pipeline No. 9 (Site No. 1: Orlando)

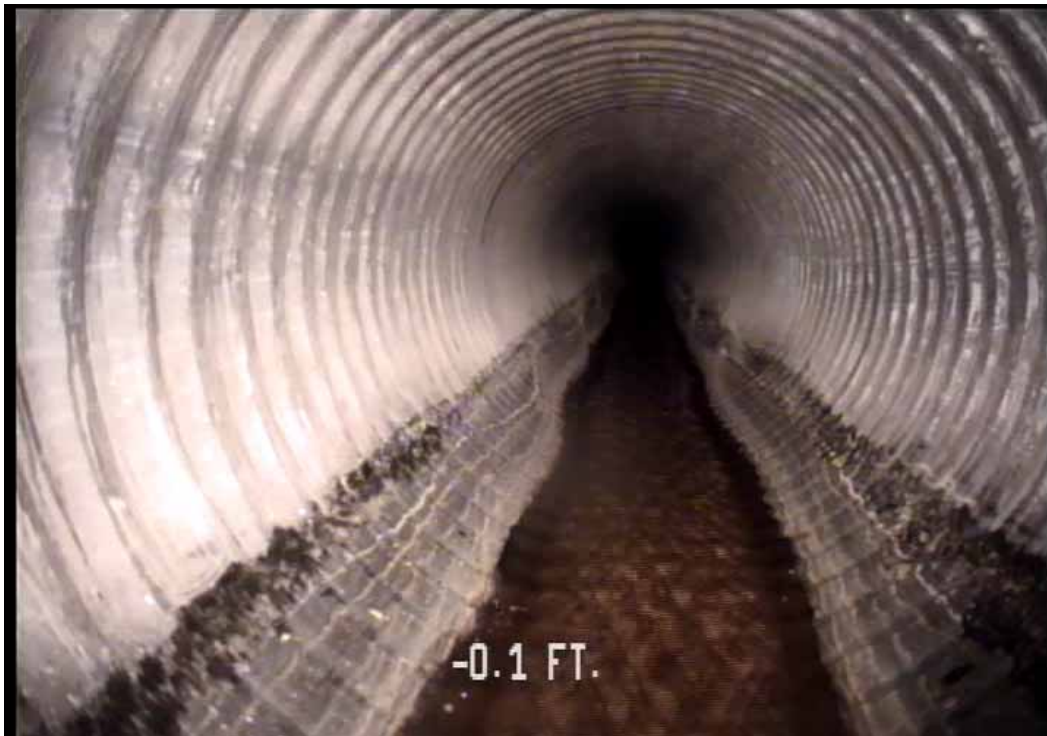
Figure 542 View of the corrugation growth failure for pipeline No. 10 (Site No. 2: Apopka)

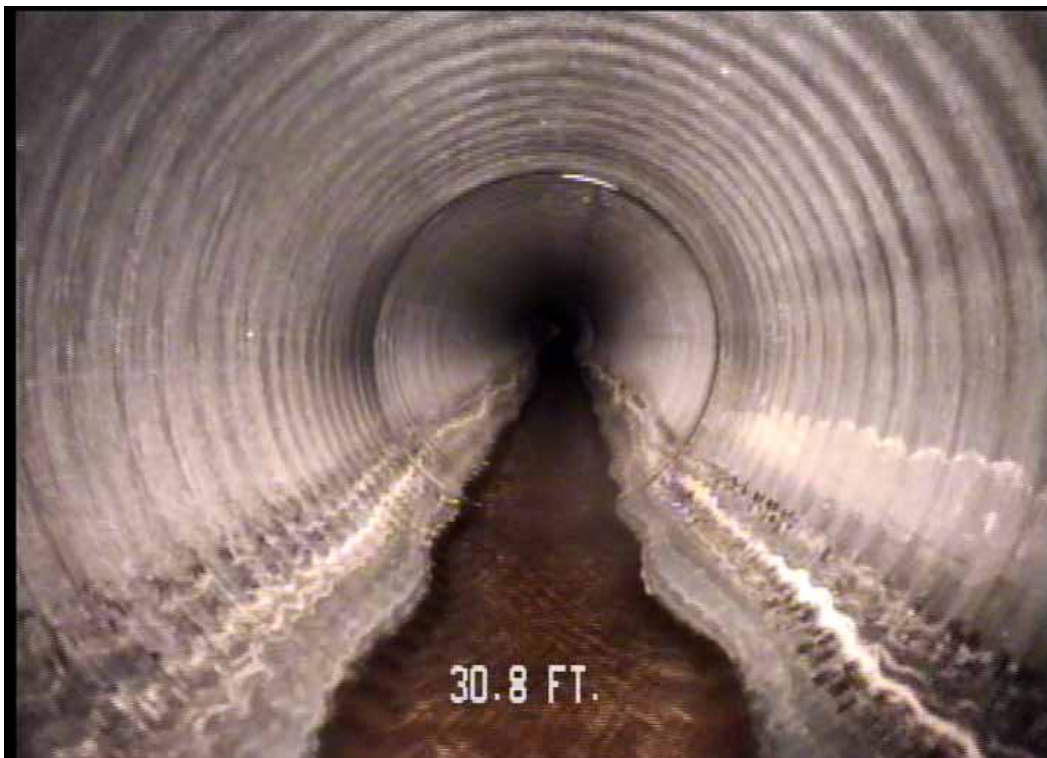
Figure 543 View of the corrugation growth, and dip in line and grade for pipeline No. 10 (Site No. 2: Apopka)

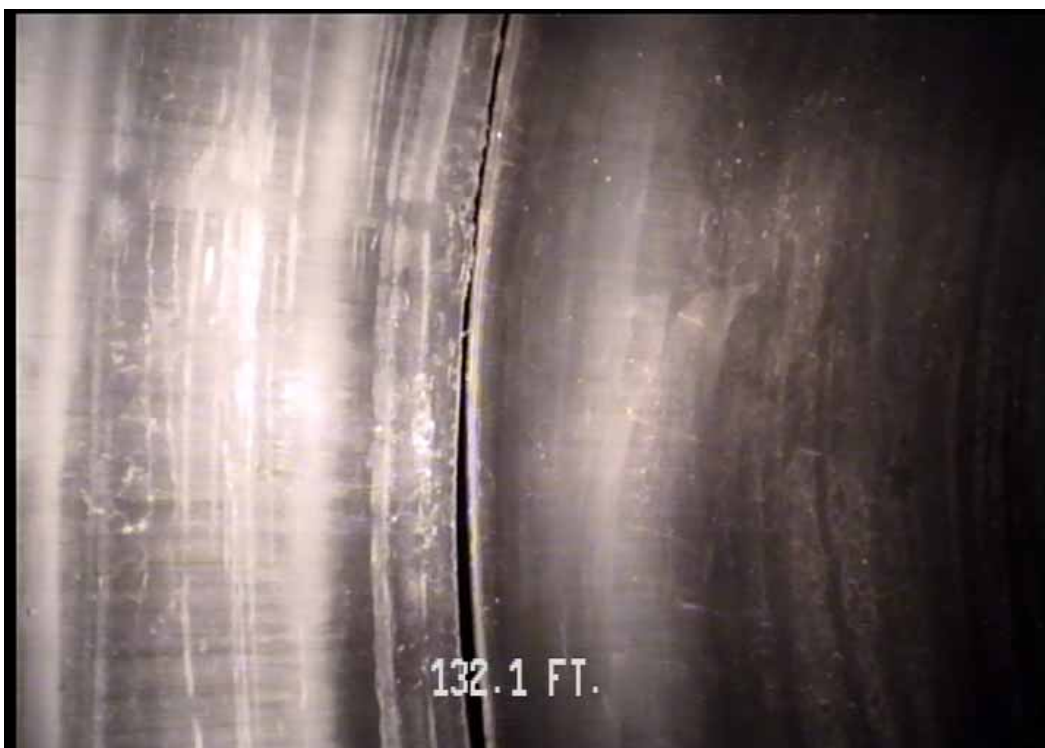
Figure 545 View of minor joint displacement for pipeline No. 10 (Site No. 2: Apopka)

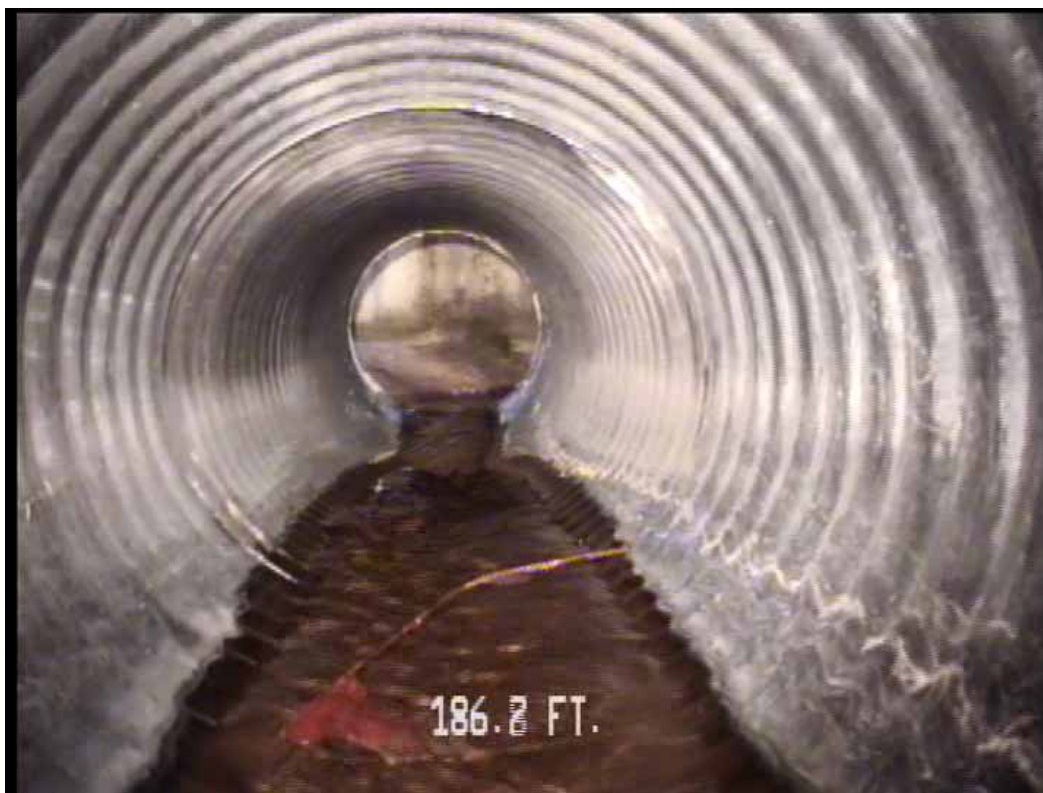
Figure 546 View of the corrugation growth and dips in line and grade for pipeline No. 10 (Site No. 2: Apopka)

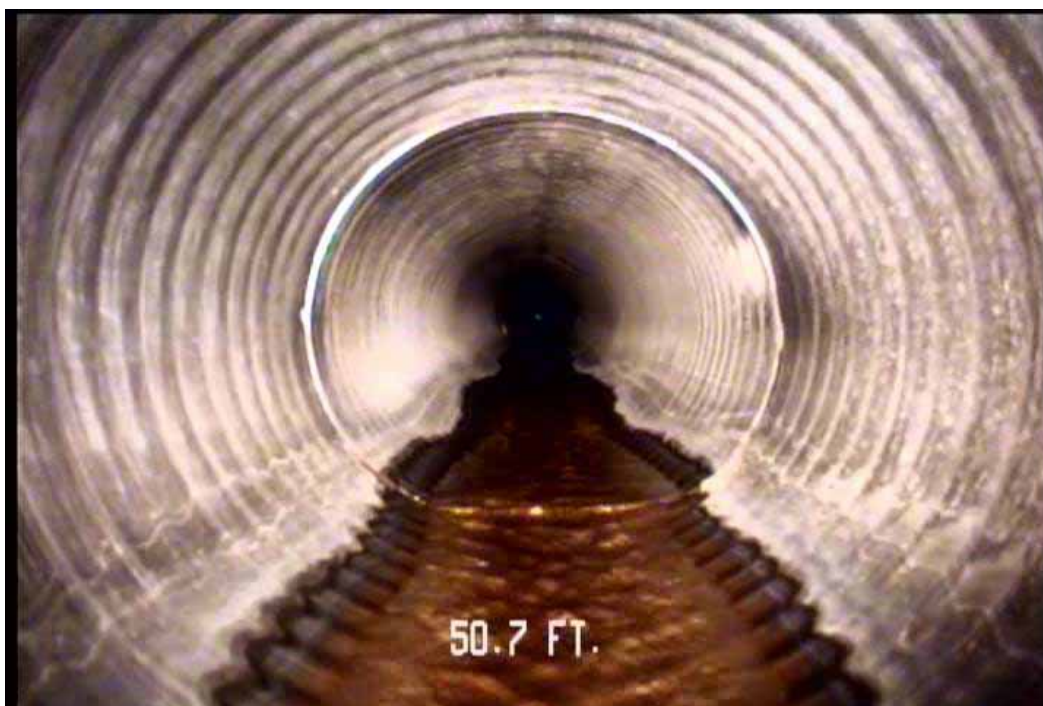
Figure 547 View of the corrugation growth failure and dips in line and grade for pipeline No. 10 (Site No. 2: Apopka)

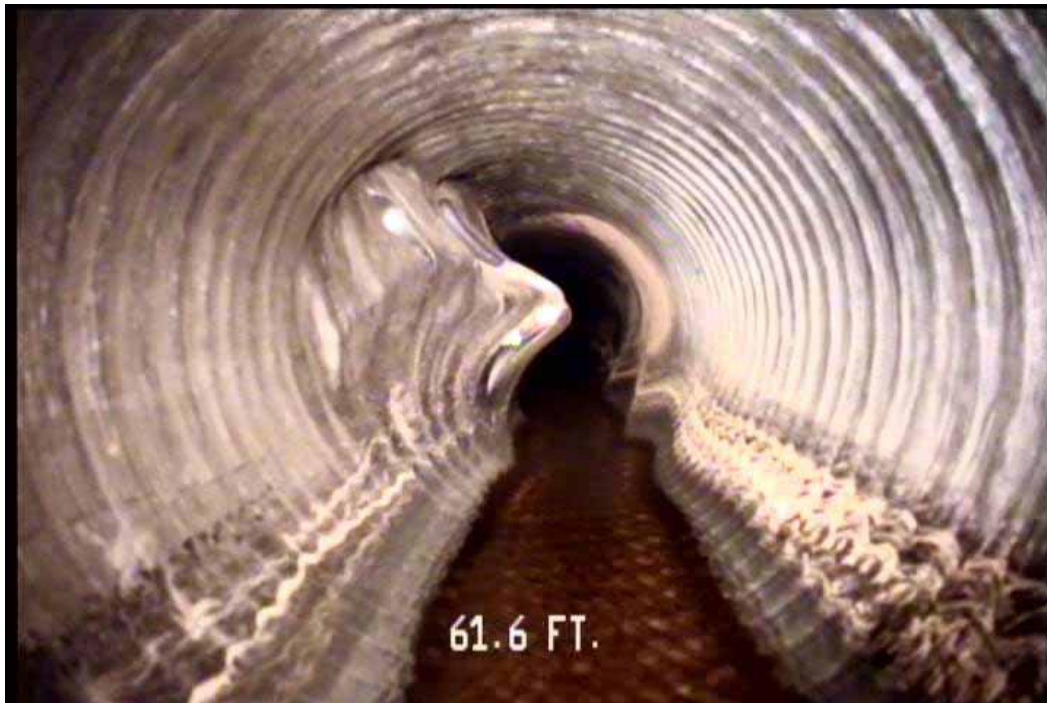
Figure 548 View of the inverse curvature failure for pipeline No. 10 (Site No. 2: Apopka)

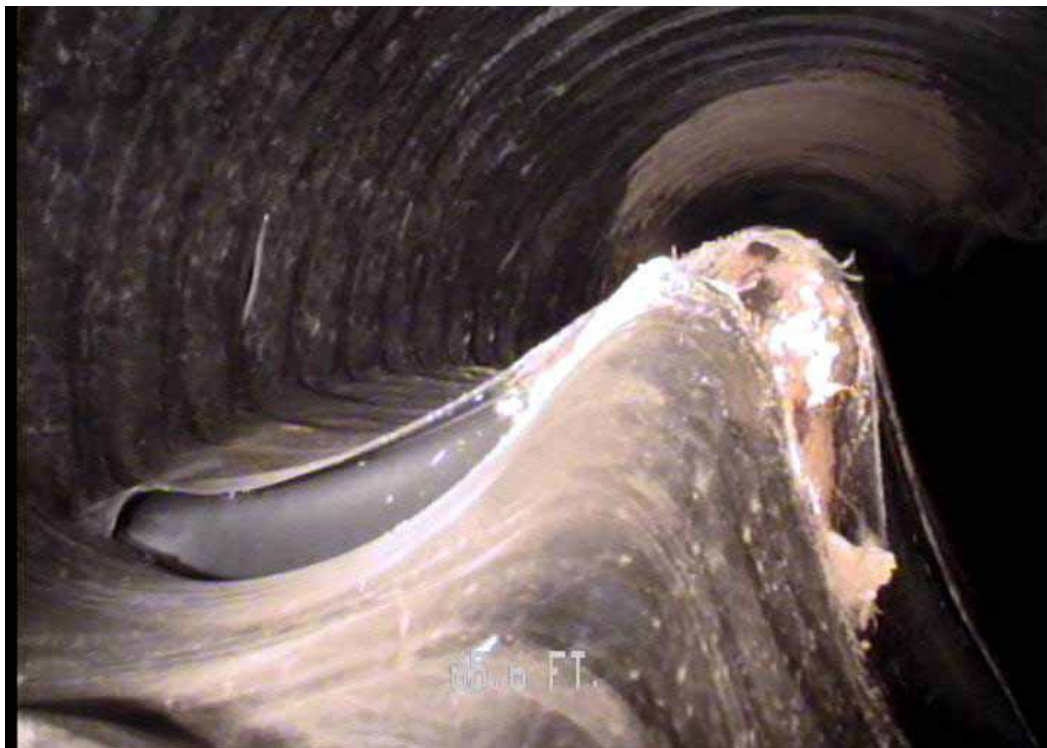
Figure 549 Close view of the inverse curvature/crack/fracture failures for pipeline No. 10 (Site No. 2: Apopka)

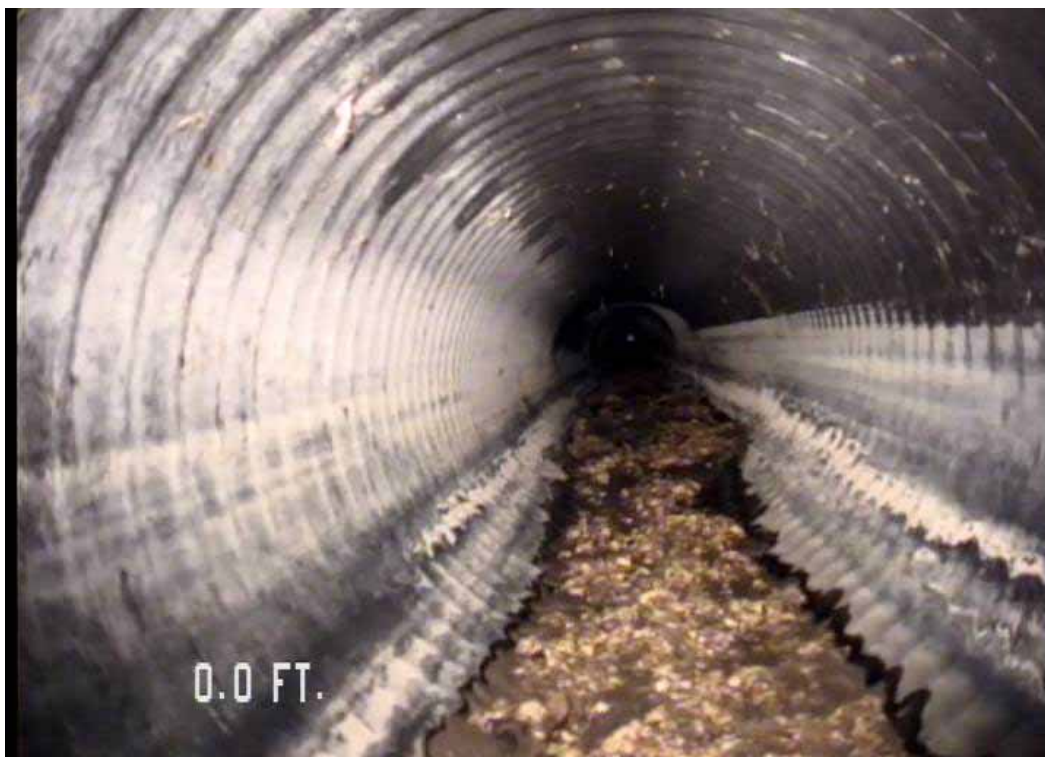
Figure 551 View of the corrugation growth failure at the opening for pipeline No. 11 (Site No. 2: Apopka)

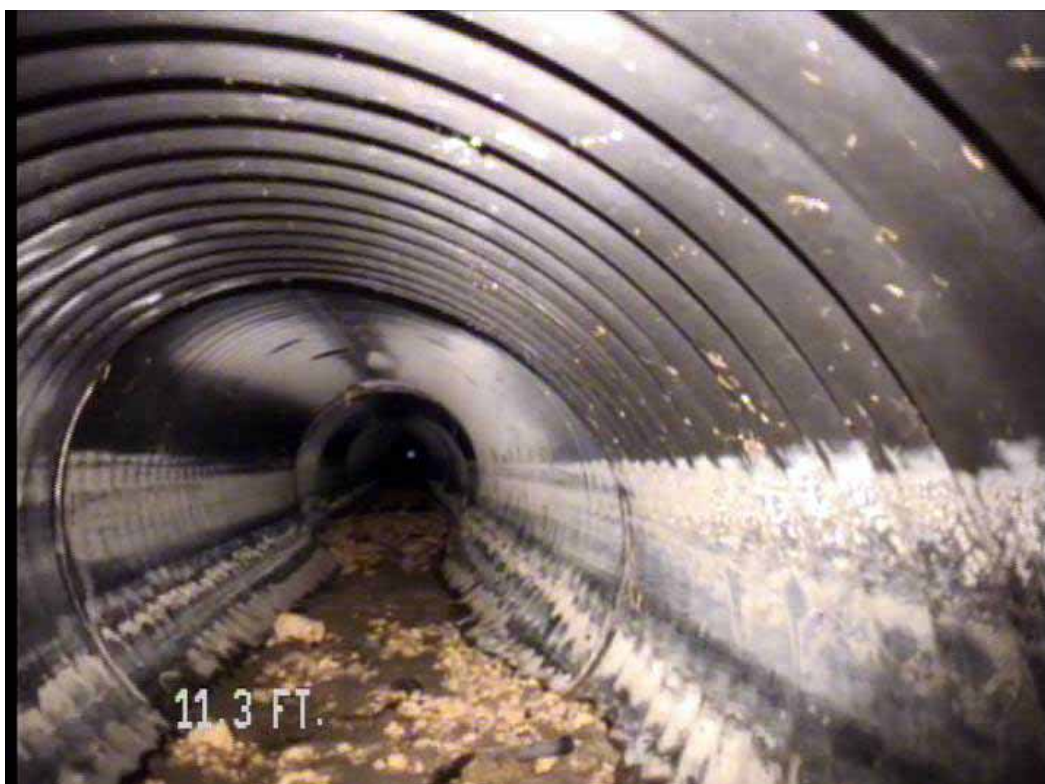
Figure 552 View of the excessive deformation and corrugation growth failures for pipeline No. 11 (Site No. 2: Apopka)

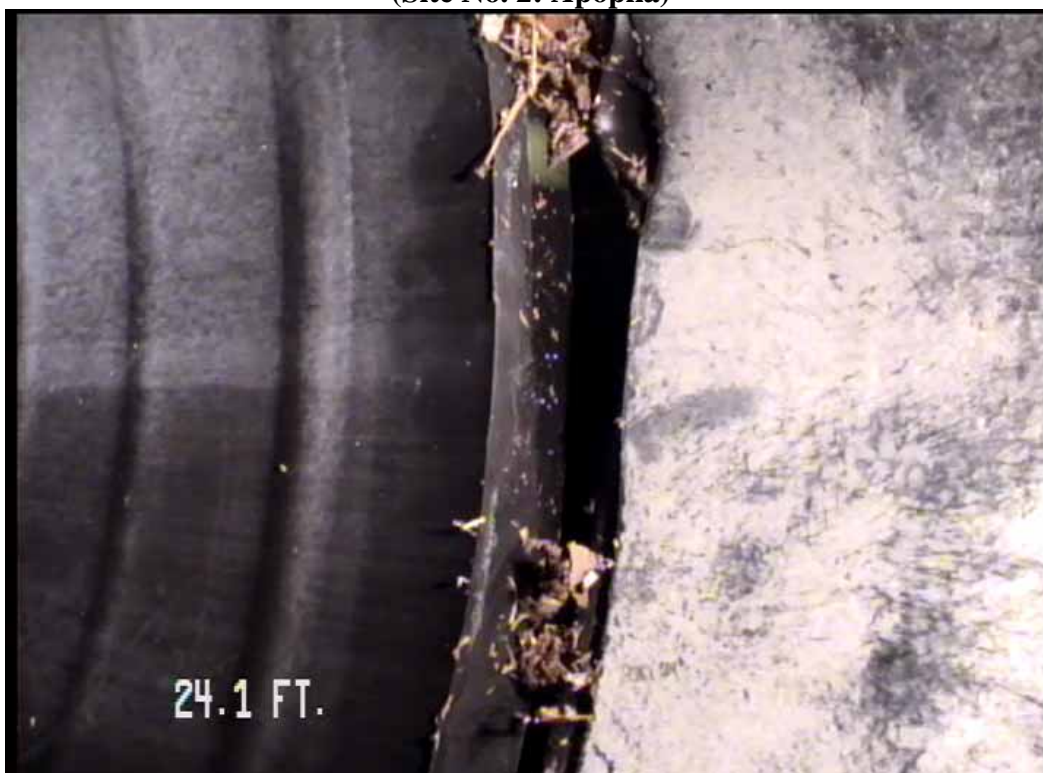
**Figure 554 View of the major joint displacement/crack/fracture failures for pipeline No. 11
(Site No. 2: Apopka)**

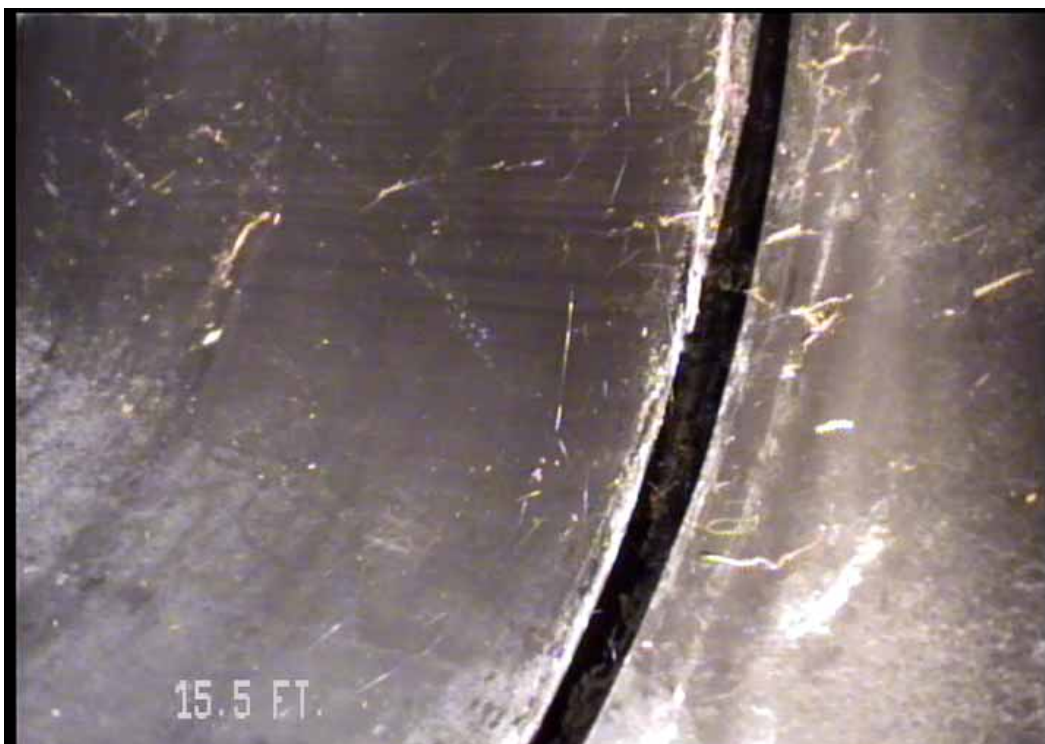
**Figure 556 View of the major joint displacement failure for pipeline No. 11
(Site No. 2: Apopka)**

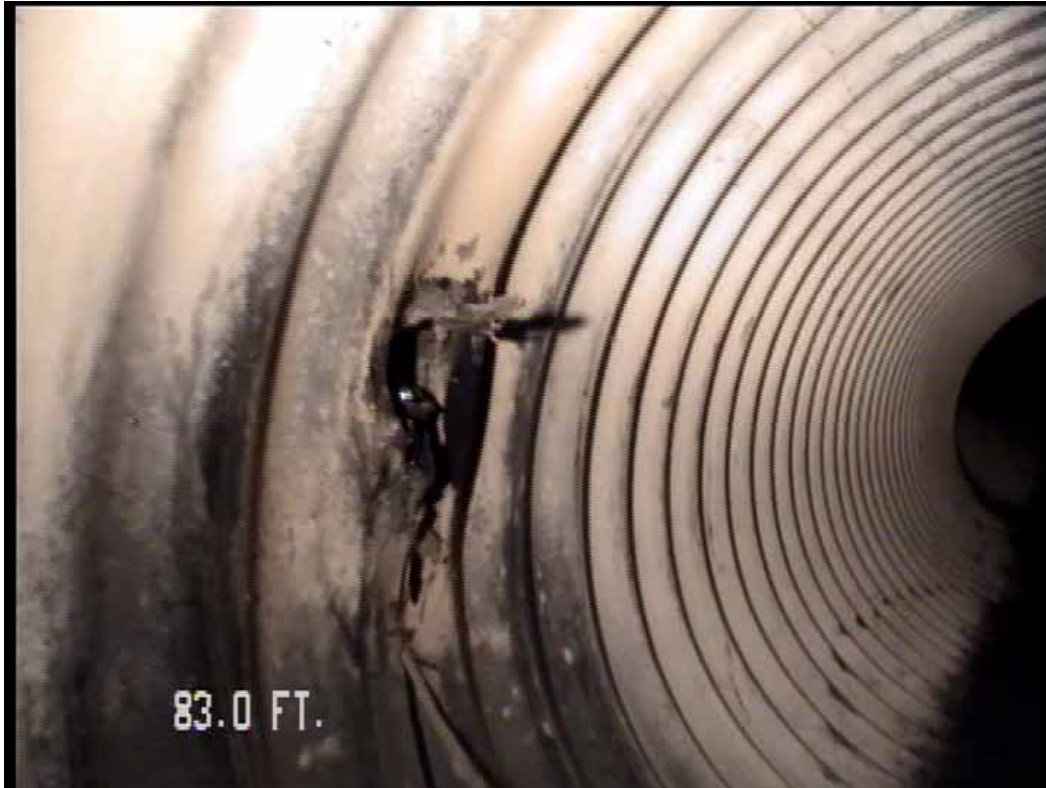
Figure 557 View of corrugation growth/cracking/fracture failures for pipeline No. 11 (Site No. 2: Apopka)

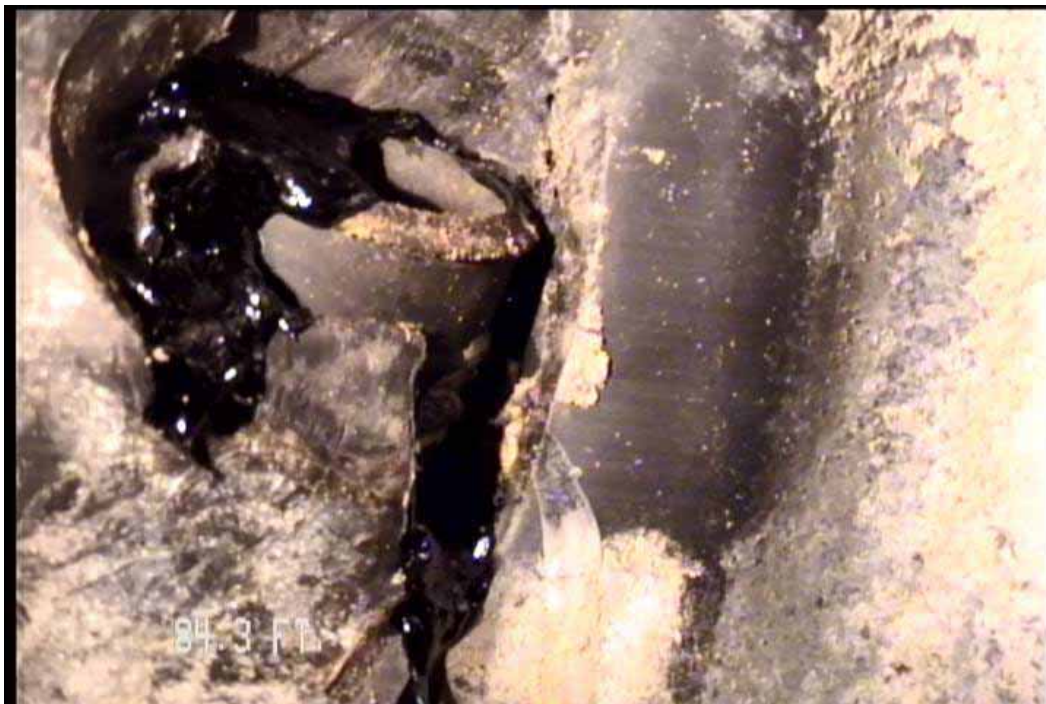
Figure 558 View of cracking/fracture failures for pipeline No. 11 (Site No. 2: Apopka)

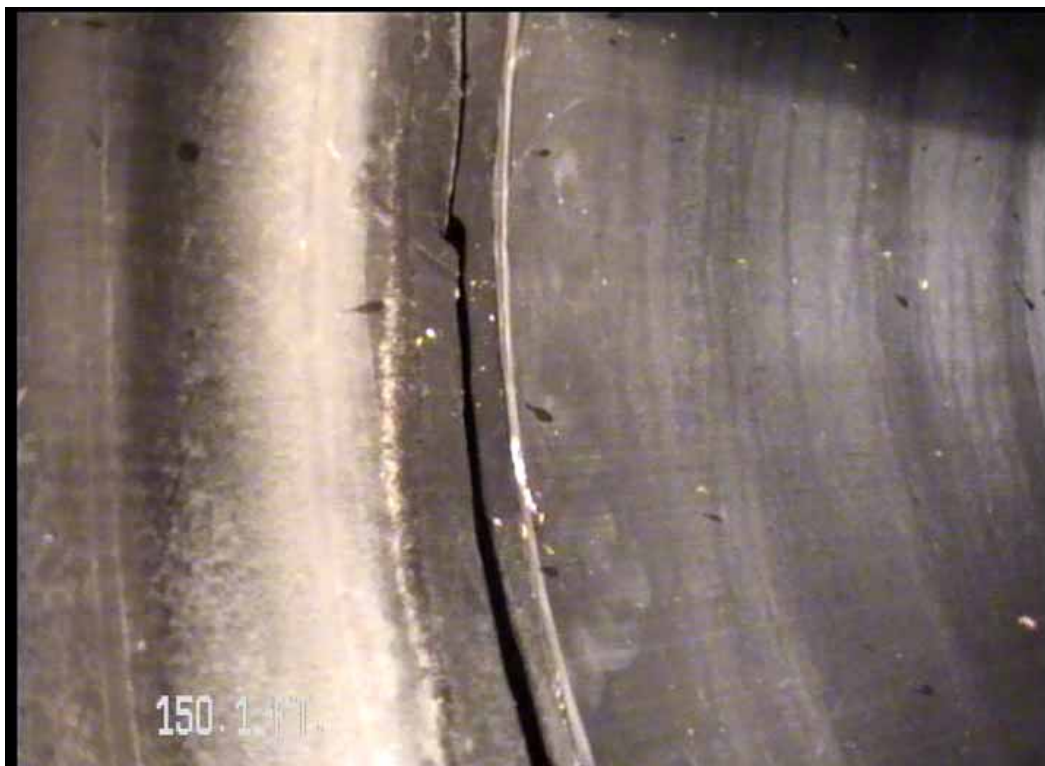
Figure 559 View of the major joint displacement failure for pipeline No. 11
(Site No. 2: Apopka)

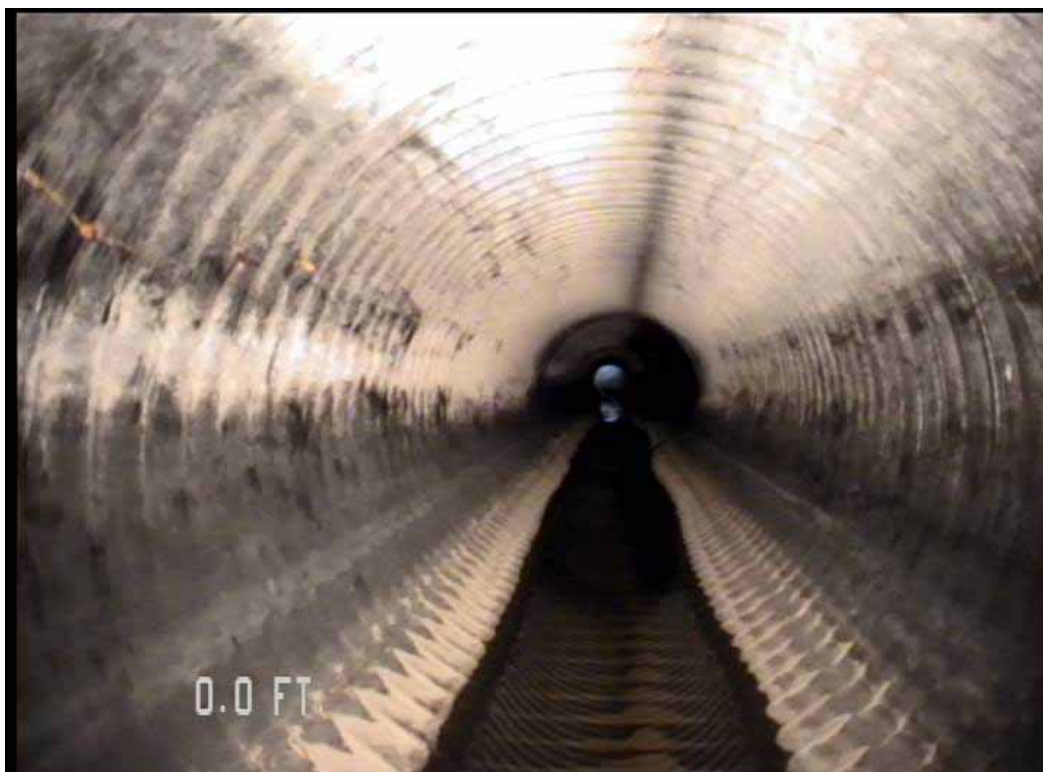
**Figure 562 View of corrugation growth failure at the opening for pipeline No. 12
(Site No. 2: Apopka)**

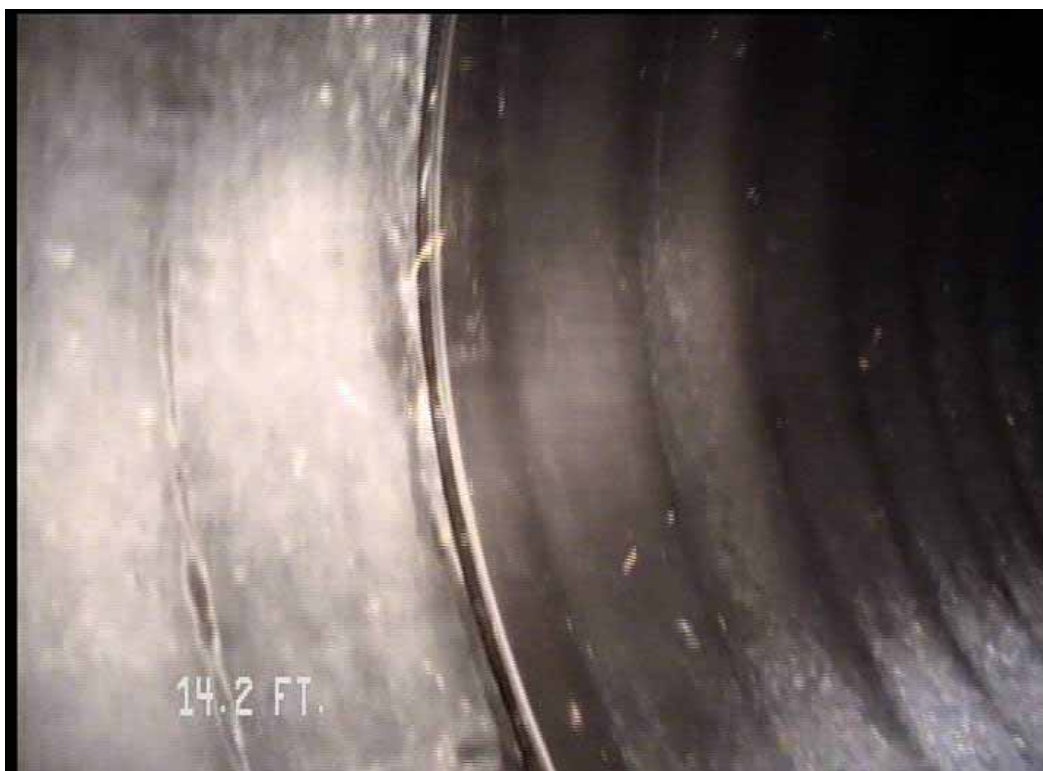
**Figure 563 View of major joint displacement failure for pipeline No. 12
(Site No. 2: Apopka)**

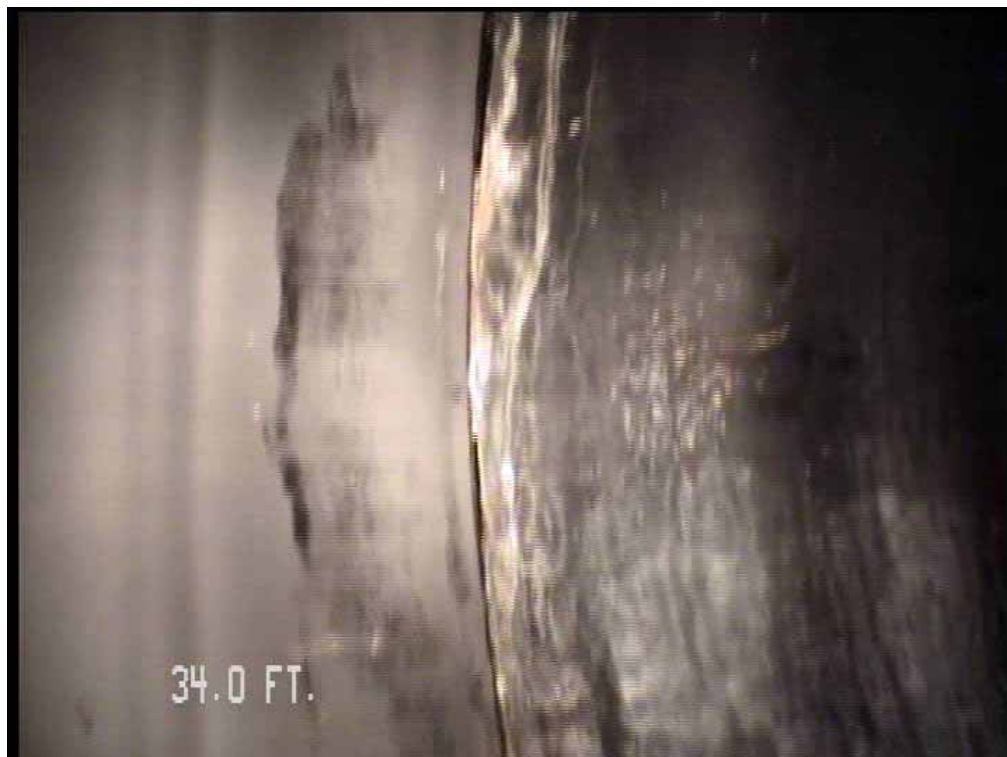
Figure 564 View of minor joint displacement for pipeline No. 12 (Site No. 2: Apopka)

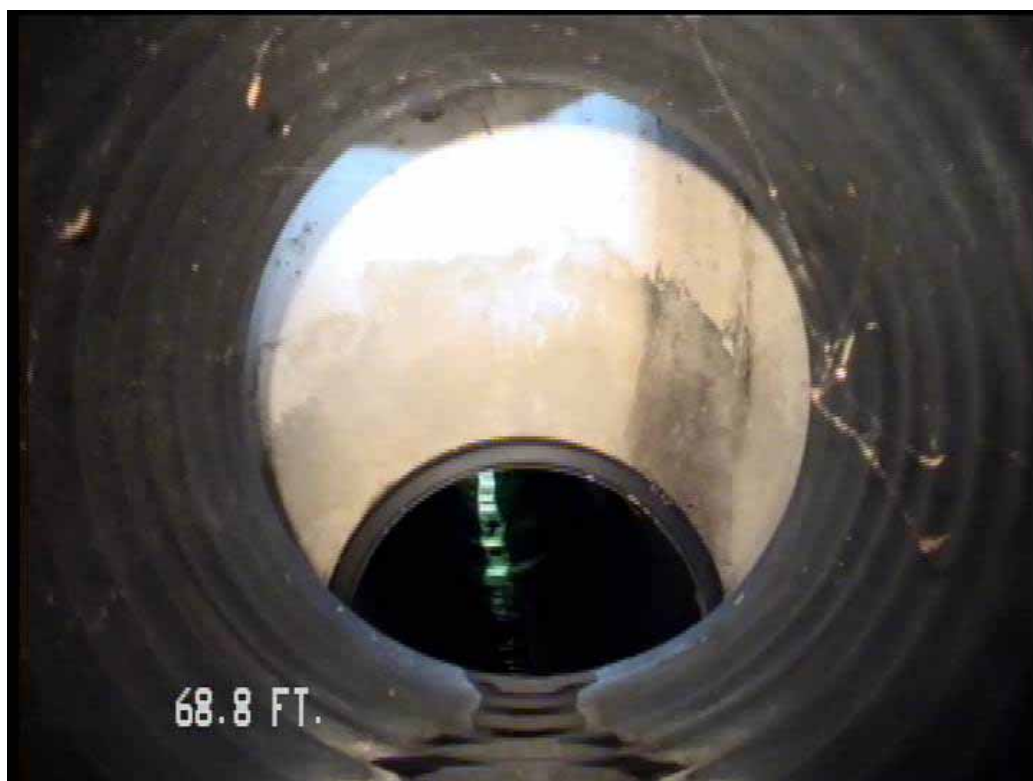
Figure 565 View of the corrugation growth failure at the end for pipeline No. 12 (Site No. 2: Apopka)
