Evaluation of HDPE Pipelines Structural Performance

UT Arlington Center for Structural Engineering Research

November 2010

**As a Part of the Initiative on the Underground Structural Health
Monitoring and Equipment Development**

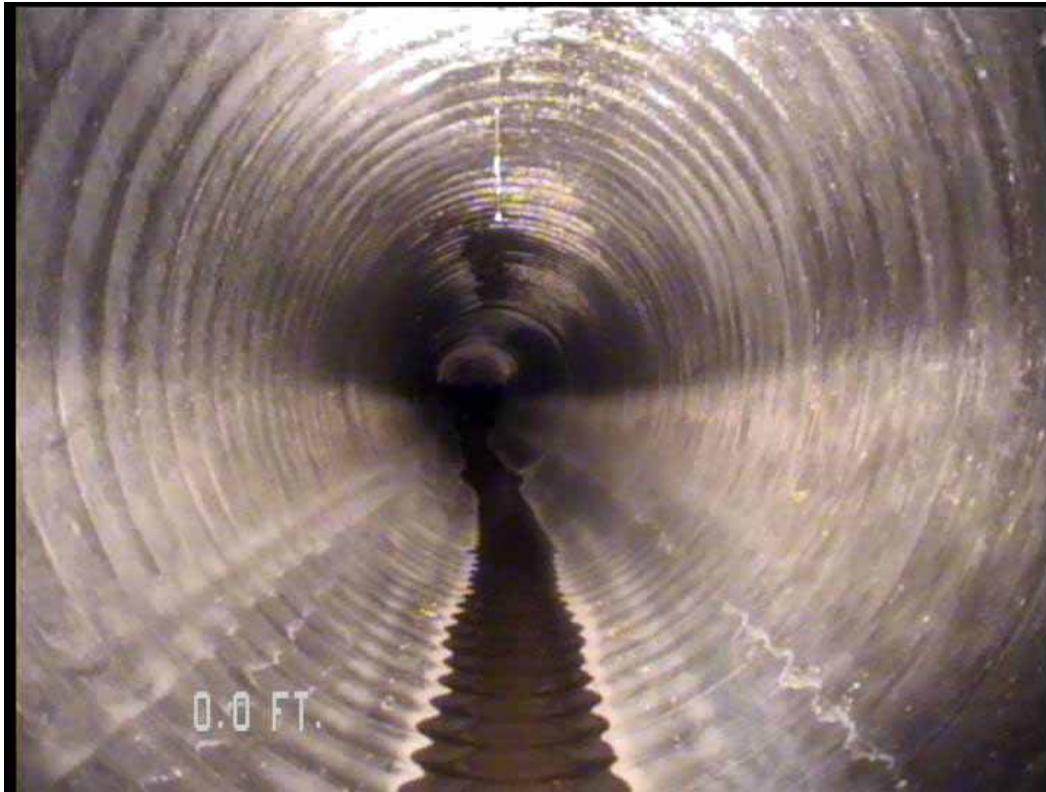
Figure 566 View of the corrugation growth failure at the opening for pipeline No. 13 (Site No. 2: Apopka)

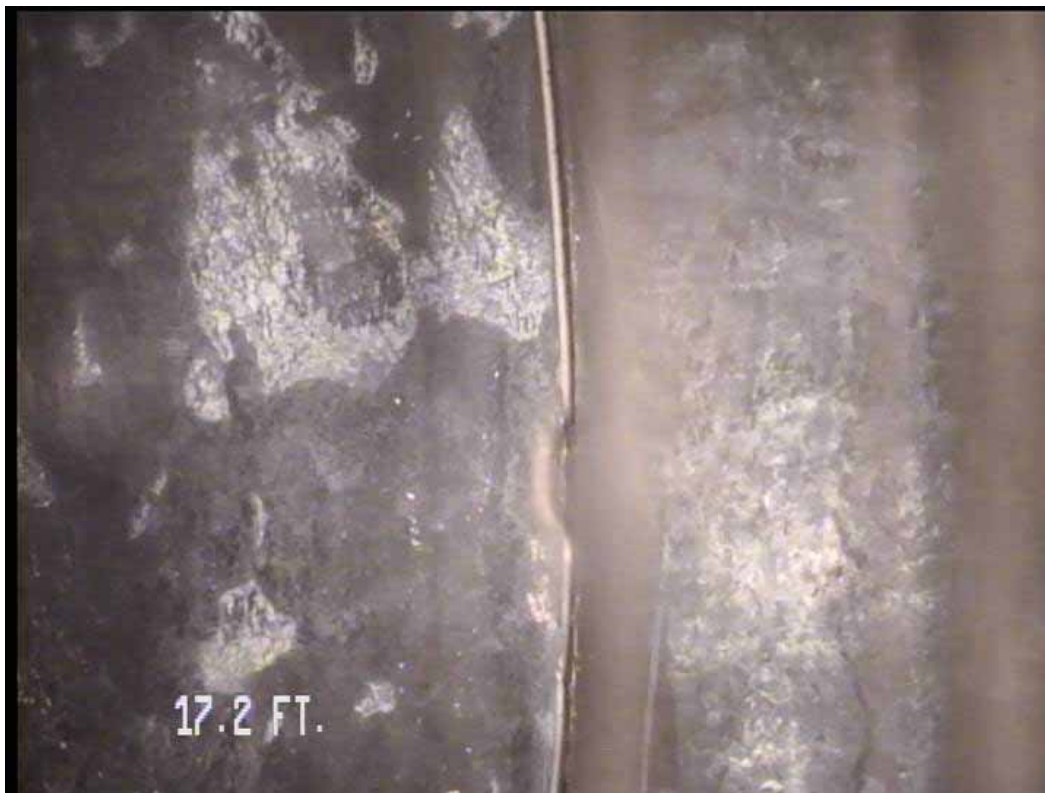
Figure 567 View of buckling failure at the joint for pipeline No. 13 (Site No. 2: Apopka)

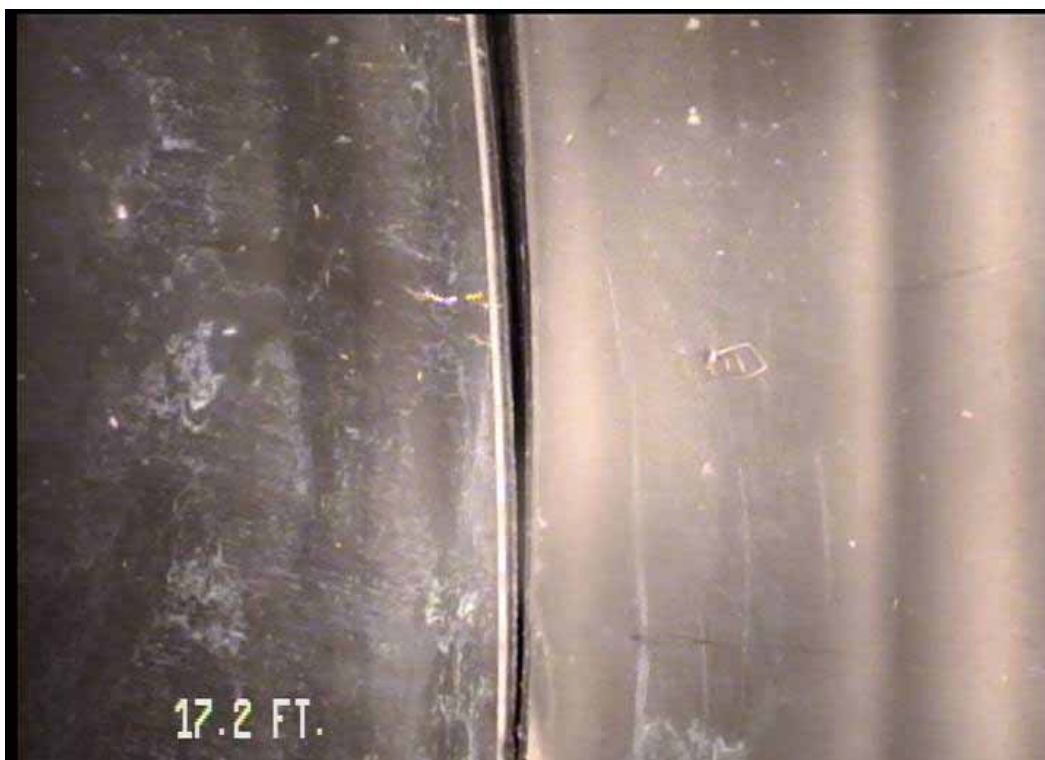
Figure 568 View of minor joint displacement failure for pipeline No. 13 (Site No. 2: Apopka)

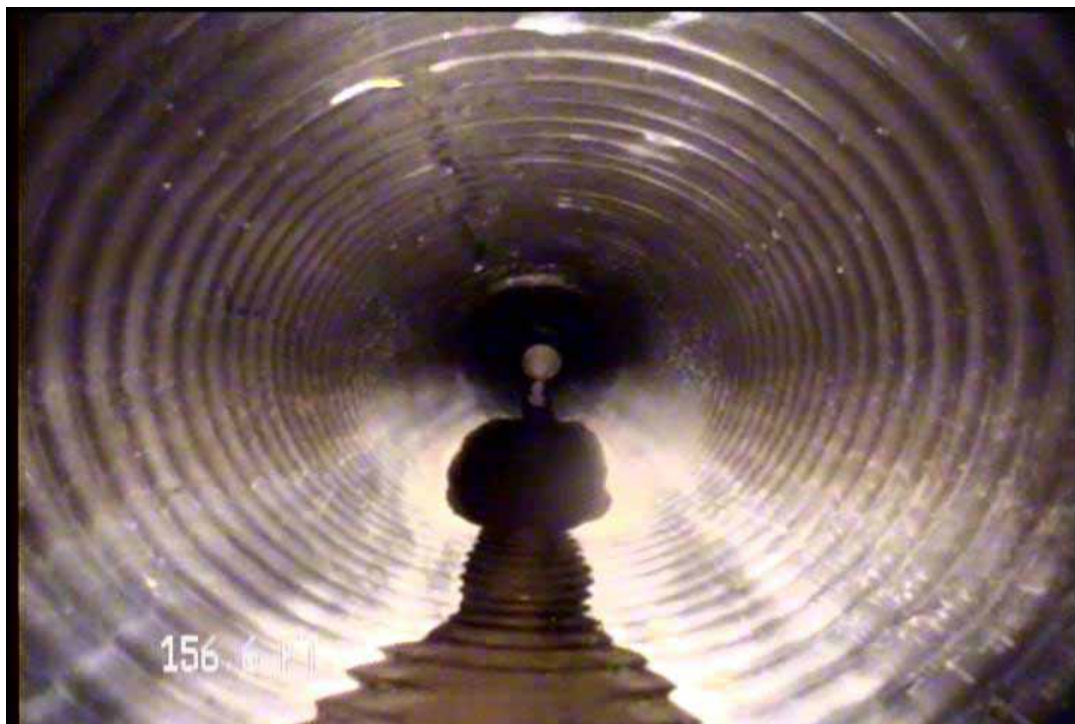
Figure 569 View of the excessive deformation, corrugation growth failures and dip in line and grade for pipeline No. 13 (Site No. 2: Apopka)

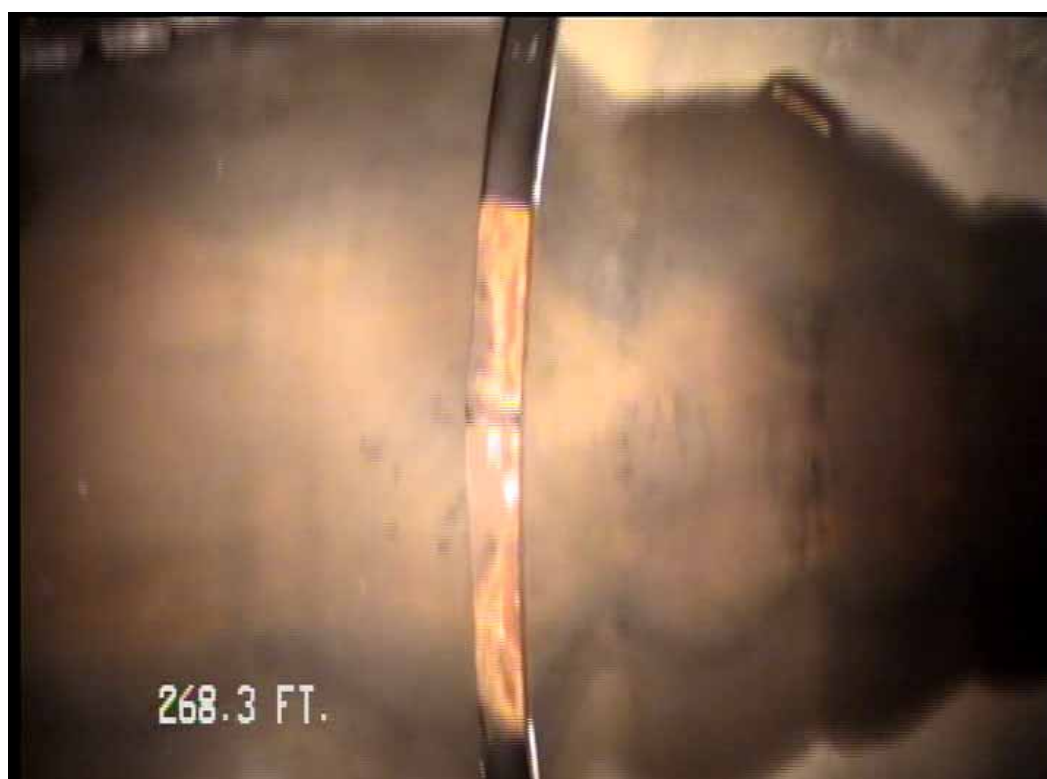
Figure 570 View of the major joint displacement failure for pipeline No. 13 (Site No. 2: Apopka)

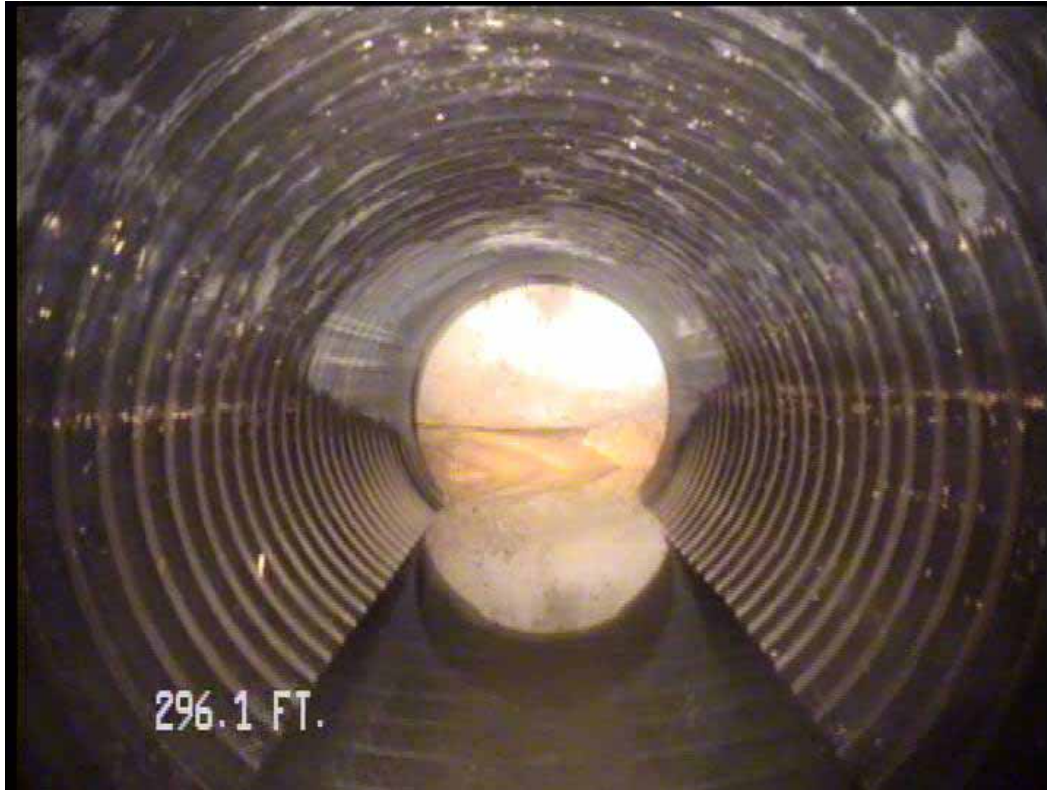
**Figure 571 View of the corrugation growth failure at the end for pipeline No. 13
(Site No. 2: Apopka)**

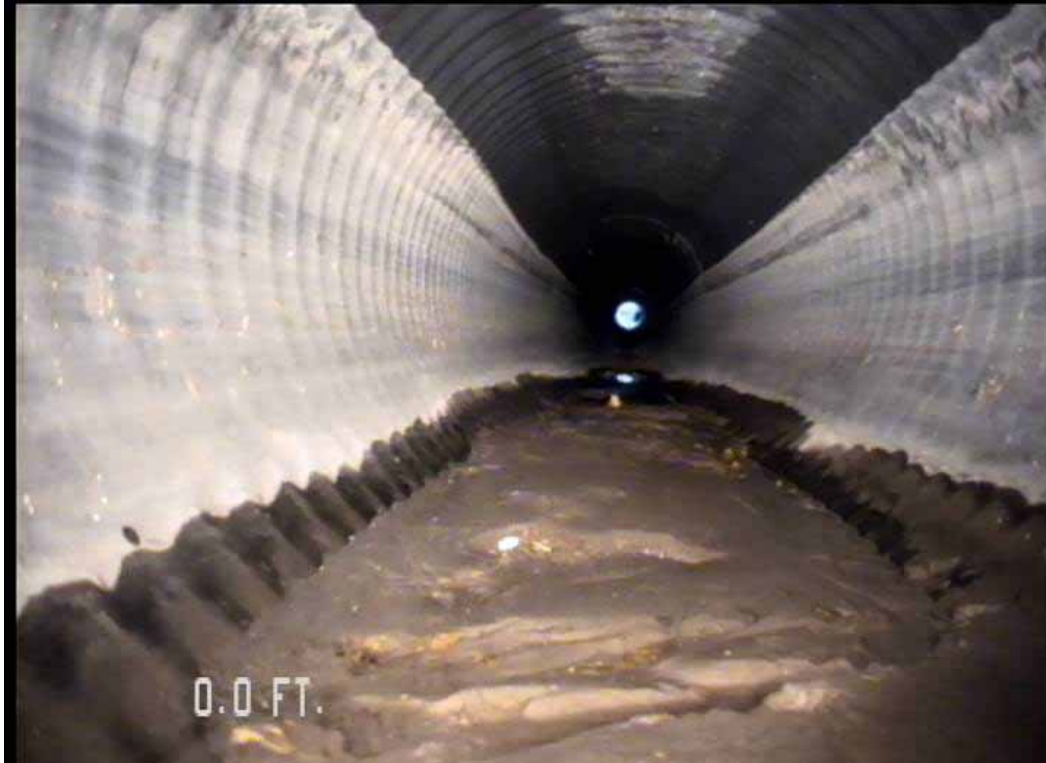
Figure 573 View of the corrugation growth and heavy build up of sediment at the opening for pipeline No. 14 (Site No. 2: Apopka)

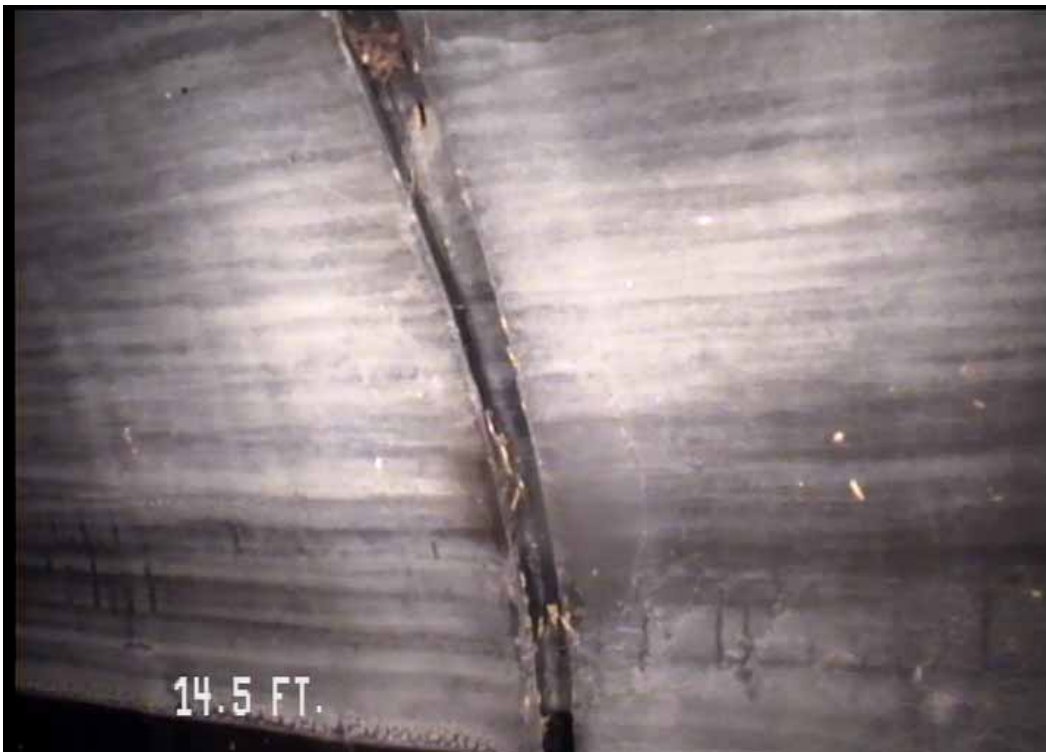
Figure 574 View of the major joint displacement failure for pipeline No. 14 (Site No. 2: Apopka)

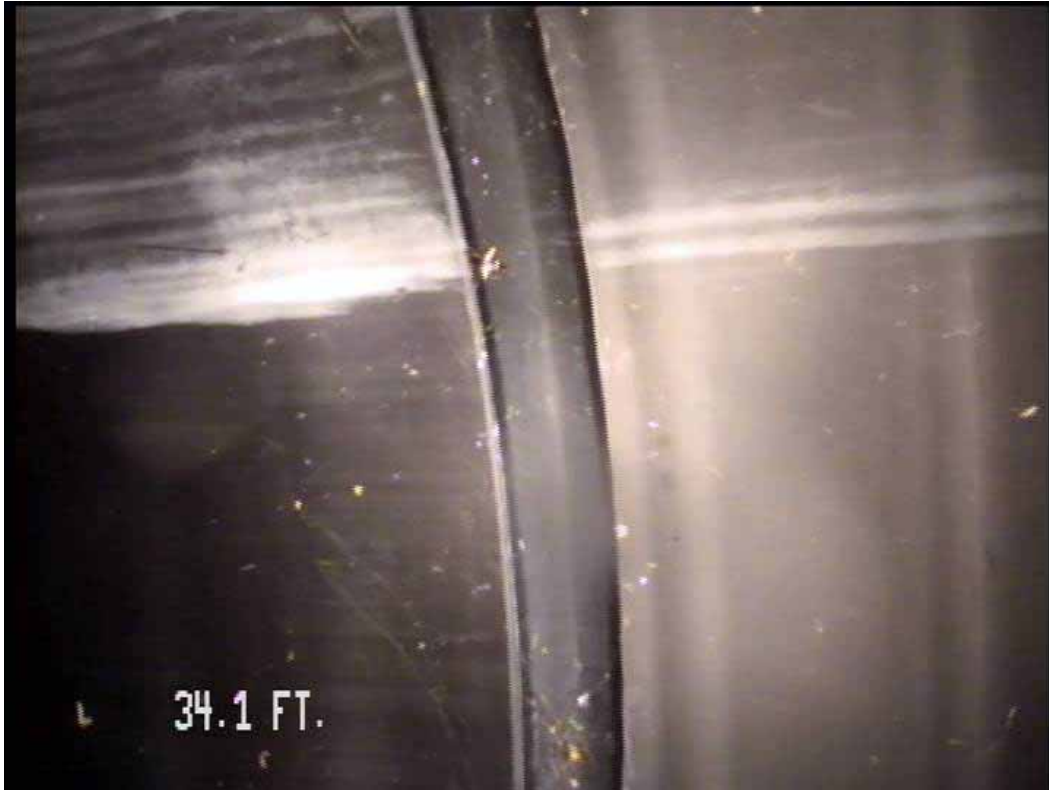
Figure 575 View of the major joint displacement failure for pipeline No. 14 (Site No. 2: Apopka)

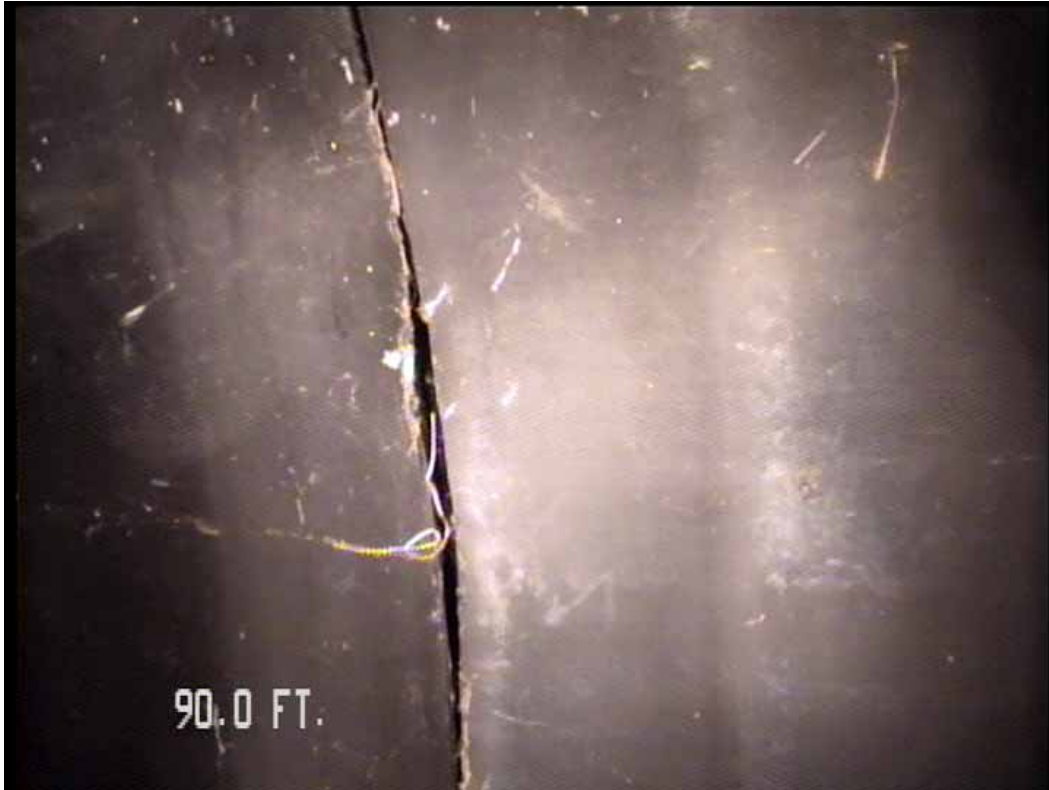
Figure 577 View of minor joint displacement for pipeline No. 14 (Site No. 2: Apopka)

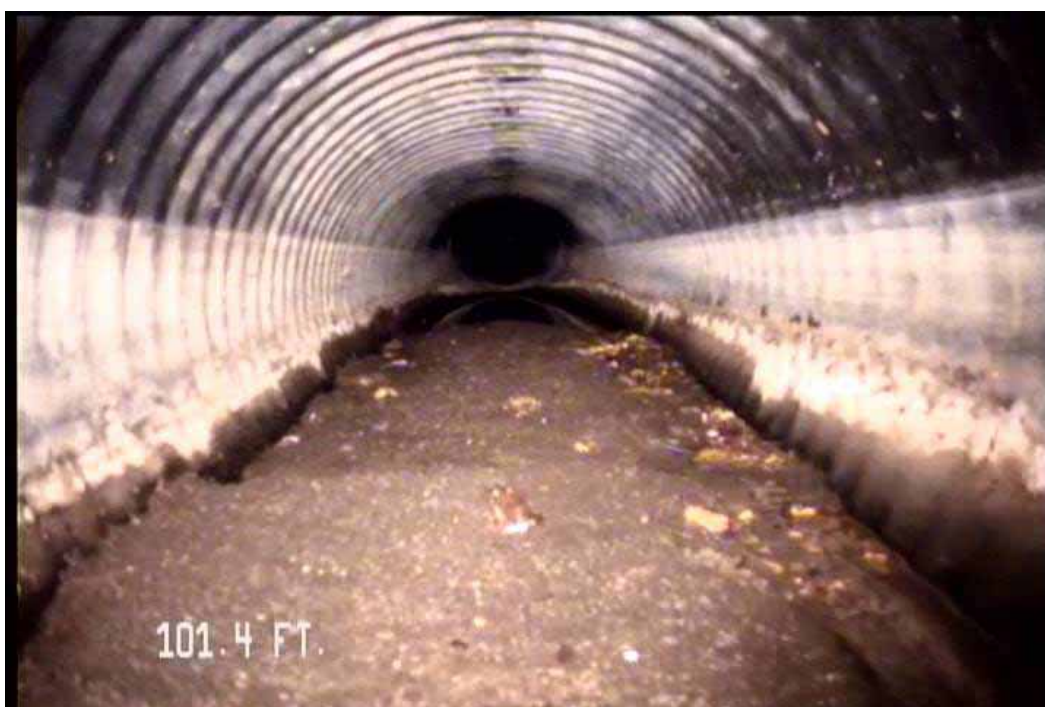
Figure 581 View of the excessive deformation, corrugation growth failures and heavy build up of sediment of pipeline No. 15 (Site No. 2: Apopka)

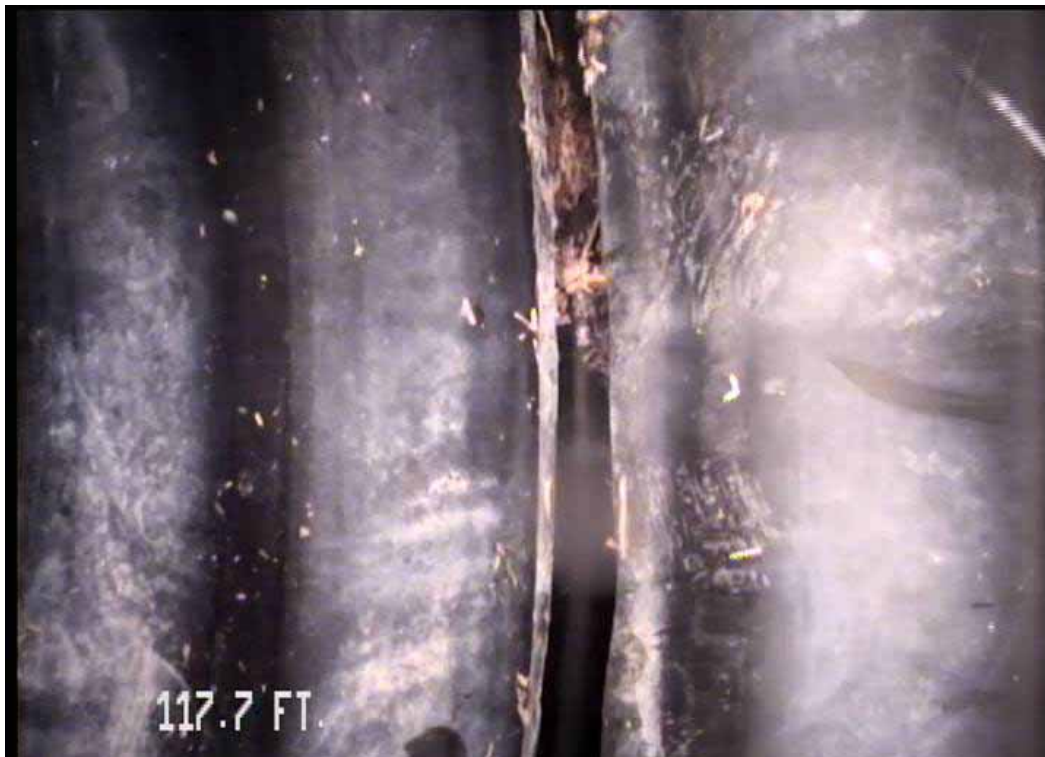
Figure 582 View of major joint displacement failure of pipeline No. 15 (Site No. 2: Apopka)

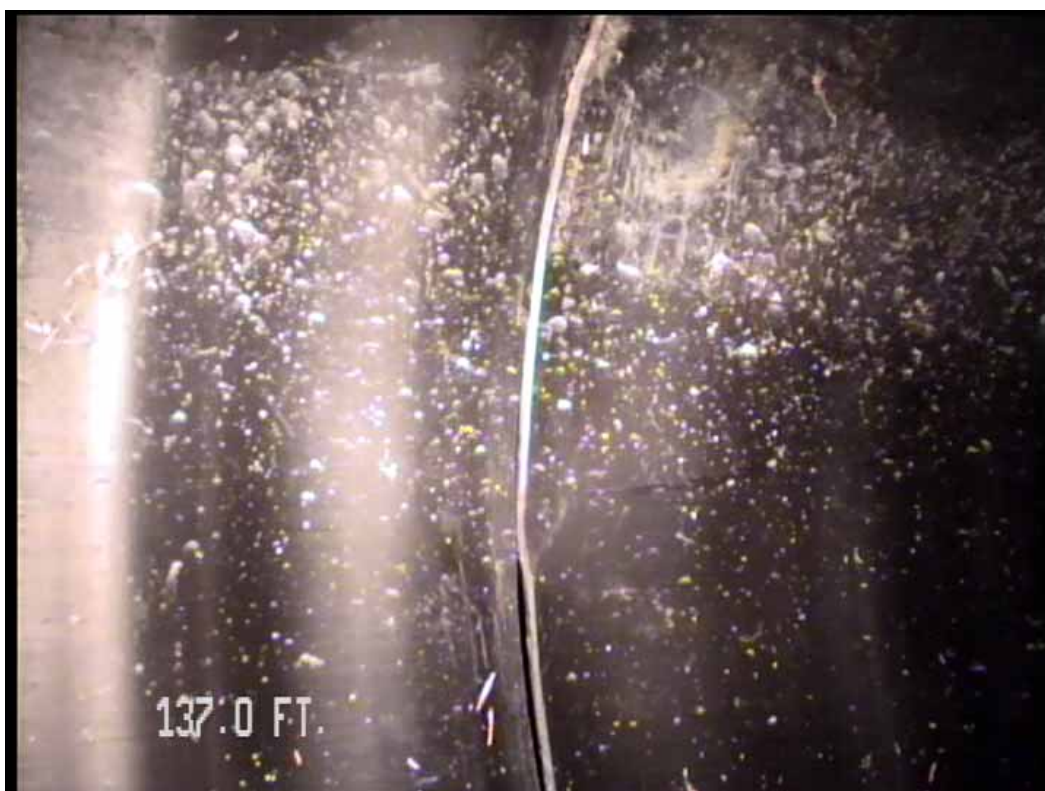
Figure 583 View of minor joint displacement for pipeline No. 15 (Site No. 2: Apopka)
