An educational document from the American Concrete Pipe Association for users and specifiers

Heavy rains in May 2011 overwhelmed a 72” four-barrel Corrugated Metal Pipe (CMP) culvert on Texas Farm to Market Road (FM) 2539 near the town of Buffalo in Leon County, Texas. Area management from the Texas Department of Transportation (TxDOT) and local maintenance crews were forced to shut down the road for more than a week while they replaced the metal culvert with reinforced concrete pipe (RCP). Estimated cost of the replacement process: \$350,000.

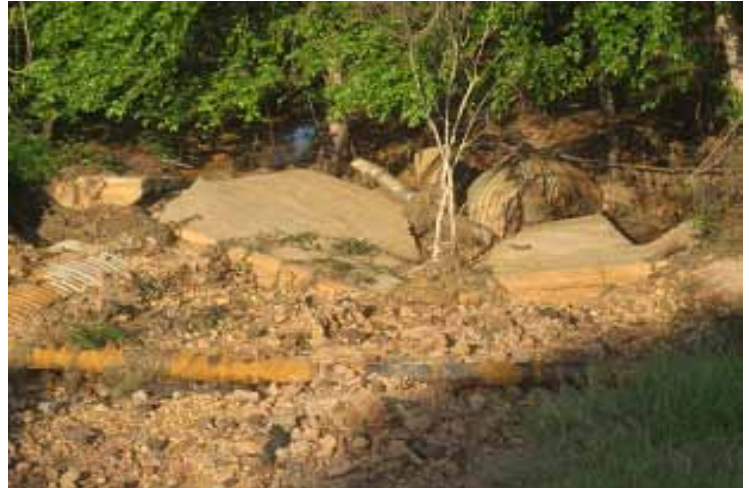
The failure occurred about five miles south of Buffalo on FM 2539, a road that serves a number of rural homes. Given the extensive damage, TxDOT was unable to conduct a full analysis of the root cause of the failure. However, TxDOT employees found sufficient evidence to indicate that the inverts failed, leading to partial collapse of the structure. The resulting restriction of the lines backed up enough water to cause the failure seen in these photographs.

Ironically, nearby landowners and TxDOT personnel confirmed that the recently failed metal culvert was installed in 1986 as a replacement for a previous CMP culvert that had also failed. Fortunately, for the third culvert installation at this location since the 1980s, TxDOT has opted to replace the failed CMP with reinforced concrete pipe, which has a design life of up to 100 years, according to the U.S. Corps of Engineers. Furthermore, unlike CMP, concrete pipe has a successful history of durability, performance over its service life and minimal risk of structural failure.

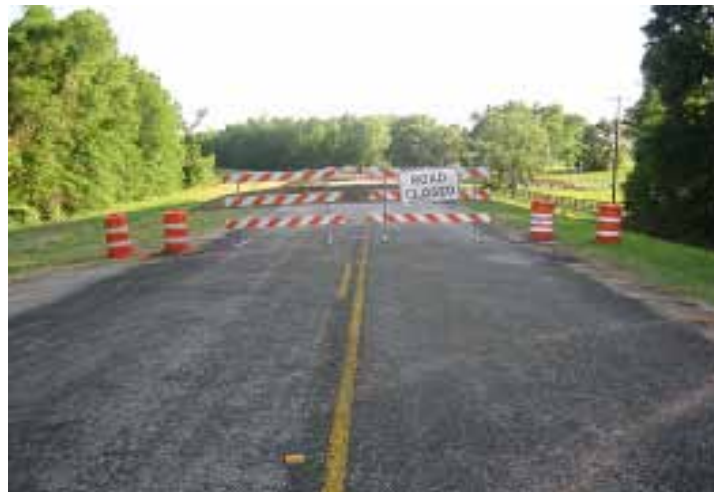
While we don't know how much was spent 25 years ago to build the recently failed CMP culvert, we can estimate its replacement cost fairly easily. TxDOT chose to directly replace the four-bbl 72" CMP with four-bbl 72" RCP. With roughly 450 feet of 72" RCP installed, the material cost is about \$100,000. Mobilization and installation is estimated at \$150,000, and repairing the roadway adds \$50,000 or more. Once engineering and administrative expenses are factored in, the total cost is projected at \$350,000.

Of course, this does not account for the economic costs associated with the closure of the only paved road into and out of the area. Many of the residents living along FM 2539 were significantly hindered in their ability to enter and leave their property during the event and its aftermath.

And let's not forget that this is the *second* failed CMP culvert at this very same location.

Nothing can be done now about the poor decisions made a quarter-century ago. Had the officials in charge installed concrete pipe the first time, they would not have had to allocate \$350,000 or more in scarce funds today. Fortunately, they won't need to worry about replacing the new RCP installation for another 75 to 100 years.
