Evaluation of HDPE Pipe Performance
on
Kentucky DOT and Ohio DOT
Construction Projects

by Pipeline and Drainage Consultants
a subsidiary of Spartan Construction

EVALUATION OF HDPE PIPE PERFORMANCE ON KENTUCKY DOT CONSTRUCTION PROJECTS

EVALUATION OF HDPE PIPE PERFORMANCE ON OHIO DOT CONSTRUCTION PROJECTS

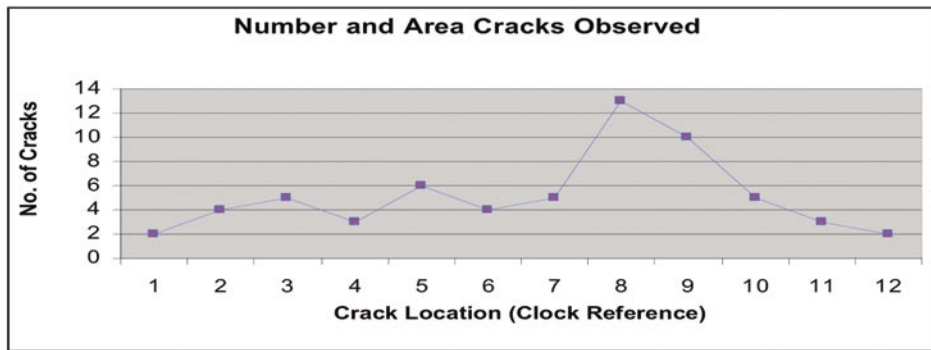
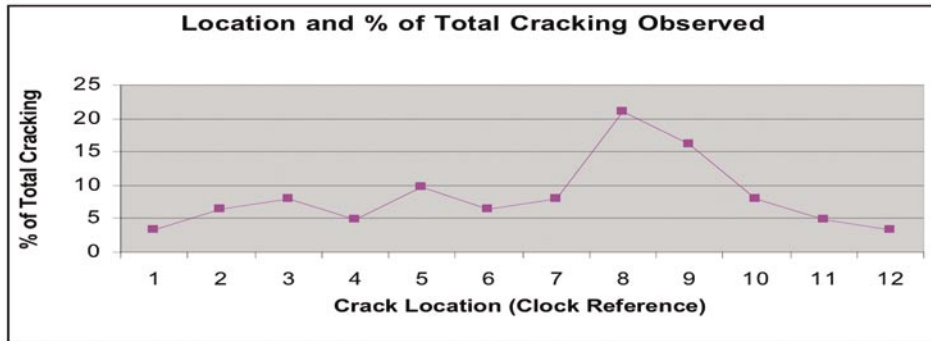
Graph on Project 6, US 127, Owen County.

Deflection readings were taken in the 48-inch pipe in 2000 by KTC. No noticeable deflection or dimpling was documented at that time. In 2002, Wiss, Janney, Elstner Associates, Inc. documented a 1" long crack 142' from the inlet and rippling (dimpling) 129-133 feet. A visual inspection survey conducted by the KTC and PDC in June of 2005 indicated that significant dimpling and radial cracking had occurred in the pipe from 108 to 176 feet from the inlet end. Most of the observed distress had occurred in the section of the pipe backfilled with crushed limestone pipe sand. This data indicated that the pipe is continuing to change eight years after installation and that significant changes have occurred in the past three years. At this time, pipe deflection is under 4%, but appears to be continuing to deflect in several new areas.

Deflection measurement of the 36-inch pipe was taken by Wiss, Janney, Elstner Associates, Inc in 2002. The cross drain was inspected again in June 2005, by KTC and PDC. At the time of the inspection there were no signs of significant distress or deflections. Corrugation growth (liner pushing inward) is the only noticeable issue.

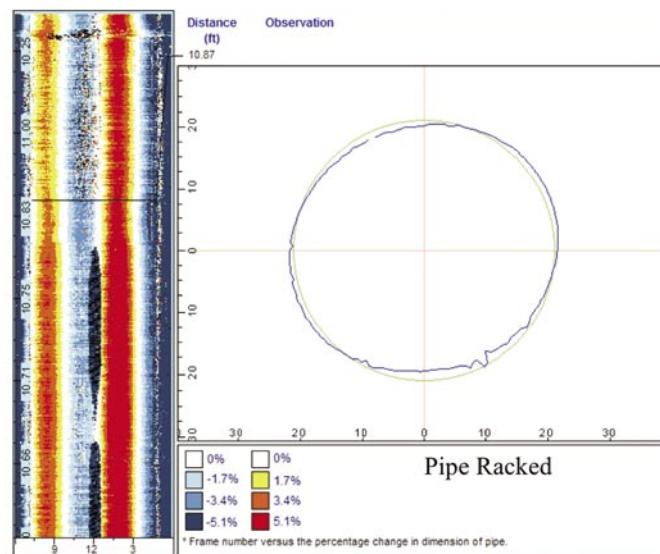
Project 9 - SR 229, Millwood

The 42-inch, 80-foot long HDPE pipe cross drain was installed in 1994 near Millwood, Ohio. The maximum fill height was approximately 10 to 11 ft. Rippling/dimpling was documented in the side walls throughout the pipe in 2001. Significant buckling has occurred in several areas since the 2001 inspection. Pipe deflection had significantly increased since the 2001 inspection with a maximum vertical deflection of 14.29% in 2001 and 22% in 2005. Inverse curvature of the crown has occurred, and 6" sections of the pipe wall have broken away at 20 feet. A large portion of the cracking has occurred in dimpled areas at the springline. The 2001 report only document 10 cracks (52, 54, 59, 63, 68, 70, 73, 75, and 79 feet), but in the 2005 inspection over 100 cracks are documented. It appears that the pipe was backfilled with a sand gradation and sand backfill is observed through cracks in the wall of the pipe in several areas. Geotextile fabric is also observed at the joints of each pipe section. Severe distress is apparent throughout large portions of the pipe.

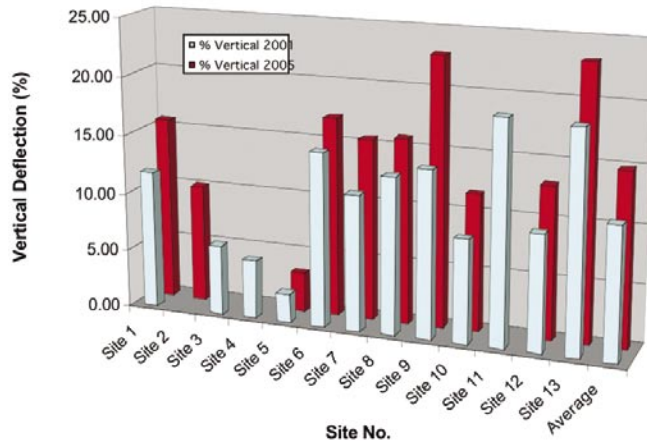
**% Vertical Deflection at Maximum Deflection Points
(2001 and 2005)**

The majority of the pipes investigated on this project would not pass a 5% deflection test and most of the sites have pipe sections that would not pass a 10% deflection test. The majority of pipes have continued to creep/deflect since the 2001 inspection. A significant number of the profiles indicate that horizontal movement/deflection has stopped, but movement is continuing vertically.

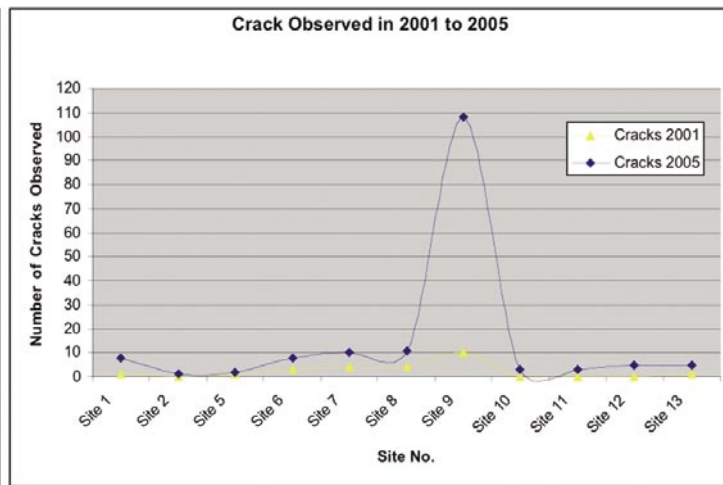
Site No.	Cracks 2001	Cracks 2005
Site 1	1	8
Site 2	0	1
Site 5	1	2
Site 6	3	8
Site 7	4	10
Site 8	4	11
Site 9	10	108
Site 10	0	3
Site 11	0	3
Site 12	0	5
Site 13	1	5
Total	24	164
Total w/o 9	14	56
