**Condition Investigations of HDPE Pipe In-Service
In the United States (Six States)
for
The American Concrete Pipe Association
Irving, Texas**

WJE No. 991592

January 24, 2002

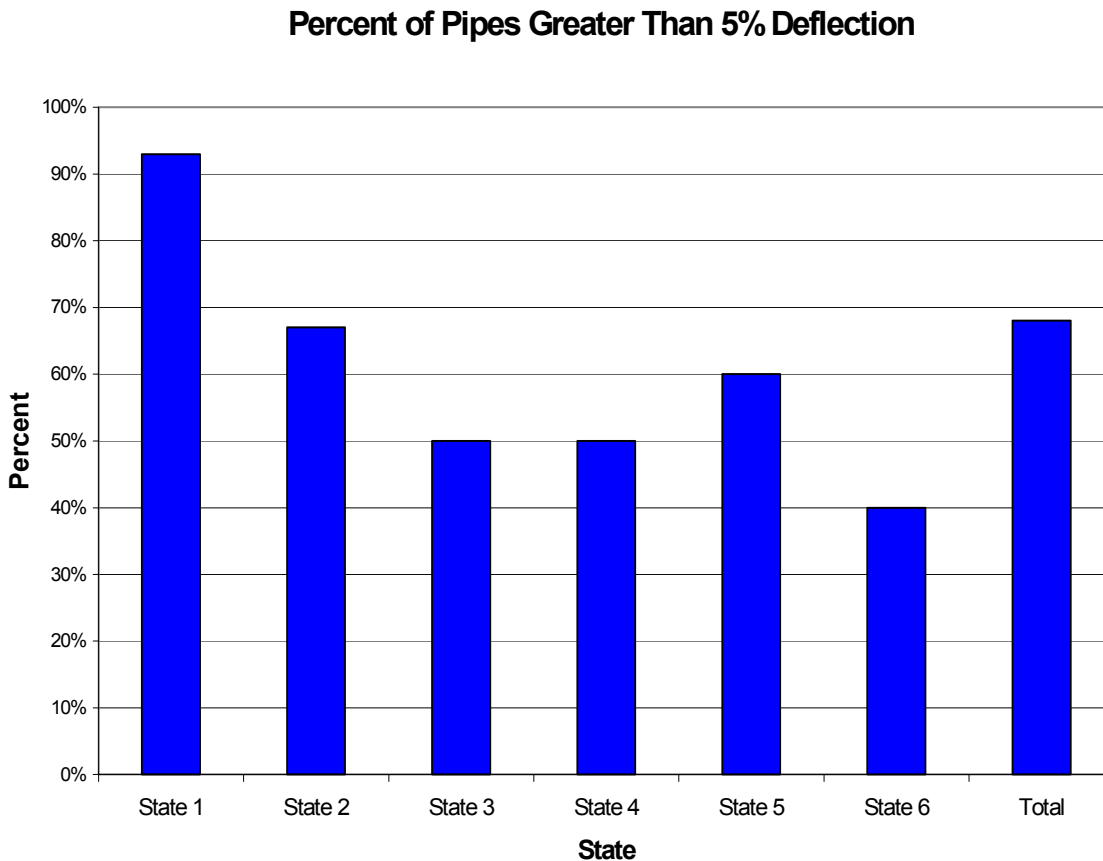
Of all the pipes inspected, 68% of the pipes had deflections greater than 5%, with State 6 having the least with 40% and State 1 having the highest with 93%.

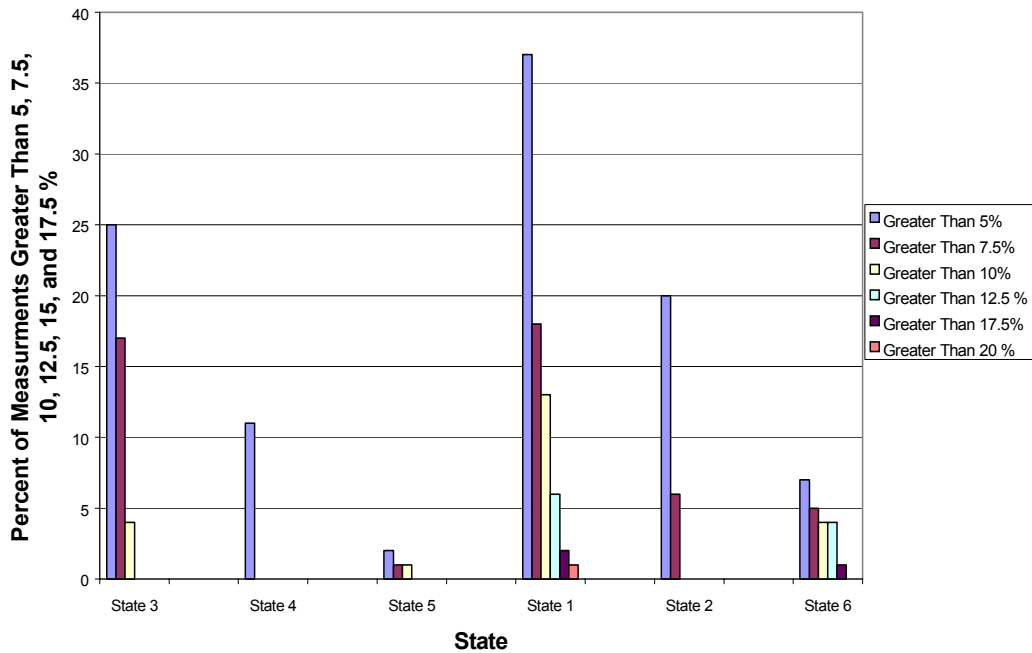
Summary of Horizontal Deflection Measurements by State

Approximately 18% of all horizontal and 16% of vertical diameter measurements exceed the 5% deflection criteria. Less than 5% of the 45° and 135° measurements exceed the 5% deflection criteria.

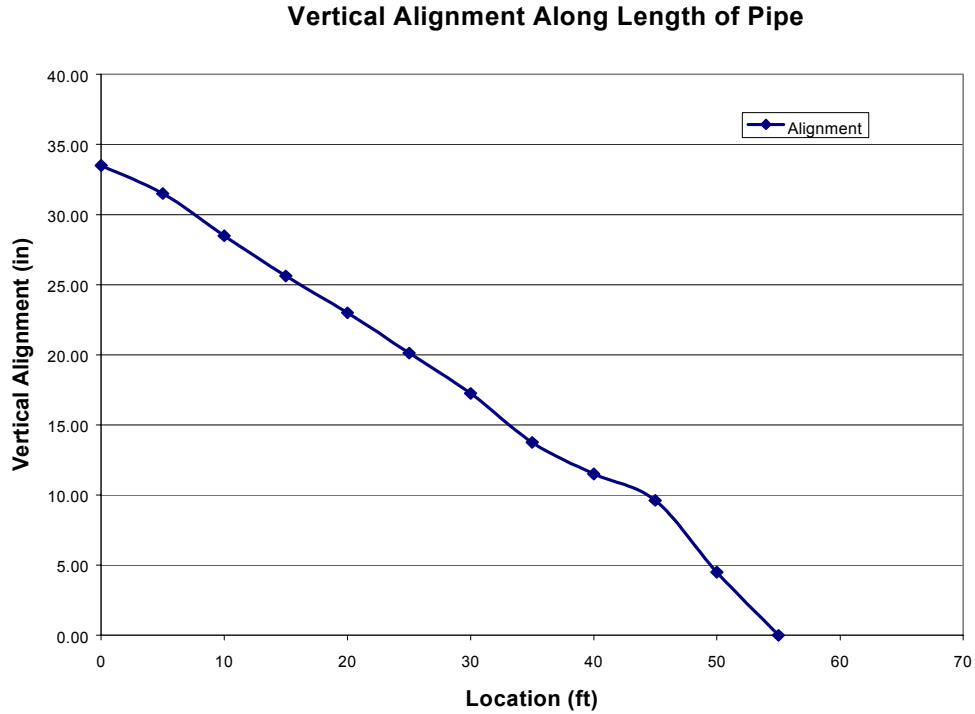
The following graph charts the vertical alignment of the pipe. As can be seen from the chart, the grade of the pipe is generally good, with only minor bulges or swells.

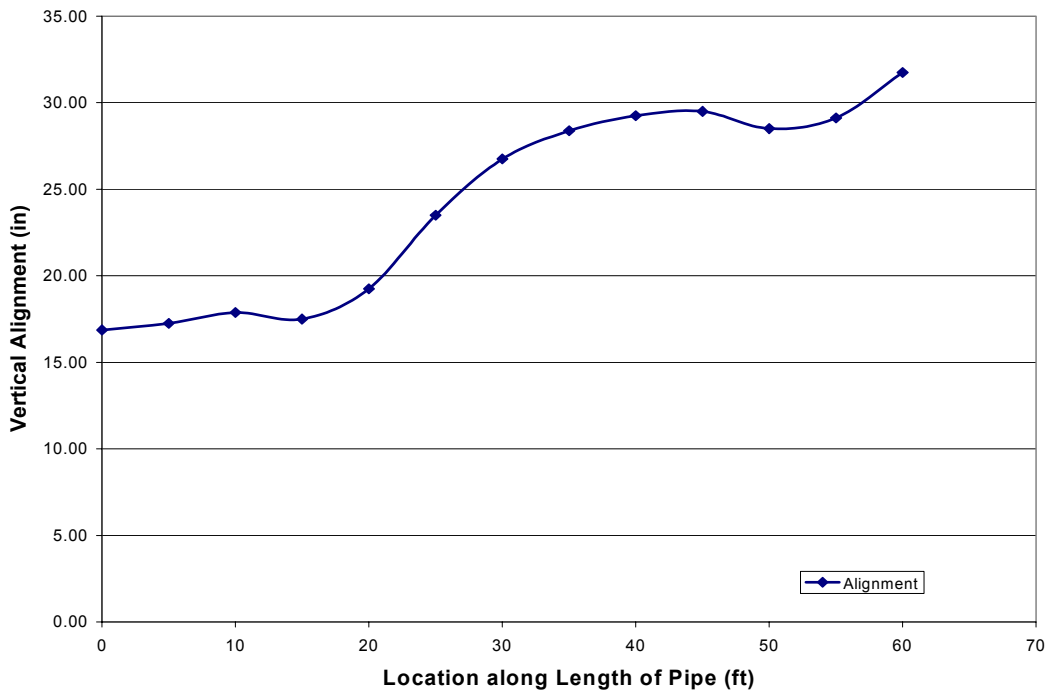
Vertical Alignment Along Length of Pipe

Thirty five percent of the deflections exceeded the 5% criteria, with the most deflection occurring in the horizontal and vertical directions. The following chart presents the vertical alignment of the pipe. A significant bulge in the pipe is apparent between 20 and 50-ft. creating two swells on either side of the bulge.

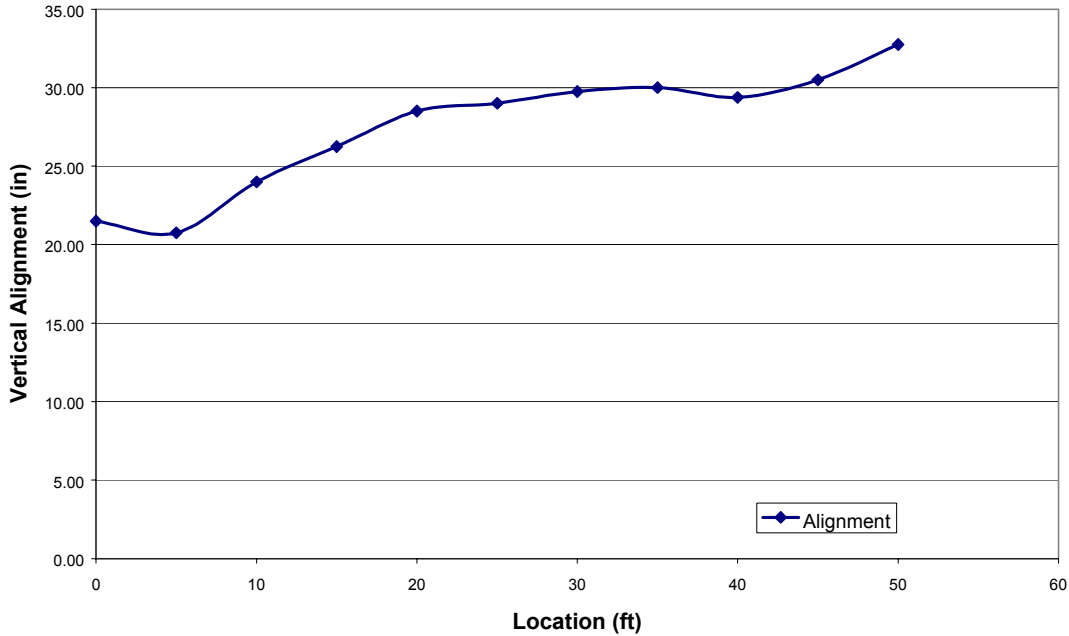
Vertical Alignment Along Length of Pipe

Pipe 11 - This pipe was installed in 1999. The pipe is 50-ft. long and has a diameter of 42-in. Joint separation ranged from 1/4-in. to 1 1/4-in. No other areas of distress were found. Significant deflection has occurred near the outlet of the pipe.

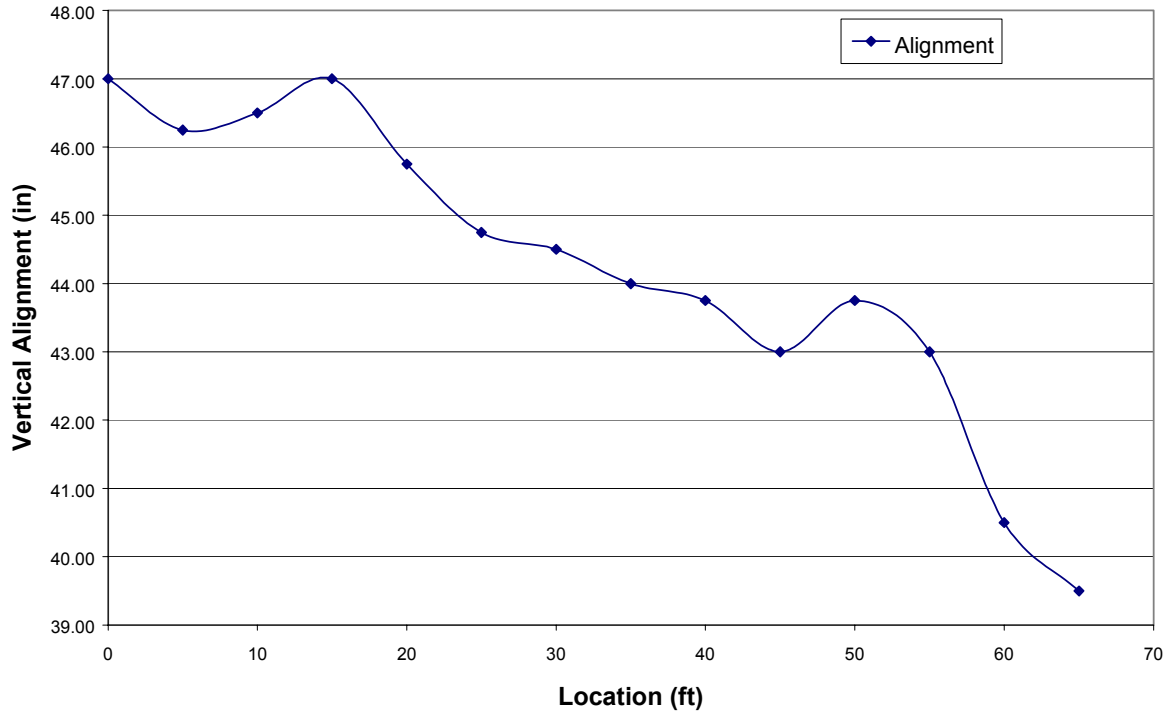
Vertical Alignment Along Length of Pipe

Alignment measurements were taken every 5-ft. along the length of the pipe. These measurements are presented in the follow chart and show several vertical offsets.
