An educational document from the American Concrete Pipe Association for users and specifiers

In April 2009, inspectors at the John D. Parker East Texas Fish Hatchery discovered that sections of 60-inch and 48-inch diameter high-density polyethylene (HDPE) drainage pipes had collapsed.¹ Ultimately, approximately 11,000 linear feet of 30-inch, 48-inch, and 60-inch diameter corrugated HDPE pipe were removed and replaced.

Design-Installation Failure of the Corrugated HDPE Pipe System

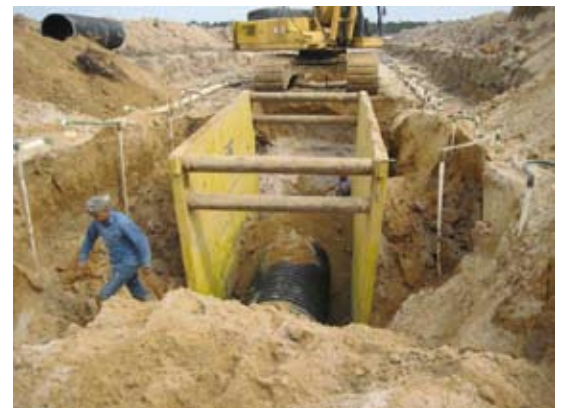
- “The corrugated HDPE drain pipes collapsed or deflected excessively because the external forces imposed by soil and hydrostatic pressures exceeded the capacity of the pipe and surrounding soil to resist those forces.”³

- Insufficient compaction of backfill material was a significant factor in the collapse and excessive deformations.³
- Sufficient compactive effort was not achieved. The gap between the pipe and trench box wall was too narrow to allow proper compaction. Further, dragging the trench box loosened the backfill around the pipe.³

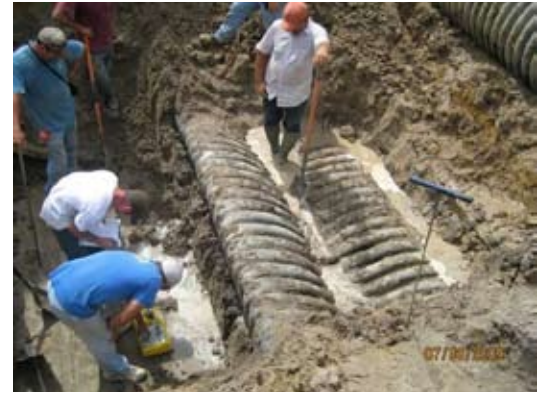
The plastic pipe association's design chart used for the East Texas Fish Hatchery project did not include the contributions of external stresses imposed by groundwater above the springline.⁴ As it turns out, the hydrostatic pressures contributed to the excessive deflection and ultimate collapse of some sections of the HDPE pipes.

If the contractor uses a pipe material allowed by the engineer and compacts to the specified quality limit, then the installed pipe is expected to perform within its design service limits. In the East Texas Fish Hatchery incident, a failure analysis indicated that excessive deflections could have resulted in the ultimate reverse curvature and collapse of the 60-inch corrugated HDPE pipe.

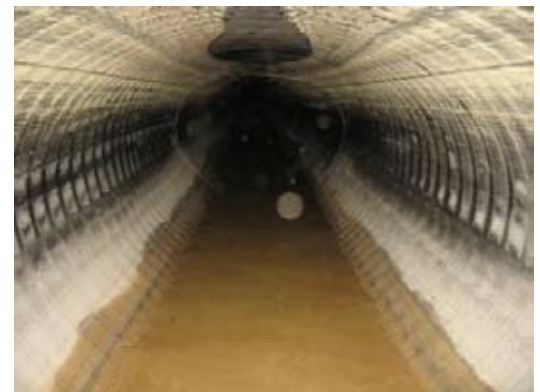
All storm pipe systems should be inspected after final backfill. It is especially important to measure shape deformations and deflection in flexible pipes using laser profiling equipment. It does not appear that internal pipe inspections were performed in the East Texas Fish Hatchery project until pipe sections had already collapsed. At that point, internal pipe inspections were used to ascertain the extent of excessive deflections. Ultimately the conditions warranted removal and replacement of pipe sections that otherwise would not have been initially detected without internal inspection. The use of the pipe inspections and deflection assessments prevented further collapse and property damage or personal injury.
