# BURIED facts

## CULVERT DURABILITY STUDY REVIEW AND IMPLEMENTATION

The Ohio Department of Transportation (ODOT) has published a 173 page report on the corrosion and abrasion resistance of various types of pipe and pipe protection used for culverts in the State of Ohio. The "Ohio Culvert Durability Study" is a compilation of a ten year investiga-

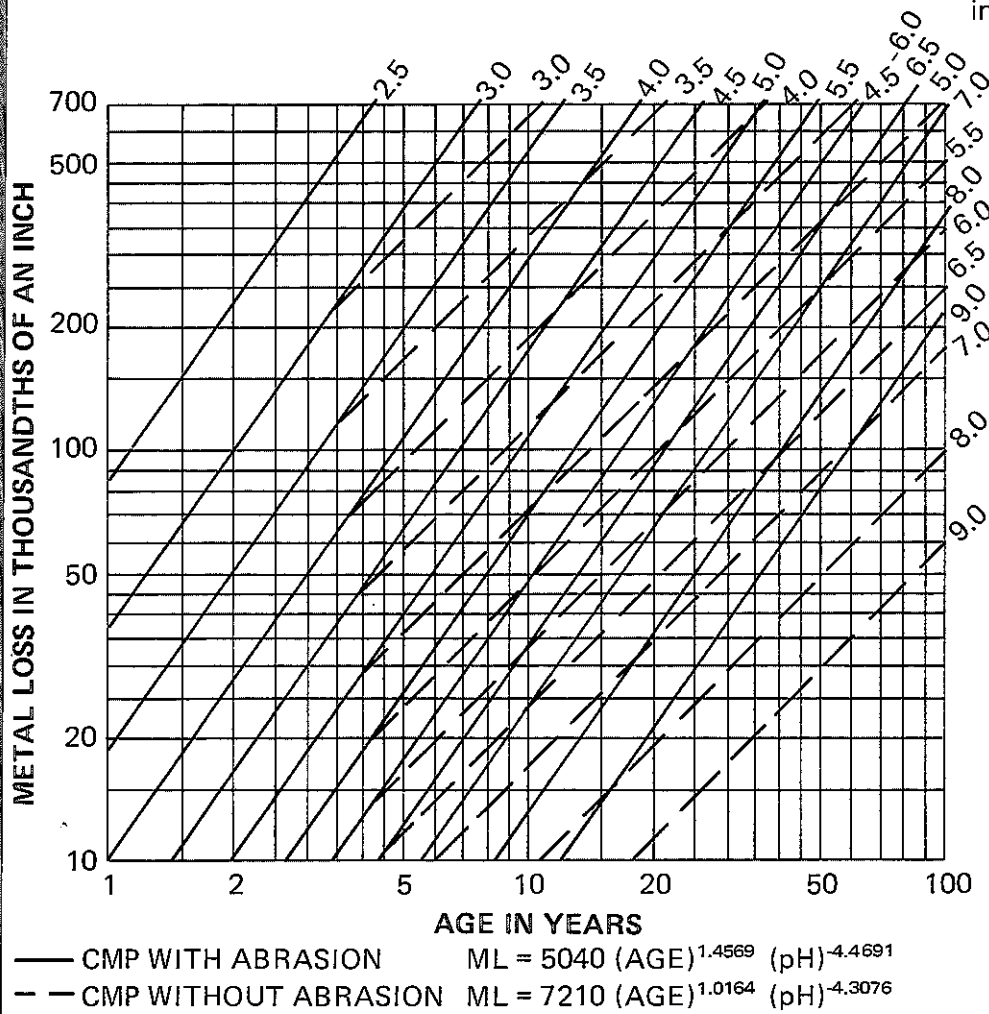
Figure 3. Predicted Metal Loss for Corrugated Metal Pipe (CMP) Culverts.

Figures 3 and 4 present metal loss in thousandths of an inch on the vertical scale and age in years on the horizontal scale. The solid diagonal lines represent pH of the water for use when there is a potential for abrasive flow and the dashed diagonal lines represent pH of the water for use when there is no potential for abrasive flow.

The predictive metal loss graphs are based on laboratory metal loss analysis of coupons obtained from 38% of the CSP culverts and 20% of the structural steel plate culverts which were included in the investigation and had exposed metal. Culverts with the inverts completely corroded away were

For any given metal thickness and pH value of the water, the number of years for the pipe invert to be completely corroded away can be readily determined by projecting a horizontal line from the given metal thickness on the vertical scale to the diagonal line representing pH and then projecting a vertical line down to the age in years on the horizontal scale. Tables III and IV were

prepared from Figure 3 and present years to complete metal loss for available corrugated steel pipe gage thicknesses and various pH levels. The tables illustrate that plain galvanized CSP has very limited service life over the full range of environmental conditions. When potential for abrasion is present, plain galvanized CSP should not be used and for the limited installations where potential for abrasion does not exist, plain galvanized CSP should only be considered under neutral environments with the heavier gage thicknesses.

**Solution:** From *Figure 3* at 64 thousandth of an inch on the vertical scale for a 16 gage metal thickness, project a horizontal line to the solid diagonal line representing a pH of 7.0 with abrasion and then down to the horizontal scale and read 20 years. Total metal loss can be expected in 20 years and, if a durability factor of safety is not applied, the maximum service life of the CSP would be 20 years.

From *Figure 3*, projecting a vertical line from an age of 40 years on the horizontal scale to the solid diagonal line representing a pH value of 7.0 with potential for abrasion, and then across to the vertical scale, read a metal thickness of 182 thousandths of an inch. A 7 gage CSP has a wall thickness of 0.188 inches.
