A Message from the American Concrete Pipe Association

Bulletin No. 122

World's Largest Corrugated Steel Arch Collapses on Alaska Highway

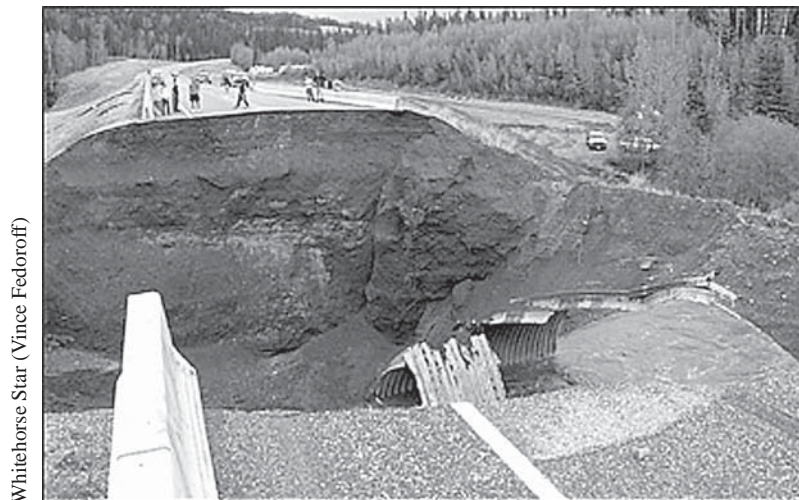
In the summer of 1998 a corrugated steel arch structure was installed on the Alaska Highway to replace an old narrow bridge at Irons Creek, just south of the British Columbia-Yukon border. The corrugated steel arch had a span of 23.3 meters (76.4 feet), a rise of 8.2 meters (27 feet) and was 35.3 meters (116 feet) long. It was touted at the time as the largest structure of its kind in the world. It came with an eighty year warranty. Less than three years later, the culvert collapsed leaving a gaping hole about 30 meters (100 feet) across the road or as reported by the *Edmonton Journal*, "The mother of all potholes".

"The mother of all potholes"
