Cracks in Installed Reinforced Concrete Pipe

American **Concrete Pipe** Association

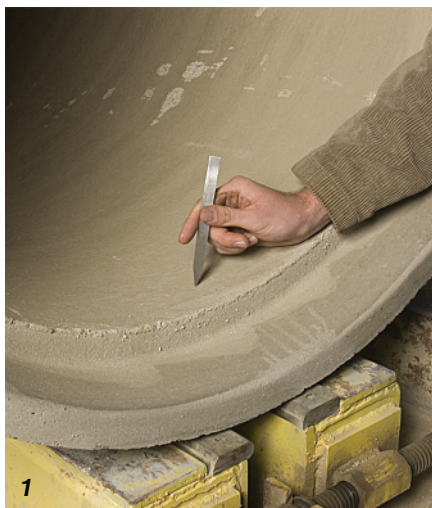
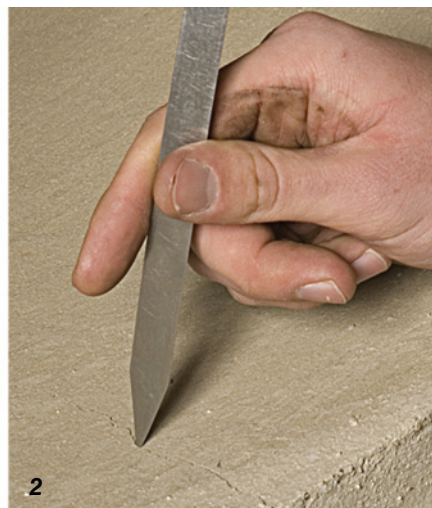
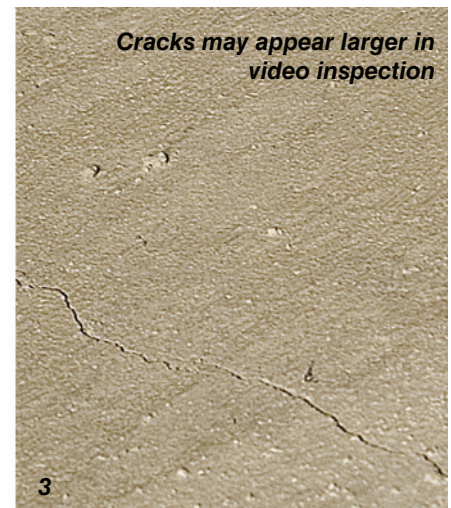
0.01-Inch Crack Measured in a 36-Inch, Class IV Pipe.

Pictures 1, 2, and 3 shown as if viewing the crack standing, kneeling, or through a video inspection, respectively.

The 0.01-inch crack was never intended to determine the failure of installed RCP. This crack width was established by Professor W.J. Schlick of Iowa State University to establish the comparative strength of RCP, in a three-edge-bearing test by using a simple 0.01-inch thick leaf gauge to determine a measurable and definitive size crack. The three-edge-bearing test is a plant test that applies a bearing strip along the top of the pipe, and two closely spaced bearing strips along the bottom. Specifications for RCP require an ultimate load resistance that exceeds the required 0.01-inch crack strength, giving the designed pipe a significant factor of safety above the required service load. The 0.01-inch crack width has absolutely no relation to the size of a crack that

should be considered a structural failure of an installed concrete pipe. In fact, ASTM C76-06 states, "As used in this specification, the 0.01-inch crack is a test criterion for pipe tested in the three-edge-bearing test and is not intended as an indication of overstressed or failed pipe under installed conditions."²

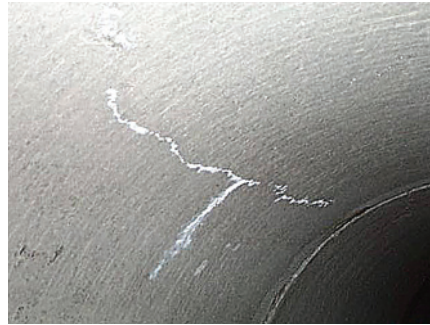
Autogenous healing in concrete pipe.

Furthermore, a phenomenon, known as autogenous healing often occurs between two surfaces of cracks in buried pipe. Autogenous healing is the ability of concrete to heal itself in the presence of moisture and air. This explains why the healing occurs in concrete pipe where moist conditions are higher than those of other concrete

During this process, calcium carbonate, (a hard white substance), forms when moisture reacts with unhydrated cement powder and regenerates the curing process. This self-healing process creates a monolithic structure. In Ohio, the Department of Transportation developed a post construction inspection standard for installed pipe that requires nothing be done to a pipe with a crack width up to 0.06-inch, due to the autogenous healing that

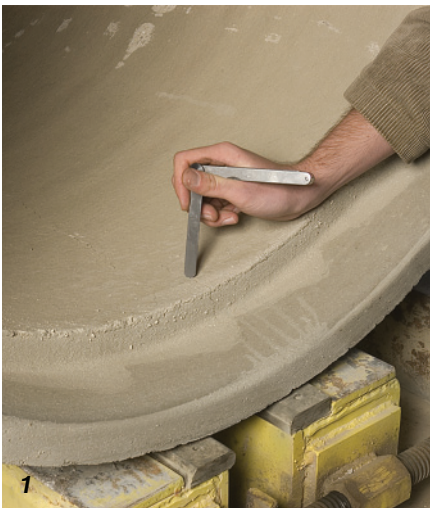
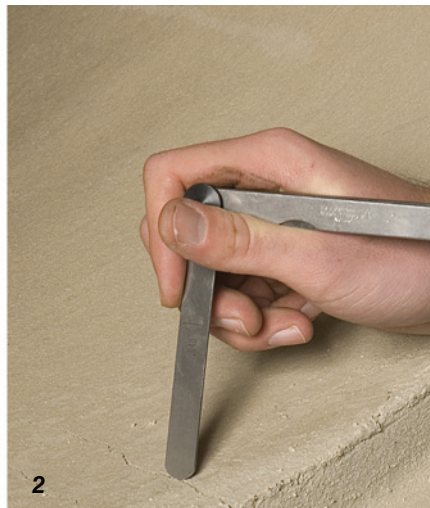
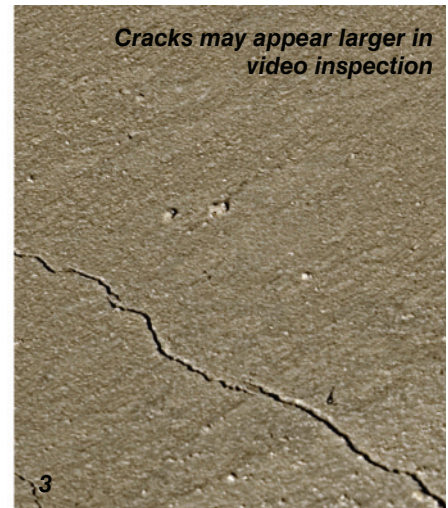
Cracks may appear larger in video inspection

The 0.04-inch crack shown is less than half the crack width of 0.10-inch accepted by Caltrans⁴ and AASHTO⁵. Pictures 1, 2, and 3 shown as if viewing the crack standing, kneeling, or through a video inspection, respectively.

ing Standards Board (GASB) 34 rules. GASB 34 radically changes how state and local governments must report their finances. Governments must perform condition assessments on all existing major infrastructure assets every three years.⁷ During these video inspections, cracks and the presence of autogenous healing may be evident. All too often an untrained inspector views a small crack in a post installation video inspection of a RCP to be a failure. This occurs most often because many of the cameras currently available for video inspections produce some distortion and unavoidably magnify hairline cracks. This causes the cracks to appear as though they are much larger, resulting in unnecessary repairs or replacements. It is important to know the intensity of magnification and how the magnified image appears in a video inspection. Recent technology has produced a calibration device that clearly indicates the actual size of the crack, resulting in an accurate inspection. Engineers, contractors and owners of pipelines should contact a professional who is familiar with the procedures involved in the inspection of RCP to ensure an accurate inspection.
