Public Works

Something fishy with failures?

High-density polyethylene pipe and reinforced concrete pipe are not interchangeable.

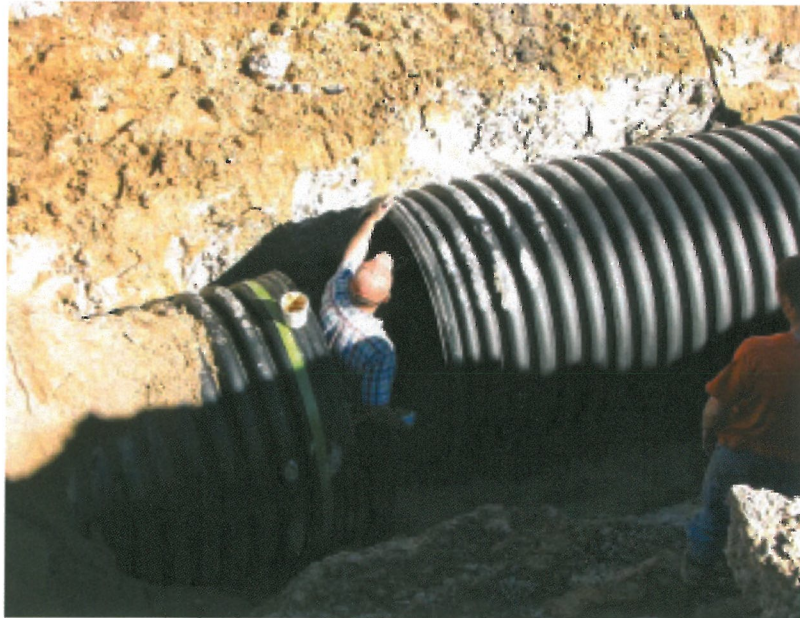
The failure was discovered in April 2009 when inspectors found sections of 60-inch and 48-inch HDPE pipe had collapsed under 10 to 17 feet of earth fill. An engineering firm hired to investigate the matter pinned the blame on the design firm. A replacement de-

sign determined that 60-inch and 48-inch corrugated HDPE pipe should be replaced with reinforced concrete pipe and more rigid PVC should be substituted for the smaller diameter, 30-inch HDPE drainage pipes.

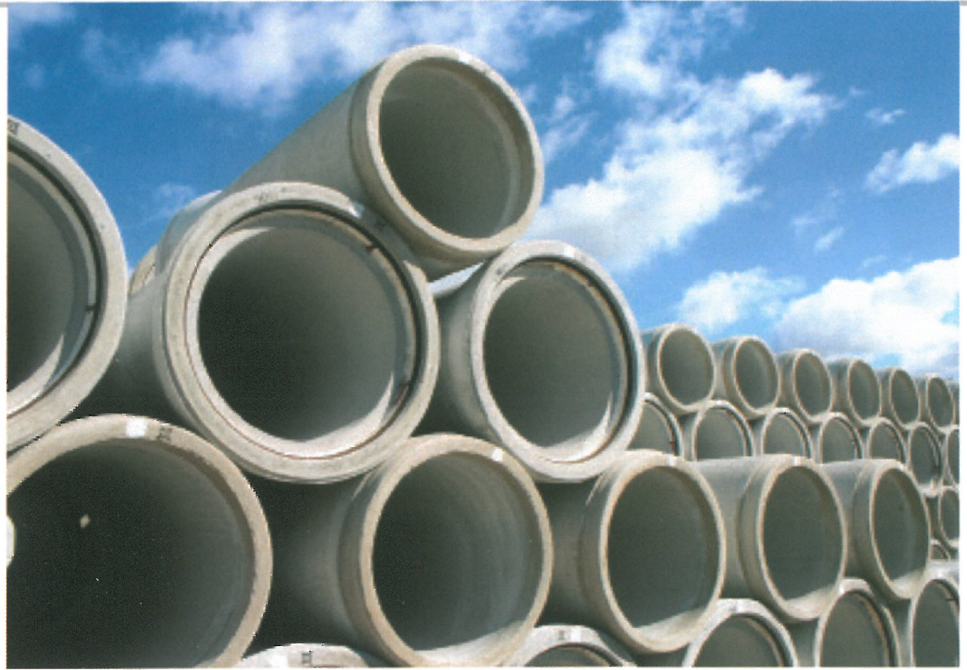
Designers and engineers need to research and analyze a number of factors and conditions for the intended application before specifying the type of pipe to be used.
