Evaluation of HDPE Pipelines Structural Performance

UT Arlington Center for Structural Engineering Research

November 2010

**As a Part of the Initiative on the Underground Structural Health
Monitoring and Equipment Development**

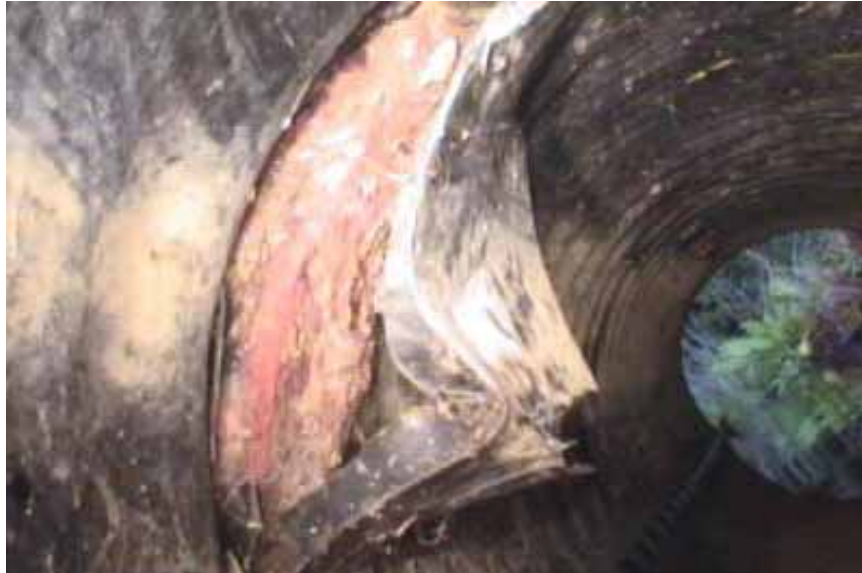
Cracking/fracture mode is defined as visible lines denoting material discontinuity. Fracture, rip and rupture are other terms used for this type of failure. The cracks can occur in either longitudinal, diagonal or radial directions. Different cases of major cracks are shown in Figure 6.

Figure 6 Cracking/fracture failure; a) California State - Pipeline No. 20 (Site No. 2: Route 36), b) Texas State - (pipeline No. 19 (Segment 2) - Site No. 8: Houston - Fennell)

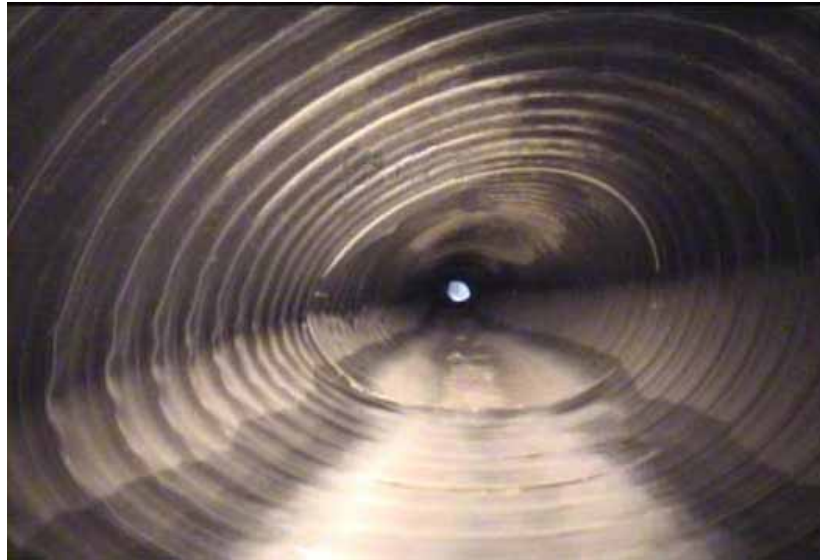
Excessive deformation is defined as flattening or the change in the diameter of the pipe. This is particularly noticeable when the surface of the culvert displays a discernible circumferential change from a circular shape. Crown flattening and racking behavior are other cases of excessive deformation. The common limit of 5% is adopted for indicating excessive deformation. In some tests, large deformations of 20% are recorded. Different cases of excessive deformation are shown in Figure 7.

Figure 7 Excessive deformation failure; a) Texas State - pipeline No. 1 (Site No. 1: San Antonio – HW 1604 & 1560), b) Minnesota State - pipeline No. 18 (Site No. 6: Brooklyn Park - DuPont)

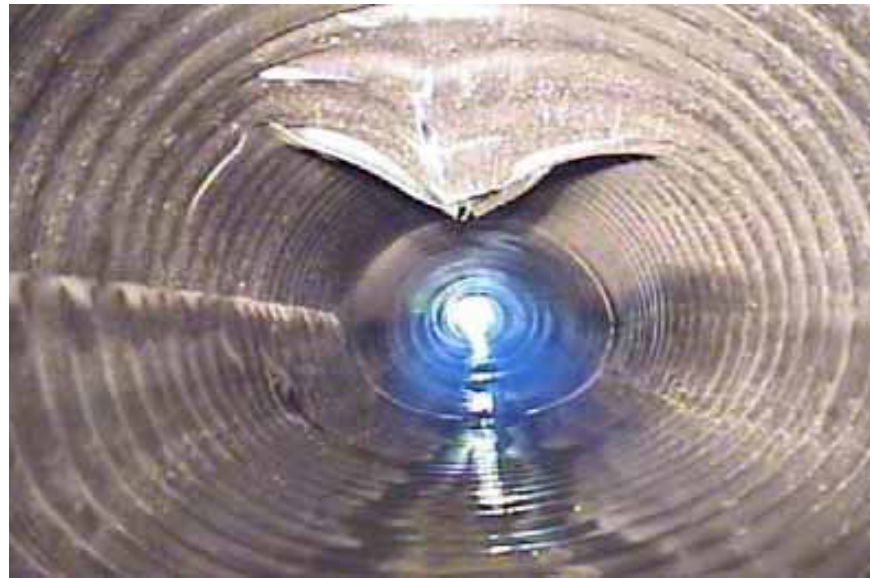
Snap through (inverse curvature) is a buckling phenomenon which creates inverse curvature by deforming into reversed shapes by undergoing tensile instead of compressive deformation. This failure mode is known as the inward projection and bulging of the surface of a pipe surface due to excessive loads on the pipe. One case of inverse curvature failure mode is shown in Figure 8.

Figure 8 Inverse curvature deformation failure; a) Utah State - Pipeline No. 9 (Site No. 2: Silver Creek Parkway) b) Texas State - Pipeline No. 20 (Segment1) (Site No. 8: Houston – Fennel)

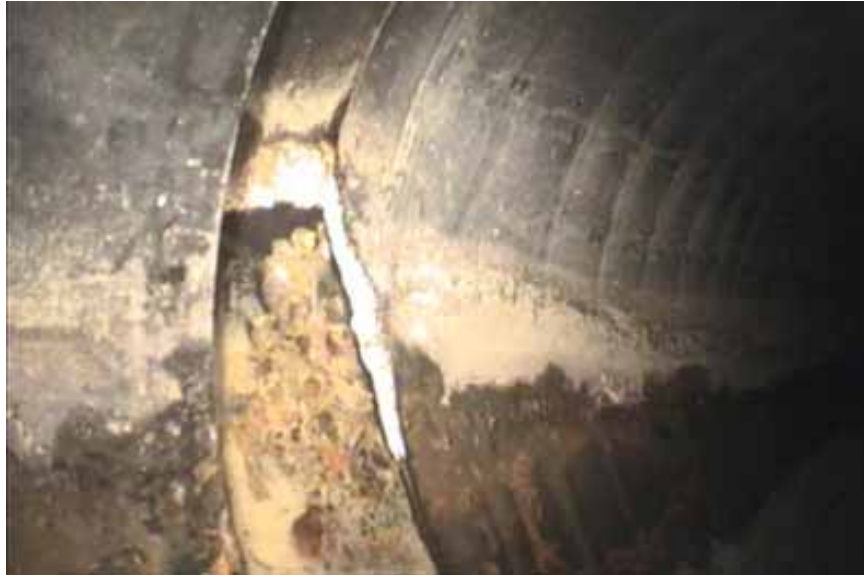
This failure mode is defined as the excessive joint displacement which causes a gap between the two adjacent pipes. The consequences permit the infiltration of embedment material and/or joint exfiltration. This case is shown in Figure 9.

Figure 9 Joint displacement failure; a) Virginia State -- pipeline No. 8 (Site No. 4: Mechanicsville), b) Texas State - pipeline No. 19 (Segment 1) (Site No. 8: Houston - Fennell)

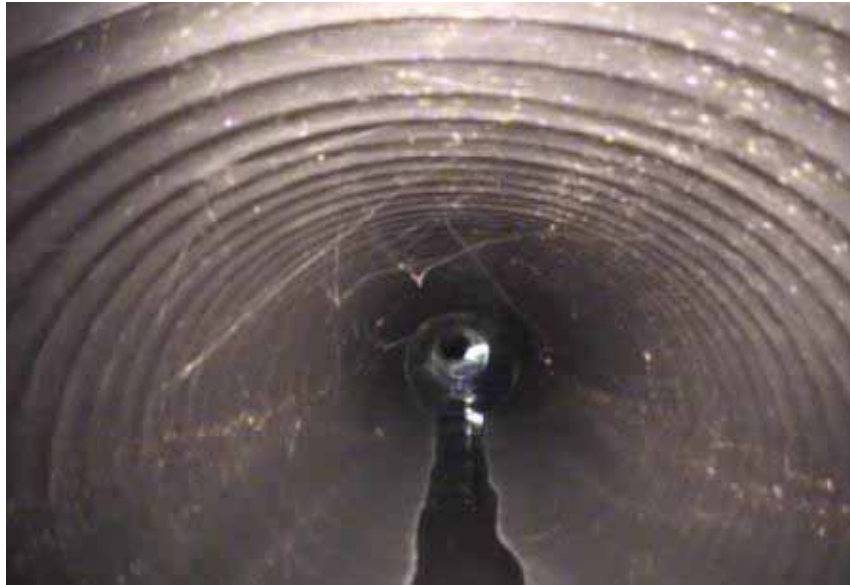
Corrugation growth is defined as the occurrence of plastic deformation in the pipe's interior liner due to the transfer of stress from the outer corrugated wall to the inner liner. This phenomenon causes waviness in the interior pipe surface that affects its flow carrying characteristics. Two cases of typical pipe corrugation growth failure mode are shown in Figure 10.

Figure 10 Corrugation failure; a) Kansas State - pipeline No. 7 (Site No. 2: Wichita), b) North Carolina State - pipeline No. 9 (Hickory-Oxford School Road)

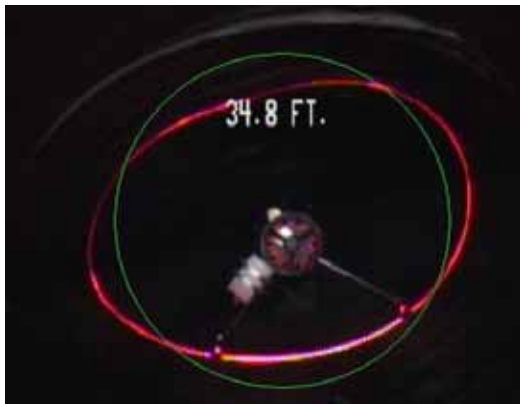
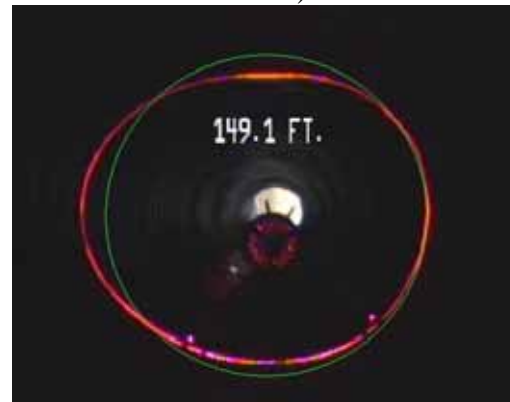
Figure 26 Horizontal and vertical deformation of the pipeline No. 2 (Site No. 1: San Antonio – HW 1604 & 1560)

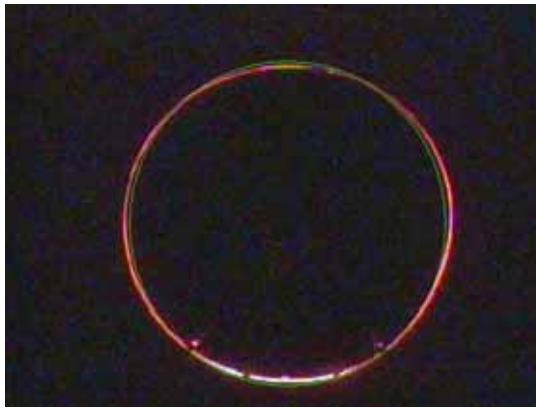
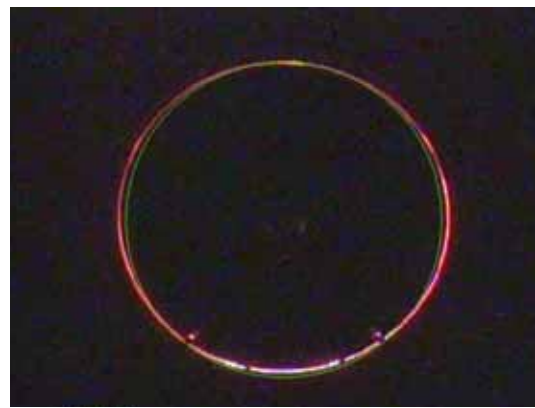
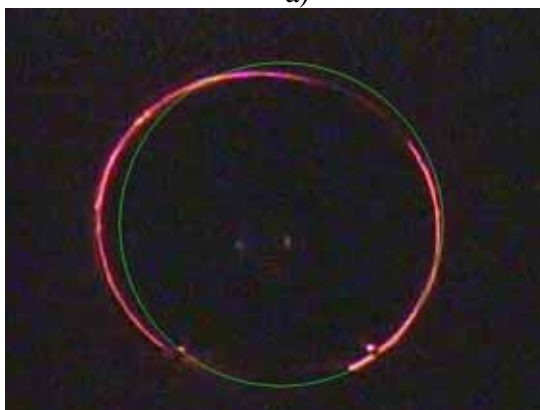
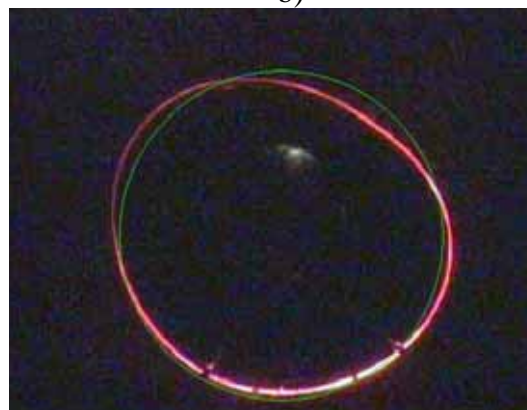
Pipeline No. 3 (Site No. 1: San Antonio – HW 1604 & 1560)

Figure 28 Horizontal and vertical deformation of the pipeline No. 3 (Site No. 1: San Antonio – HW 1604 & 1560)

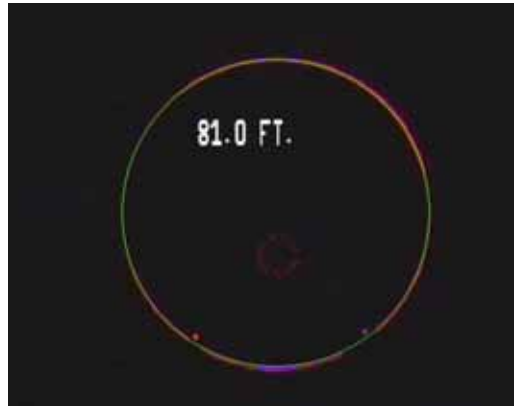
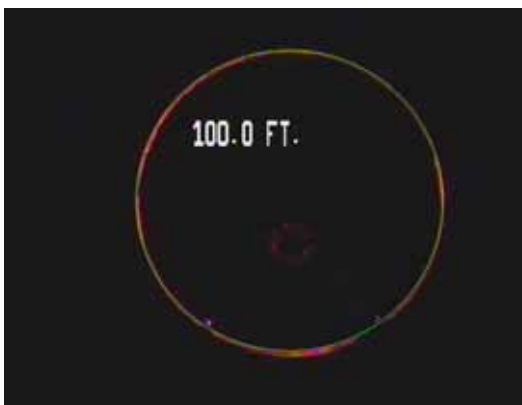
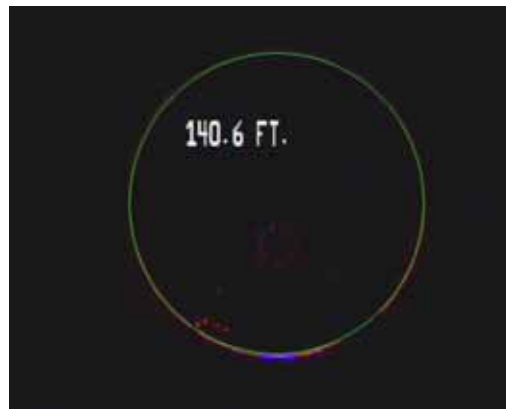
Pipeline No. 4 (Site No. 2: Junction - HW 83)

Figure 31 Horizontal and vertical deformation of the pipeline No. 4 (Site No. 2: Junction – HW 83)

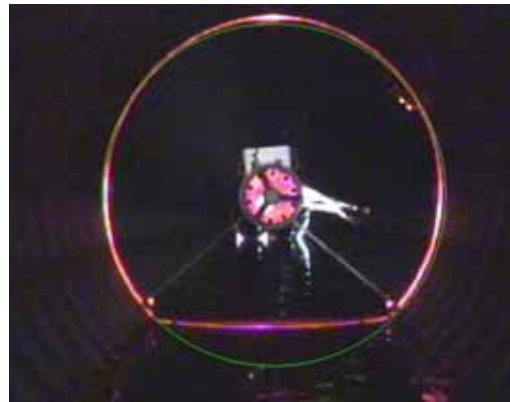
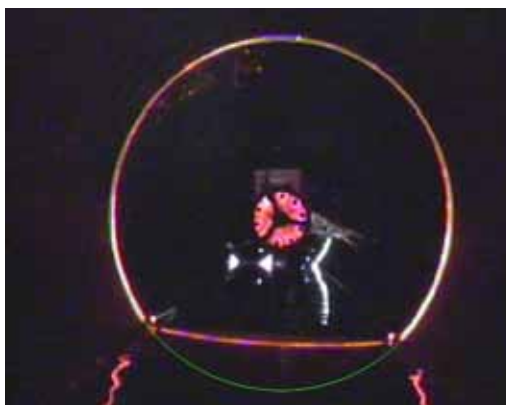
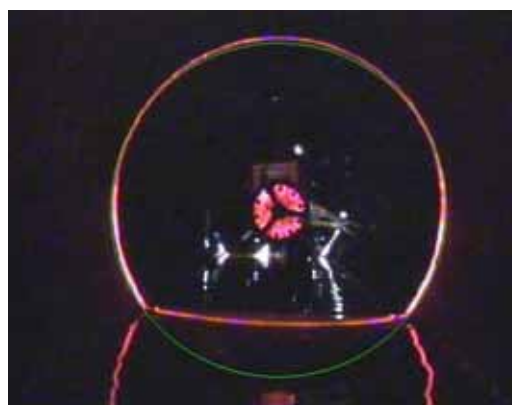
Pipeline No. 5 (Site No. 3: Houston – HW 530)

Figure 32 Horizontal and vertical deformation of the pipeline No. 5 (Site No. 3: Houston – HW 530)

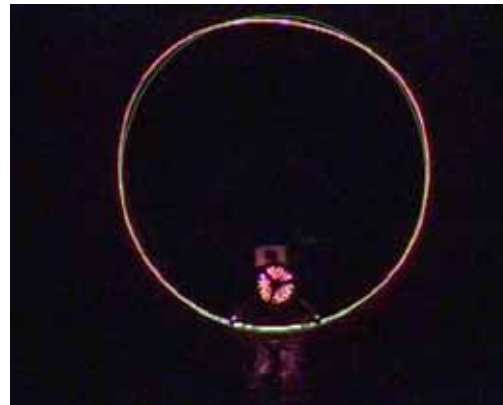
Pipeline No. 8 (Site No. 4: Houston - Briargrove - HW 119)

Figure 34 Horizontal and vertical deformation of the pipeline No. 8 (Site No. 4: Houston - Briargrove - HW 119)

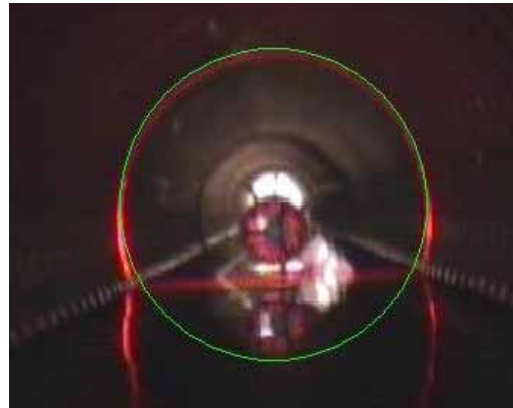
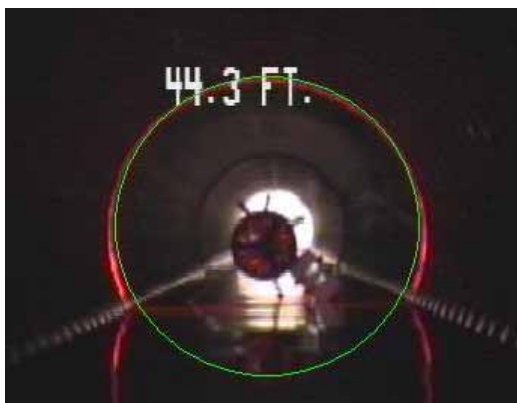
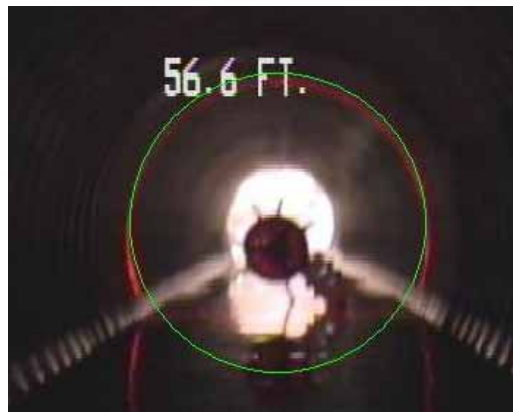
Pipeline No. 9 (Site No. 5: Houston – Riley Fussel)

Figure 35 Horizontal and vertical deformation of the pipeline No. 9 (Site No. 5: Houston – Riley Fussel)

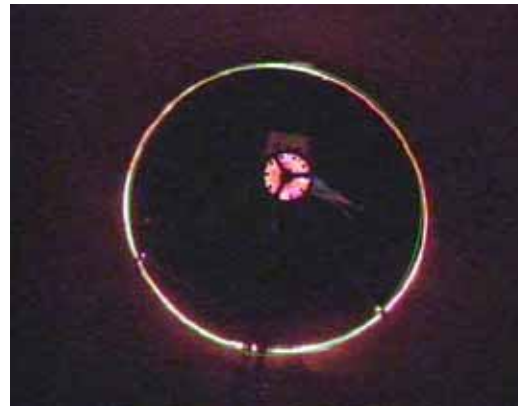
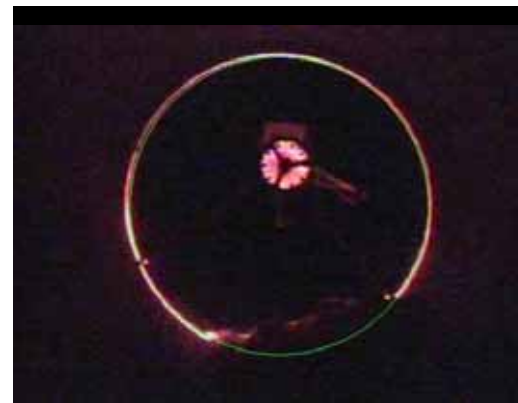
Pipeline No. 10 (Site No. 6: North Texas - Atlanta - FM 997)

Figure 36 Horizontal and vertical deformation of the pipeline No. 10 (Site No. 6: North Texas - Atlanta - FM 997)

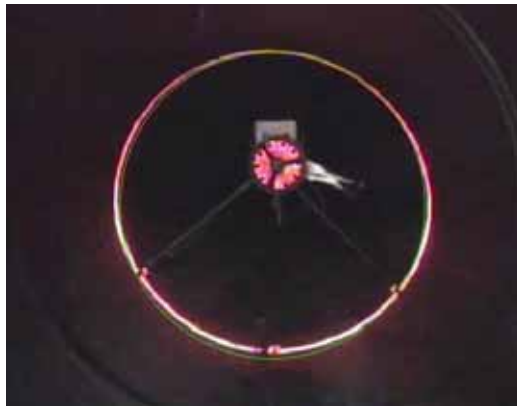
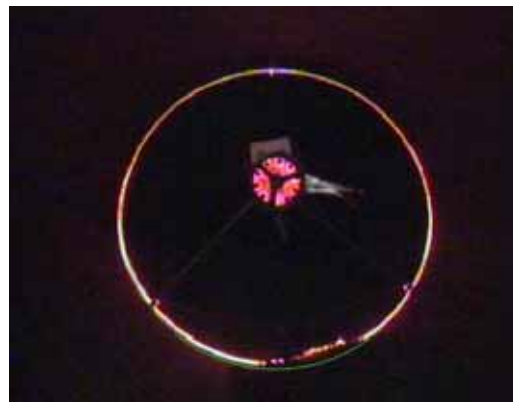
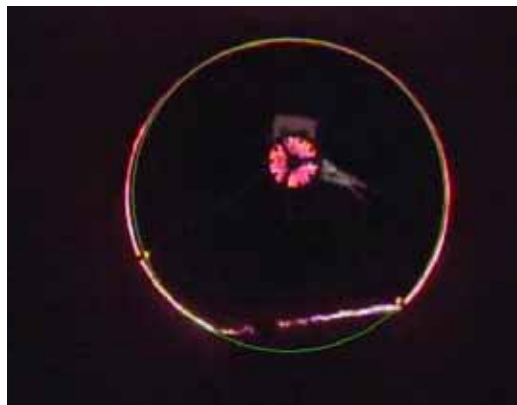
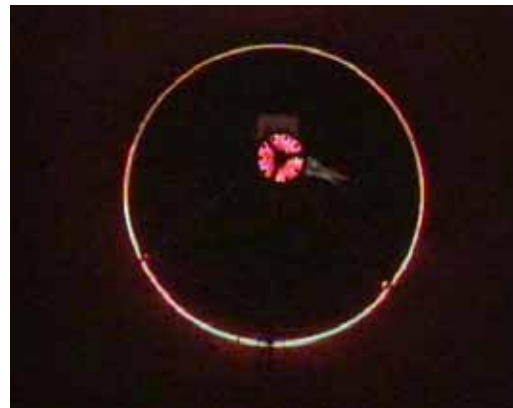
Pipeline No. 11 (Site No. 6: North Texas - Atlanta - FM 997)

Figure 37 Horizontal and vertical deformation of the pipeline No. 11 (Site No. 6: North Texas - Atlanta - FM 997)

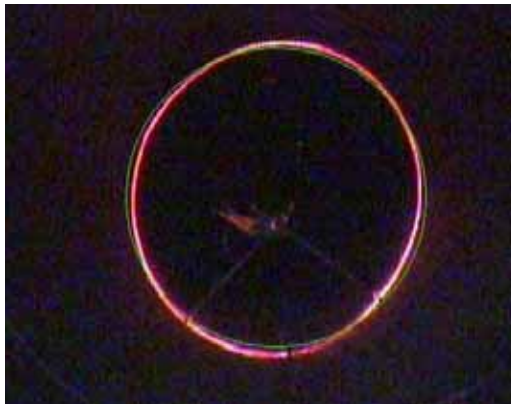
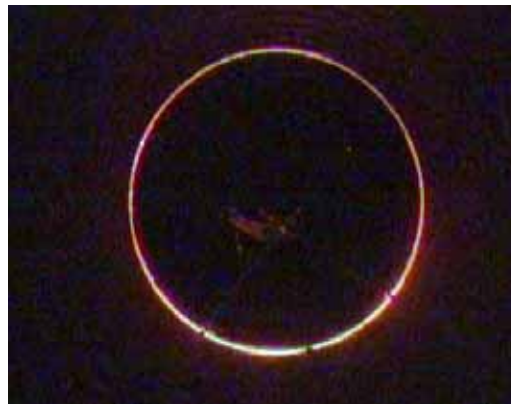
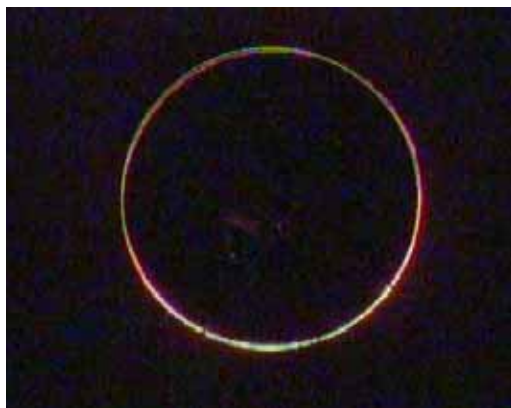
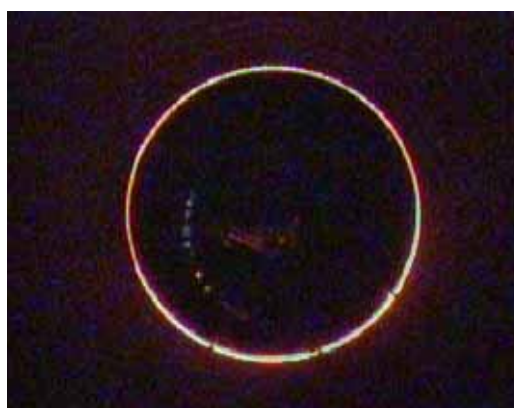
Figure 38 Horizontal and vertical deformation of the pipeline No. 15 (Site No. 7: North Texas - Henrietta - FM1197)

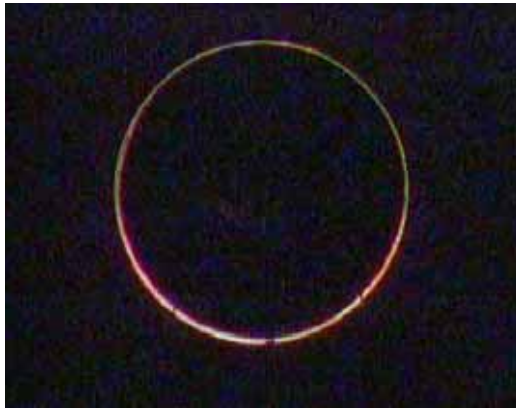
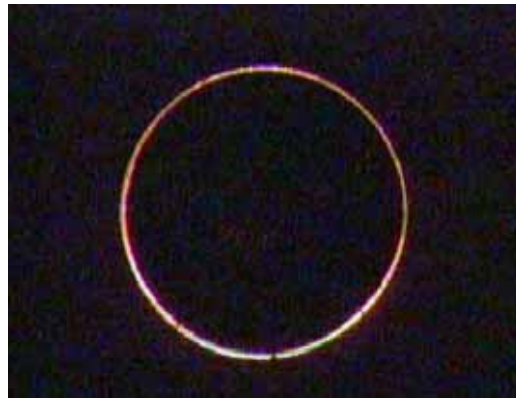
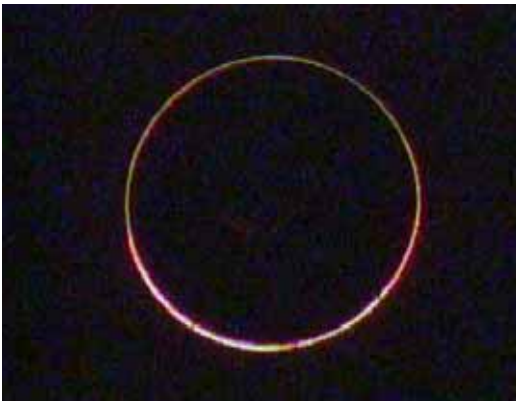
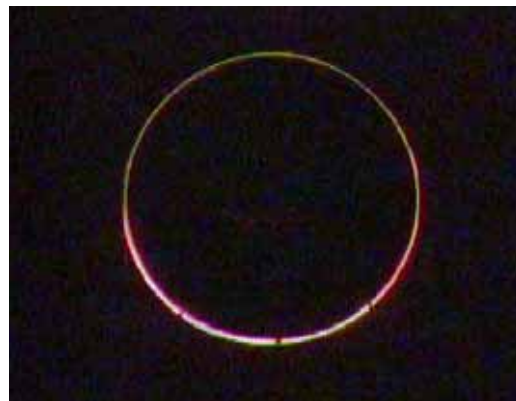
Figure 39 Horizontal and vertical deformation of the pipeline No. 16 (Site No. 7: North Texas - Henrietta - FM1197)

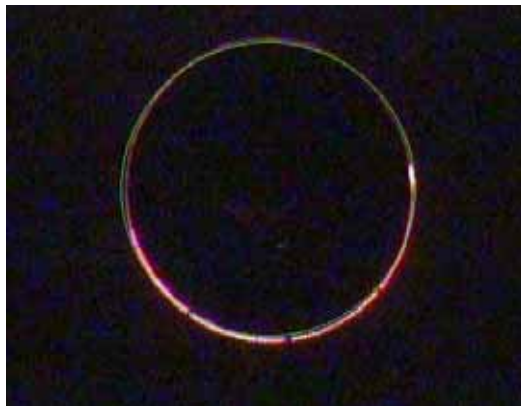
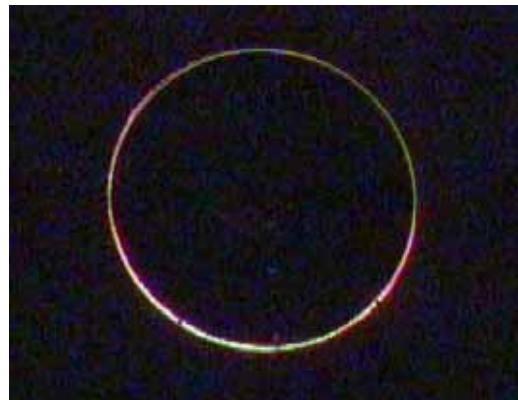
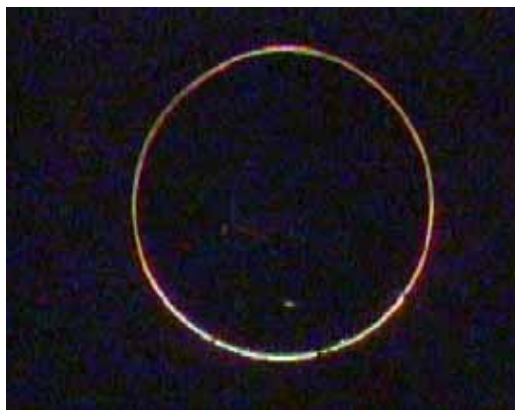
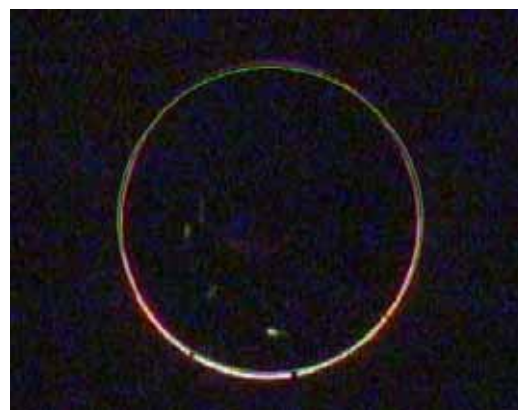
Figure 40 Horizontal and vertical deformation of the pipeline No. 17 (Site No. 7: North Texas - Henrietta - FM1197)

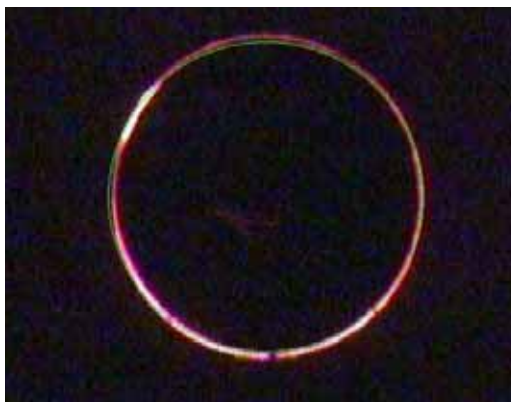
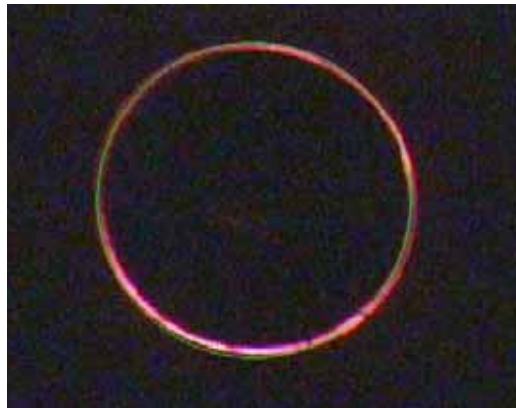
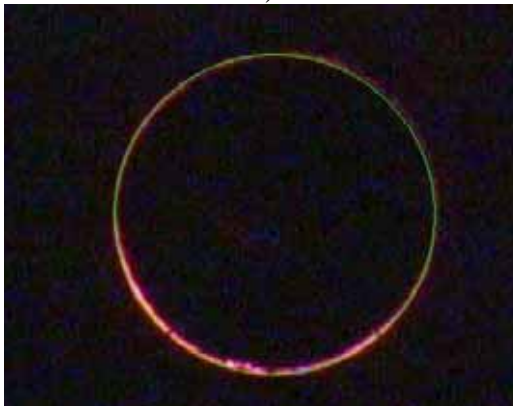
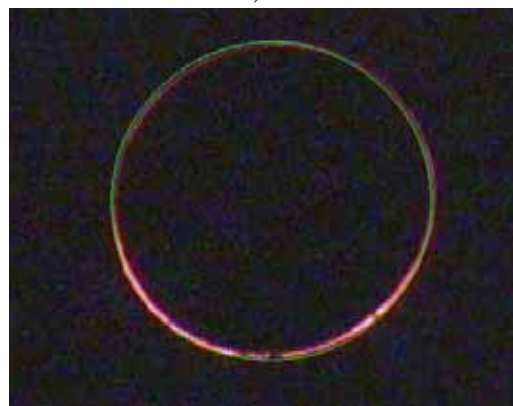
Figure 41 Horizontal and vertical deformation of the pipeline No. 18 (Site No. 7: North Texas - Henrietta - FM1197)

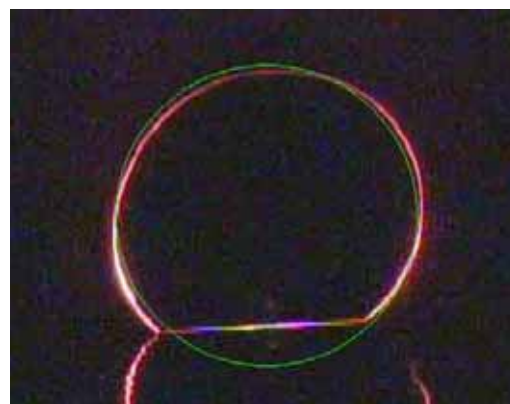
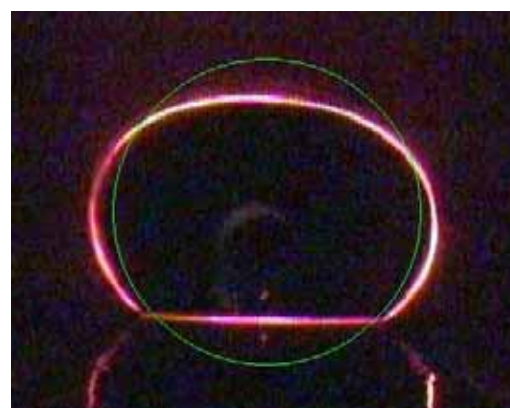
Figure 46 Horizontal and vertical deformation of the pipeline No. 19 (Segment 2) (Site No. 8: Houston – Fennell)

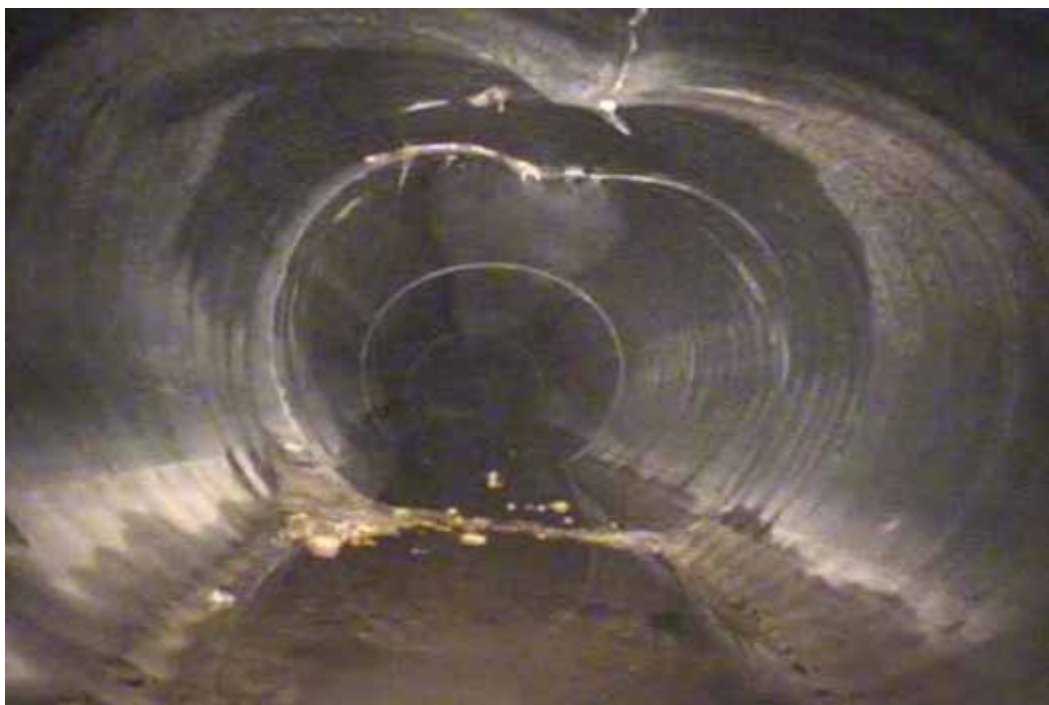
Figure 52 Major joint, inverse curvature and cracking/fracture failures for pipeline No. 20 (Segment 1) (Site No. 8: Houston – Fennell)

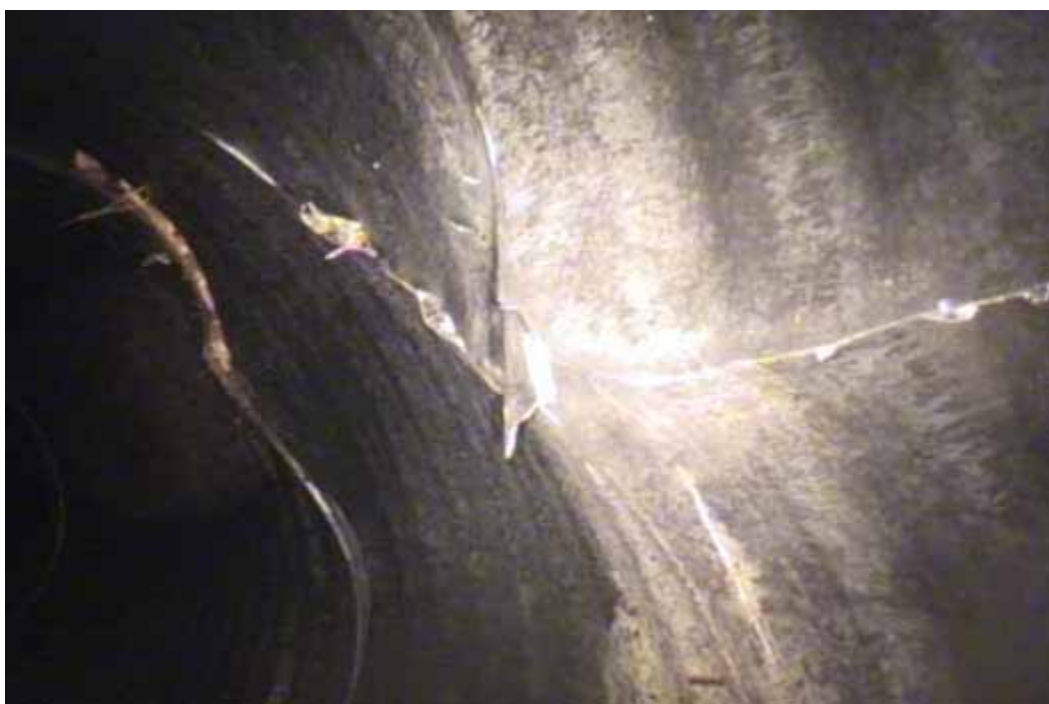
Figure 53 Cracking/fracture and inverse curvature failures for pipeline No. 20 (Segment 1) (Site No. 8: Houston – Fennell)

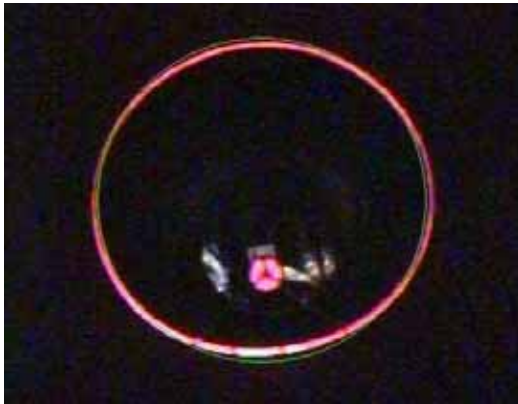
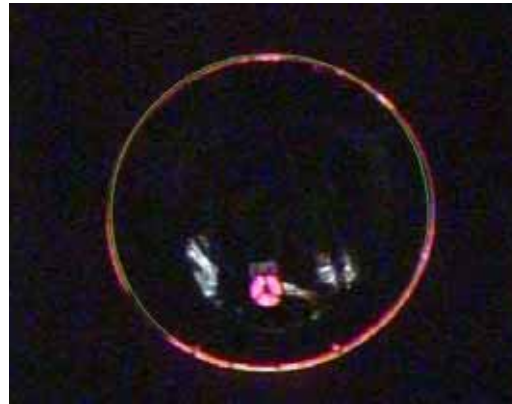
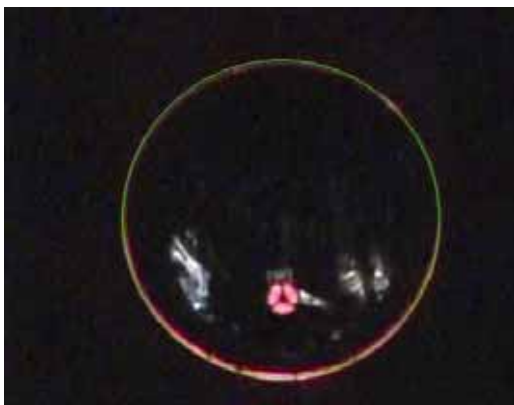
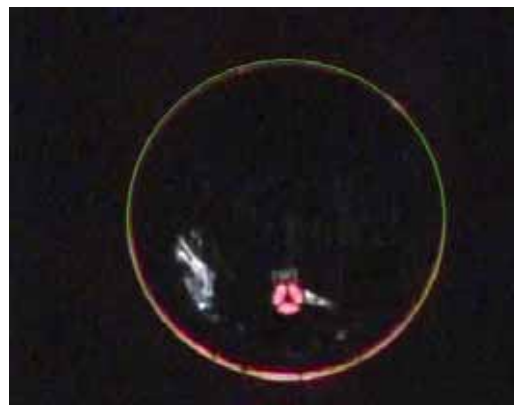
Pipeline No. 21 (Site No. 9: Houston - HW 531)

Figure 57 Horizontal and vertical deformation of the pipeline No. 21 (Site No. 9: Houston - HW 531)

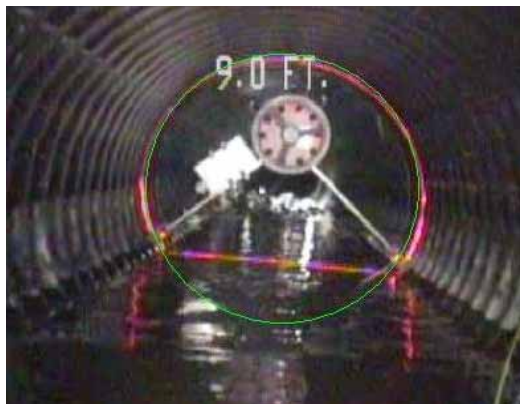
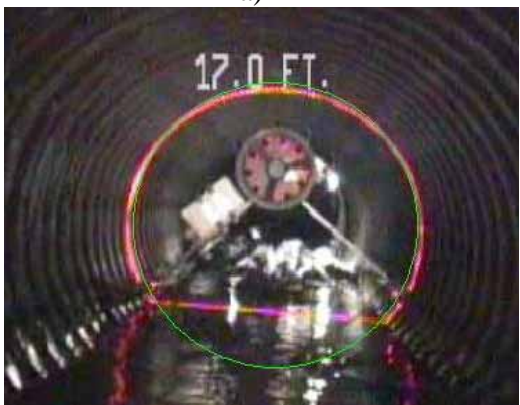
Pipeline No. 2 (Site No. 1: Elm City – Stagecoach Rd)

Figure 62 Horizontal and vertical deformation of the pipeline No. 2 (Site No. 1: Elm City – Stagecoach Rd)

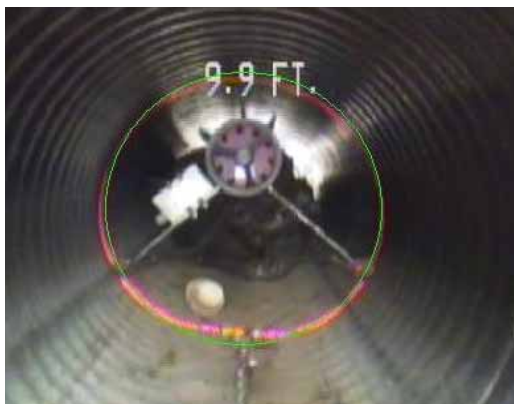
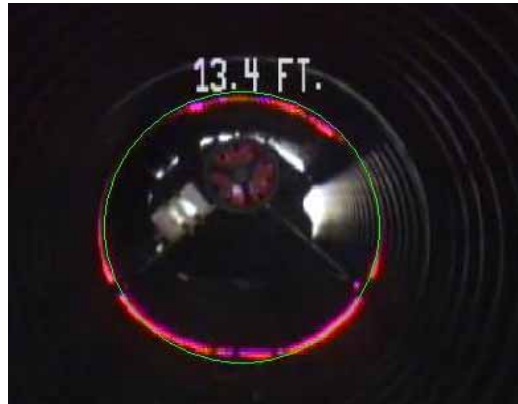
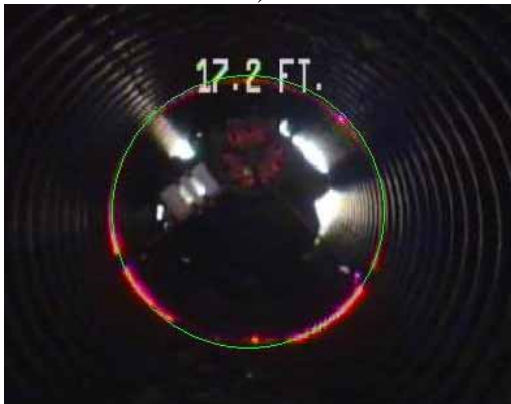
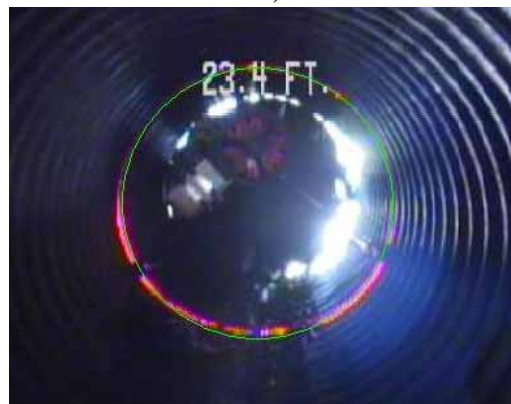
Pipeline No. 3 (Site No. 1: Elm City – Stagecoach Rd)

Figure 63 Horizontal and vertical deformation of the pipeline No. 3 (Site No. 1: Elm City – Stagecoach Rd)

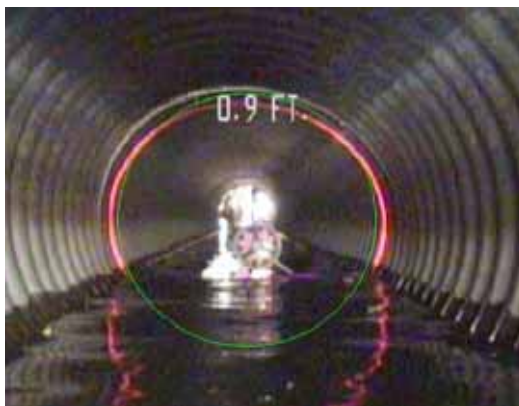
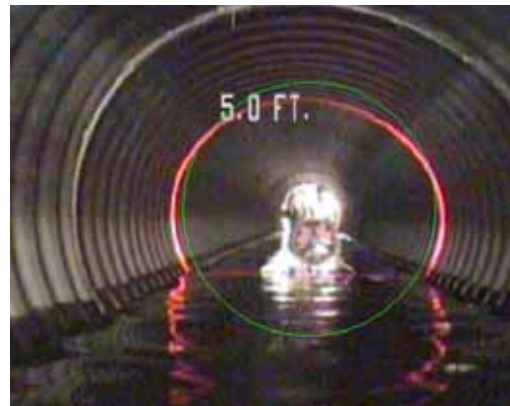
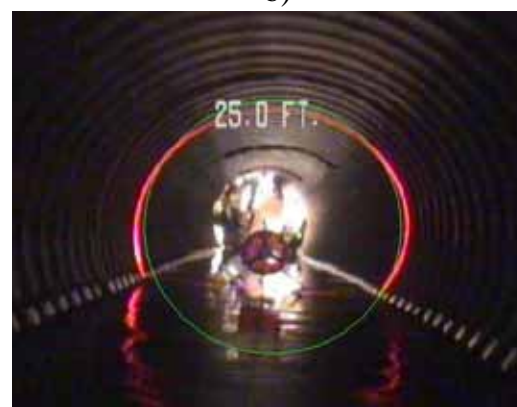
Figure 64 Horizontal deformation of the pipeline No. 5 (Site No. 2: Elm City – Lake Wilson Rd)

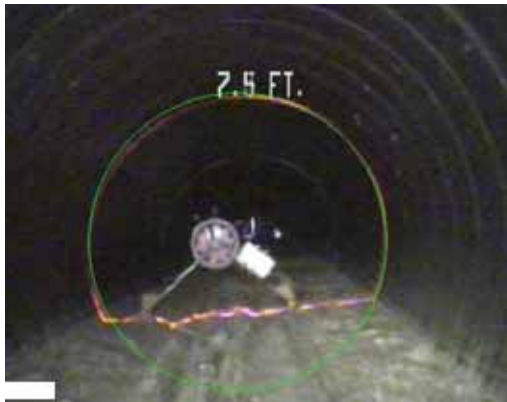
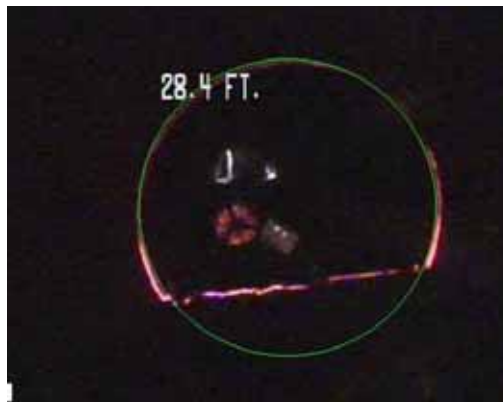
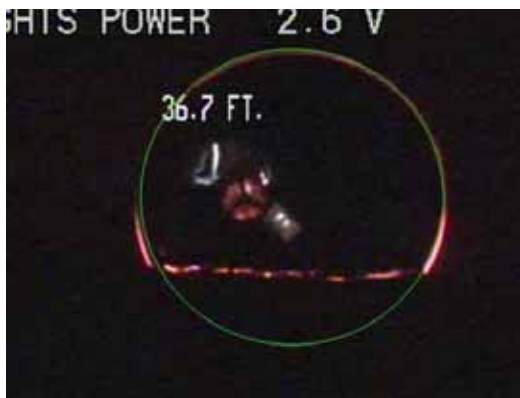
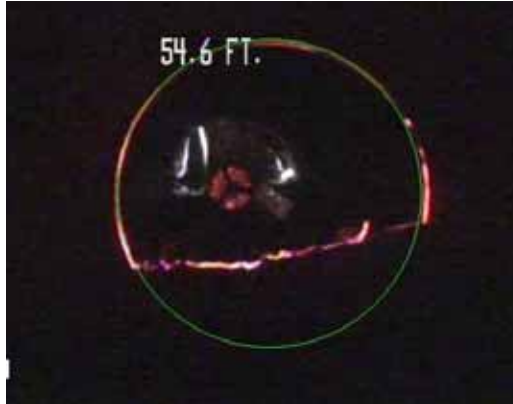
Pipeline No. 7 (Site No. 4: Wendell – Huntzell Main Drive)

Figure 70 Horizontal deformation of the pipeline No. 7 (Site No. 4: Wendell – Huntzell Main Drive)

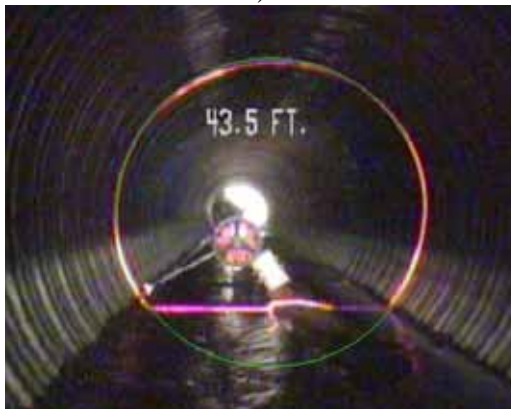
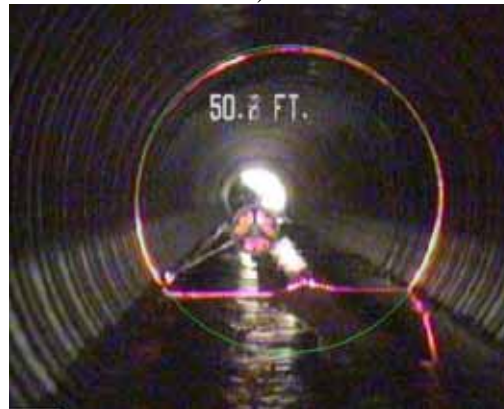
Figure 74 Horizontal deformation of the pipeline No. 8 (Site No. 4: Wendell – Huntzell Main Drive)

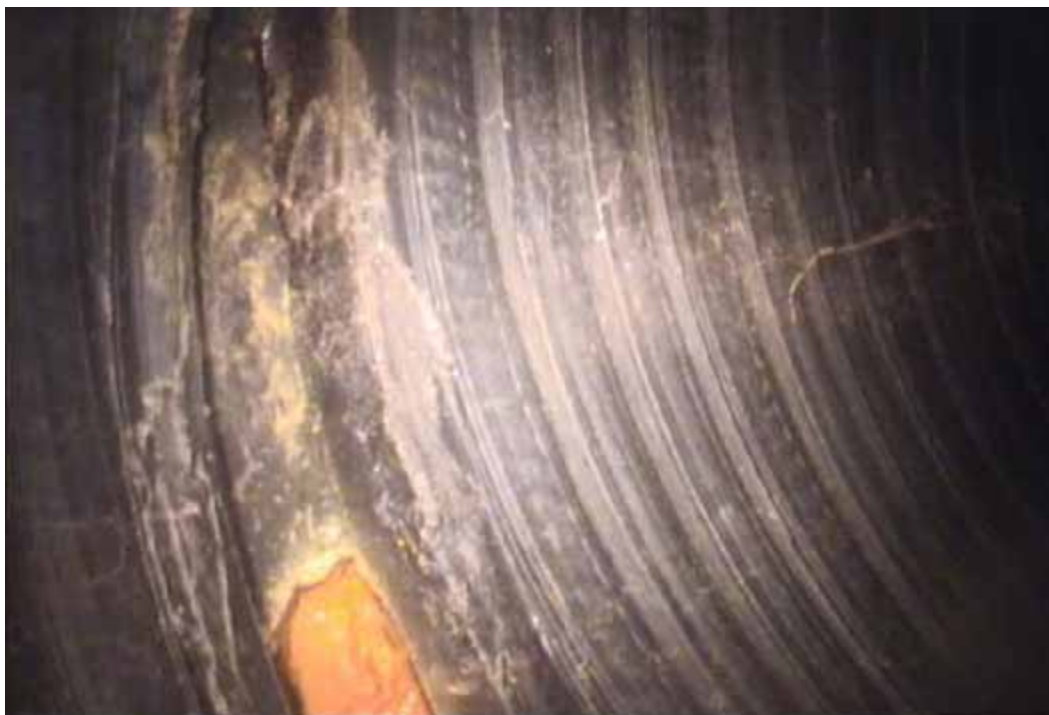
Figure 98 View of major joint displacement failure for pipeline No. 11 (Site No. 6: Rockingham – Love Ln)

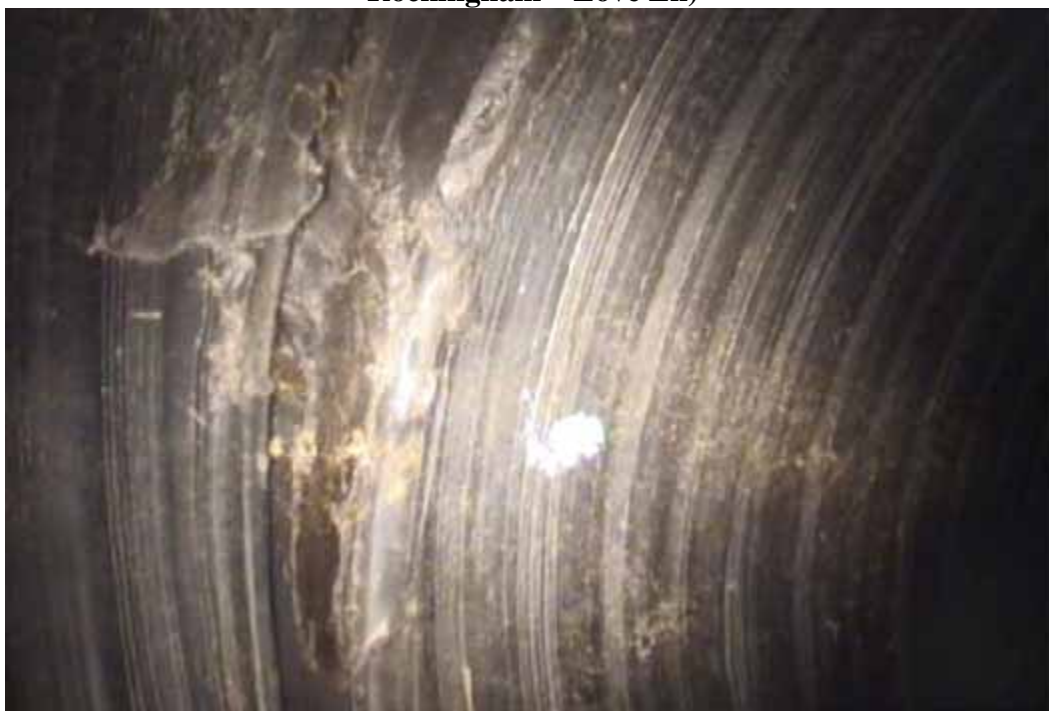
Figure 99 View of cracking and major joint displacement failures for pipeline No. 11 (Site No. 6: Rockingham – Love Ln)

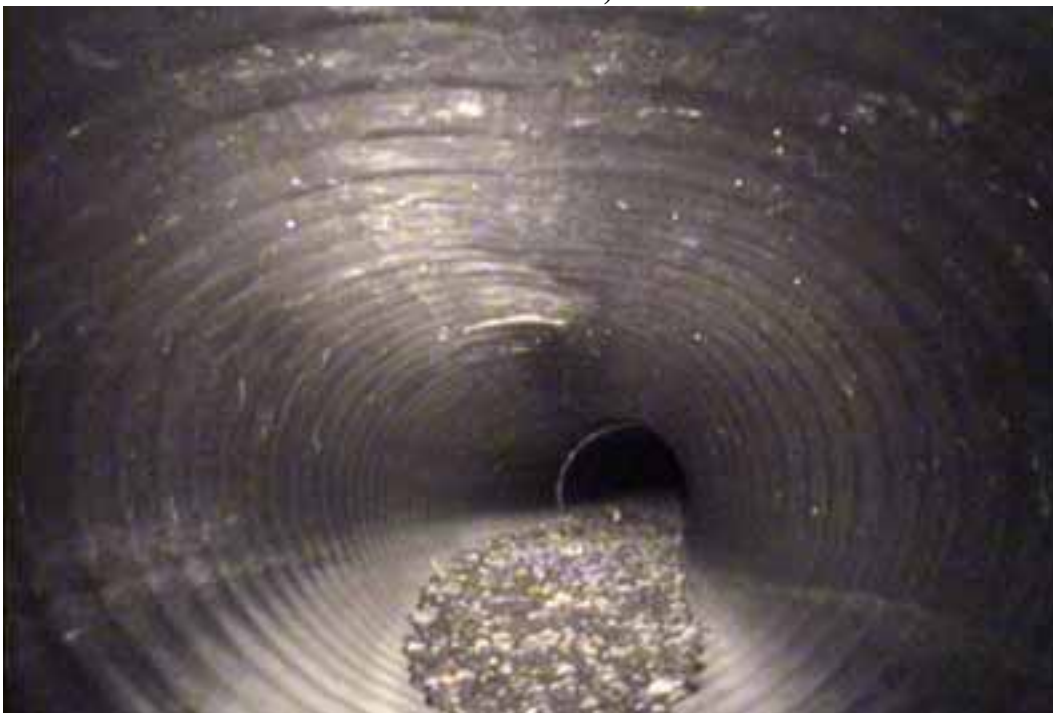
Figure 147 View of inverse curvature and corrugation growth failures for pipeline No. 16 (Site No. 6: Winchester)

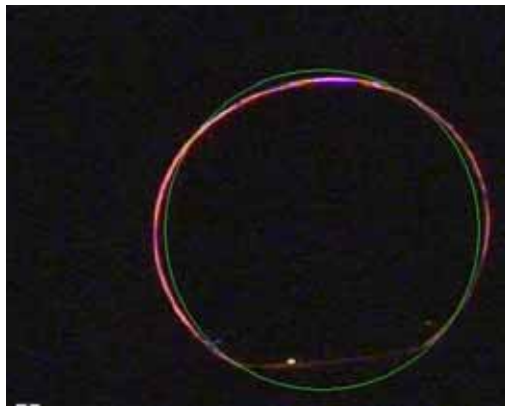
Pipeline No. 3 (Site No. 1: Brooklyn Park - 64th Ave.)

Figure 160 Horizontal and vertical deformation of the pipeline No. 3 (Site No. 1: Brooklyn Park – 64th Avenue)

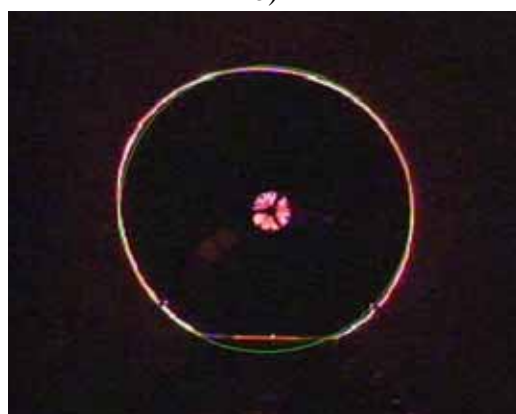
Figure 166 Horizontal and vertical deformation of the pipeline No. 7 (Site No. 2: Brooklyn Park - 71st Ave)

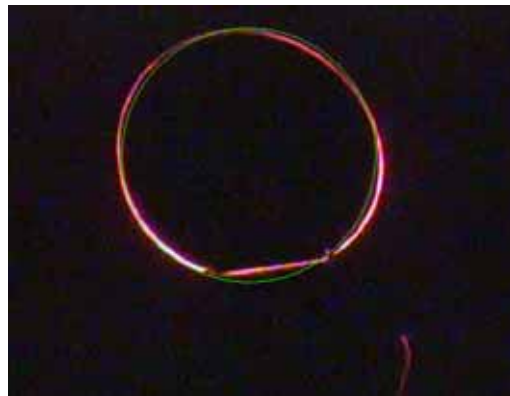
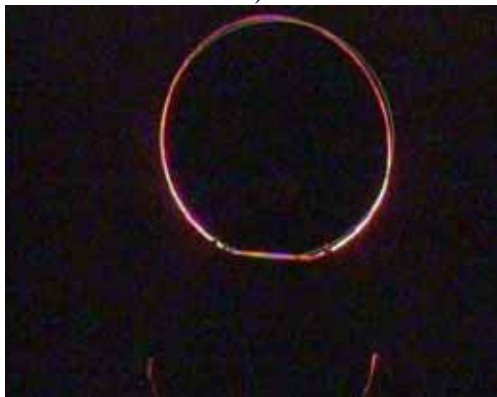
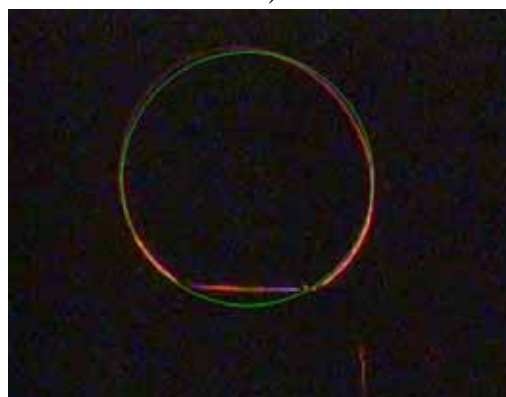
Figure 181 Horizontal and vertical deformation of the pipeline No. 19 (Site No. 6: Brooklyn Park - DuPont)

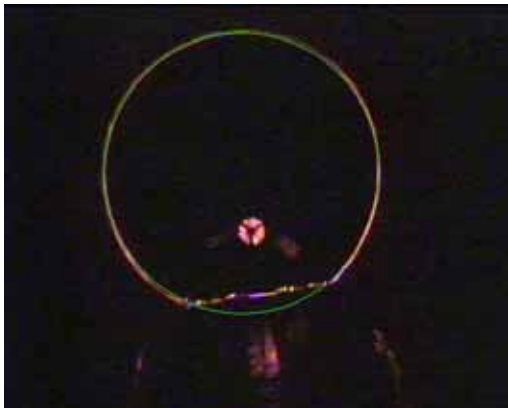
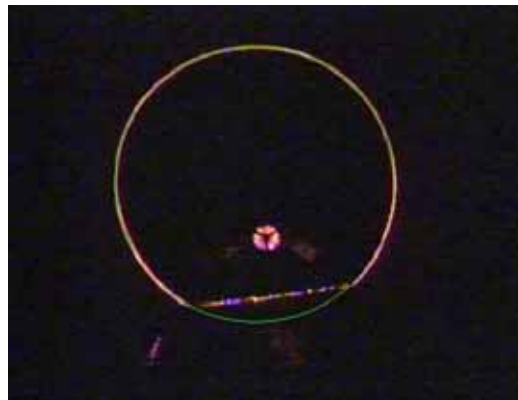
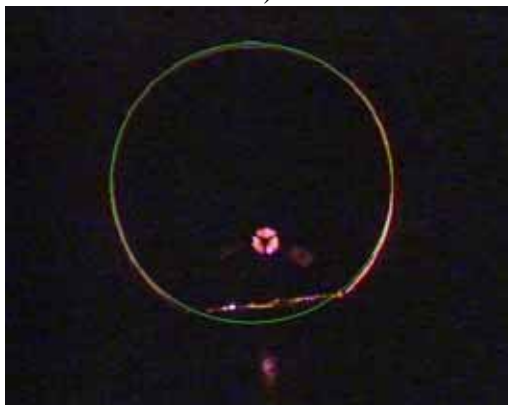
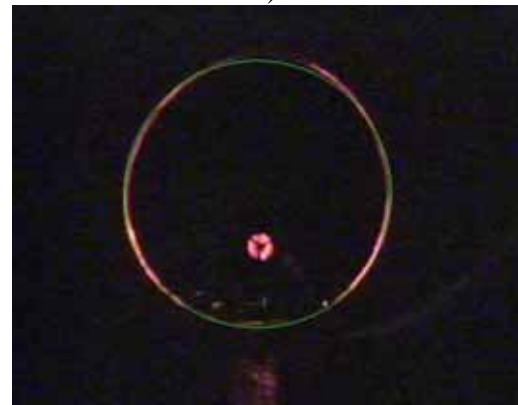
Figure 183 Horizontal and vertical deformation of the pipeline No. 20 (Site No. 7: Mendota Heights)

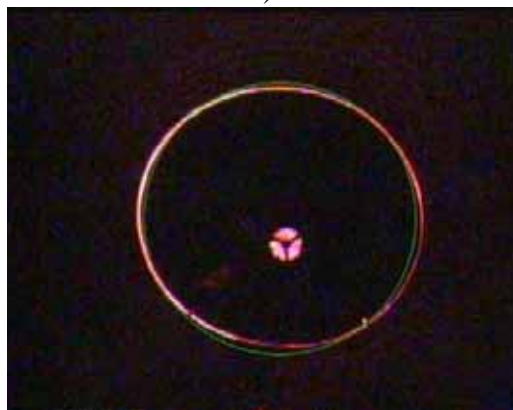
Figure 207 Horizontal and vertical deformation of the pipeline No. 2 (Site No. 1: Lenexa)

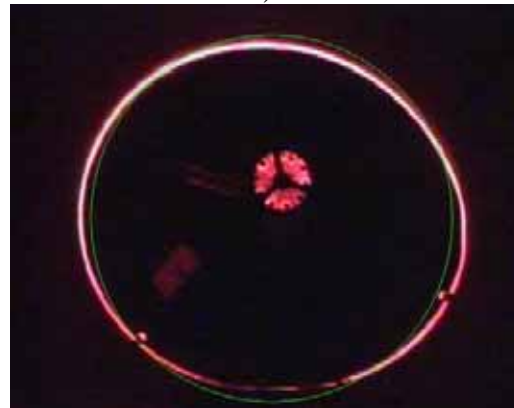
Figure 211 Horizontal and vertical deformation of the pipeline No. 4 (Site No. 1: Lenexa)

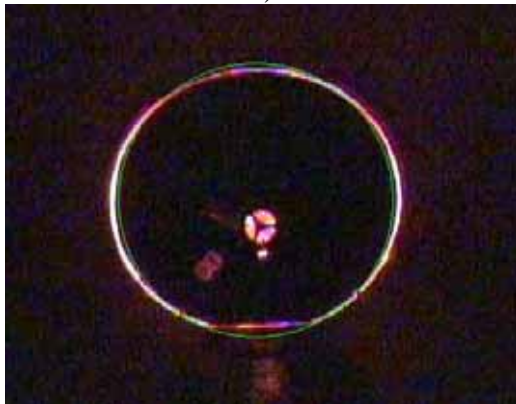
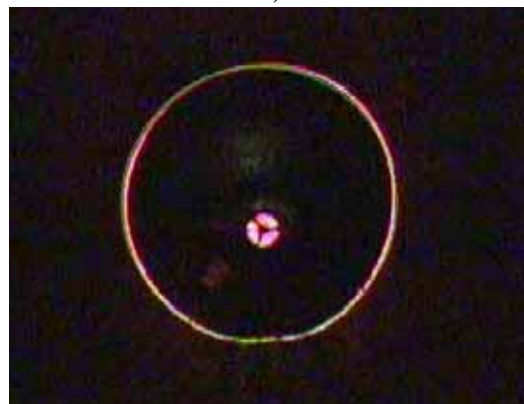
Pipeline No. 3a (Site No: 1 Howell County – HW 63)

Figure 229 Horizontal and vertical deformation of the pipeline No. 3a (Site No. 1: Howell County – HW 63)
