Evaluation of HDPE Pipelines Structural Performance

UT Arlington Center for Structural Engineering Research

November 2010

**As a Part of the Initiative on the Underground Structural Health
Monitoring and Equipment Development**

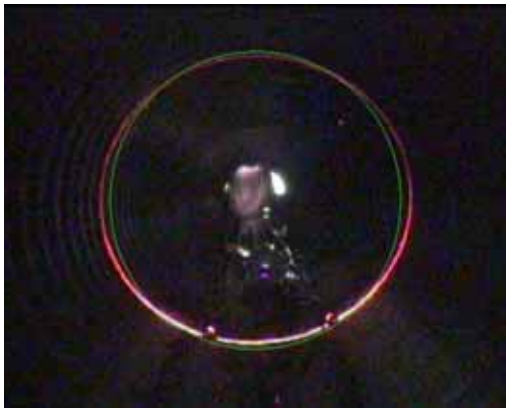
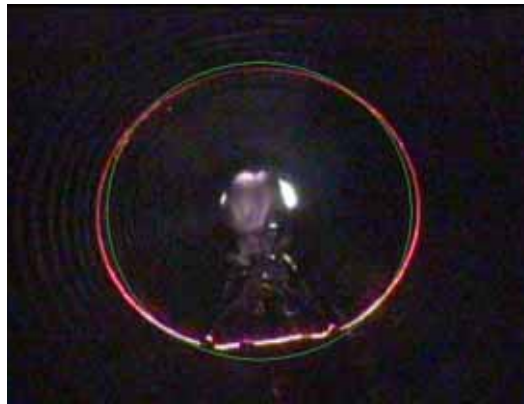
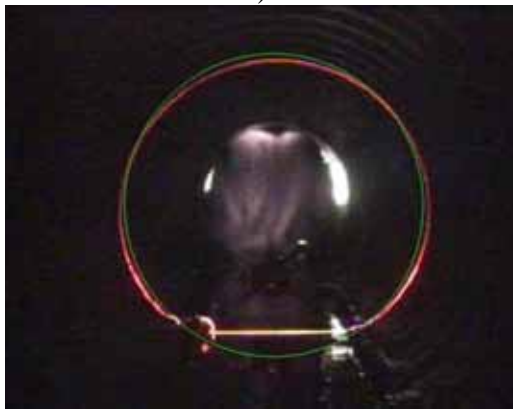
Pipeline No. 5 (Site No. 3: Franklin County – Route FF)

Figure 233 Horizontal and vertical deformation of the pipeline No. 5 (Site No. 3: Franklin County – Route FF)

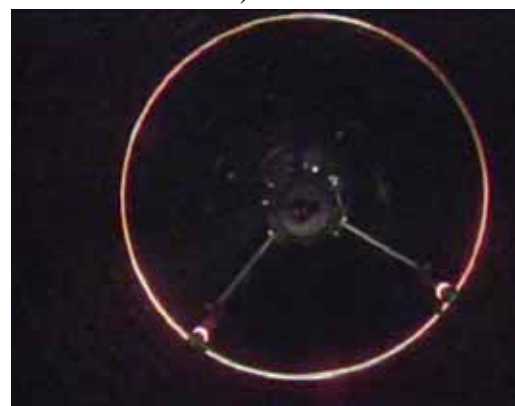
Figure 243 Horizontal and vertical deformation of the pipeline No. 11 (Site No. 3: Franklin County – Route FF)

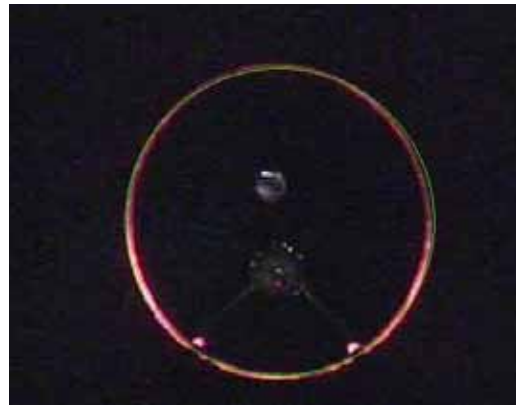
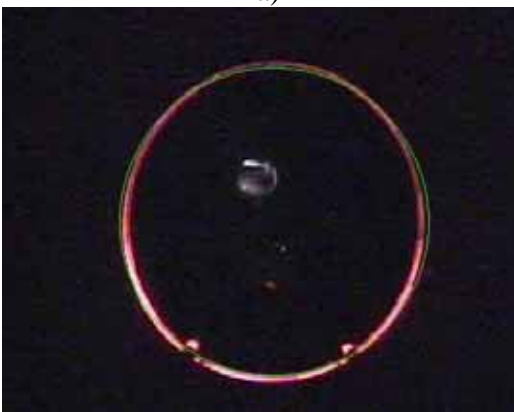
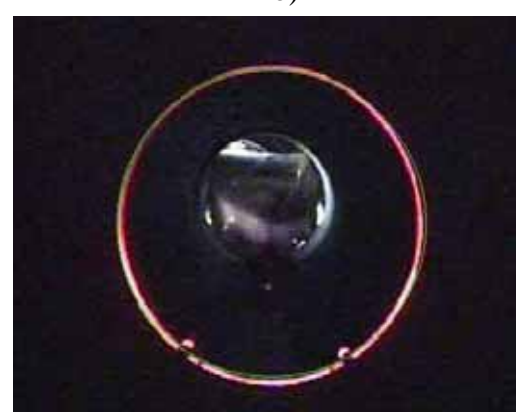
Pipeline No. 15 (Site No: 4 North of Macon – HW 63)

Figure 248 Horizontal and vertical deformation of the pipeline No. 15 (Site No. 4: North of Macon – HW 63)

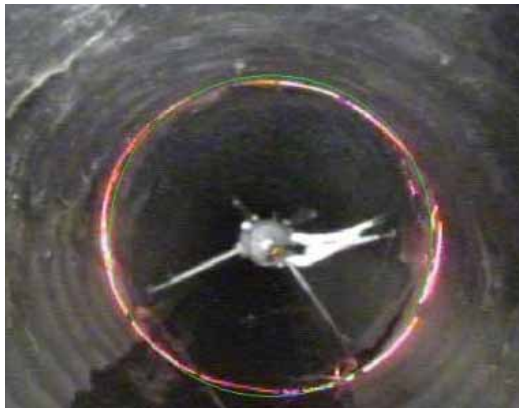
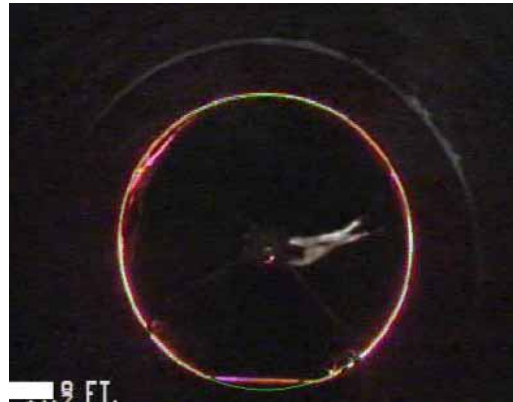
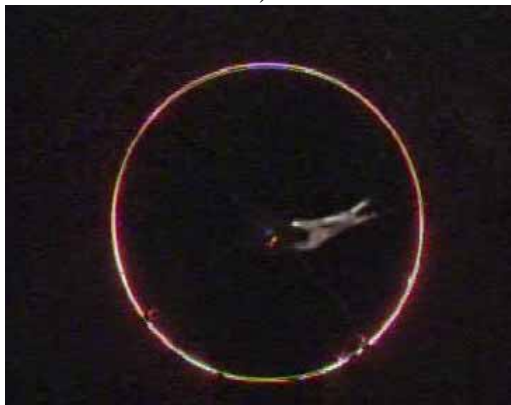
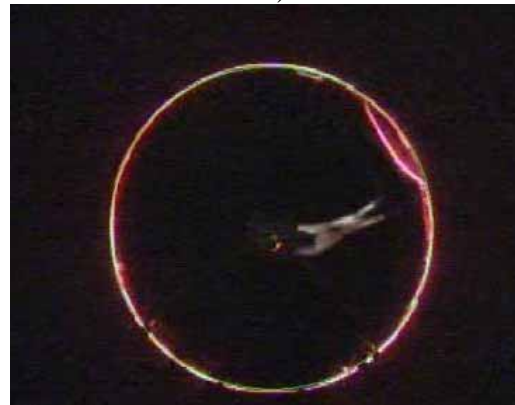
Figure 323 Horizontal and vertical deformation of Pipeline No. 17 (Site No. 2: Route 36)

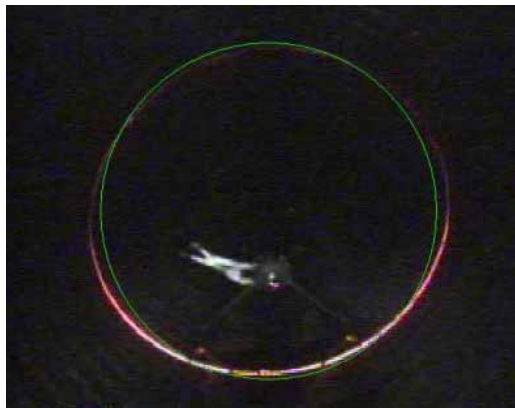
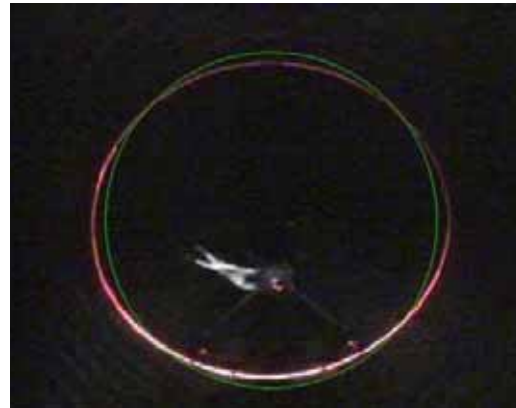
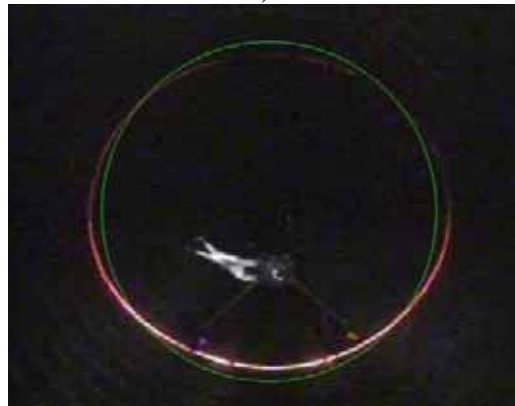
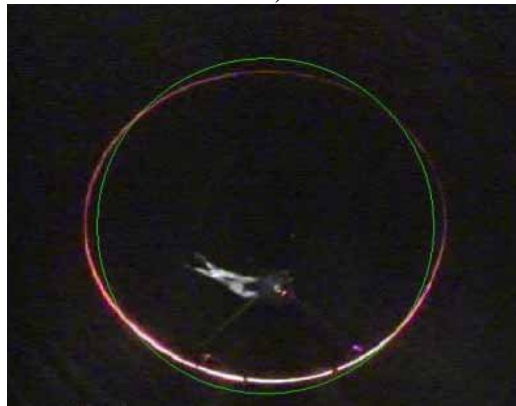
Figure 326 Horizontal and vertical deformation of Pipeline No. 19 (Site No. 2: Route 36)

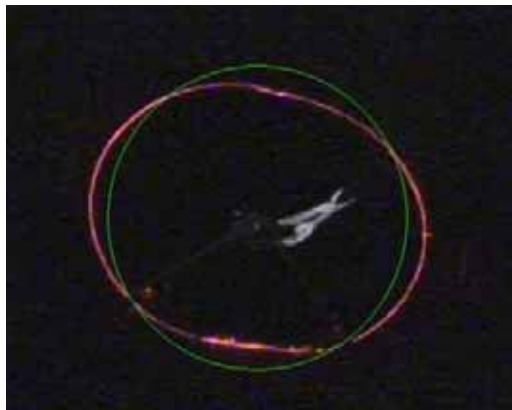
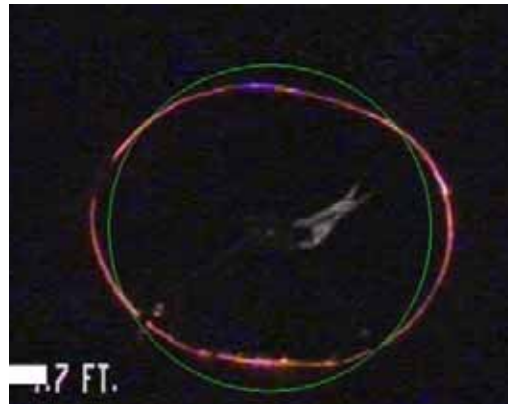
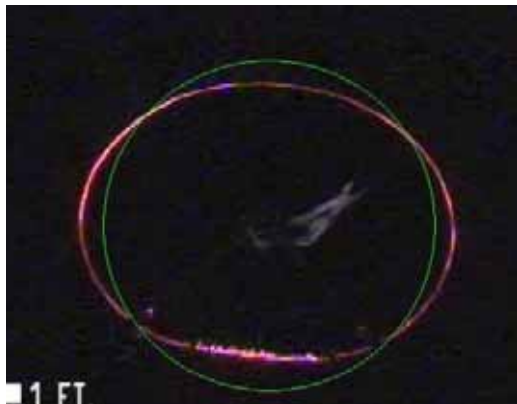
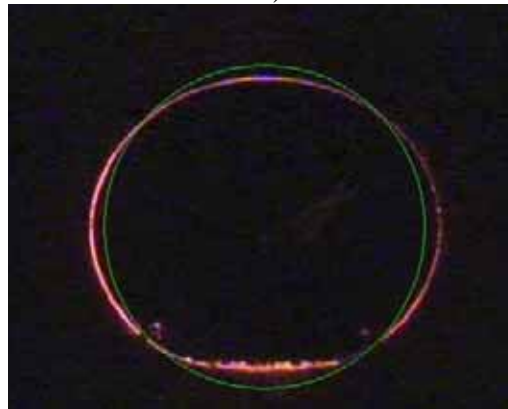
Figure 337 Horizontal and vertical deformation of Pipeline No. 23 (Site No. 2: Route 36)

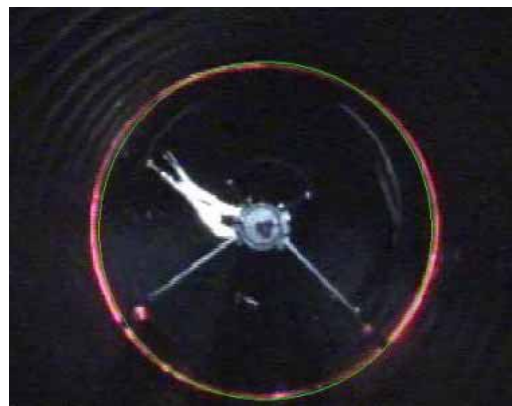
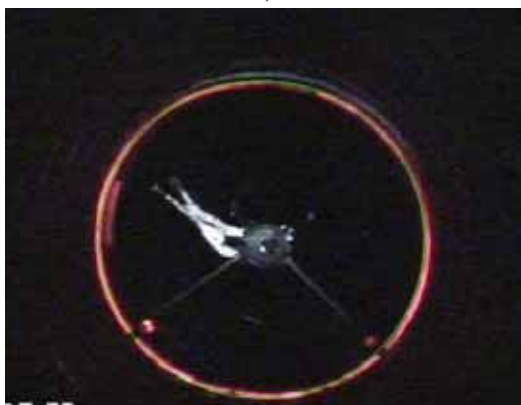
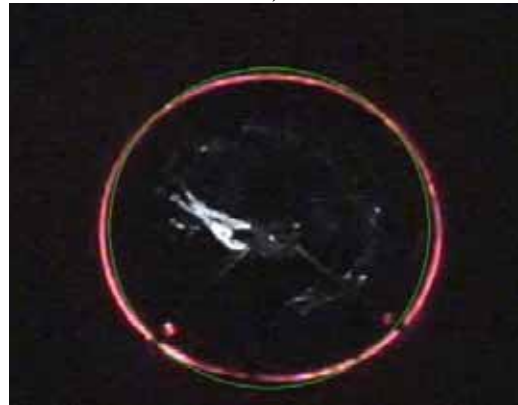
Figure 350 Horizontal and vertical deformation of Pipeline No. 25 (Site No. 2: Route 36)

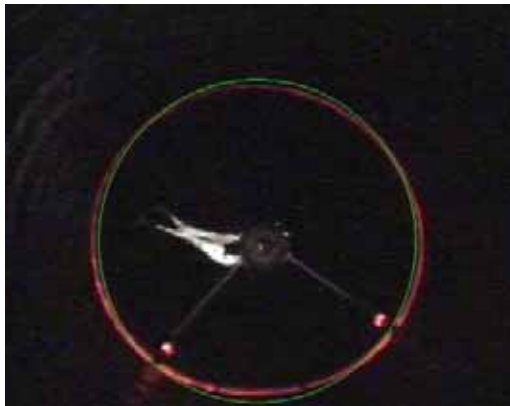
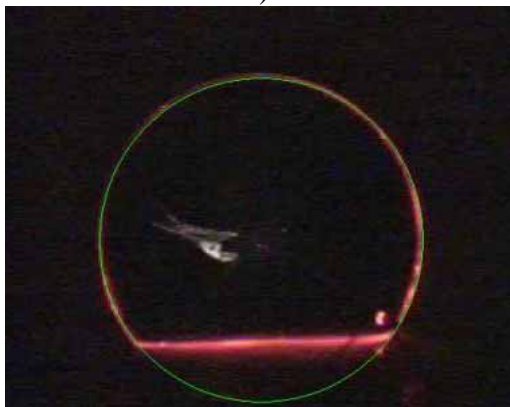
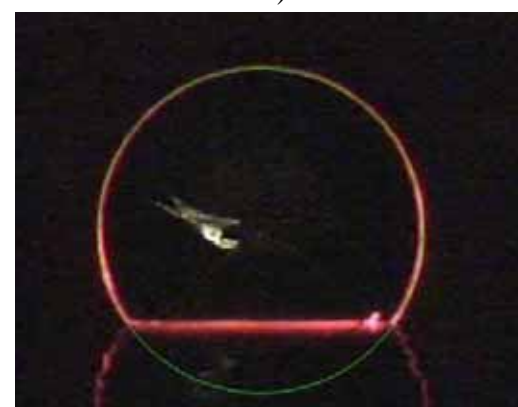
Figure 351 Horizontal and vertical deformation of Pipeline No. 26 (Site No. 2: Route 36)

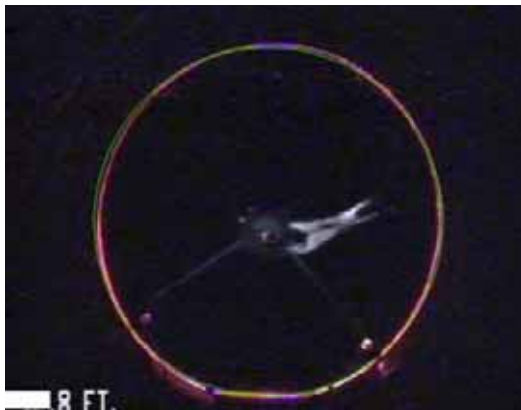
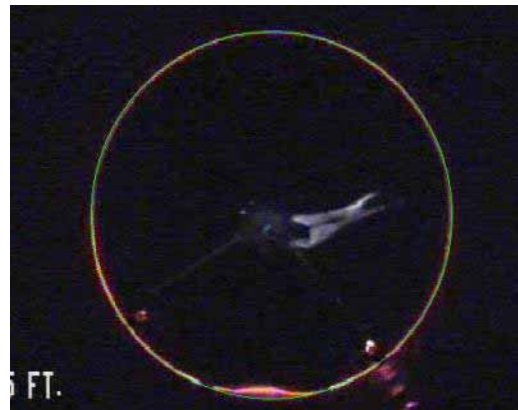
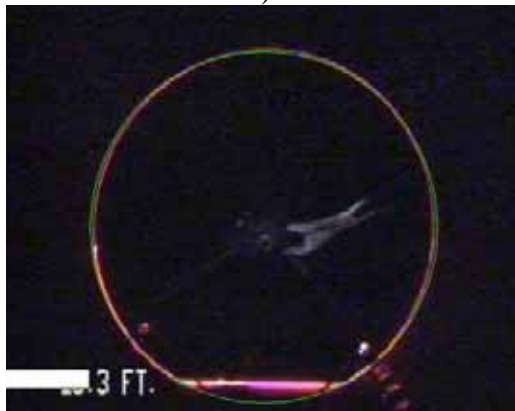
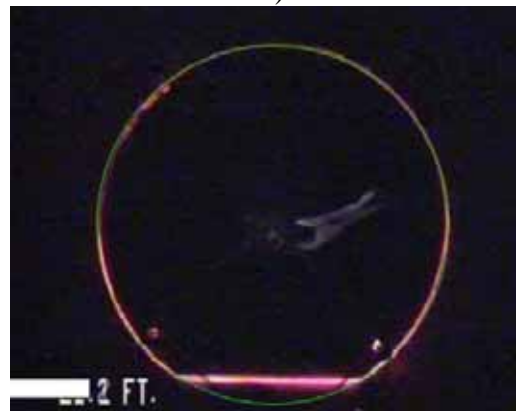
Figure 352 Horizontal and vertical deformation of Pipeline No. 27 (Site No. 2: Route 36)

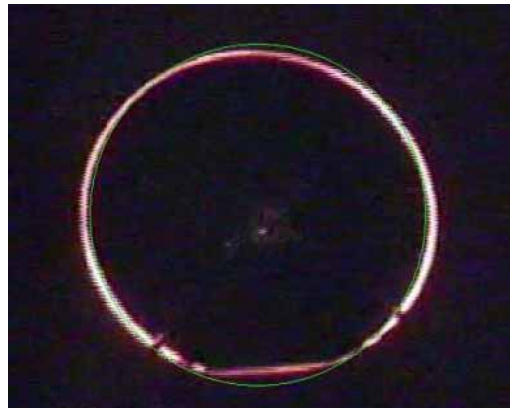
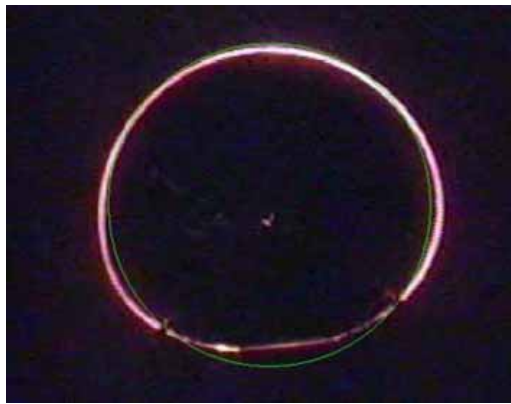
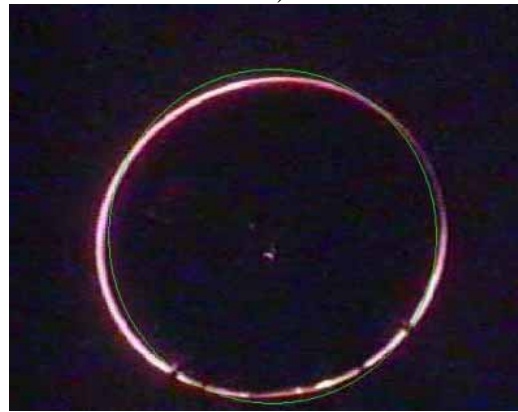
Figure 357 Horizontal and vertical deformation of Pipeline No. 1 (Site No. 1: Legacy Parkway)

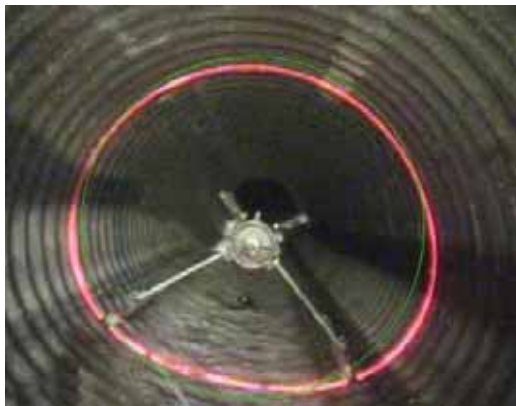
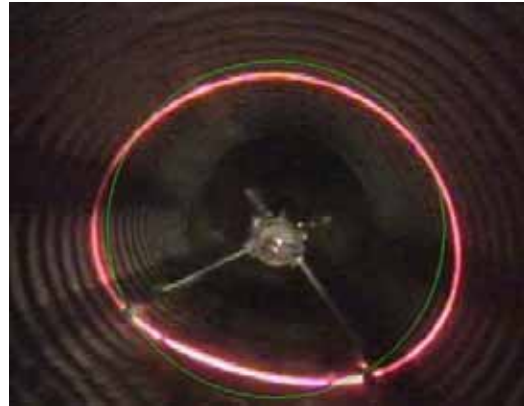
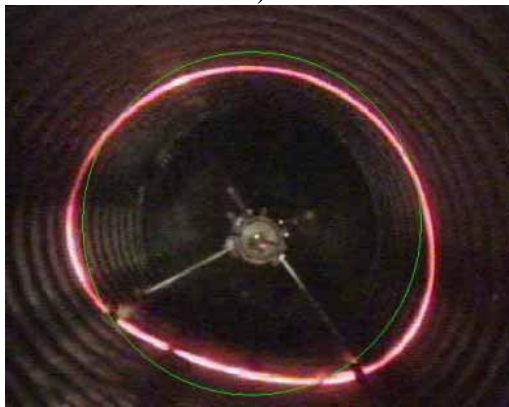
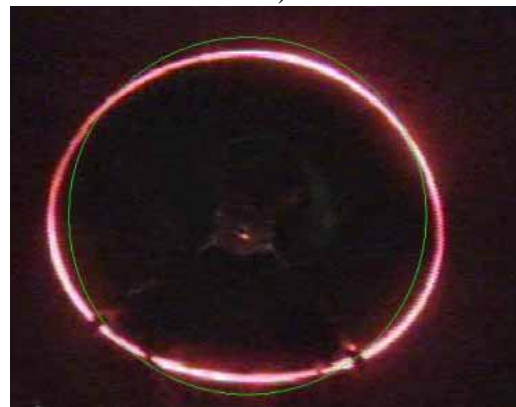
Figure 367 Horizontal and vertical deformation of Pipeline No. 5 (Site No. 1: Legacy Parkway)

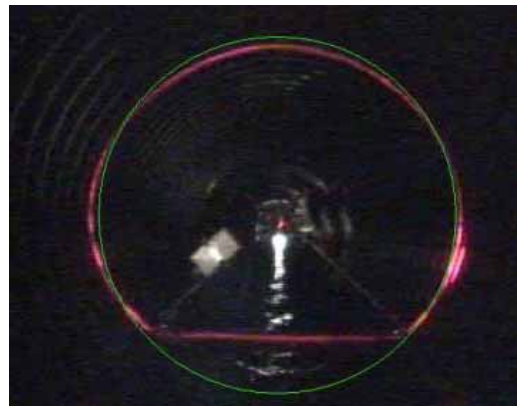
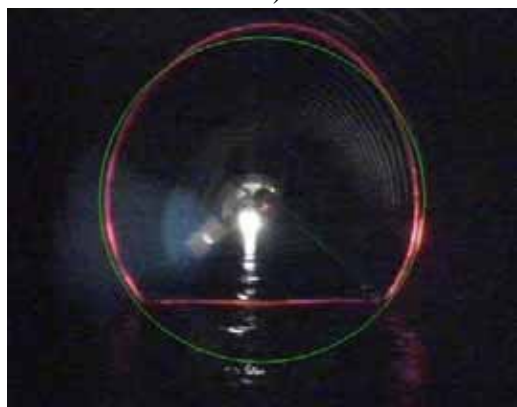
Figure 374 Horizontal and vertical deformation of Pipeline No. 8 (Site No. 1: Legacy Parkway)

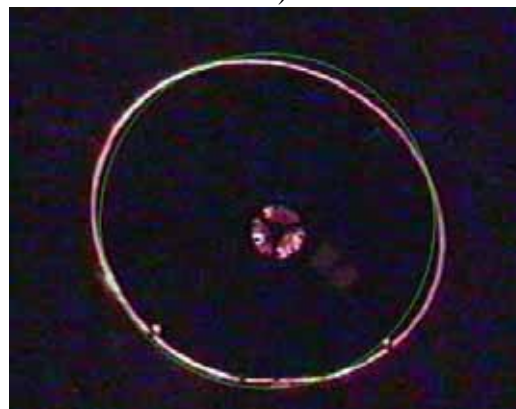
Pipeline No. 24a (Site No. 13 Burlinghame Avenue)

Figure 461 Horizontal and vertical deformation of Pipeline No. 24a (Site No. 13: Burlinghame Avenue)

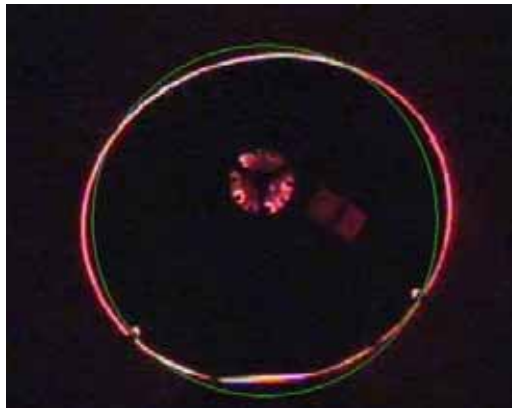
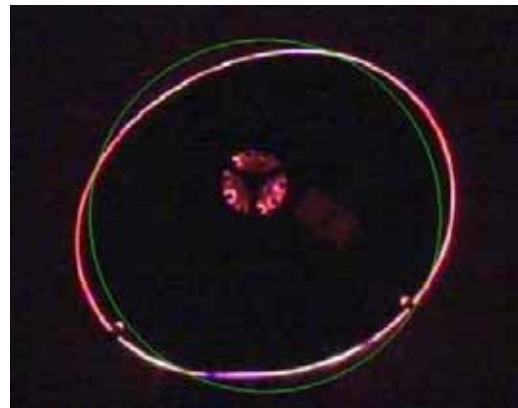
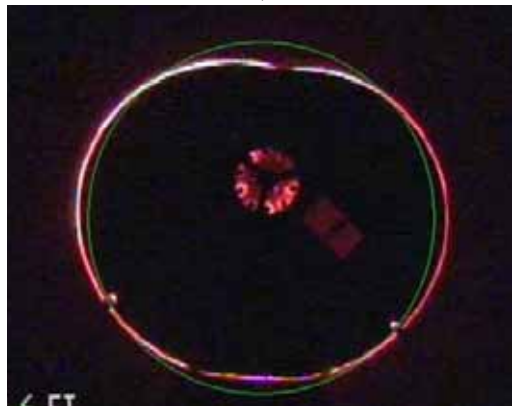
Pipeline No. 24b (Site No. 13 Burlinghame Avenue)

Figure 462 Horizontal and vertical deformation of Pipeline No. 24b (Site No. 13: Burlinghame Avenue)

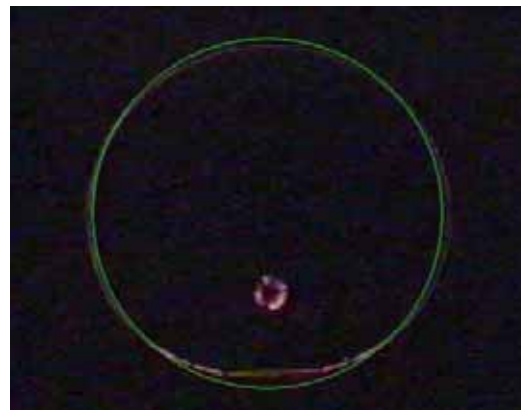
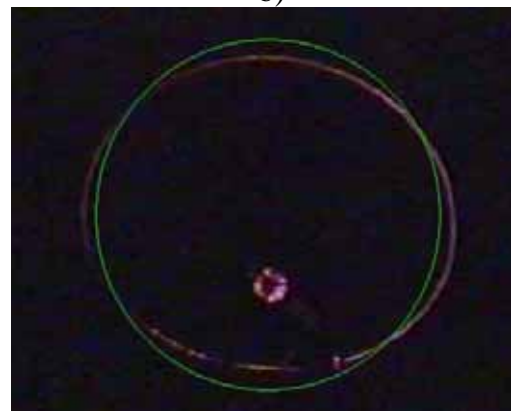
Pipeline No. 26 (Site No. 15 Greenville)

Figure 469 Horizontal and vertical deformation of Pipeline No. 26 (Site No. 15: Greenville)

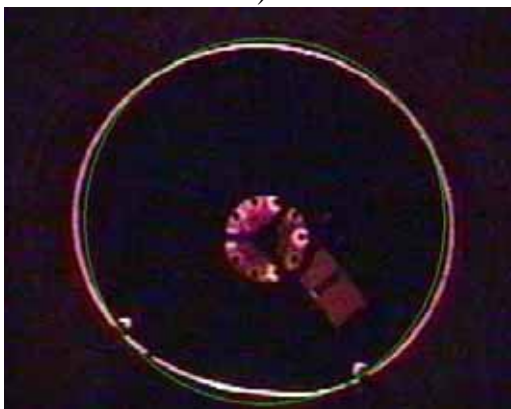
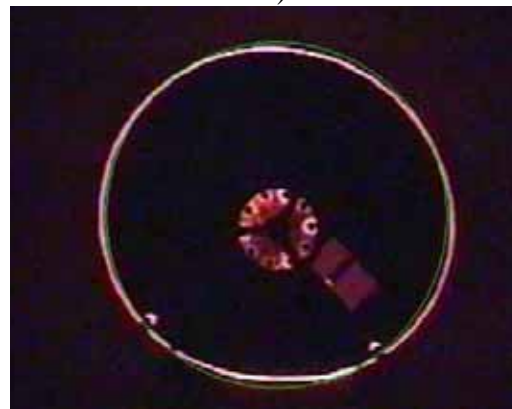
Figure 472 Horizontal and vertical deformation of Pipeline No. 29 (Site No. 16: Knapp and M44)

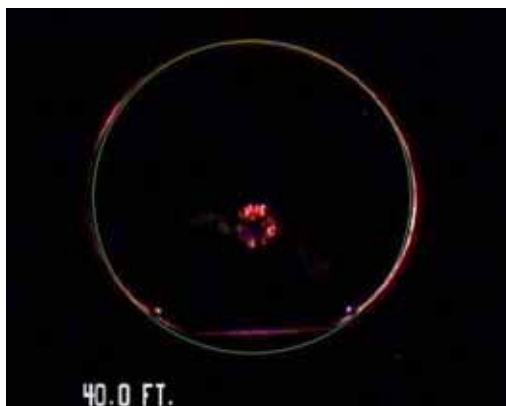
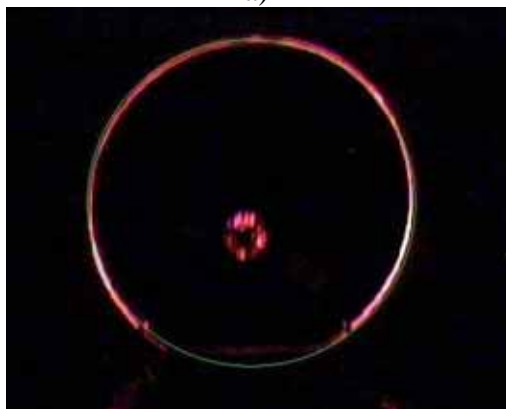
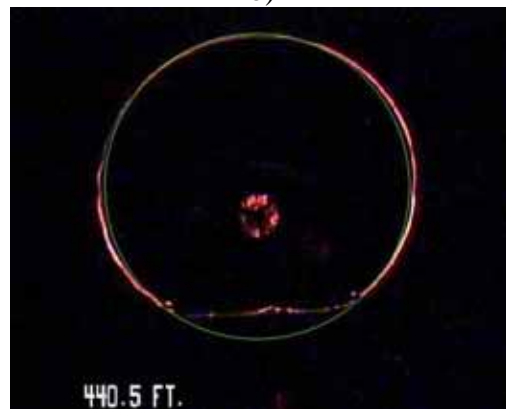
Figure 481 Horizontal and vertical deformation of the pipeline No. 2 (Site No. 1: Orlando)

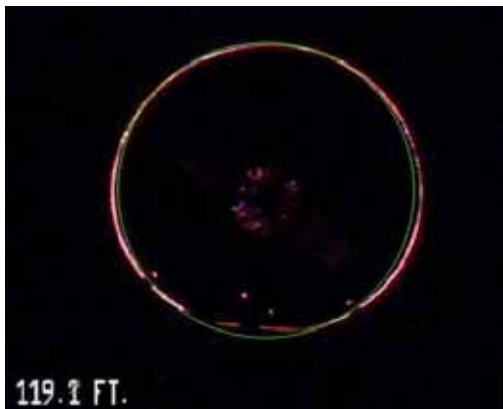
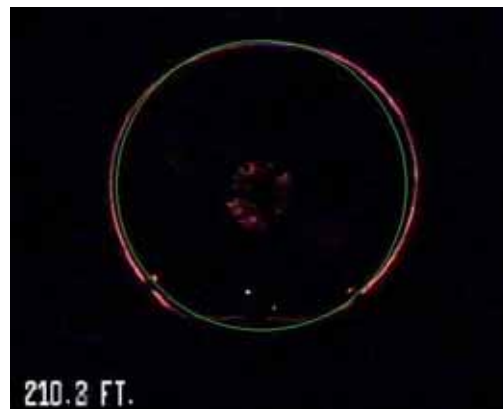
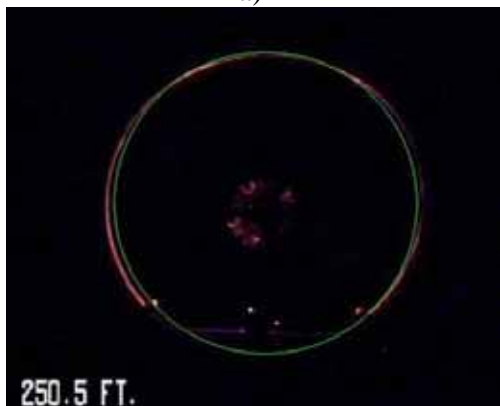
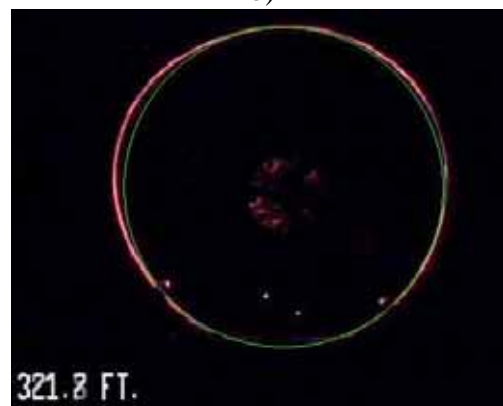
Figure 503 Horizontal and vertical deformation of the pipeline No. 6 (Site No. 1: Orlando)

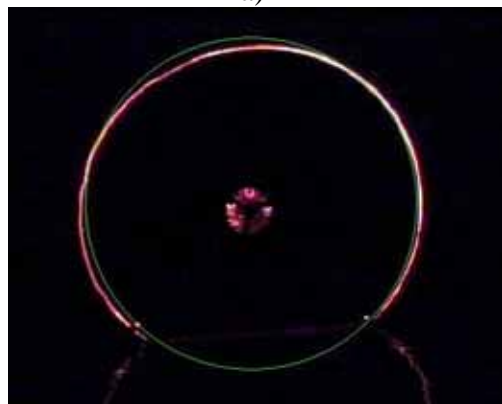
Pipeline No. 9 (Site No. 1: Orlando)

Figure 532 Horizontal and vertical deformation of the pipeline No. 9 (Site No. 1: Orlando)

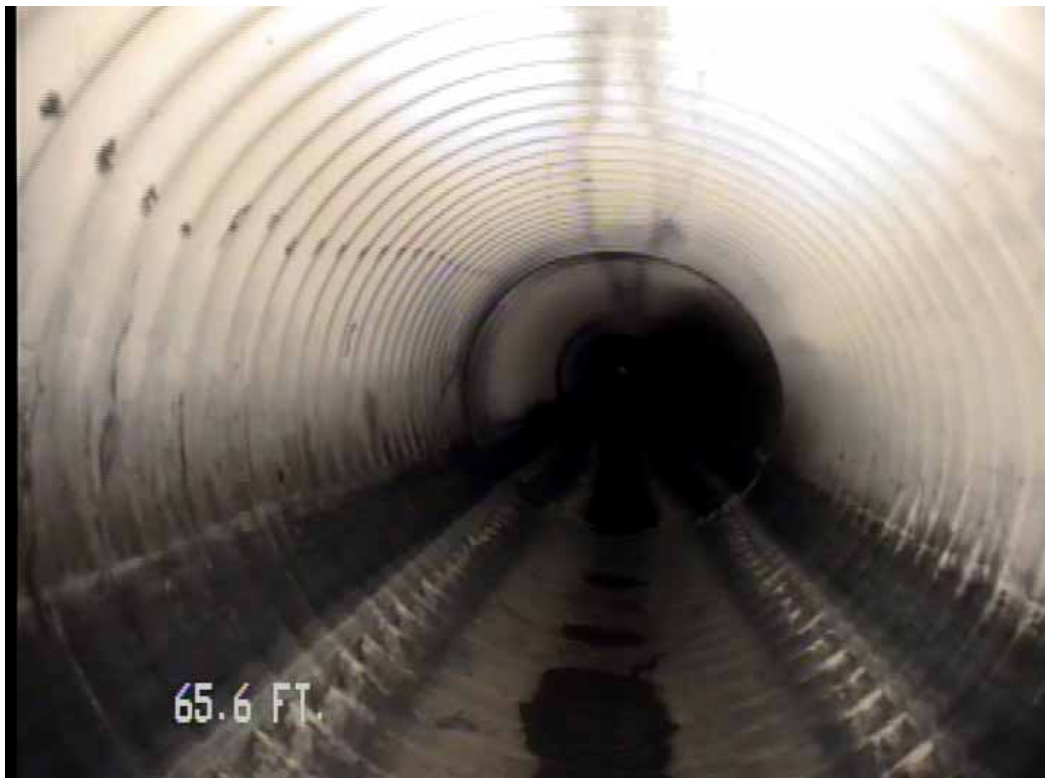
**Figure 555 View of corrugation growth failure for pipeline No. 11
(Site No. 2: Apopka)**

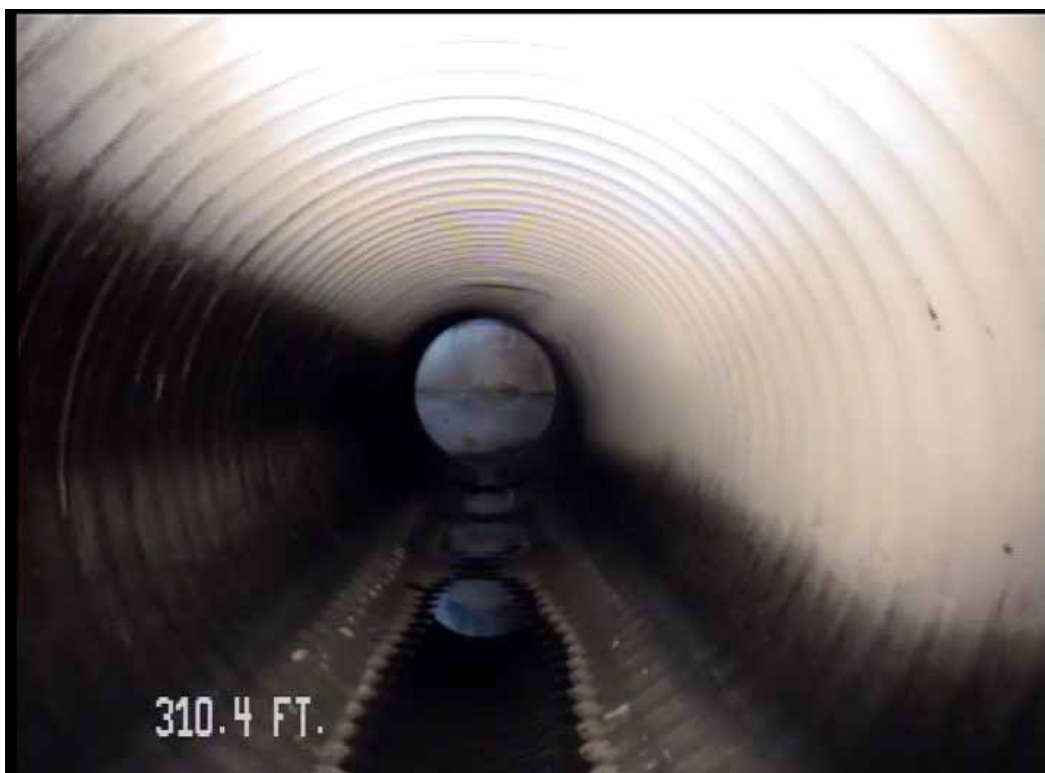
Figure 560 View of corrugation growth failure for pipeline No. 11
(Site No. 2: Apopka)
